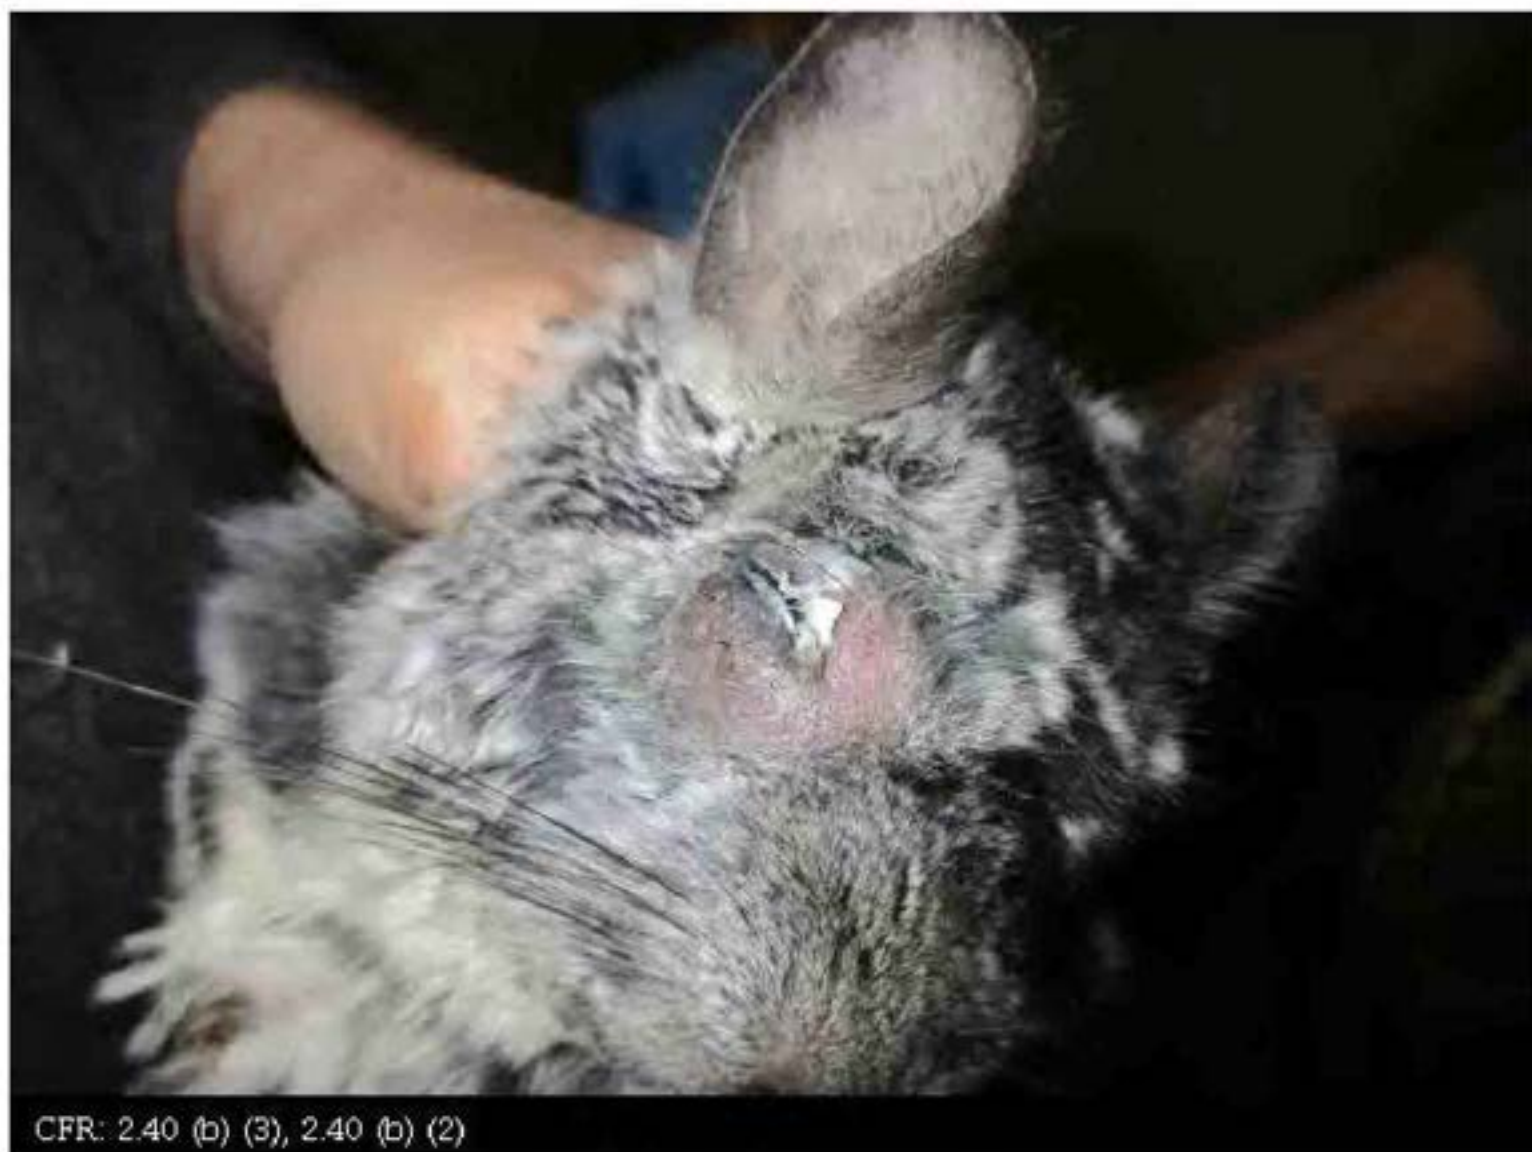
| Description: | Female with eartag "505"; its right eyelids sealed shut with crusty material with hair loss, reddened skin, and a pale creamy discharge from eye. | | |

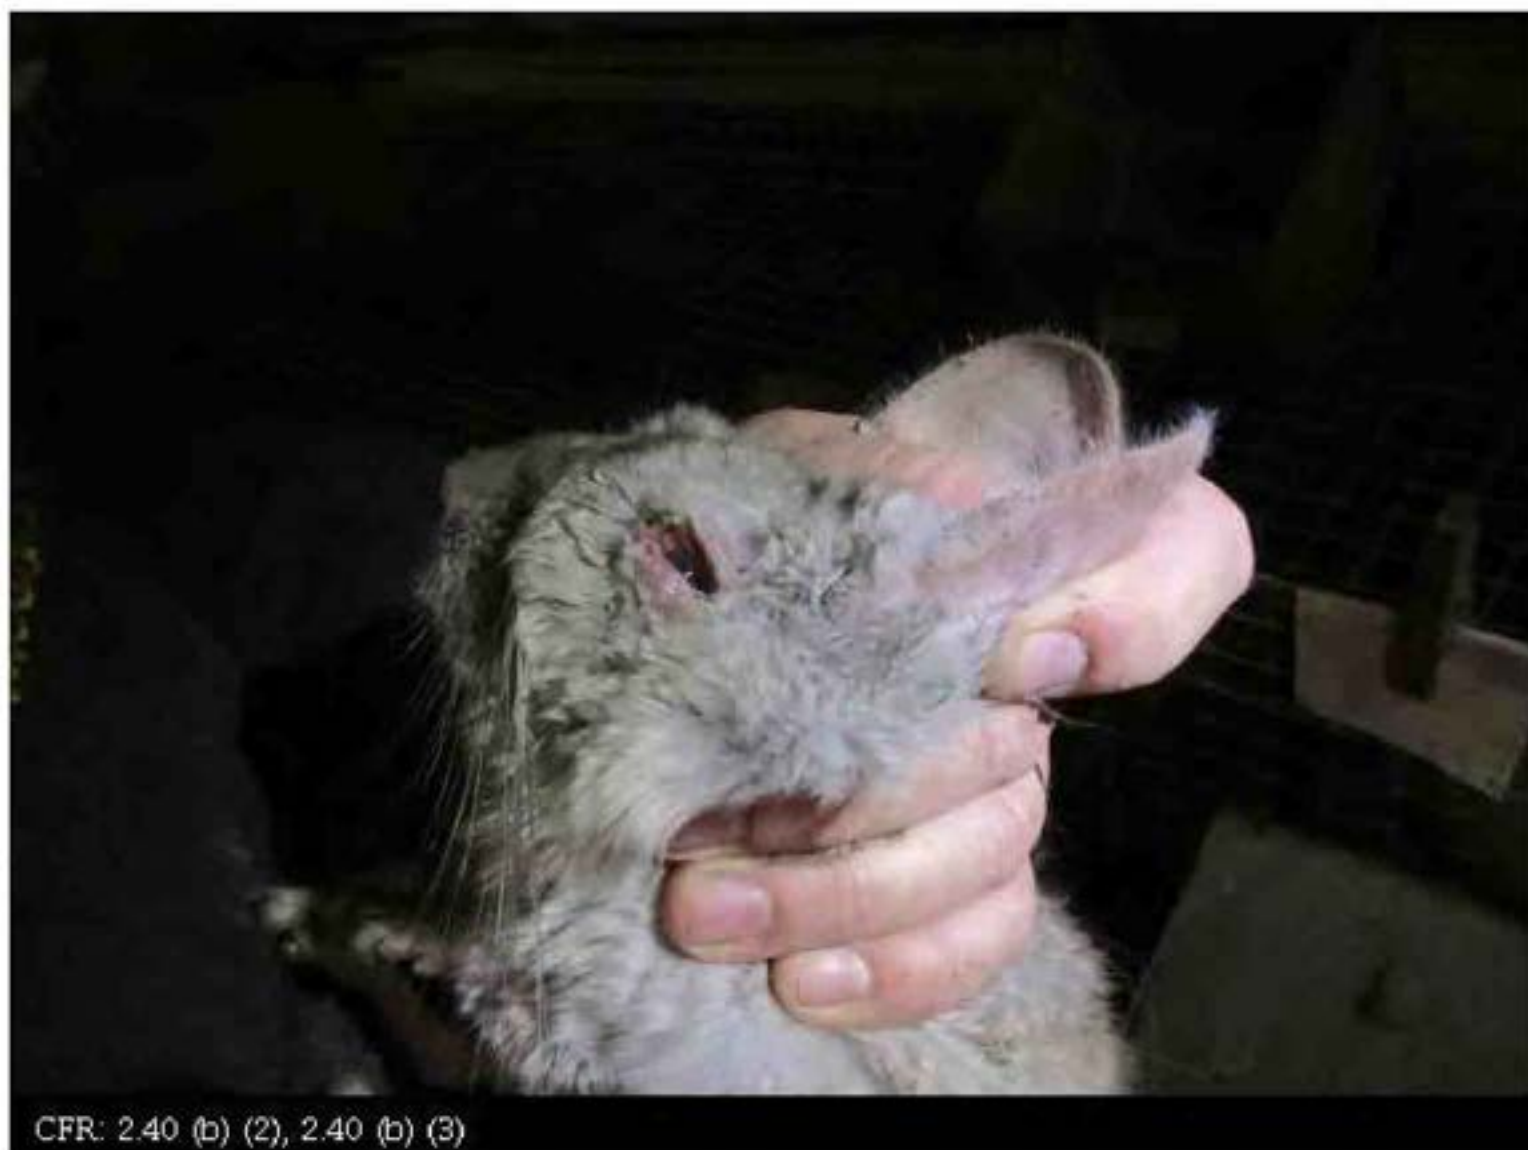
| Description: | Female with eartag "505" its left eyelids sealed shut with crusty material with hair loss, reddened skin, and a pale creamy discharge from eye. | | |

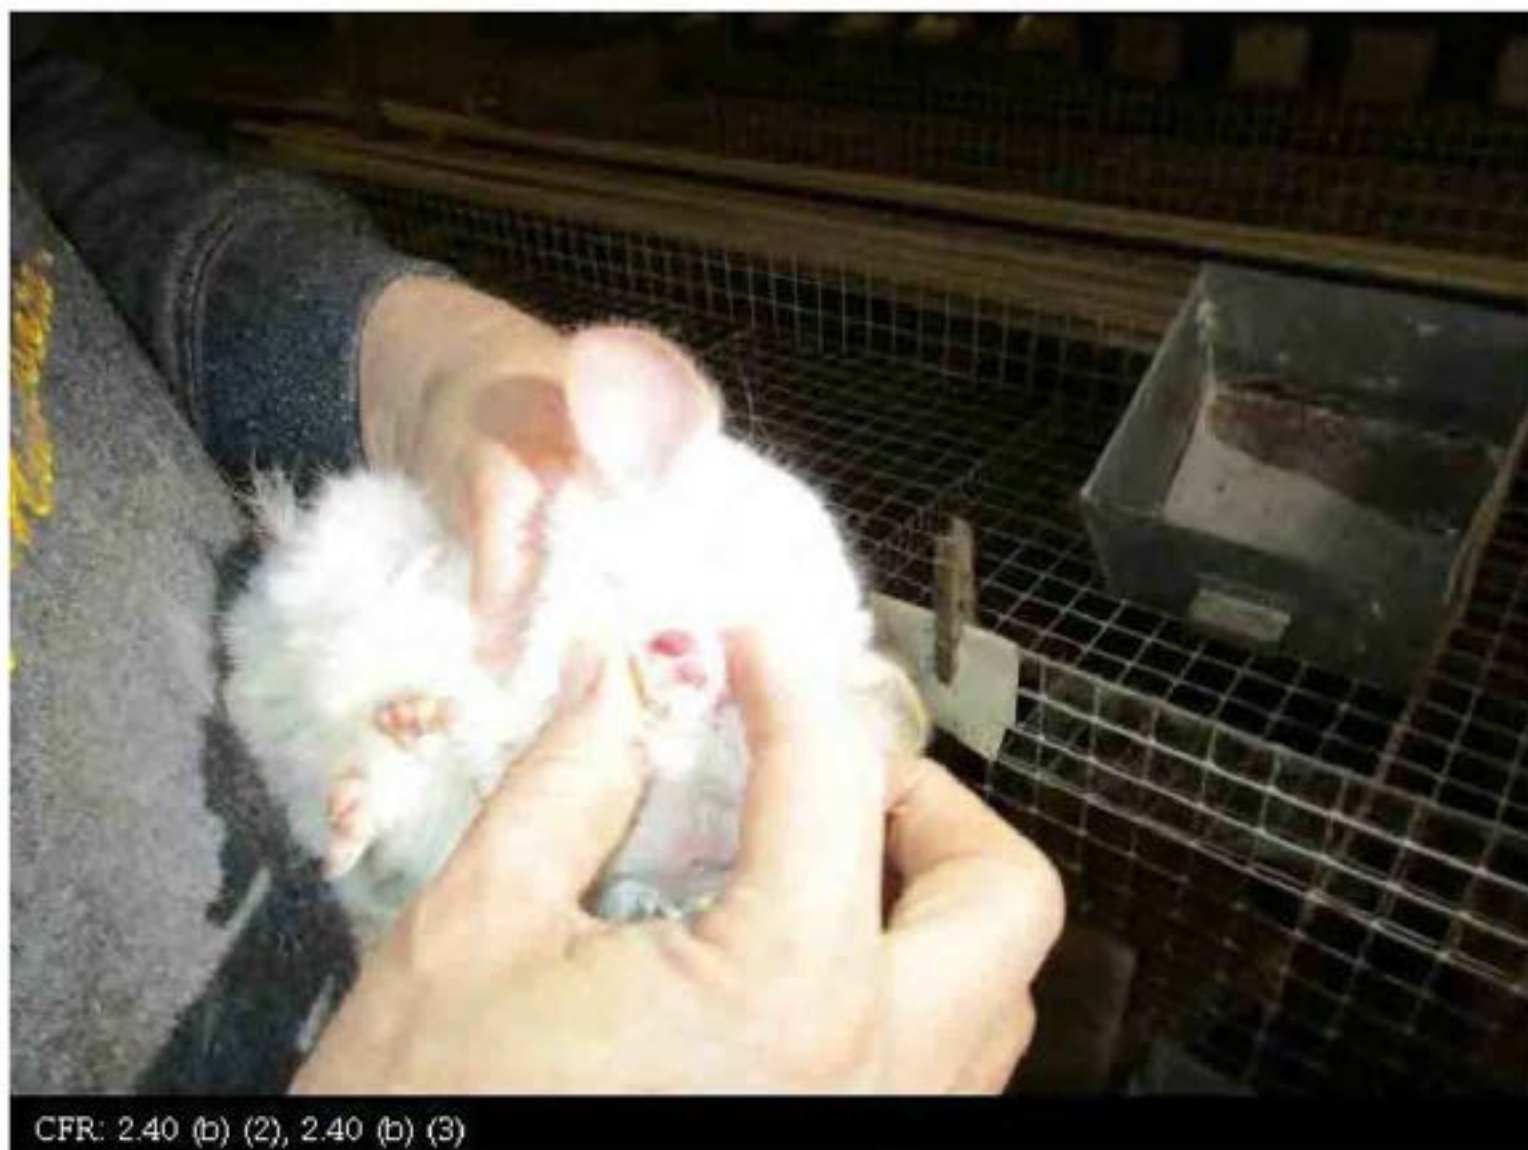
| Description: | Male (no id; cage card "4-8"); its right eye was crusted shut; eyelids swollen with hair loss and surrounding tissues under eyelids bright red. | | |

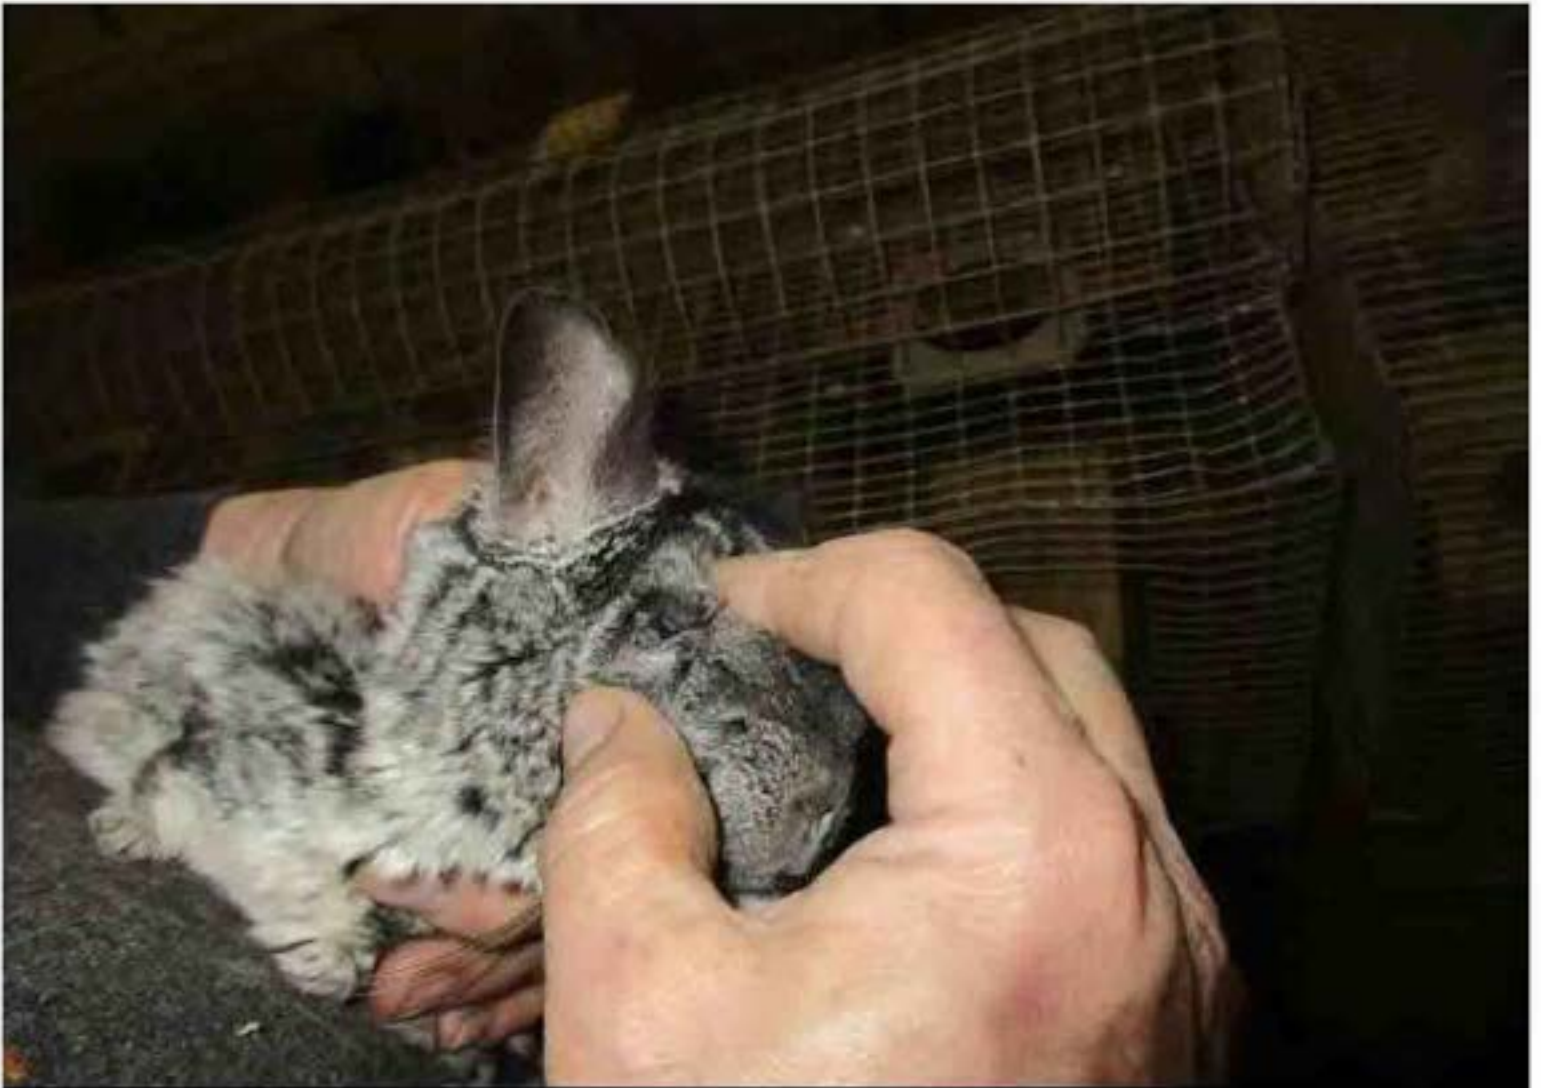
| Description: | Male (no id; cage card "9-13-11"); right eye was sealed shut with crusted material and had some pale creamy discharge. | | |

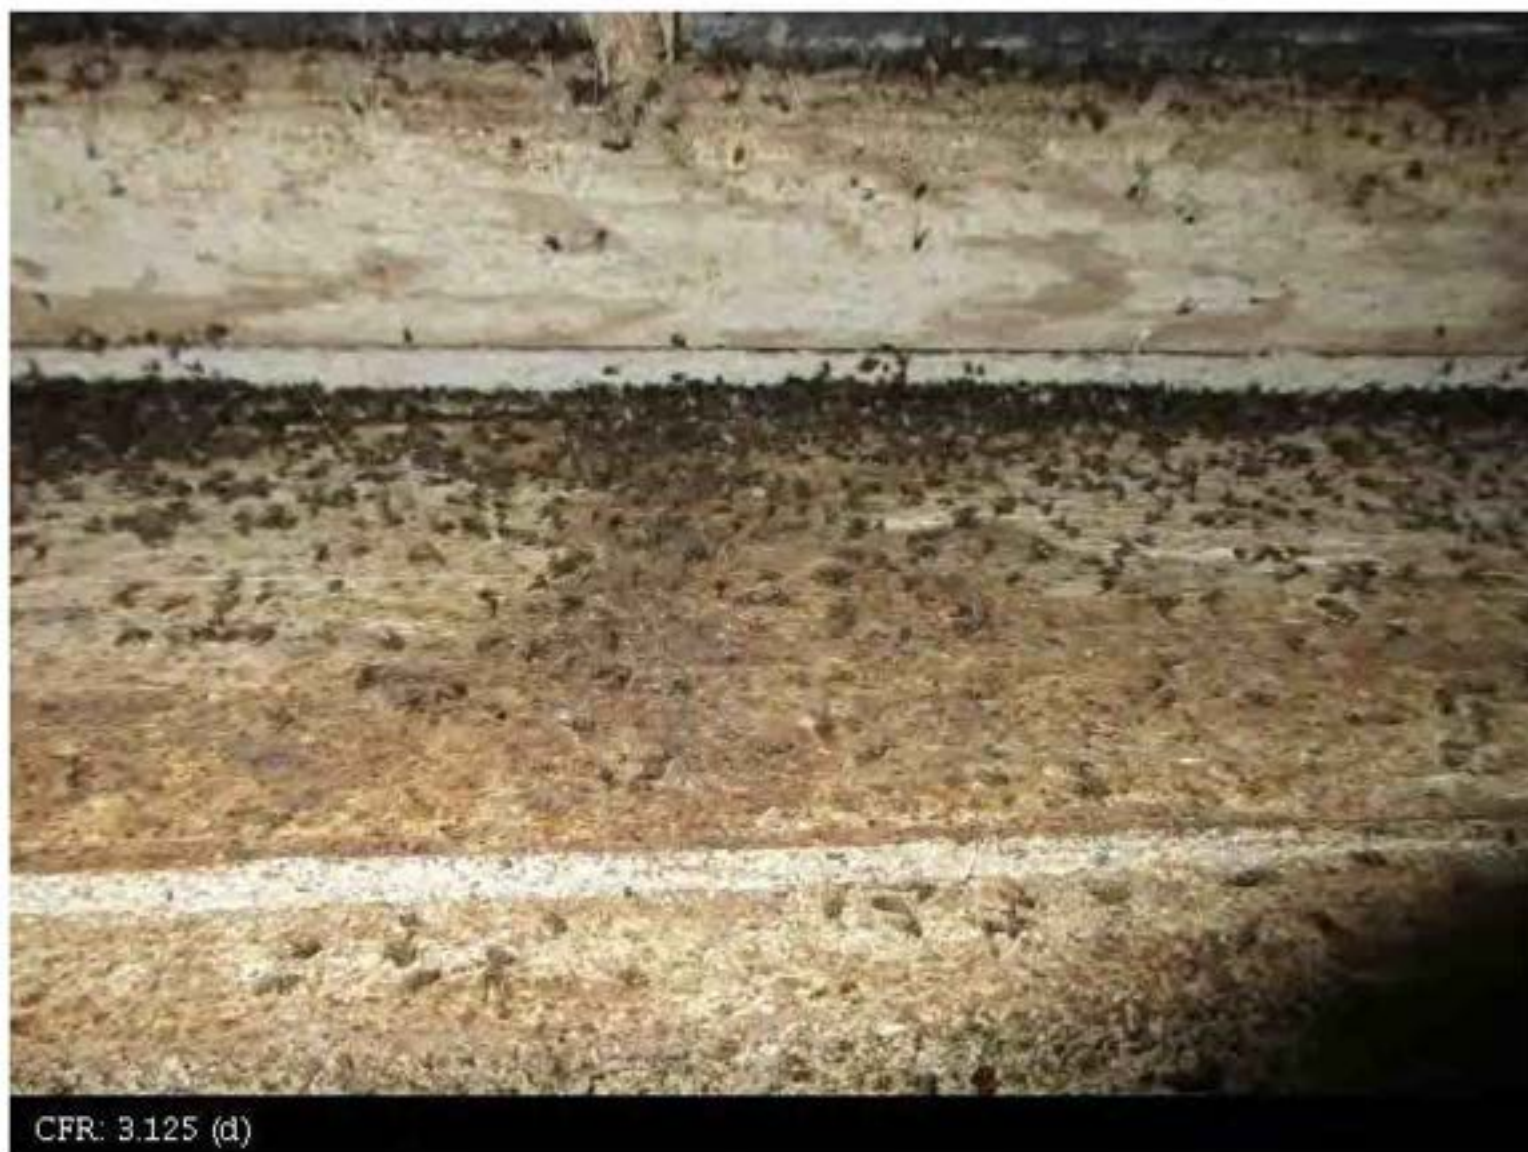
| Description: | Window sill covered with dead bugs and debris. | | |

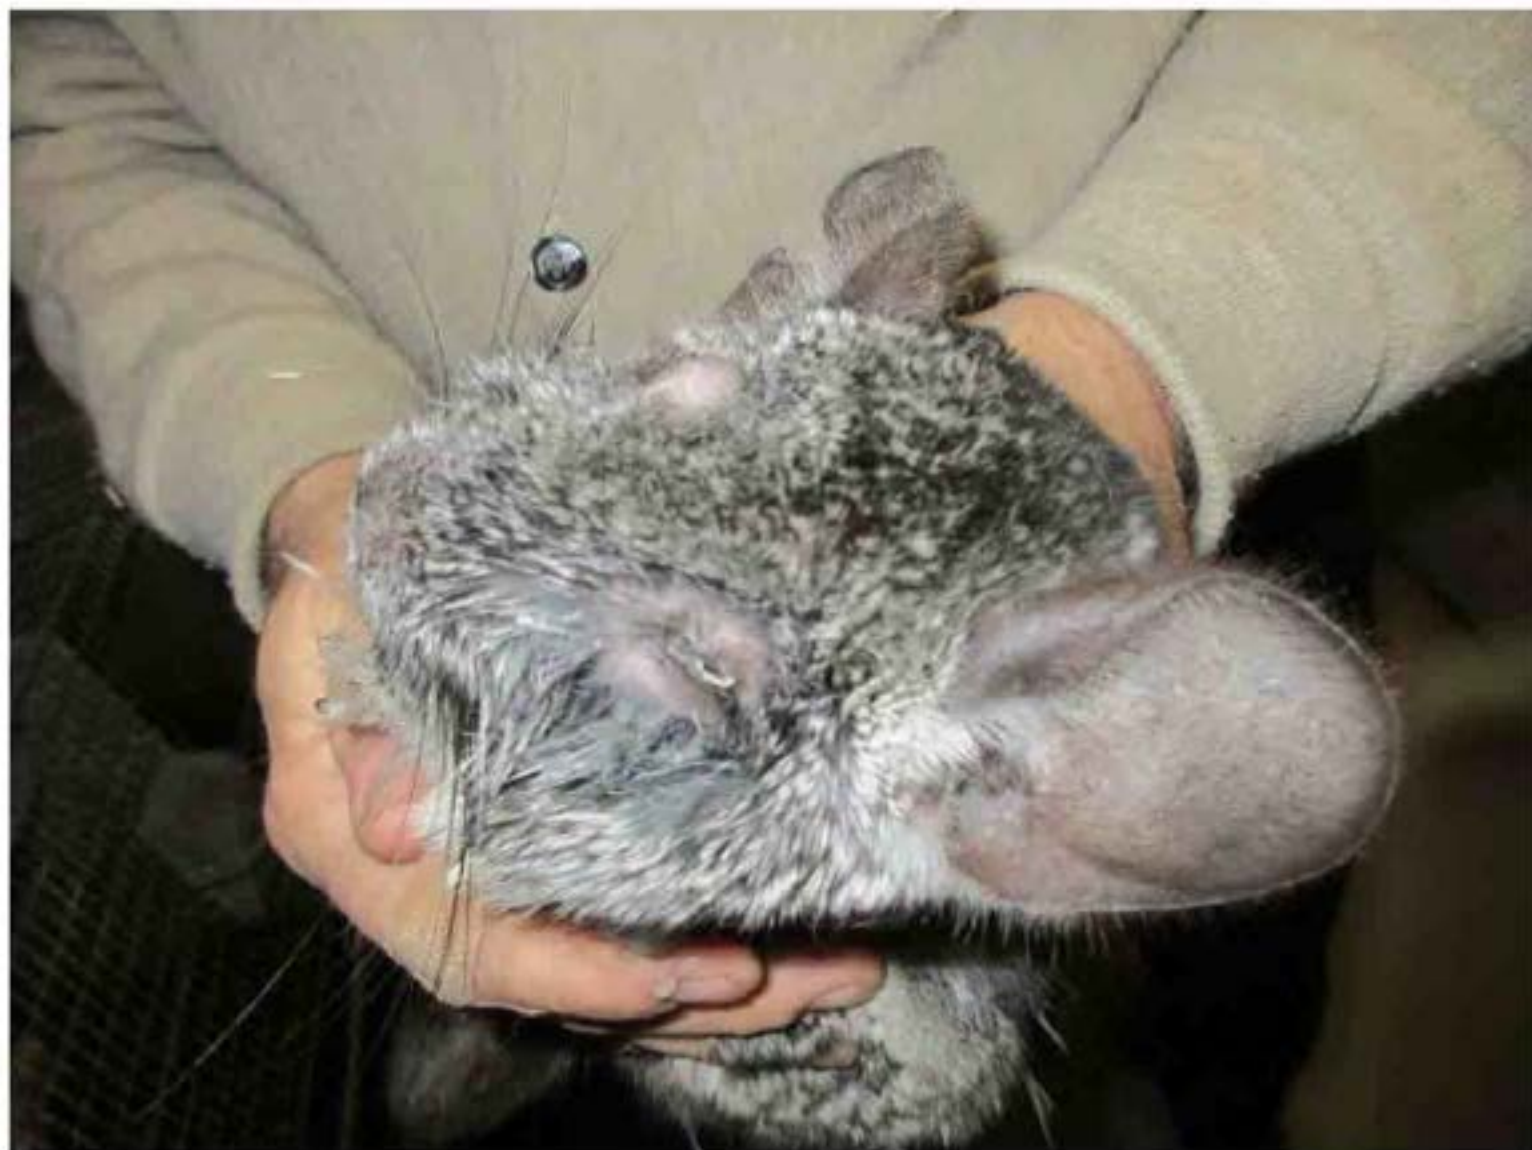
| Description: | Left eye black and silver female Chinchilla (eartag DJM 145). Per records, cage marker; and licensee, animal is receiving veterinary-prescribed treatment. | | |

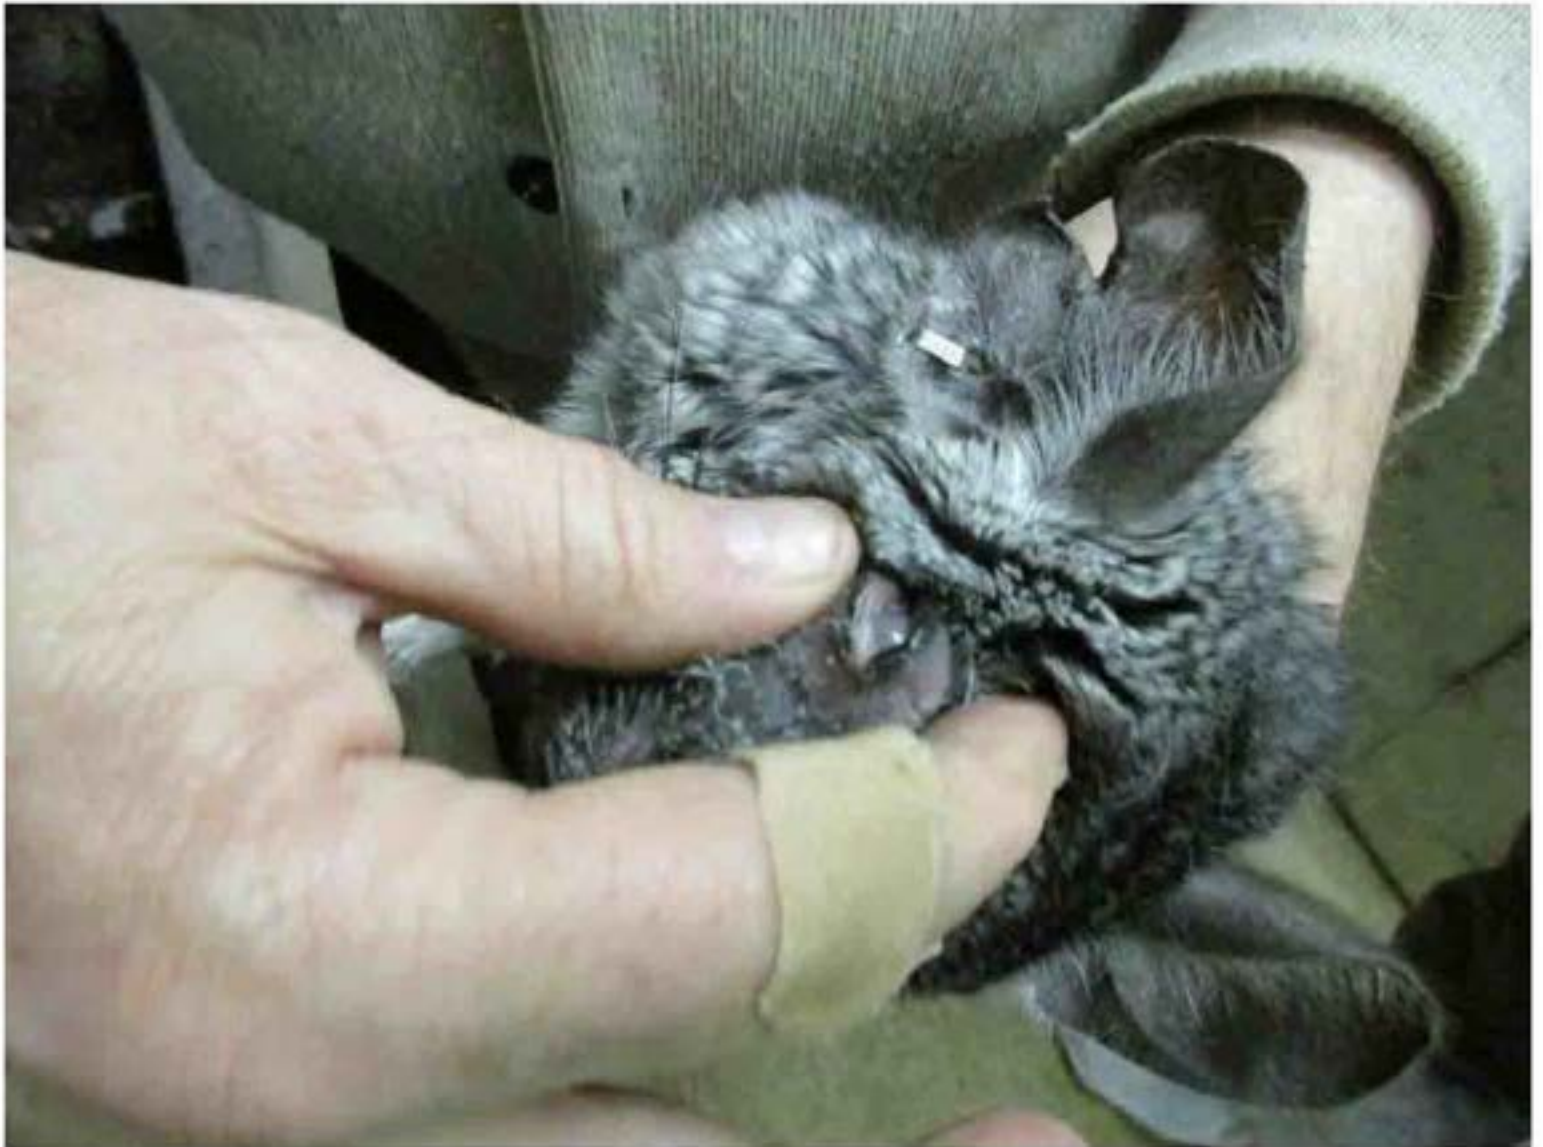
| Description: | Left eye of a silver and black female Chinchilla (eartag OKES108 or 801). Per records, cage marker; and licensee, animal is receiving veterinary-prescribed treatment. | | |

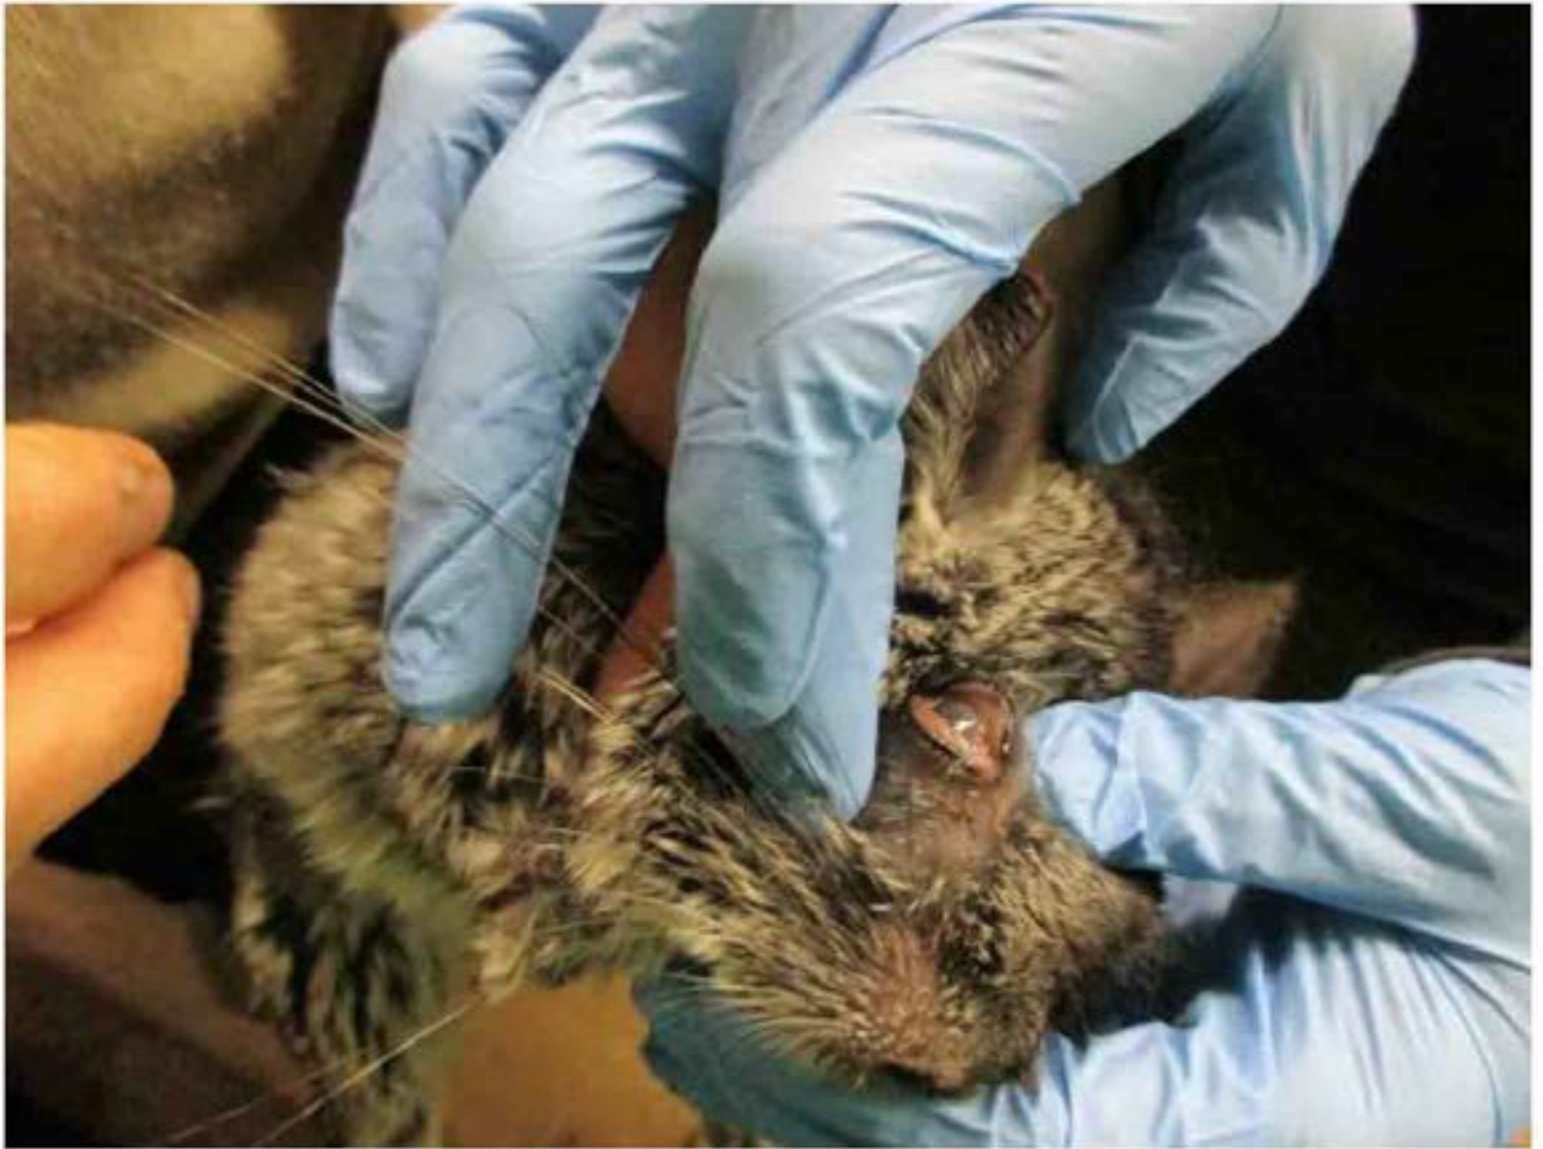
| Description: | Right eye of a silver and black female Chinchilla (eartag OKES 108 or 801). Per records, cage marker; and licensee, animal is receiving veterinary-prescribed treatment. | | |

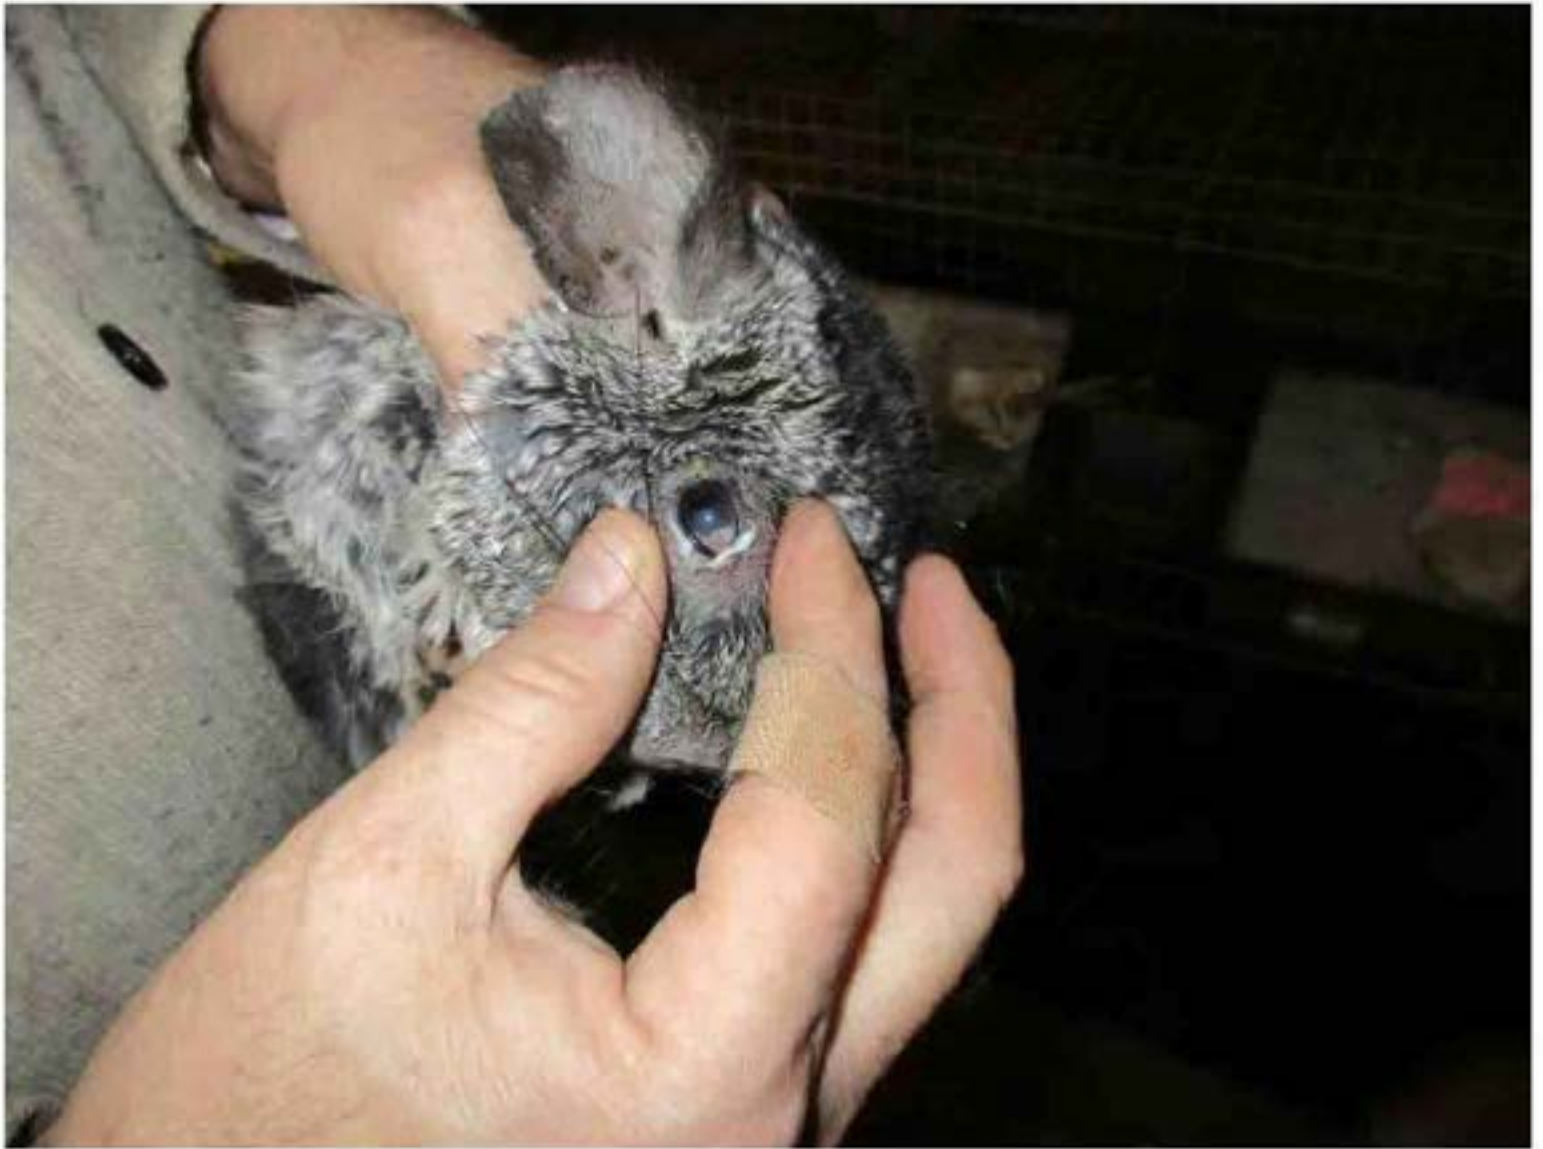
| Description: | Right eye of a black and silver male Chinchilla (eartag VVCR 179). Per records, cage marker; and licensee, animal is receiving veterinary-prescribed treatment. | | |

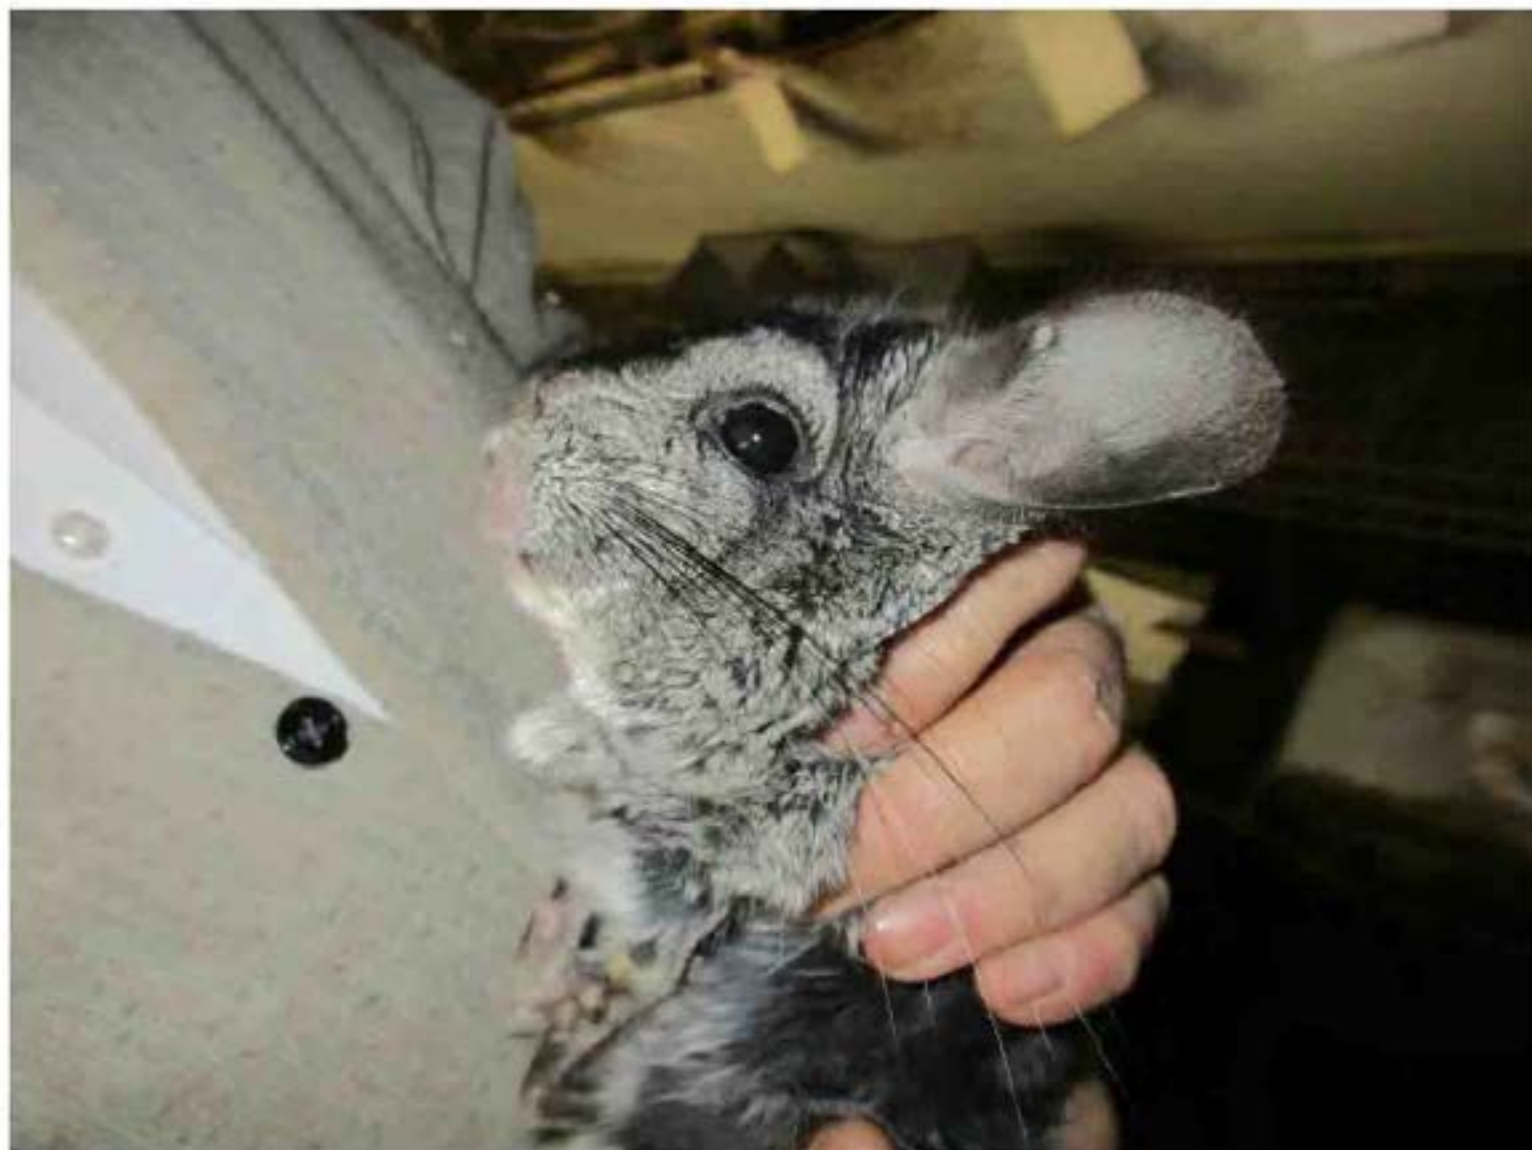
| Description: | Right eye of a black and silver female Chinchilla (eartag GROS 337). Per records, cage marker; and licensee, animal is receiving veterinary-prescribed treatment. | | |

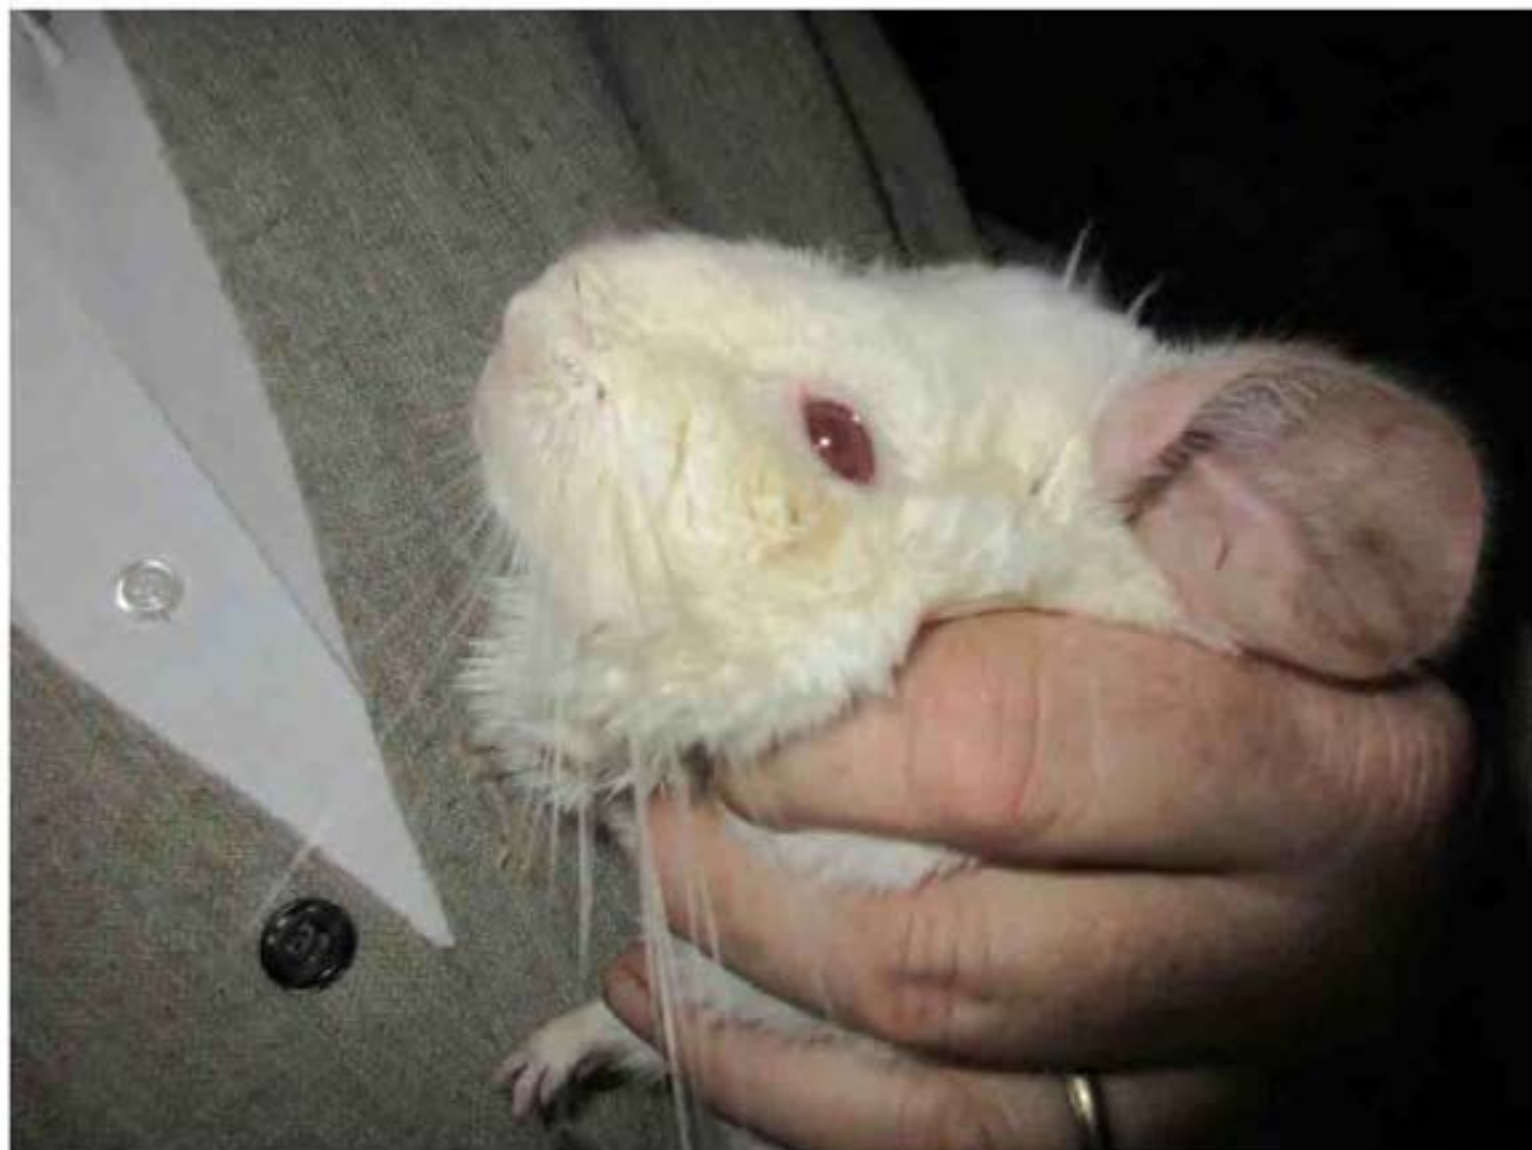
| Description: | Right eye of a white male Chinchilla (no tag). Per records, cage marker; and licensee, animal is receiving veterinary-prescribed treatment. | | |

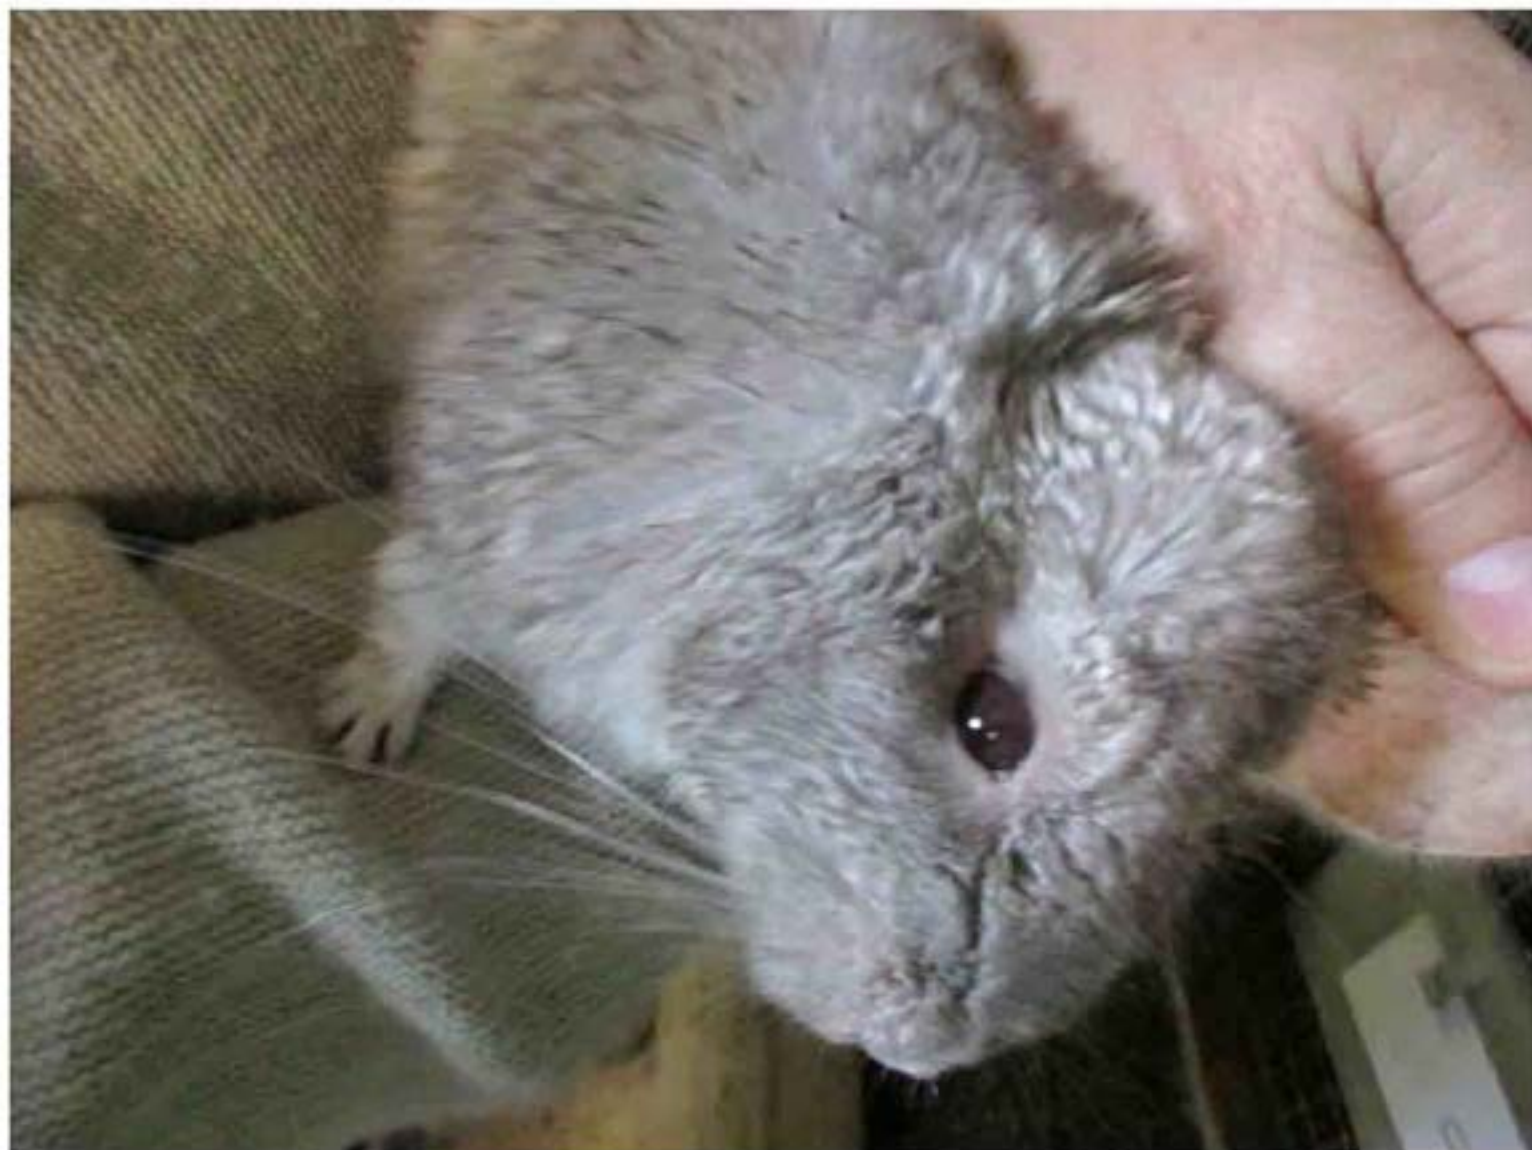
| Description: | Left eye of a beige male Chinchilla (eartag 968). Per records, cage marker; and licensee, animal is receiving veterinary-prescribed treatment. | | |
