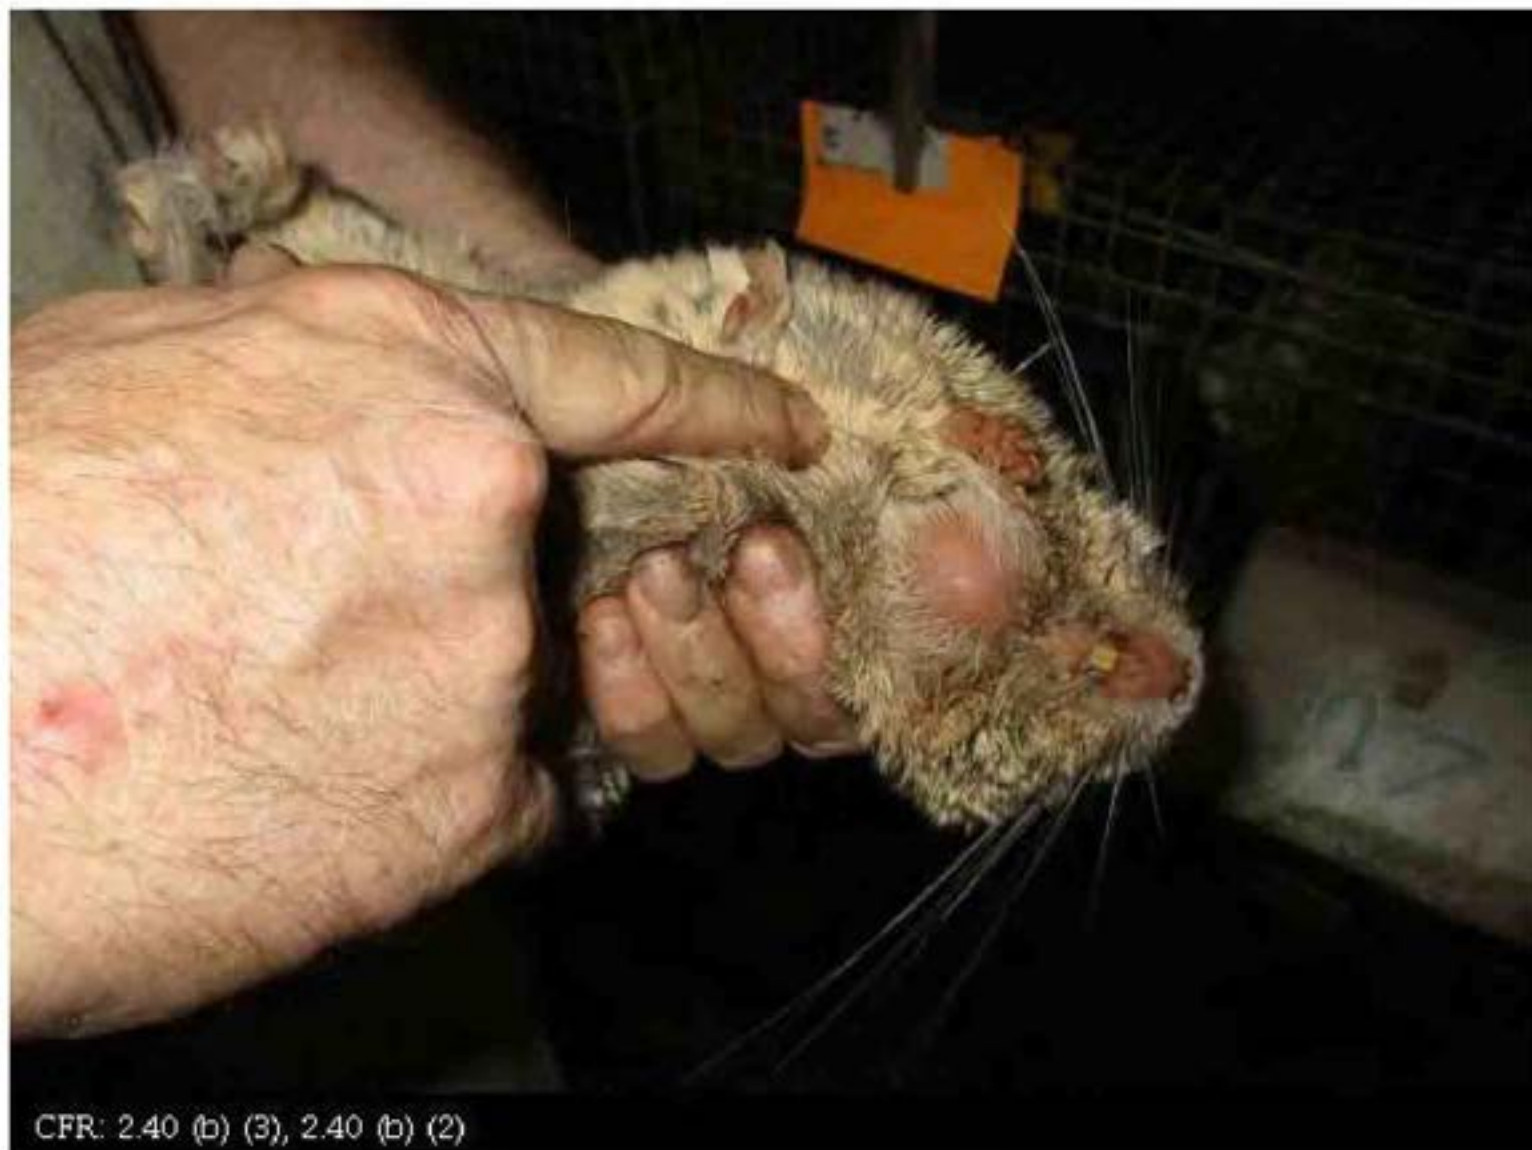
| Description: | Chinchilla (no id, pen 166); Per records, cage marker; and licensee, animal is receiving veterinary-prescribed treatment. | | |

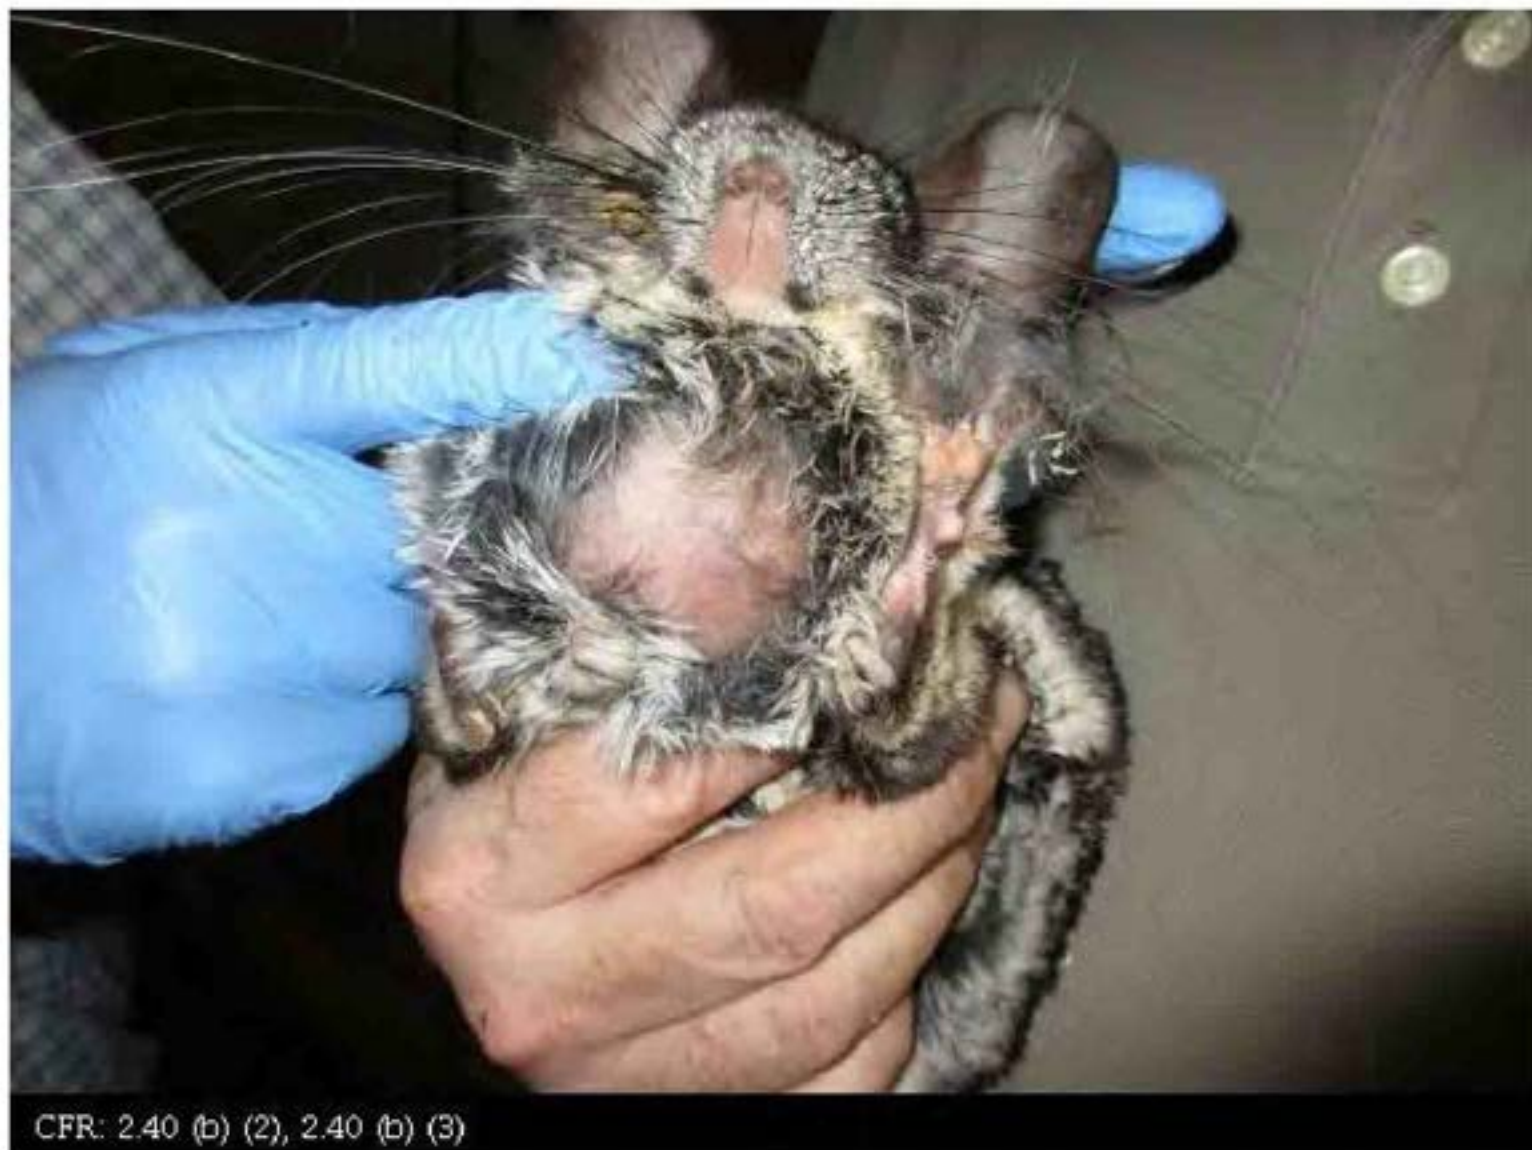
| Description: | Male grey (no id, in south stacked cages, west/front room); its right eye can't be seen because it is crusted shut. | | |

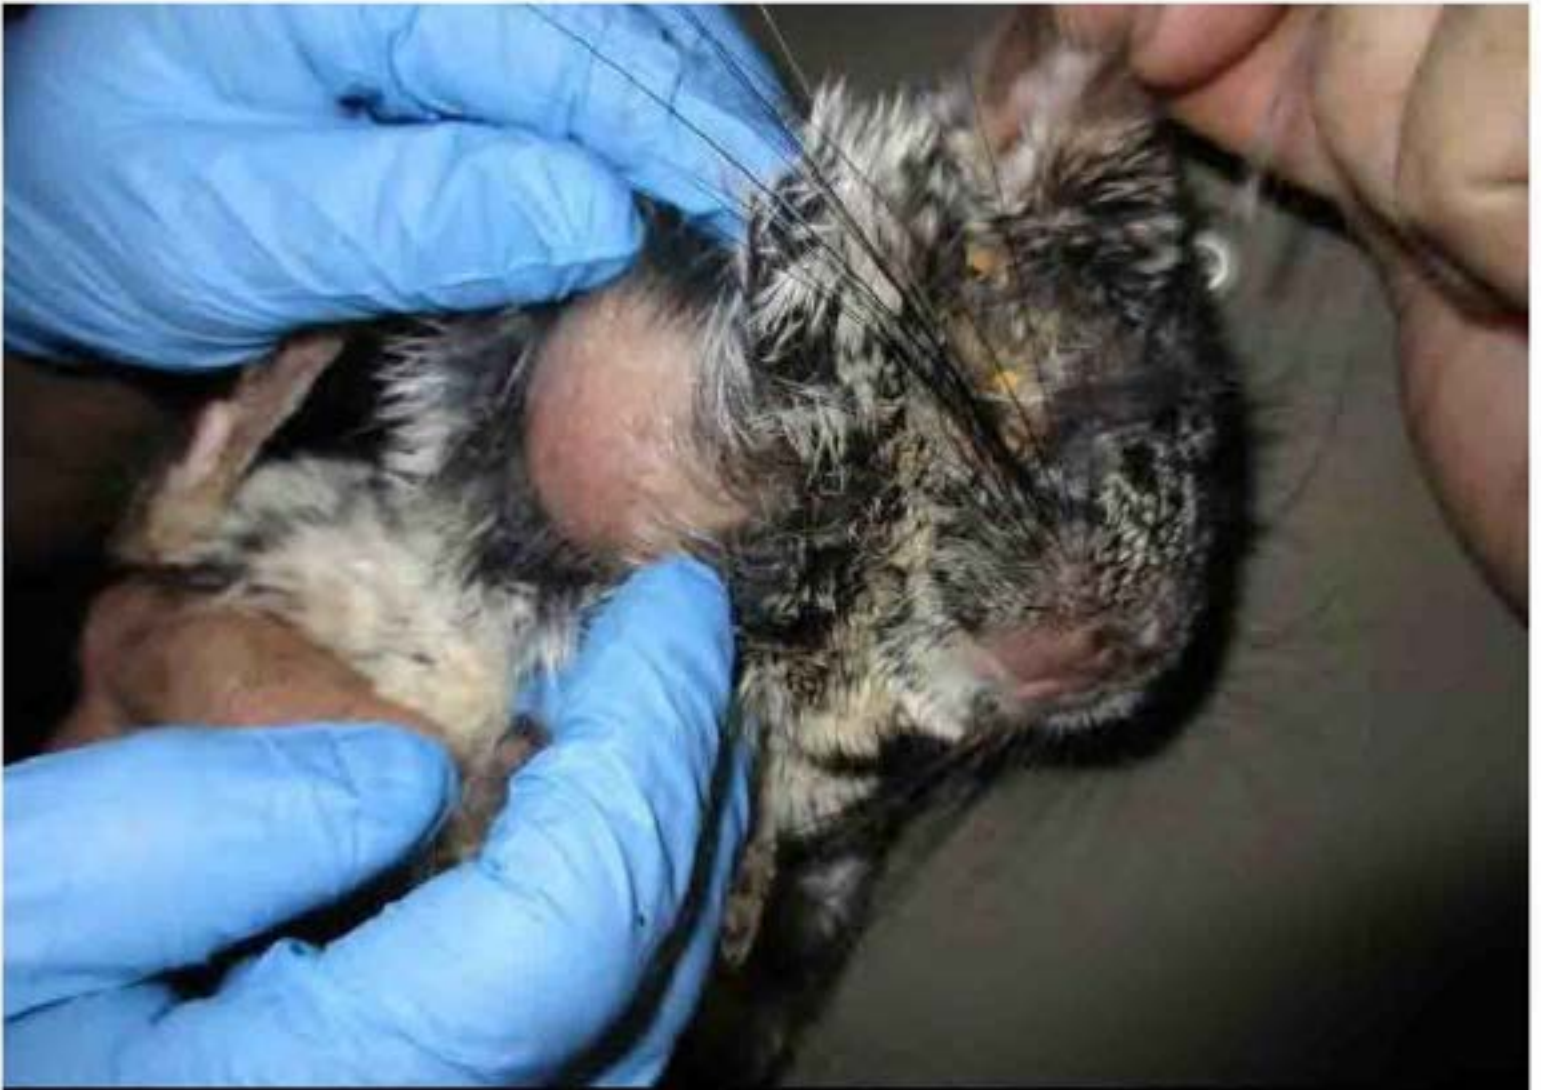
| Description: | Male grey (no id in south stacked cages, west/front room); large hairless swelling under chin and note its right eye crusted over. | | |

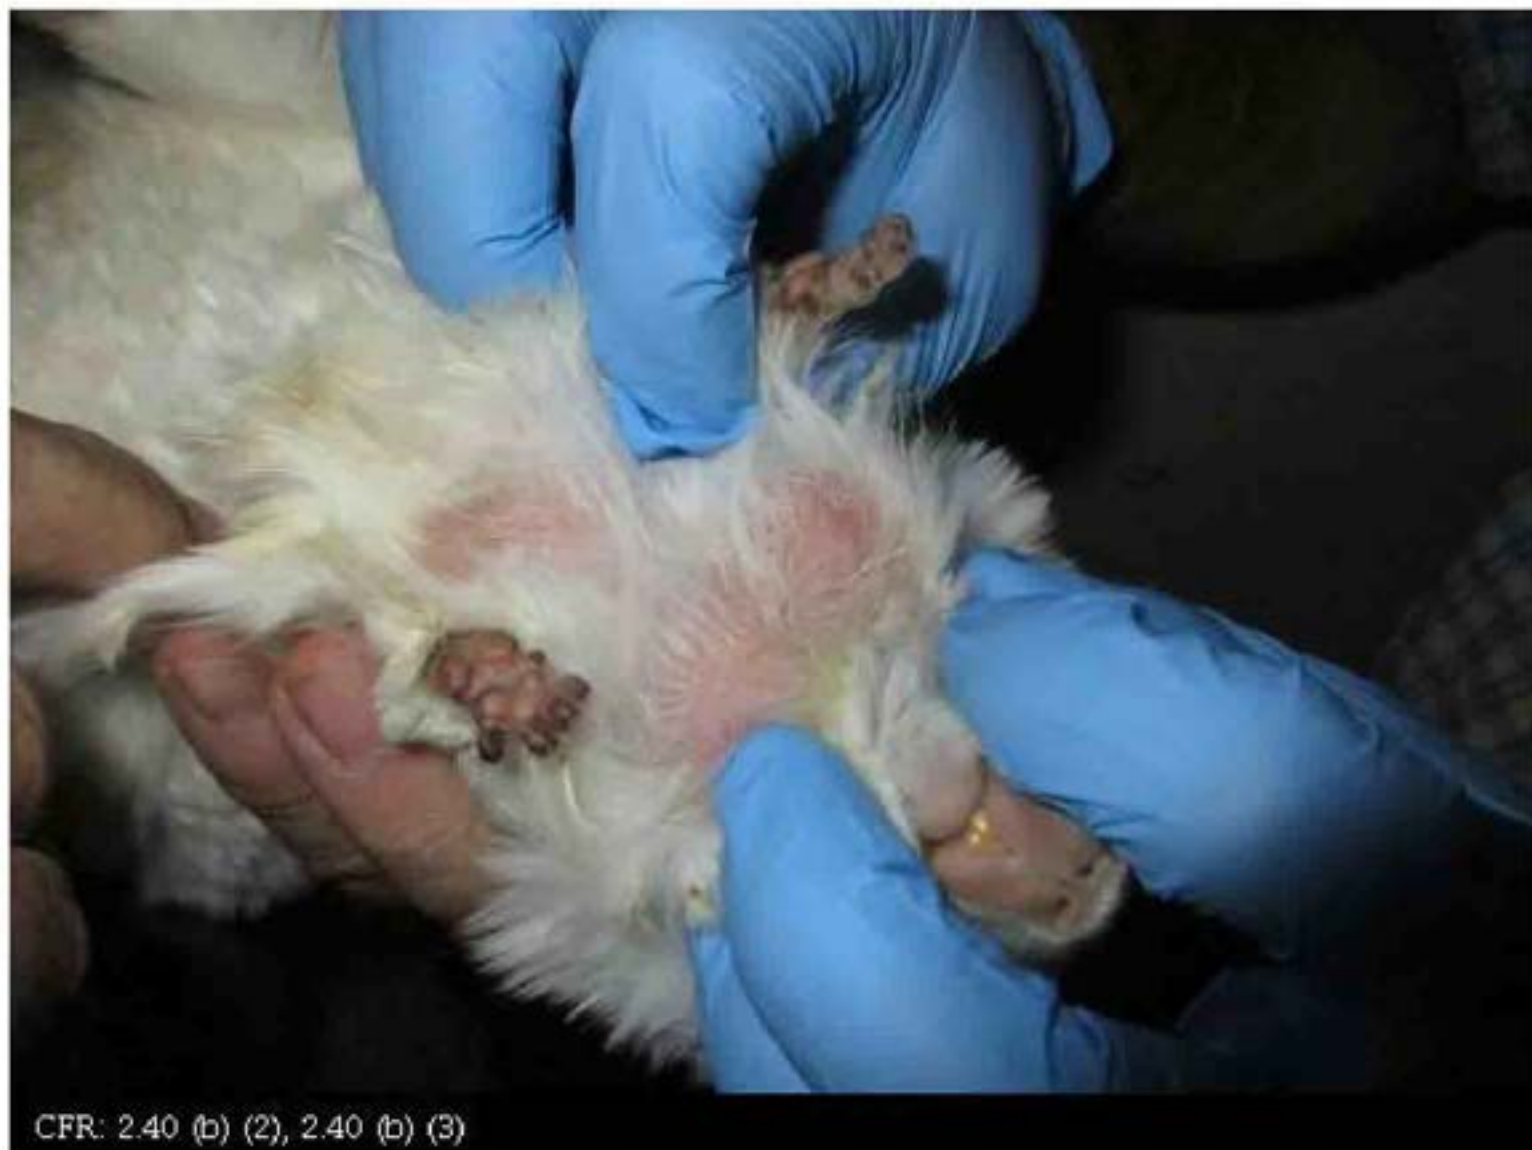
| Description: | White female in cage 168, ear tag 876; swollen area with hair loss under chin. Tissues felt thickened to VMO (gloved hands). | | |

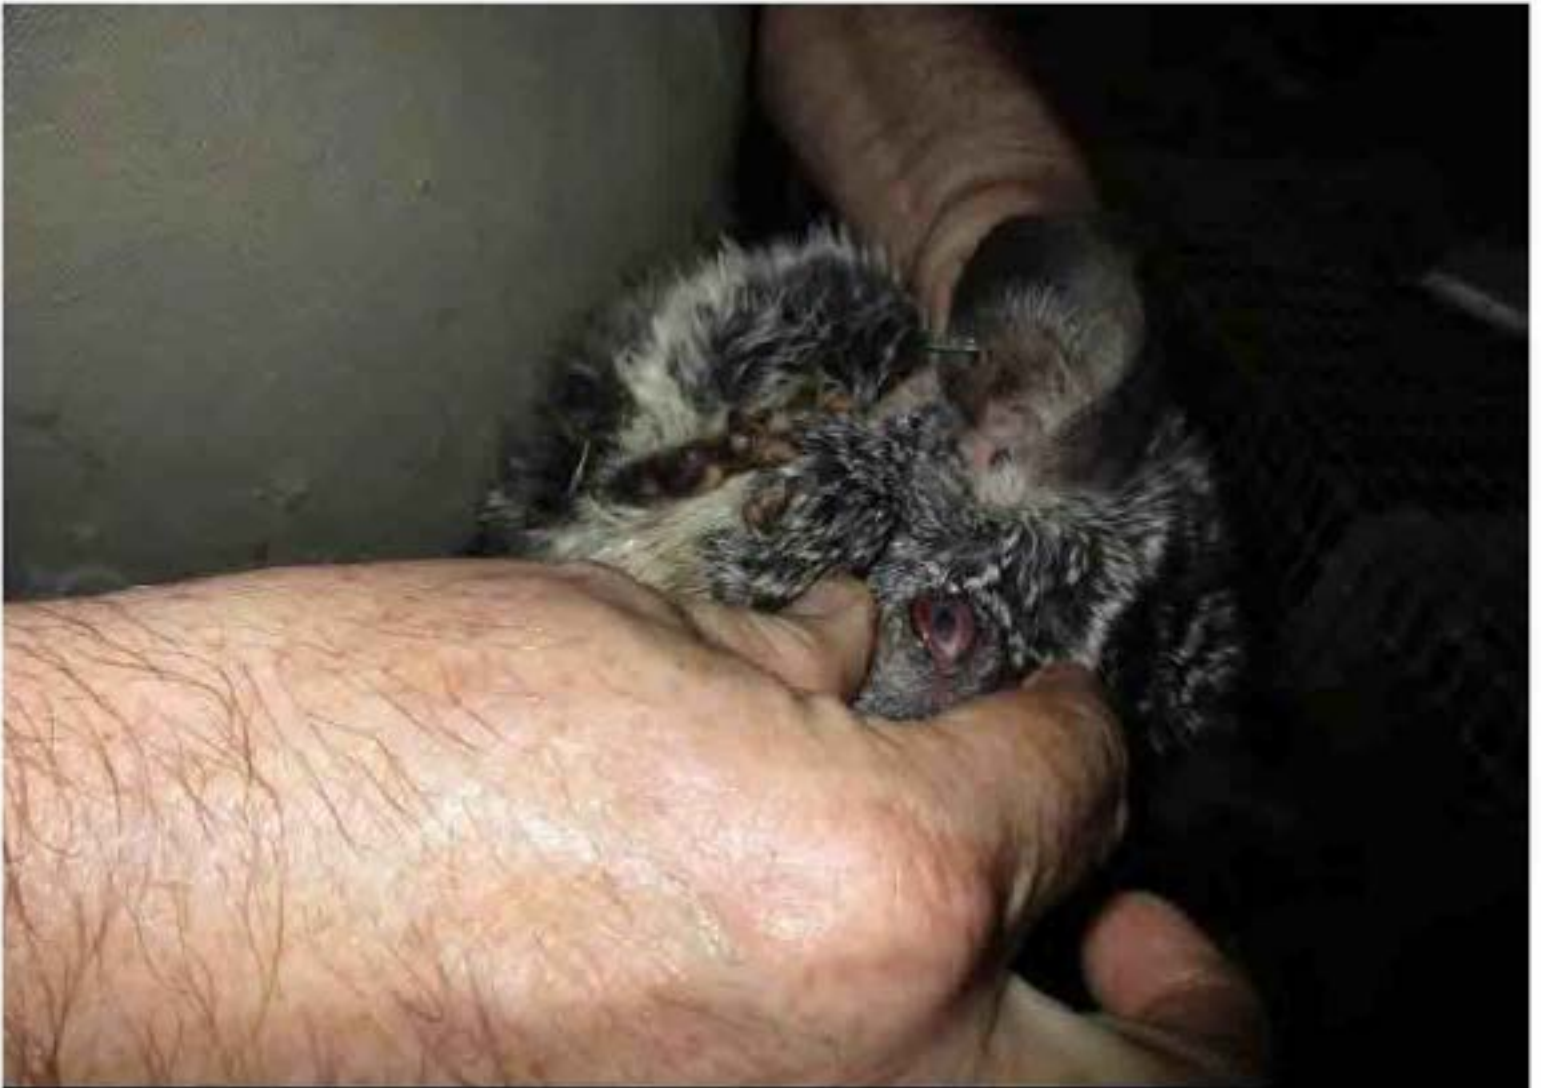
| Description: | White female in cage 168, ear tag 876; swollen area with hair loss under chin. Tissues felt thickened to VMO (gloved hands). | | |

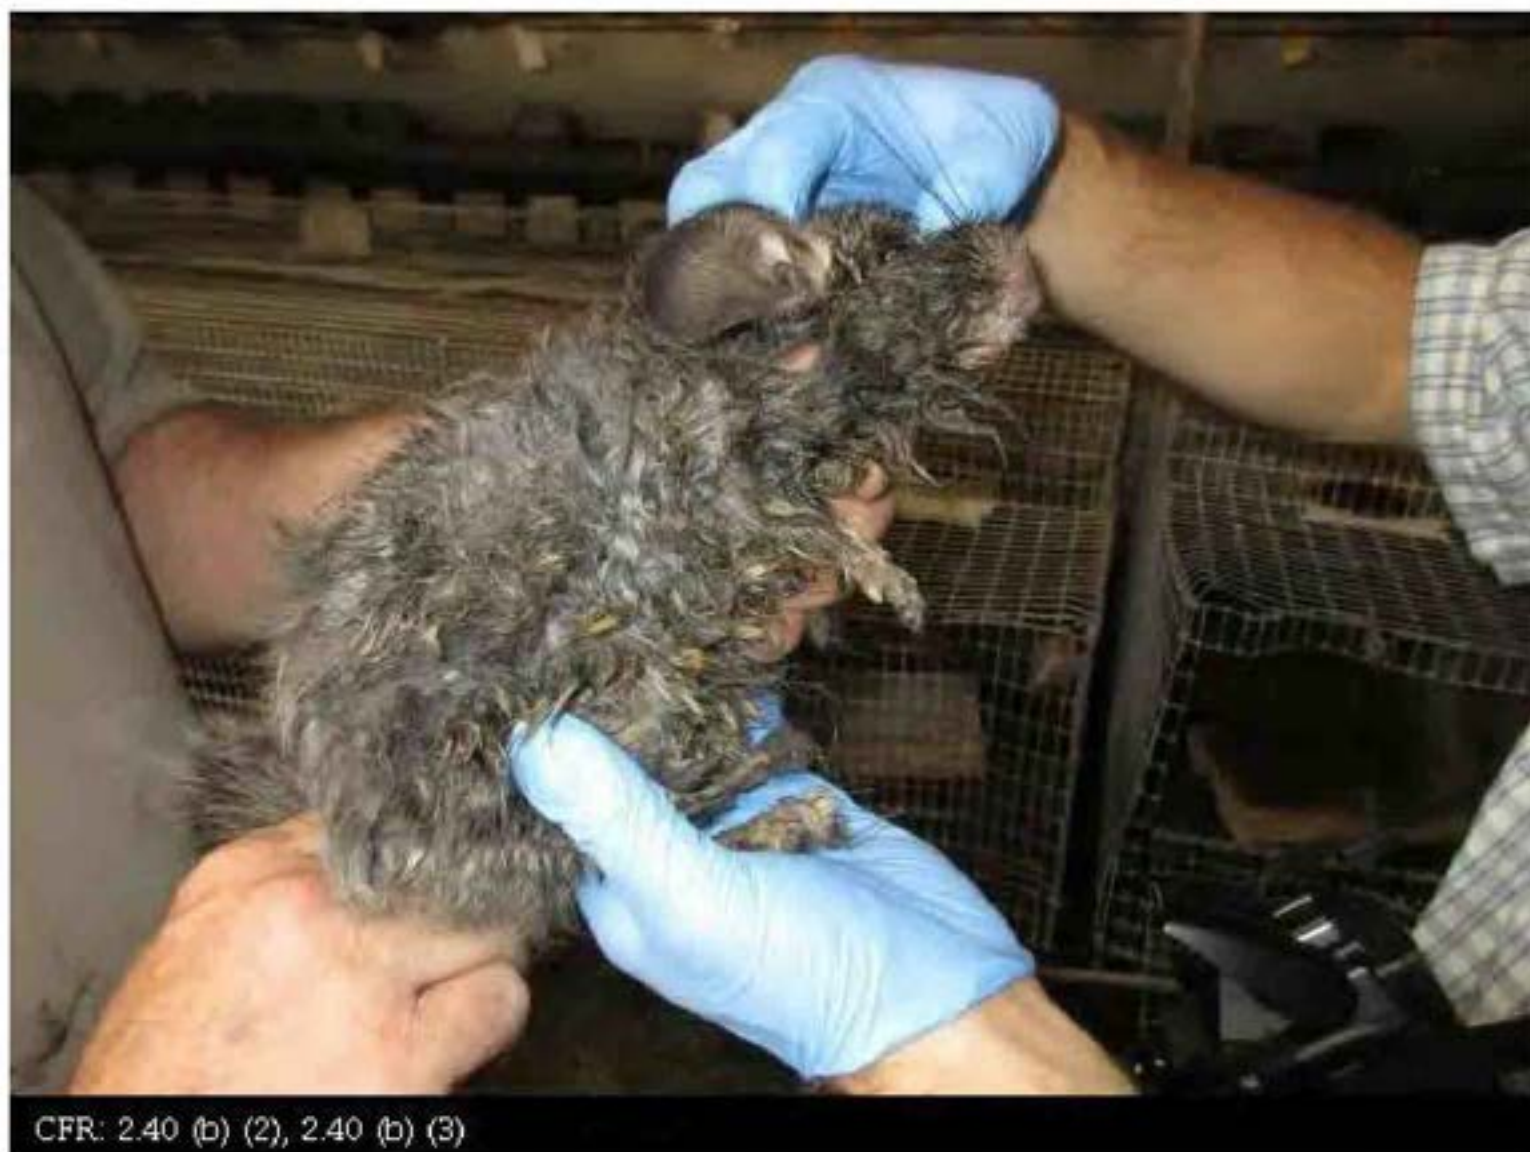
| Description: | Female grey-- ear tag 332; its right eye is swollen and had a pale creamy discharge. | | |

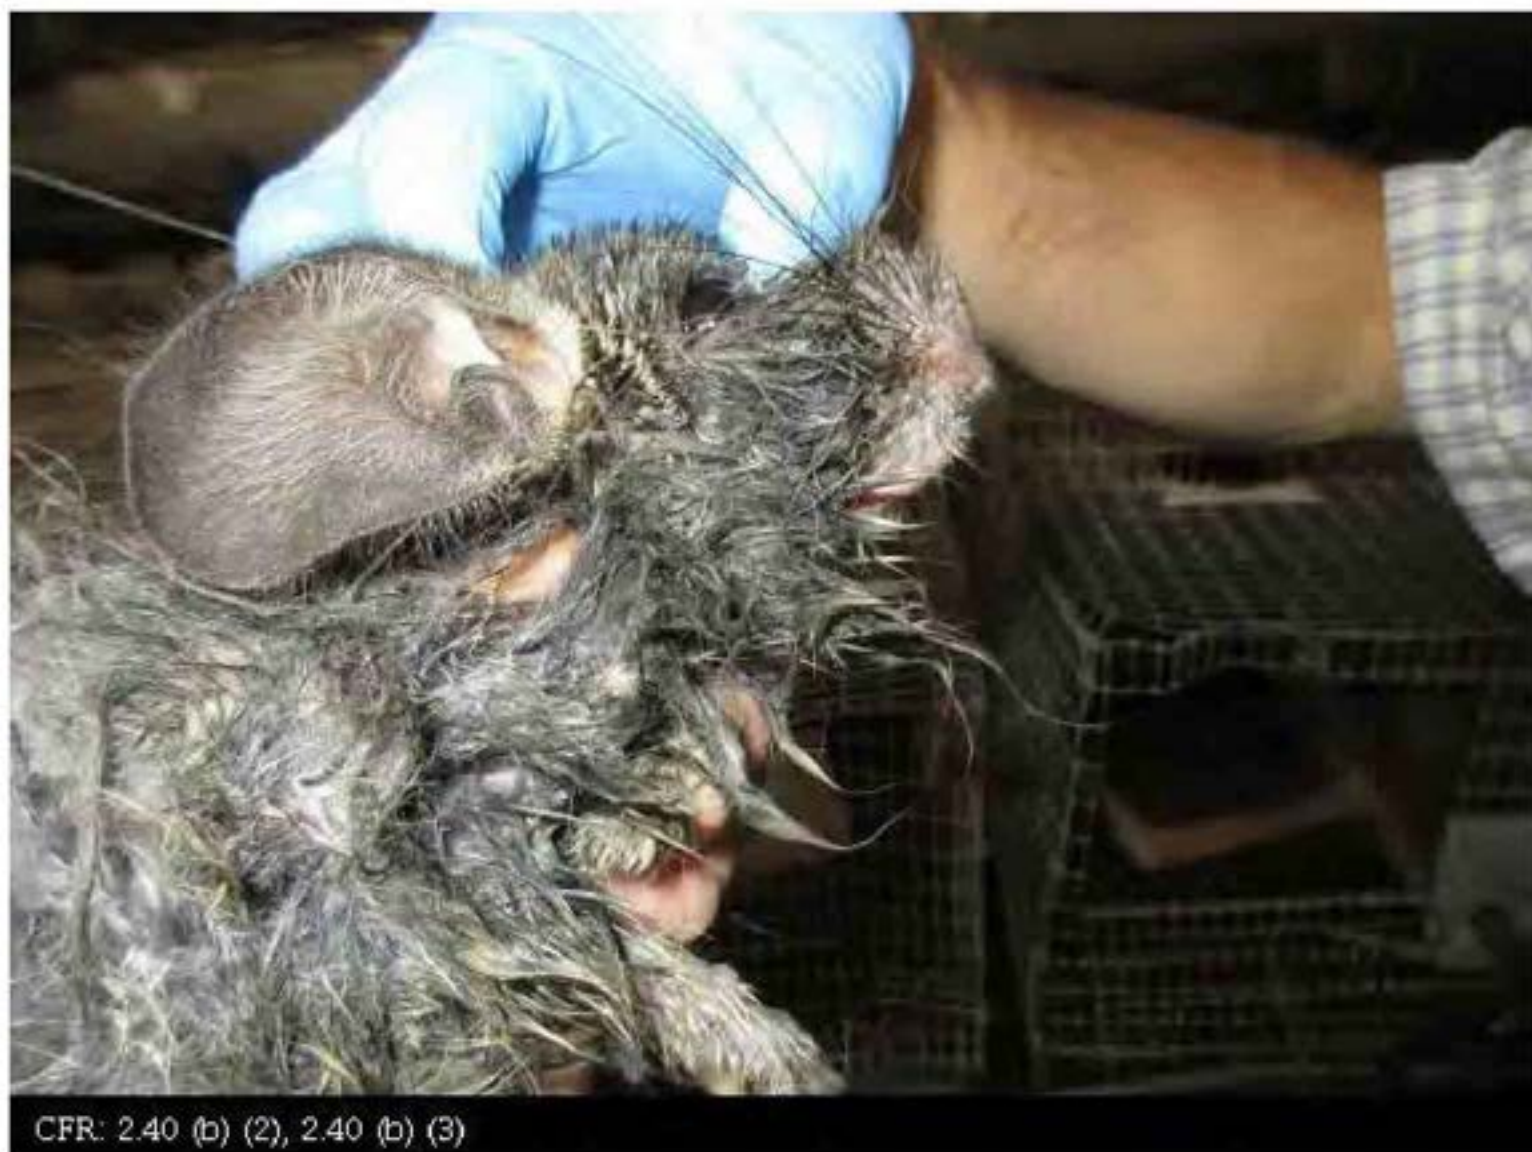
| Description: | Female black; eartag GROS 313; note unkempt hair coat. | | |

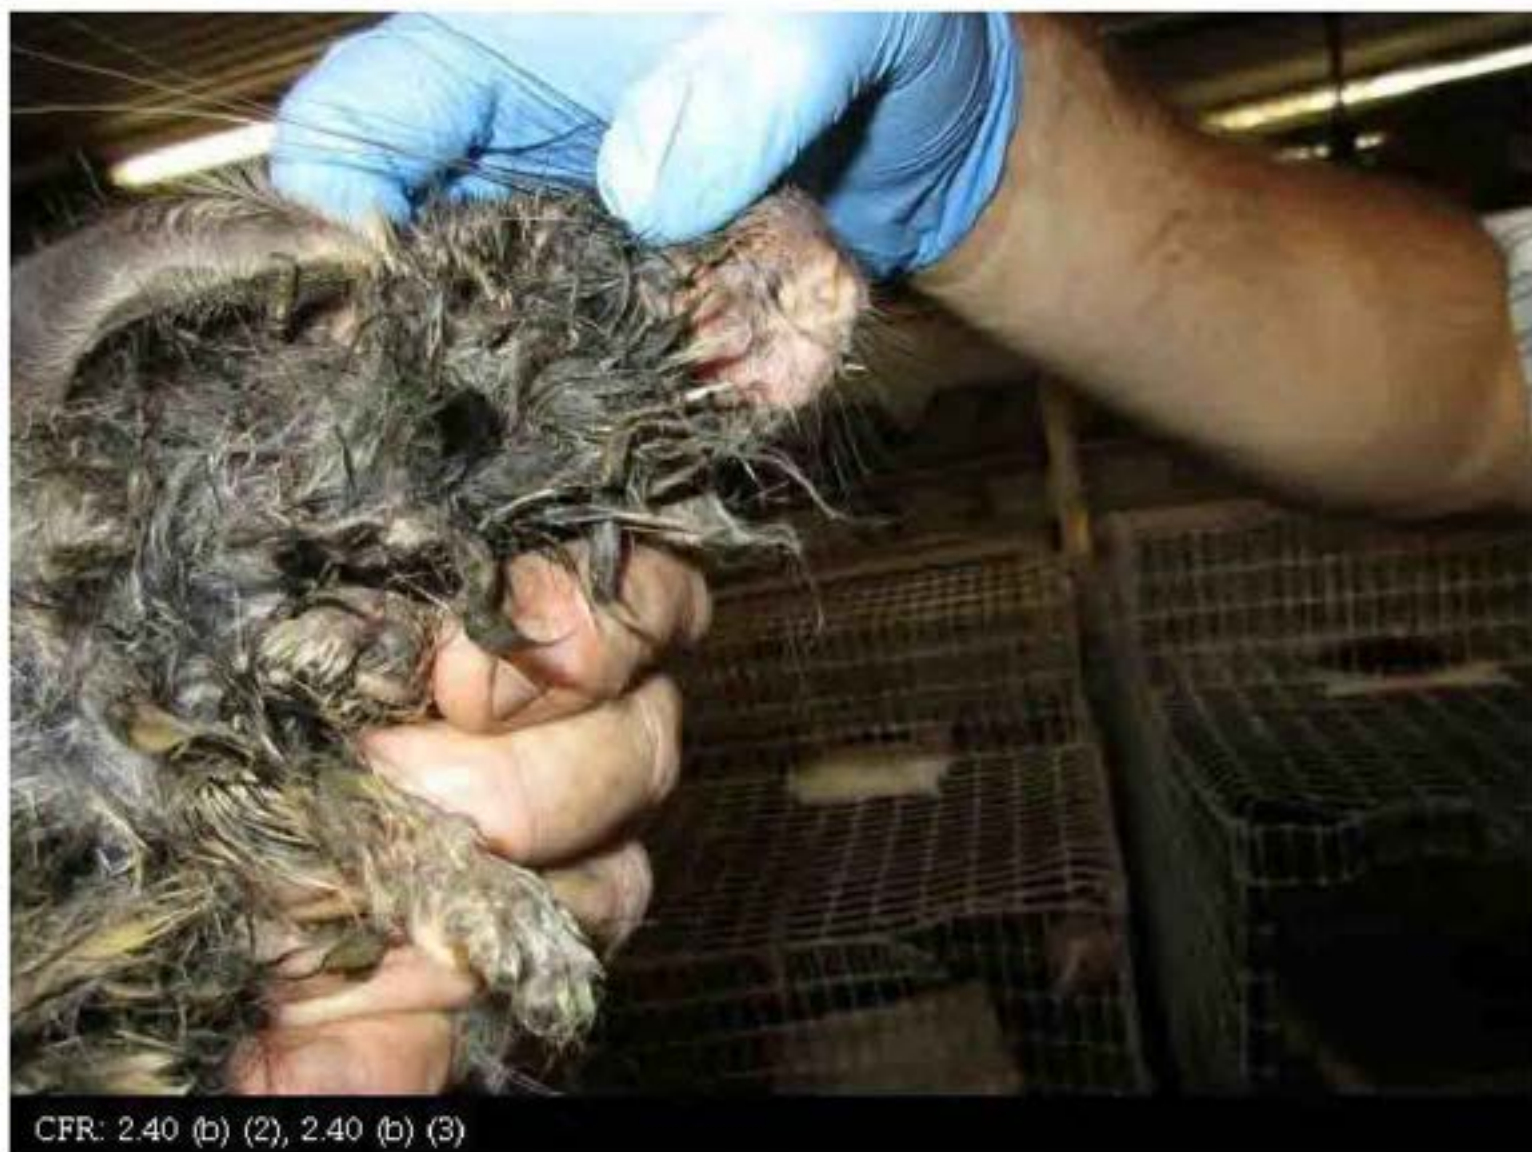
| Description: | Female black; eartag GROS 313; note unkempt hair coat and hair loss around mouth | | |

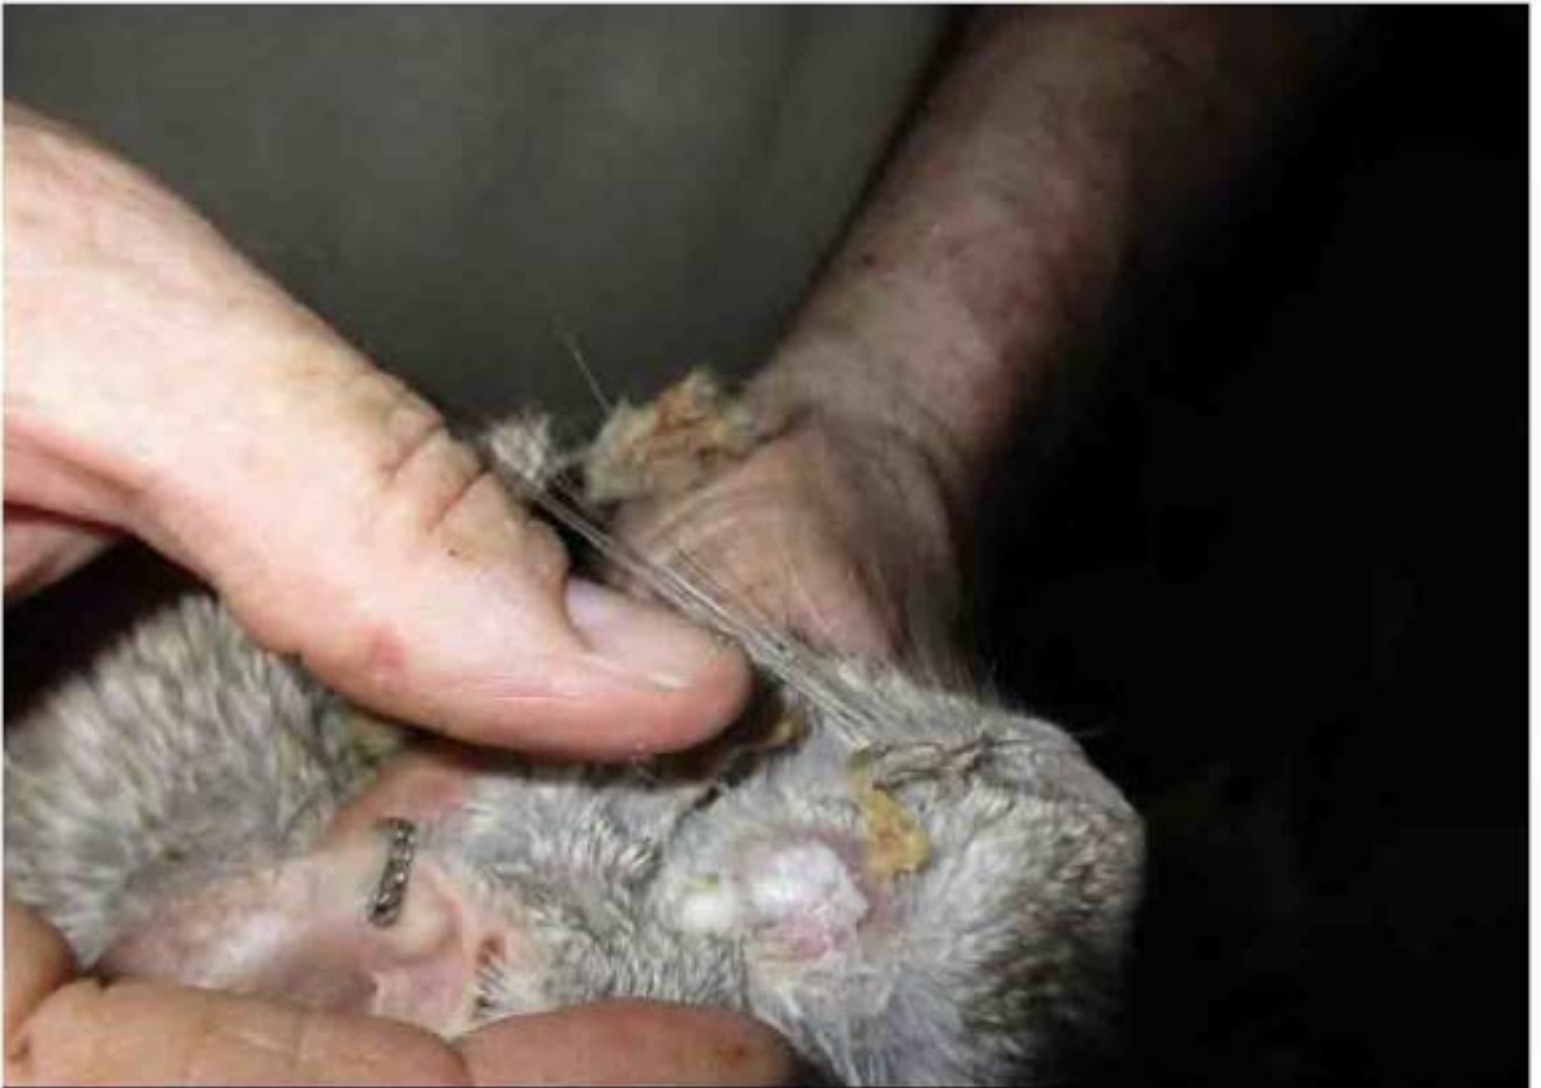
| Description: | Male beige with eartag GROS 329; its left eye was swollen and a pale creamy discharge. | | |

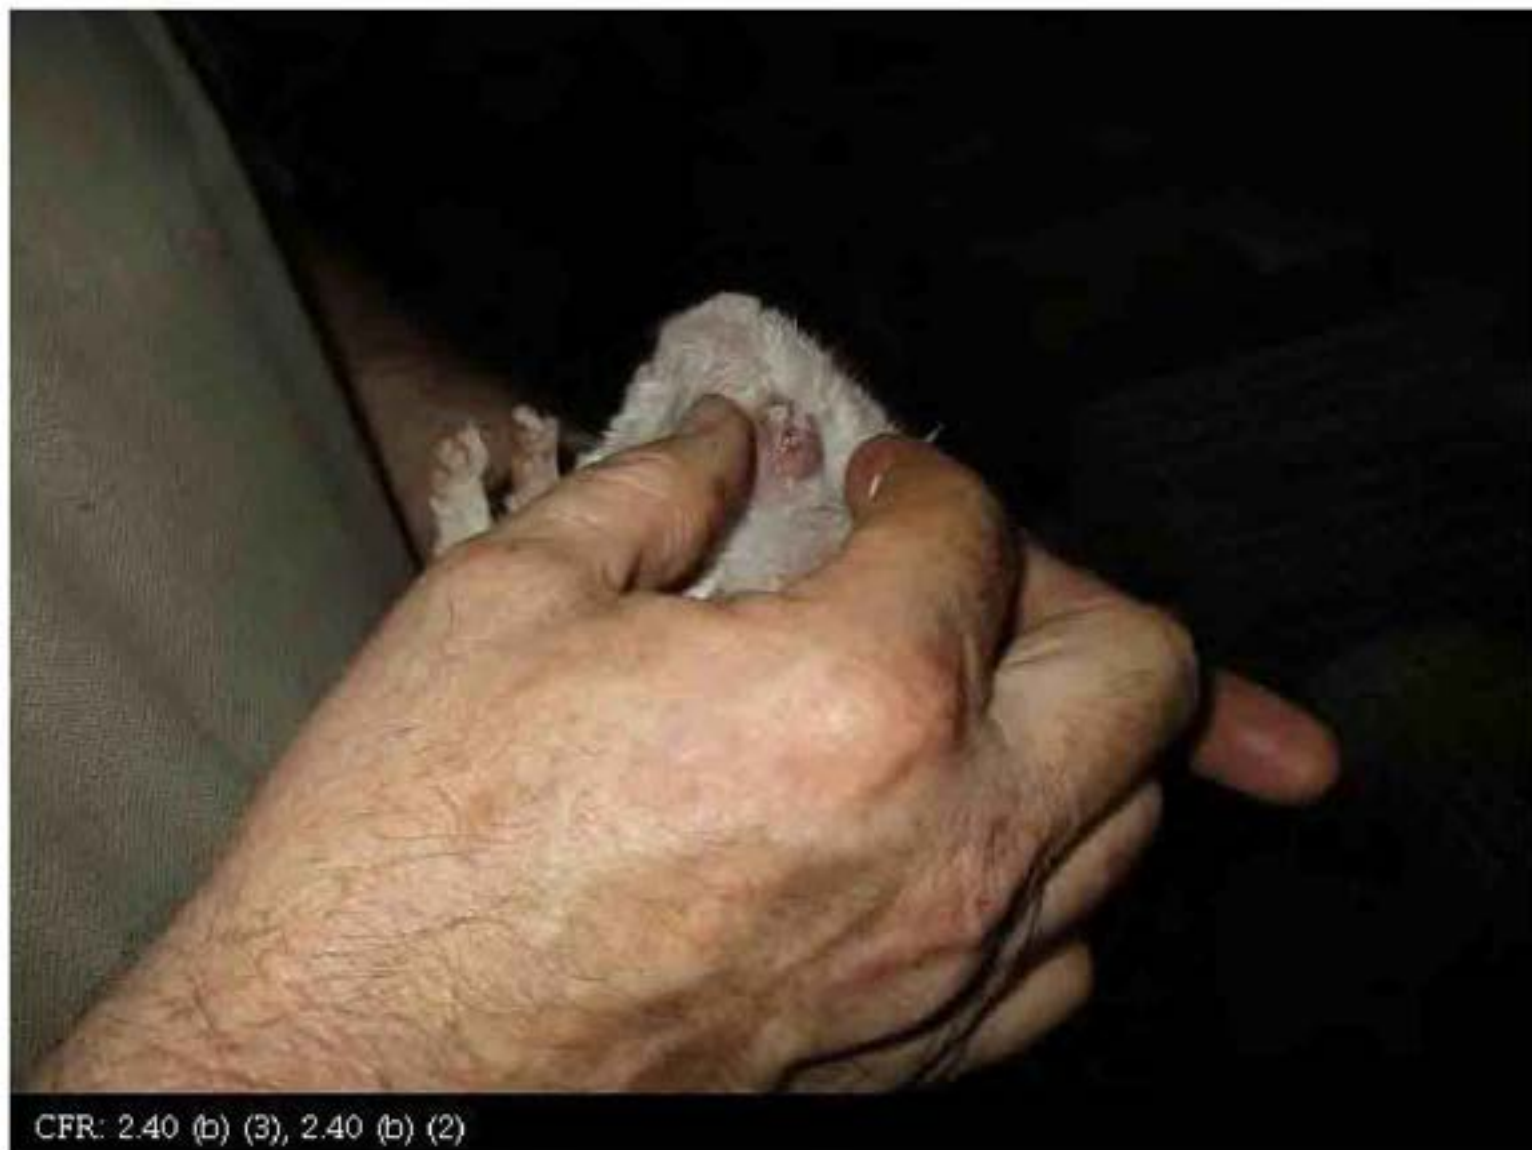
| Description: | Male beige with eartag GROS 329; its left eye was swollen and a pale creamy discharge. | | |

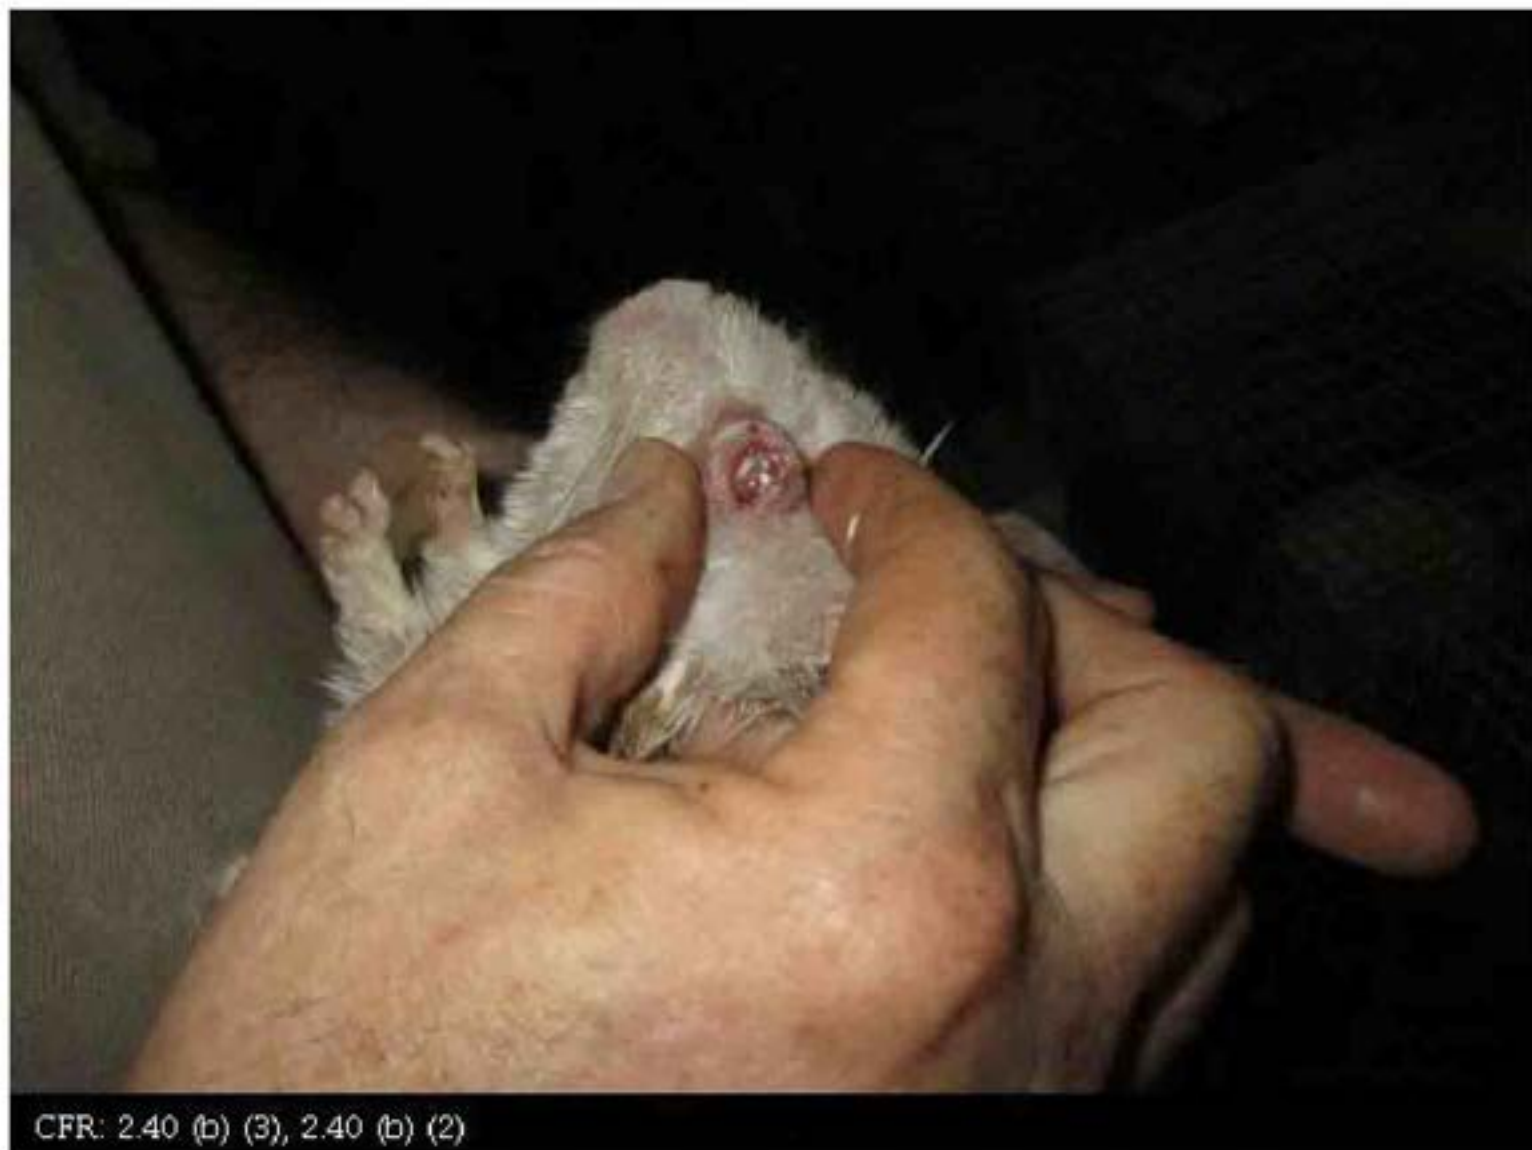
| Description: | Male beige (no ID; cage card AMMC); note left eye swollen with pale creamy discharge. | | |

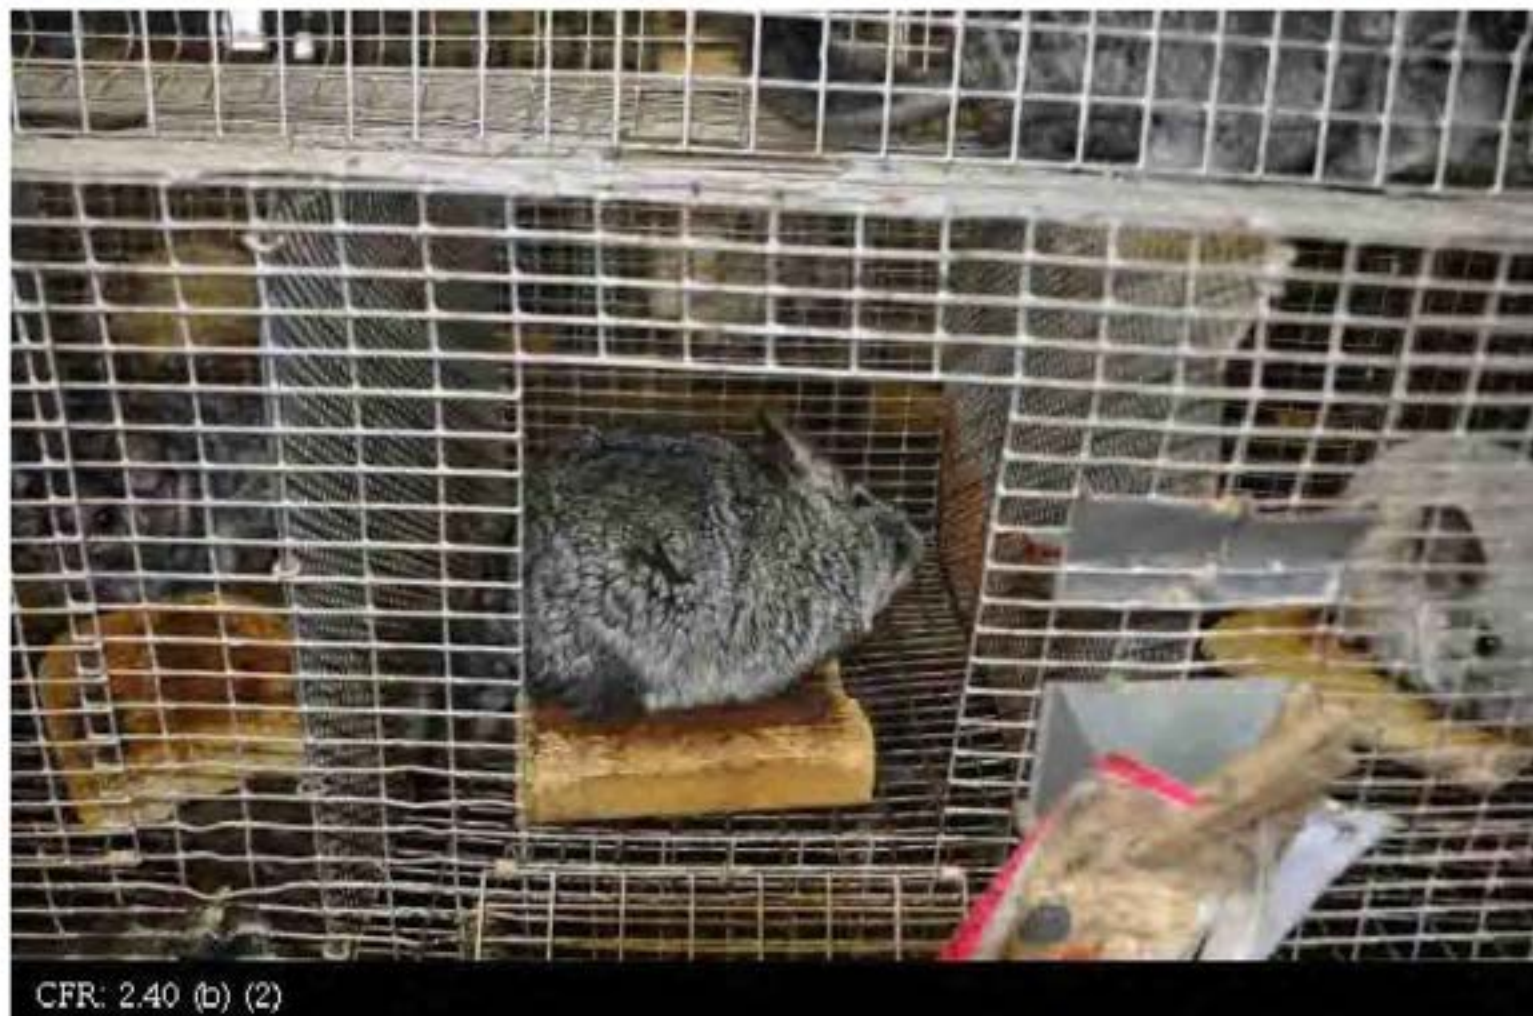
| Description: | Female grey with eartag PMR 233; its left eyeball was noted to have an opaque mass inside it. | | |

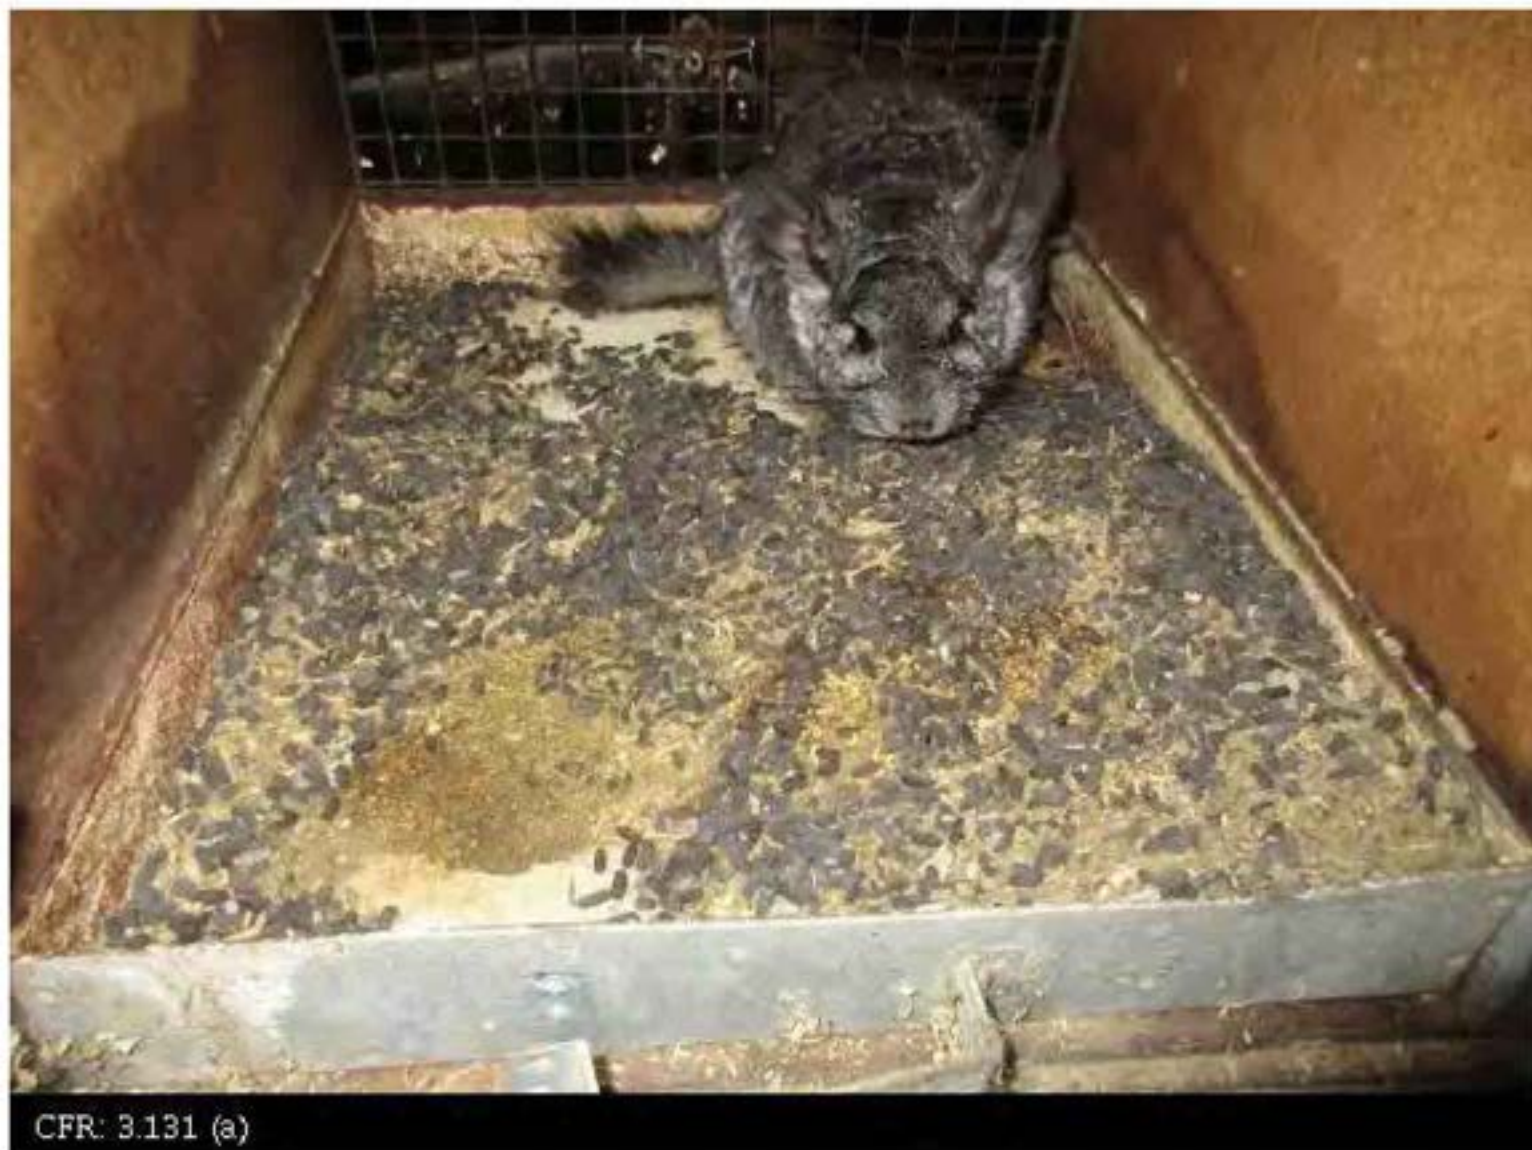
| Description: | Front room middle pen, excessive feces. | | |
