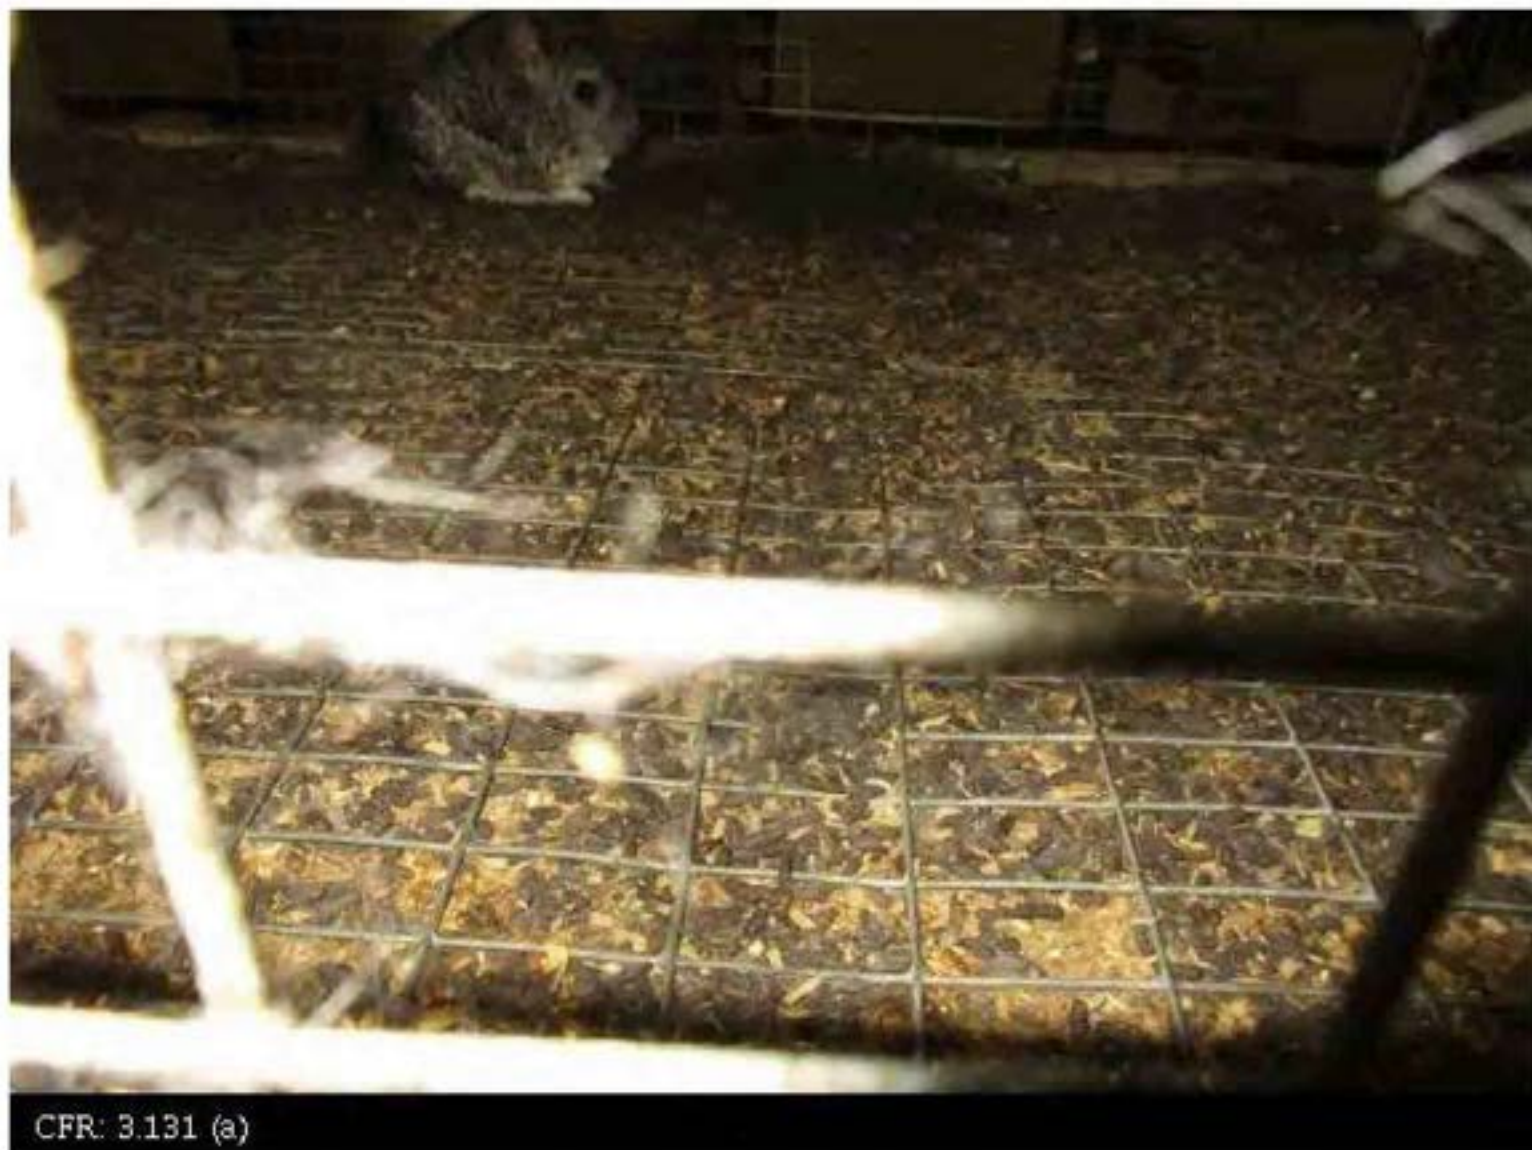
| Description: | Enclosure in front room, south side; representative of enclosures with excessive feces and soiled material. | | |

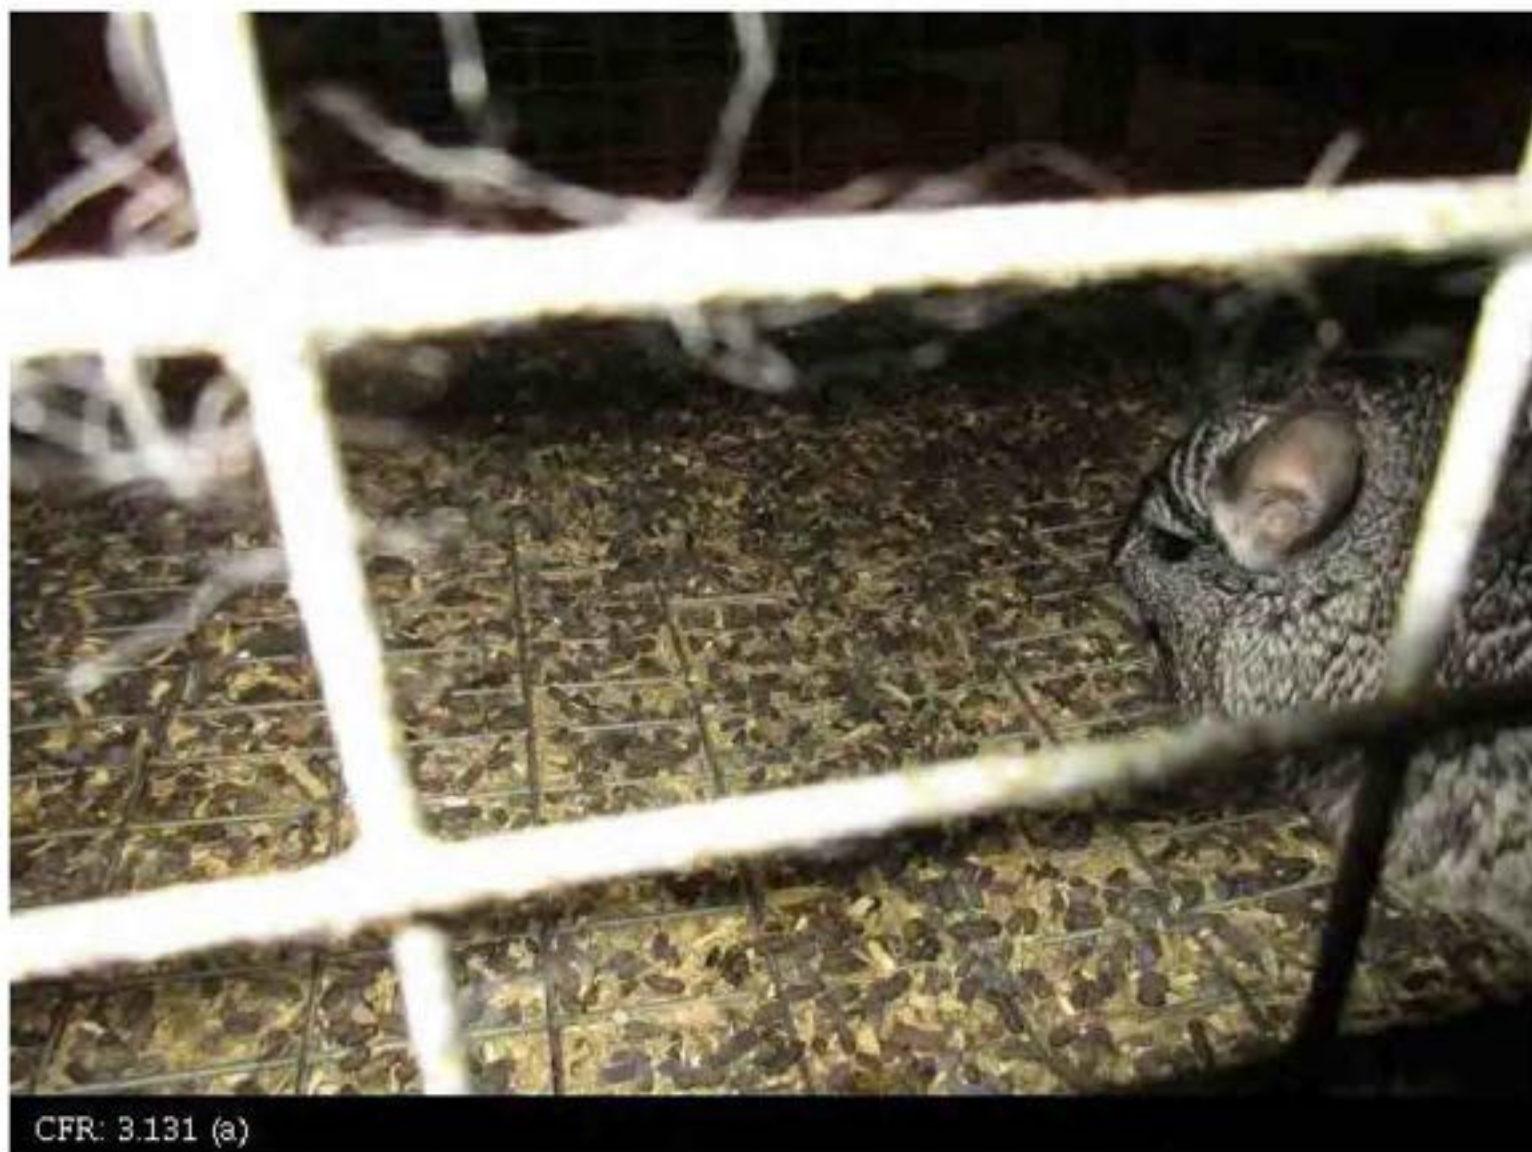
| Description: | Front room middle row pen, excessive feces. | | |

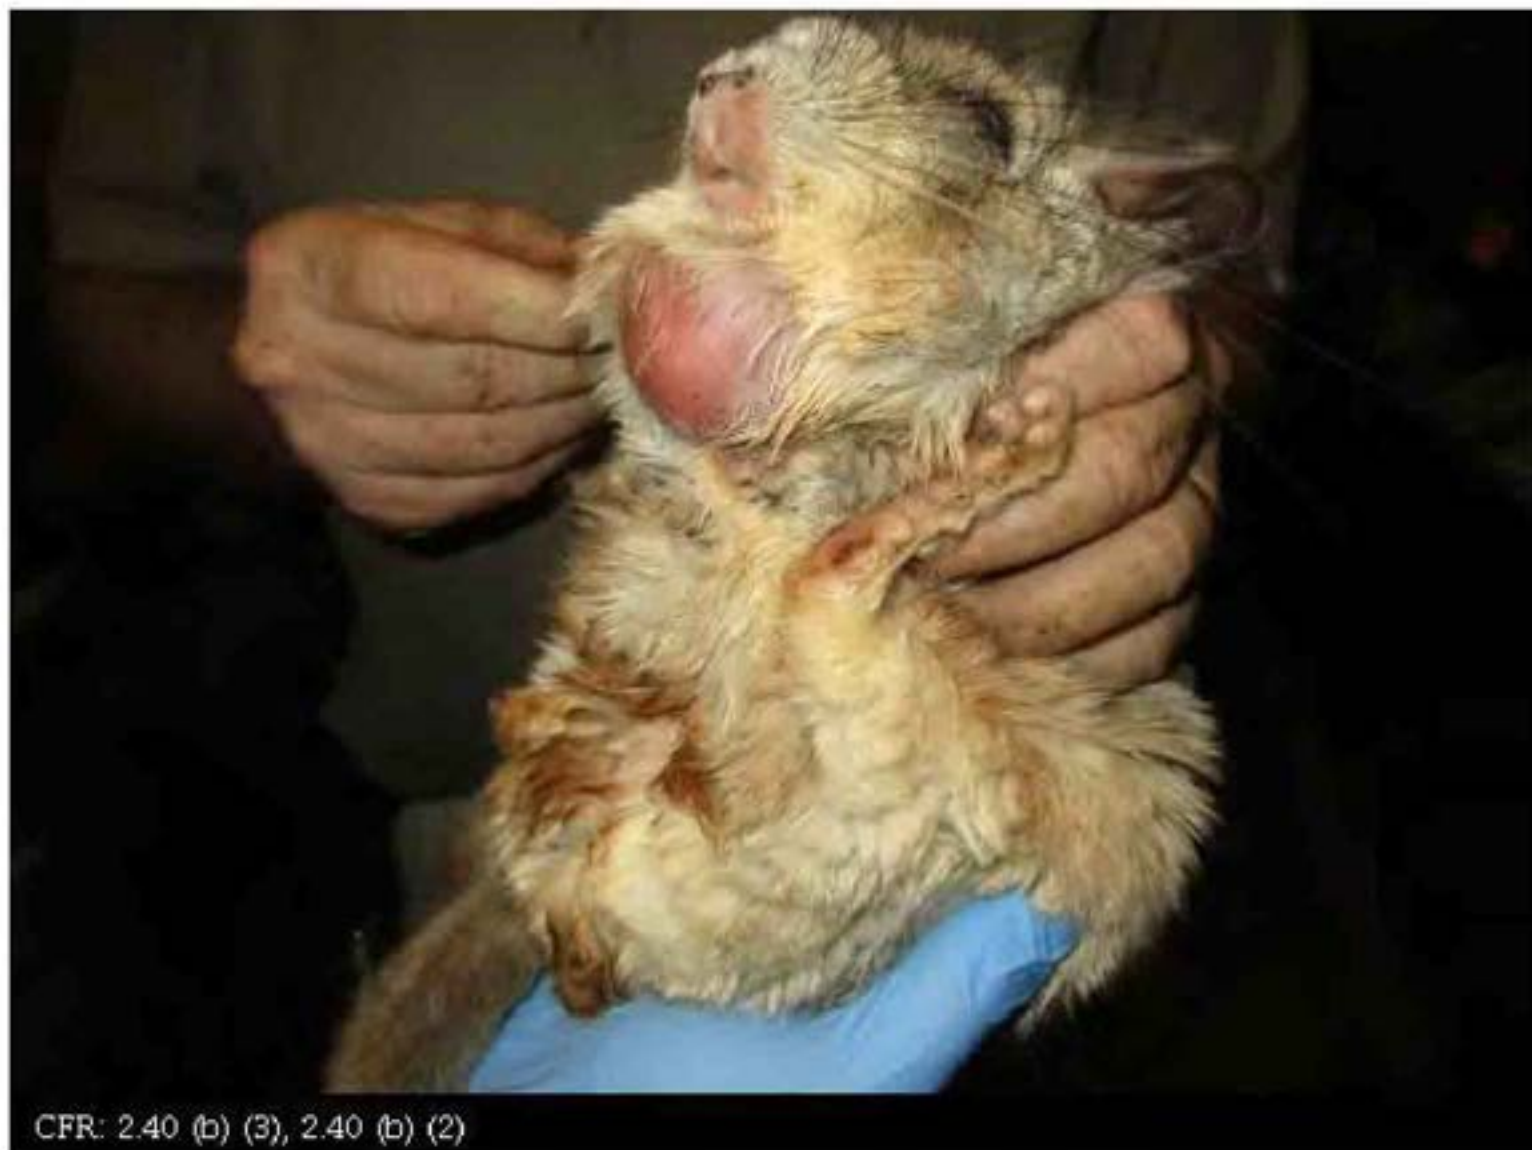
| Description: | Male cream eartag GROS 375; large reddened hairless swelling under chin. | | |
