**Inspection No:** 2016082569612273

**Certificate:** 41-B-0239

**DAN MOULTON**

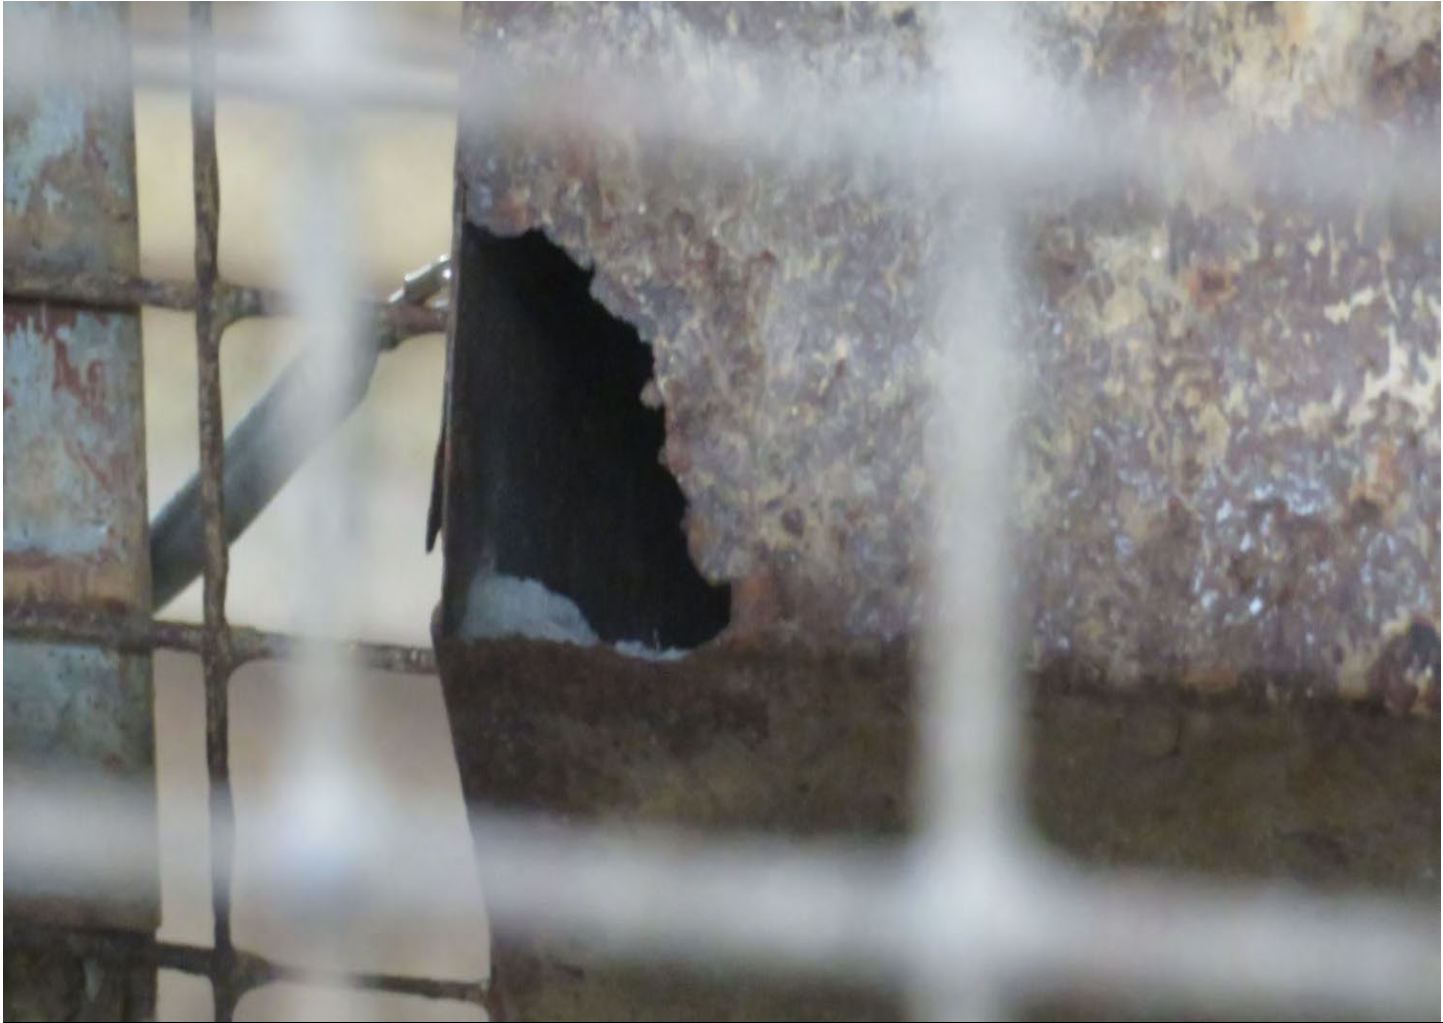
Close-up of rusted hole in dust box with edges exposed to animal.

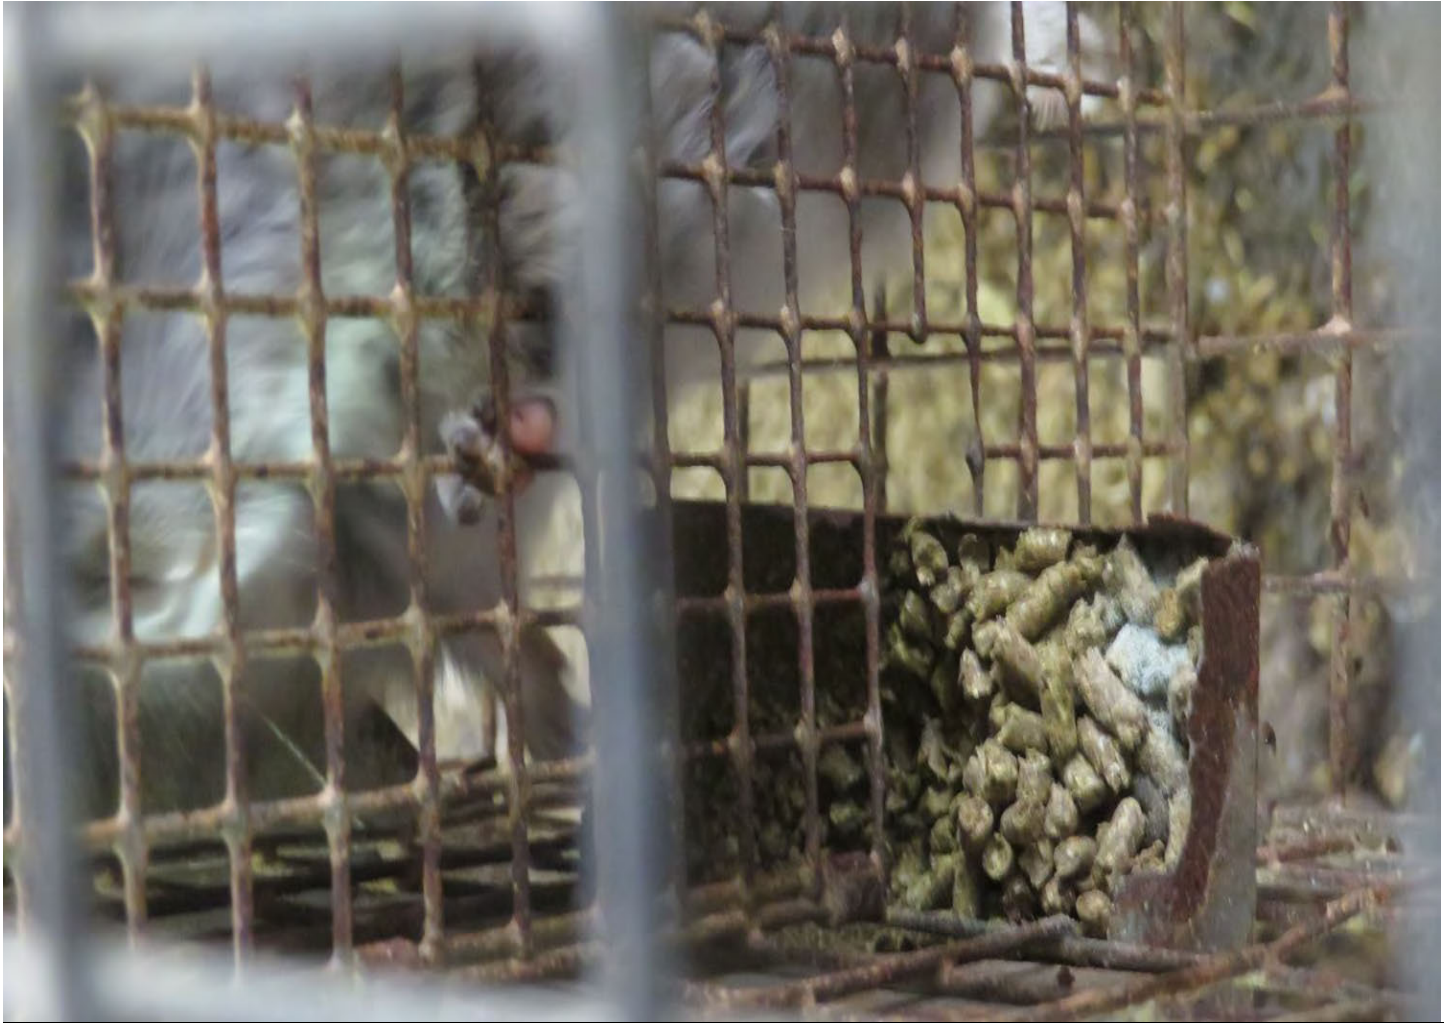
Feeder with rusted and rough edges; similar to most of feeders in facility.

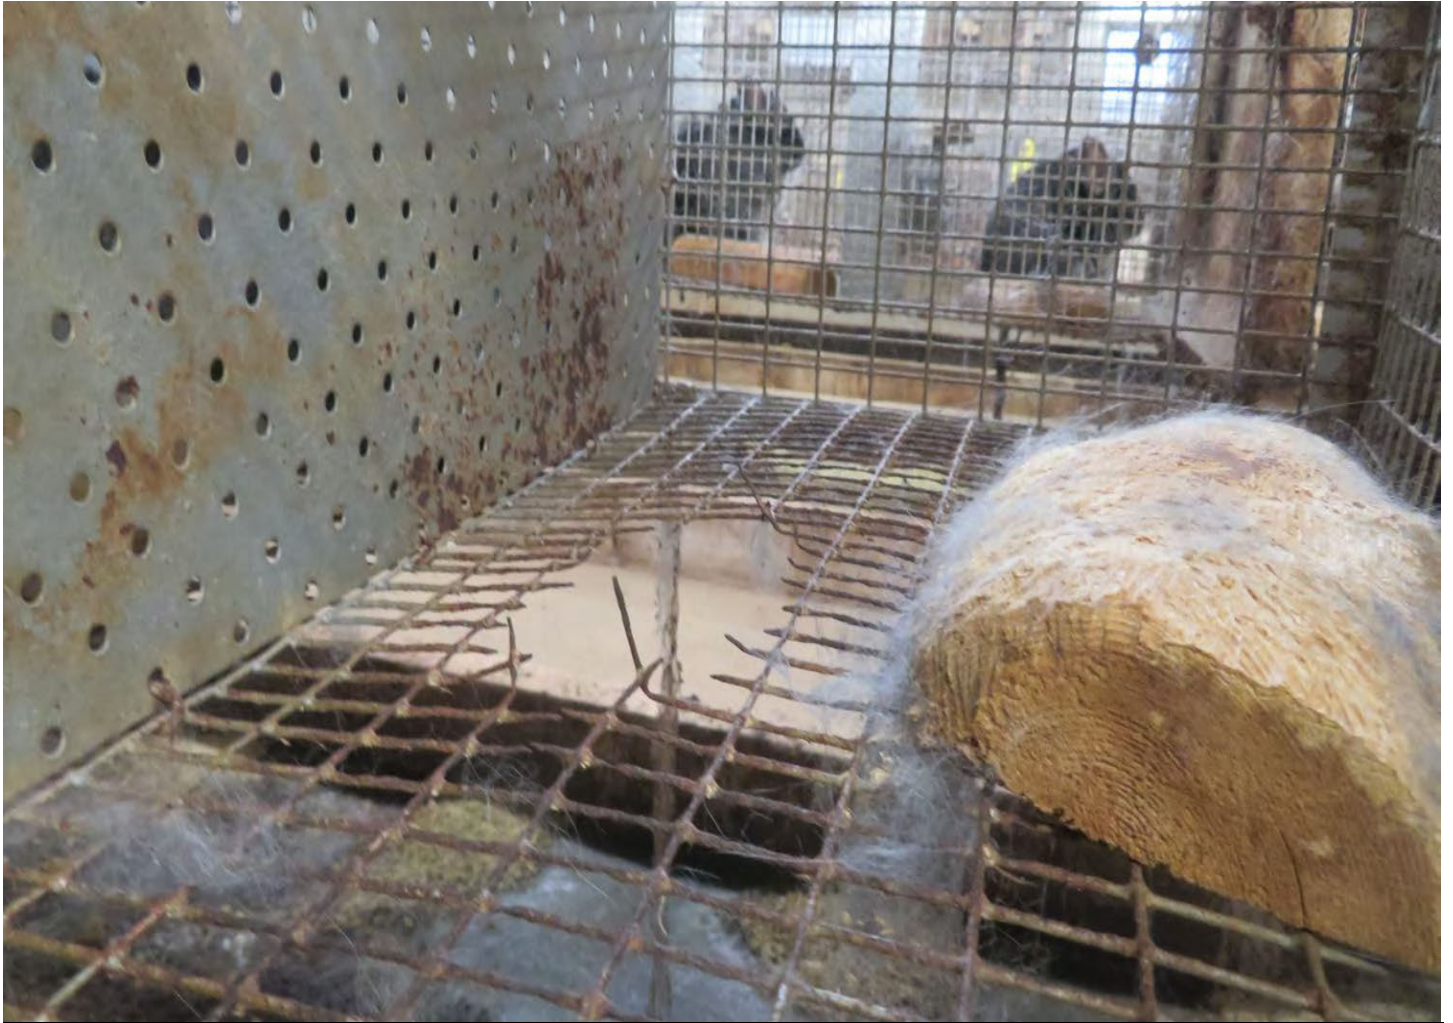
Broken wires in enclosure floor that was housing chinchilla during inspection  
(licensee immediately moved chinchilla to a safe enclosure).

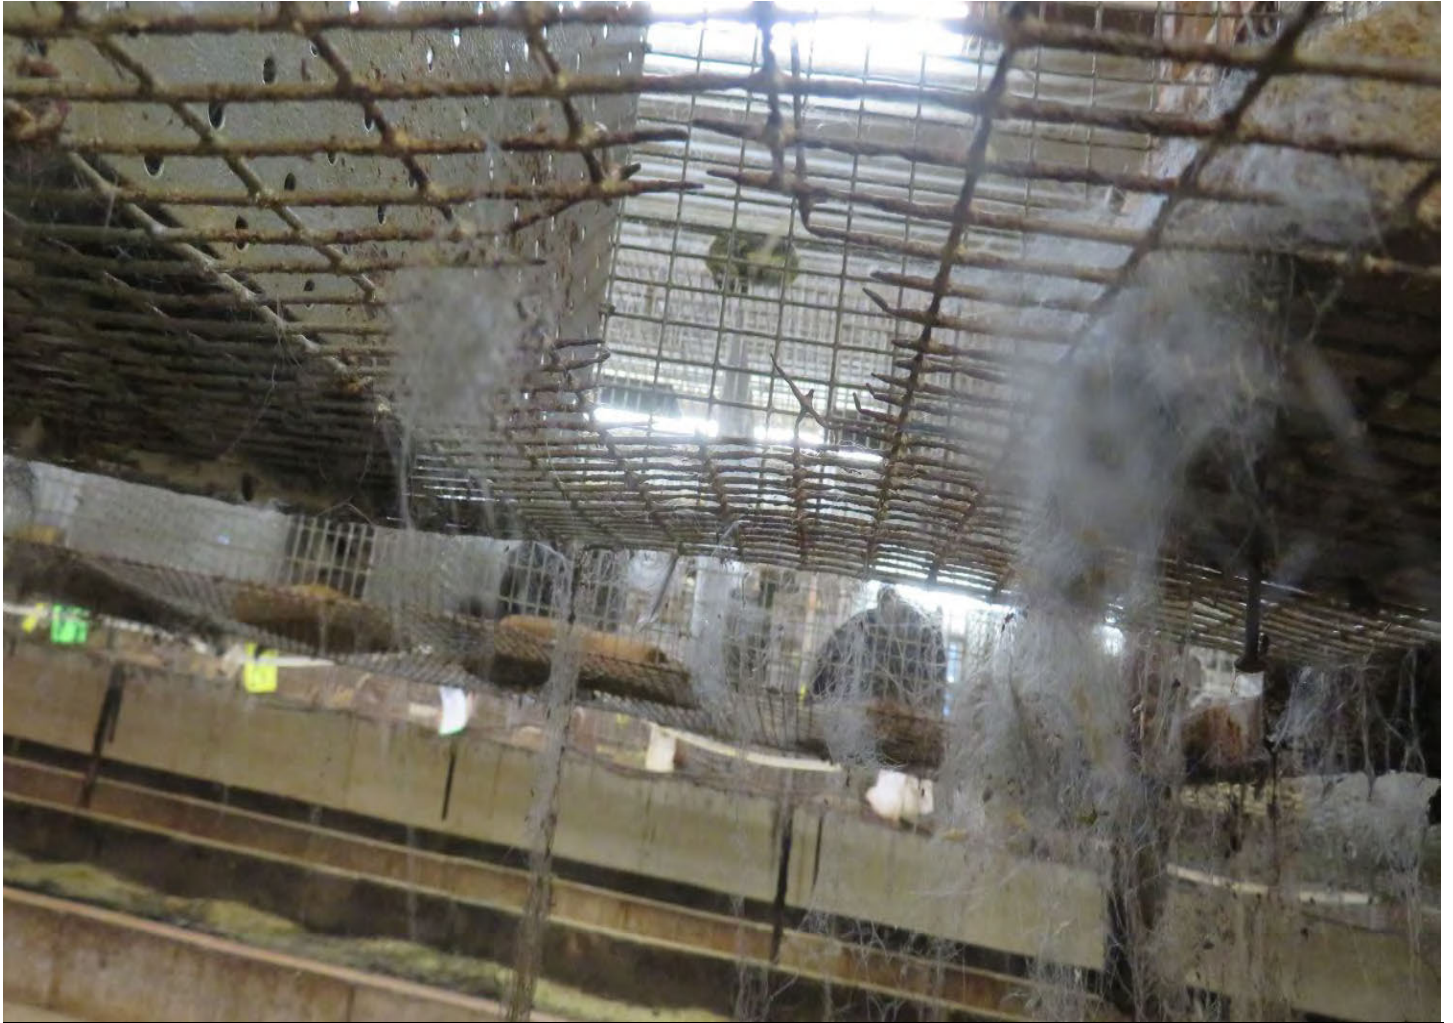
Looking up at broken wires in enclosure floor that was housing chinchilla during inspection (licensee immediately moved chinchilla to a safe enclosure).

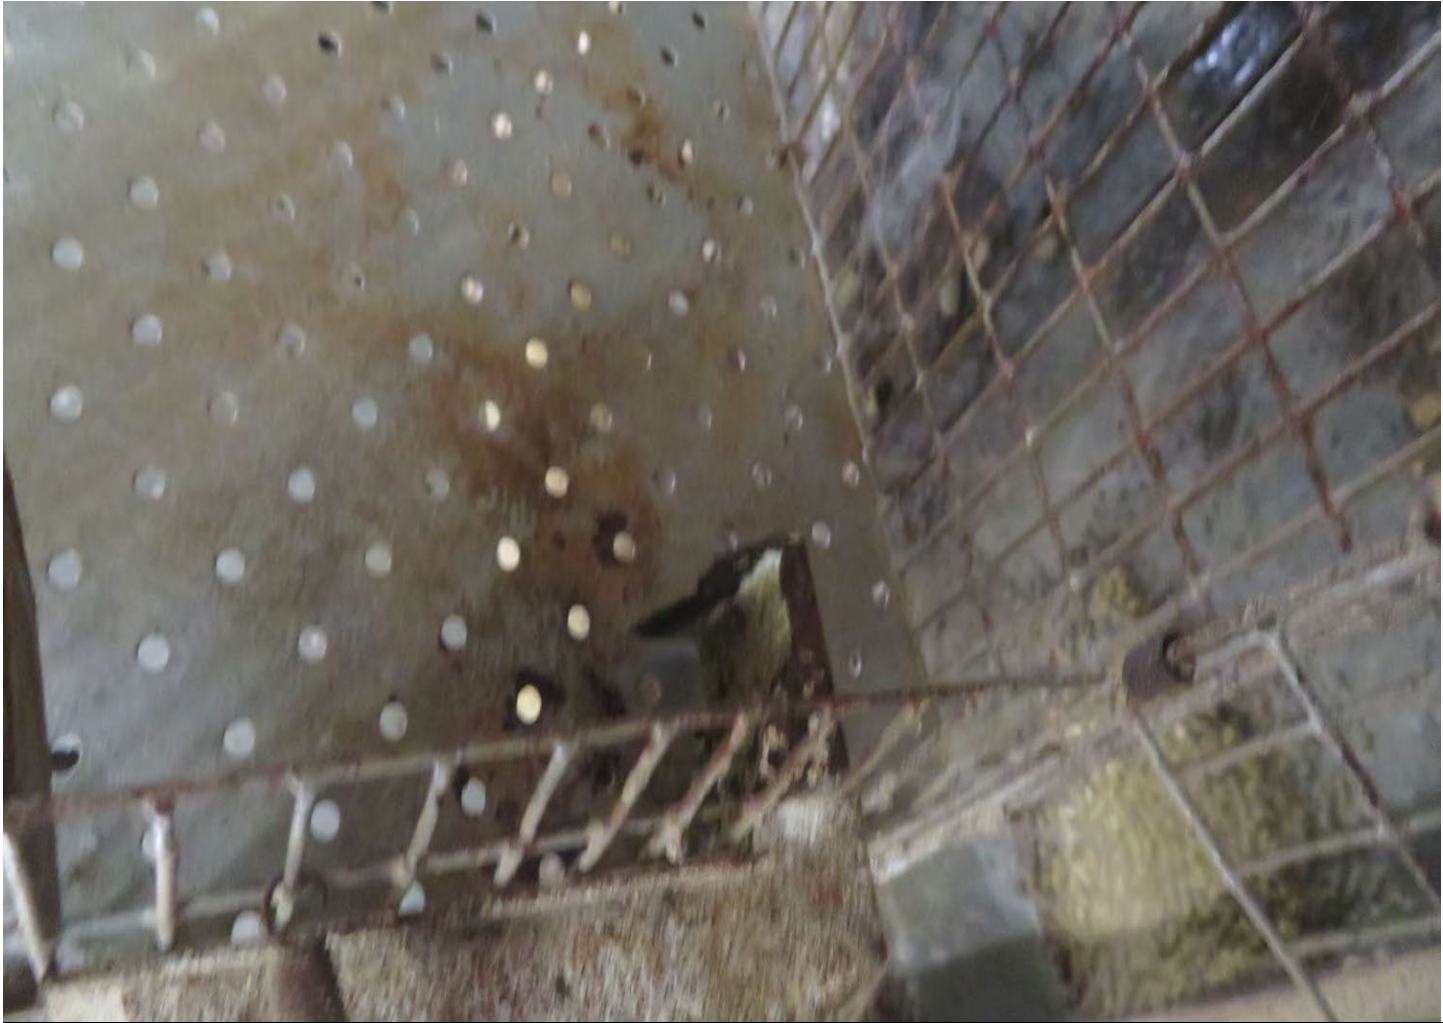
Feeder with rusted and rough edges; similar to most of feeders in facility.

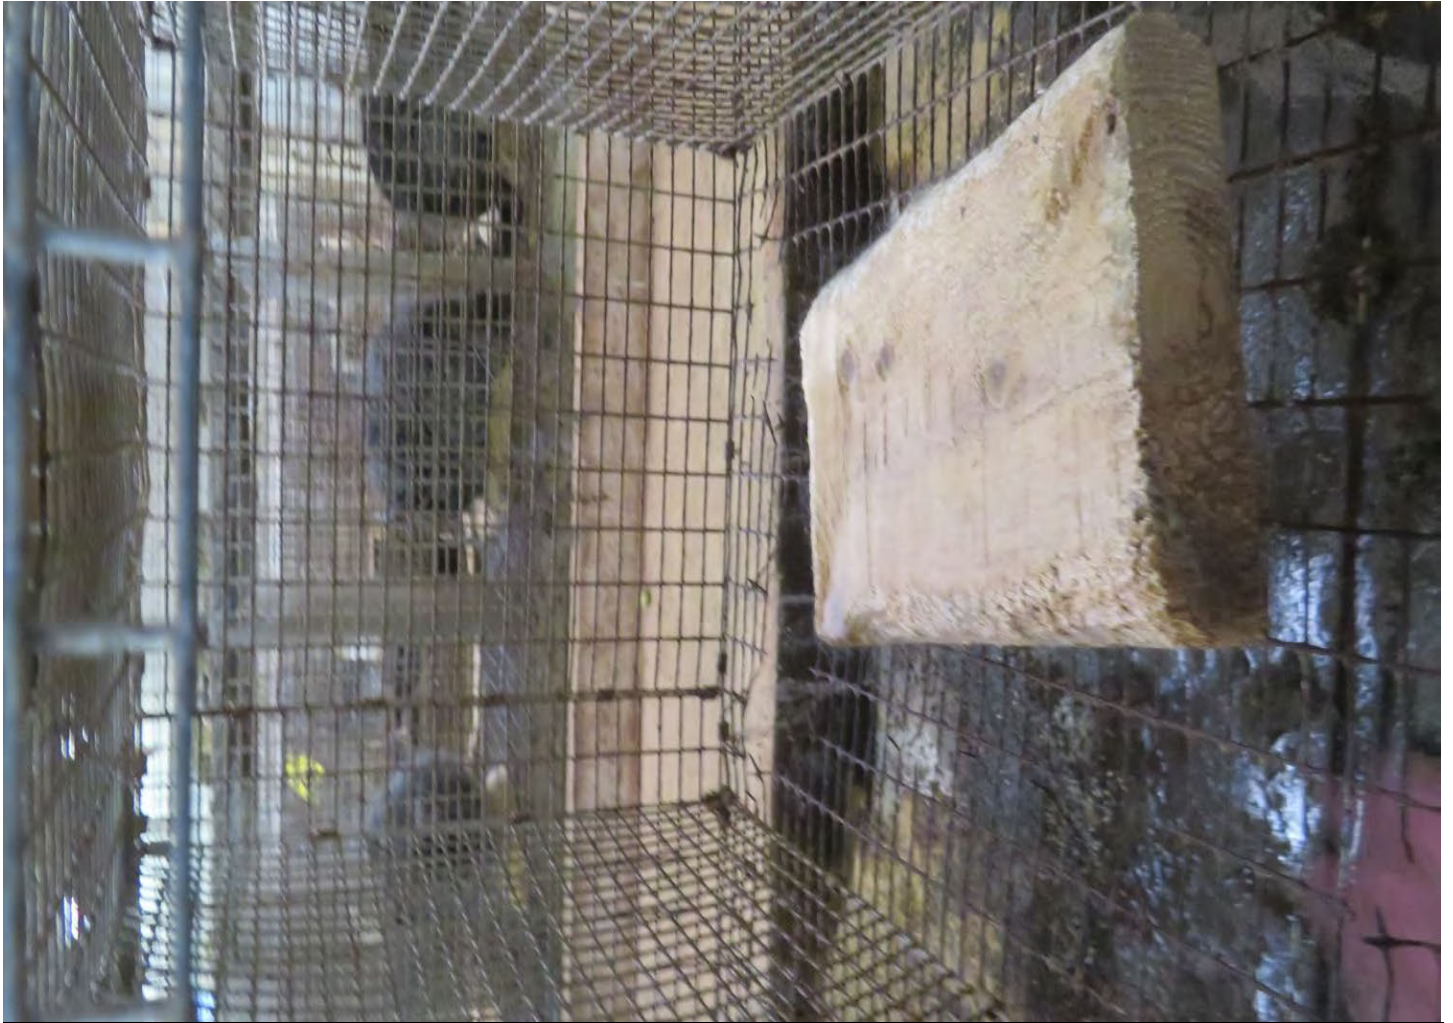
Broken wires in back part of enclosure floor and by block that was housing chinchilla during inspection (licensee immediately moved chinchilla to a safe enclosure).

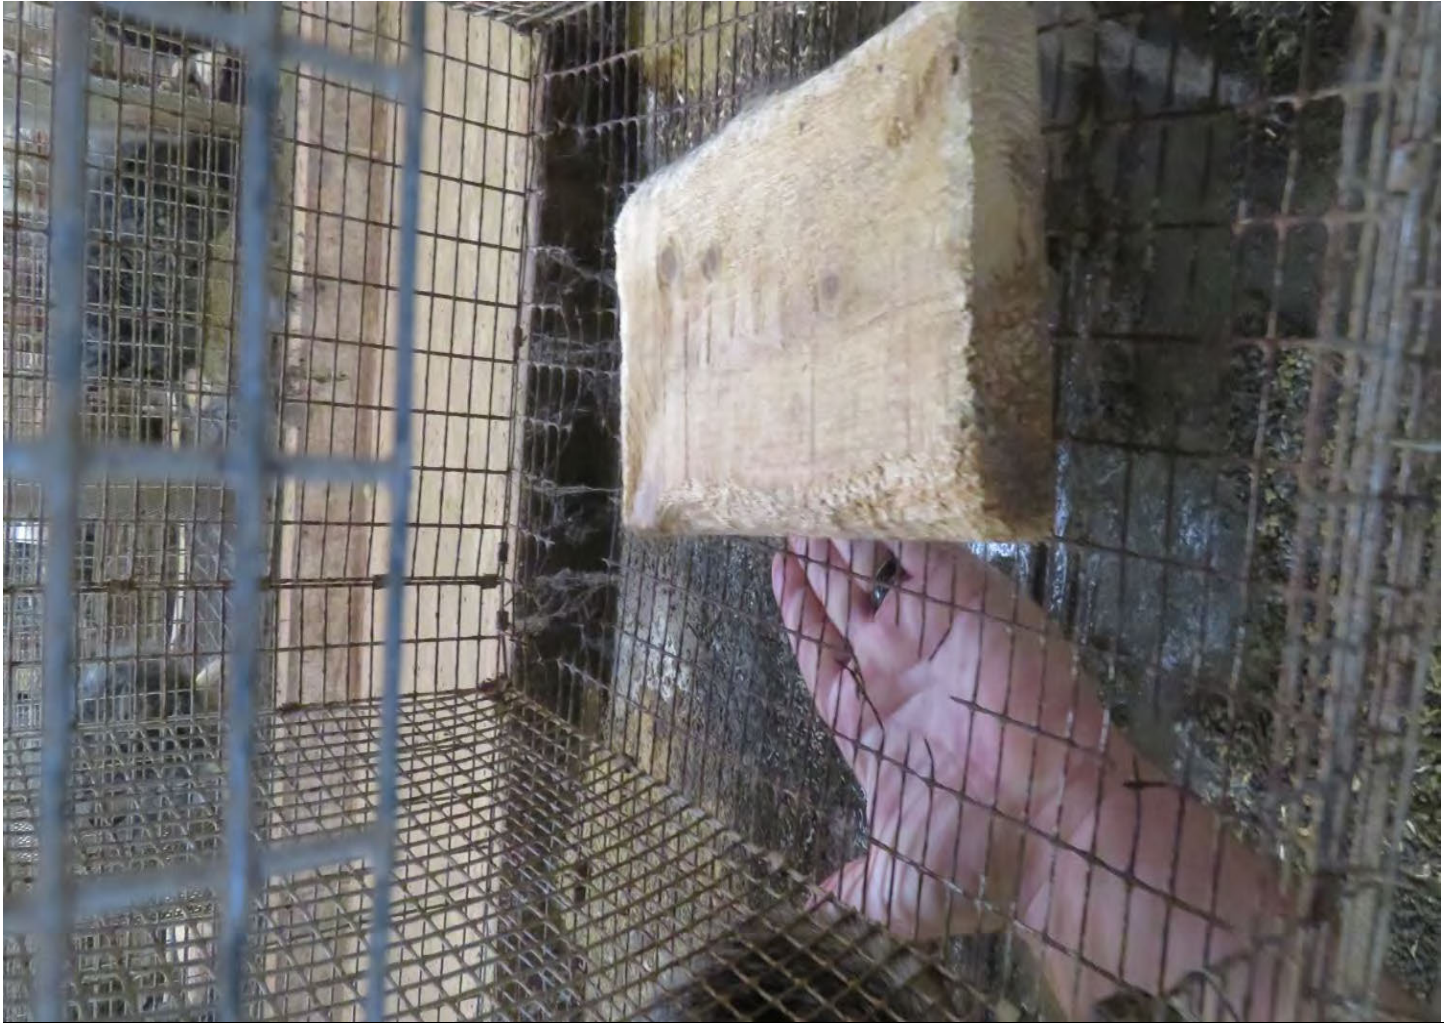
Broken wires in enclosure floor that was housing chinchilla during inspection  
(licensee immediately moved chinchilla to a safe enclosure).

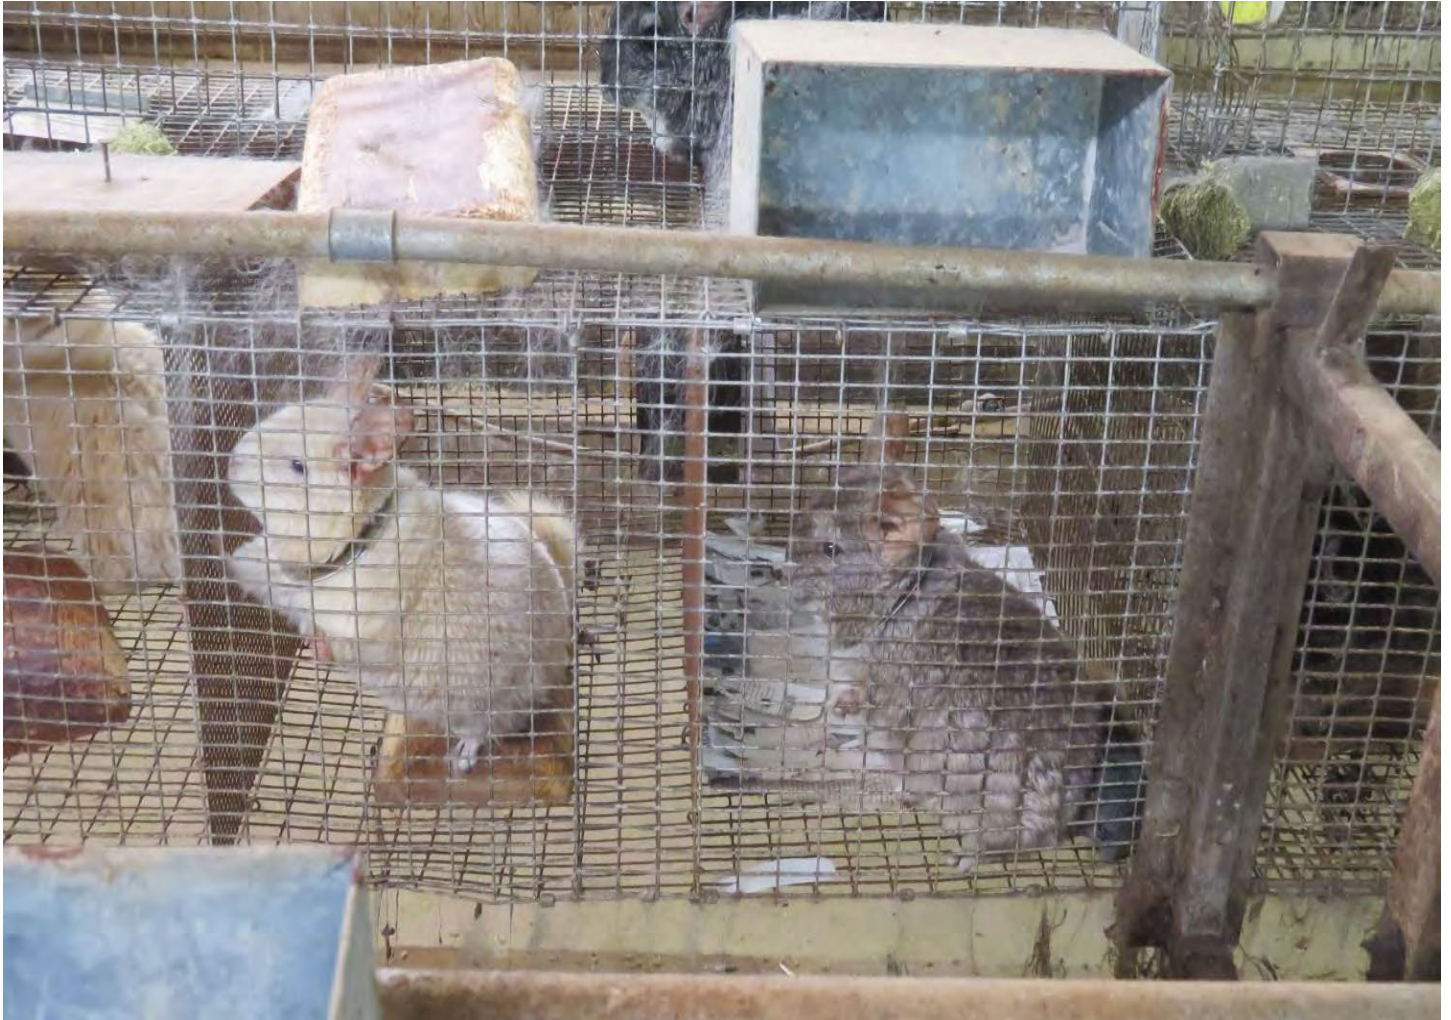
Grey chinchilla mother on right (43A) had young chinchilla that was crossing over to white chinchilla on left (43B) through hole by feeder.

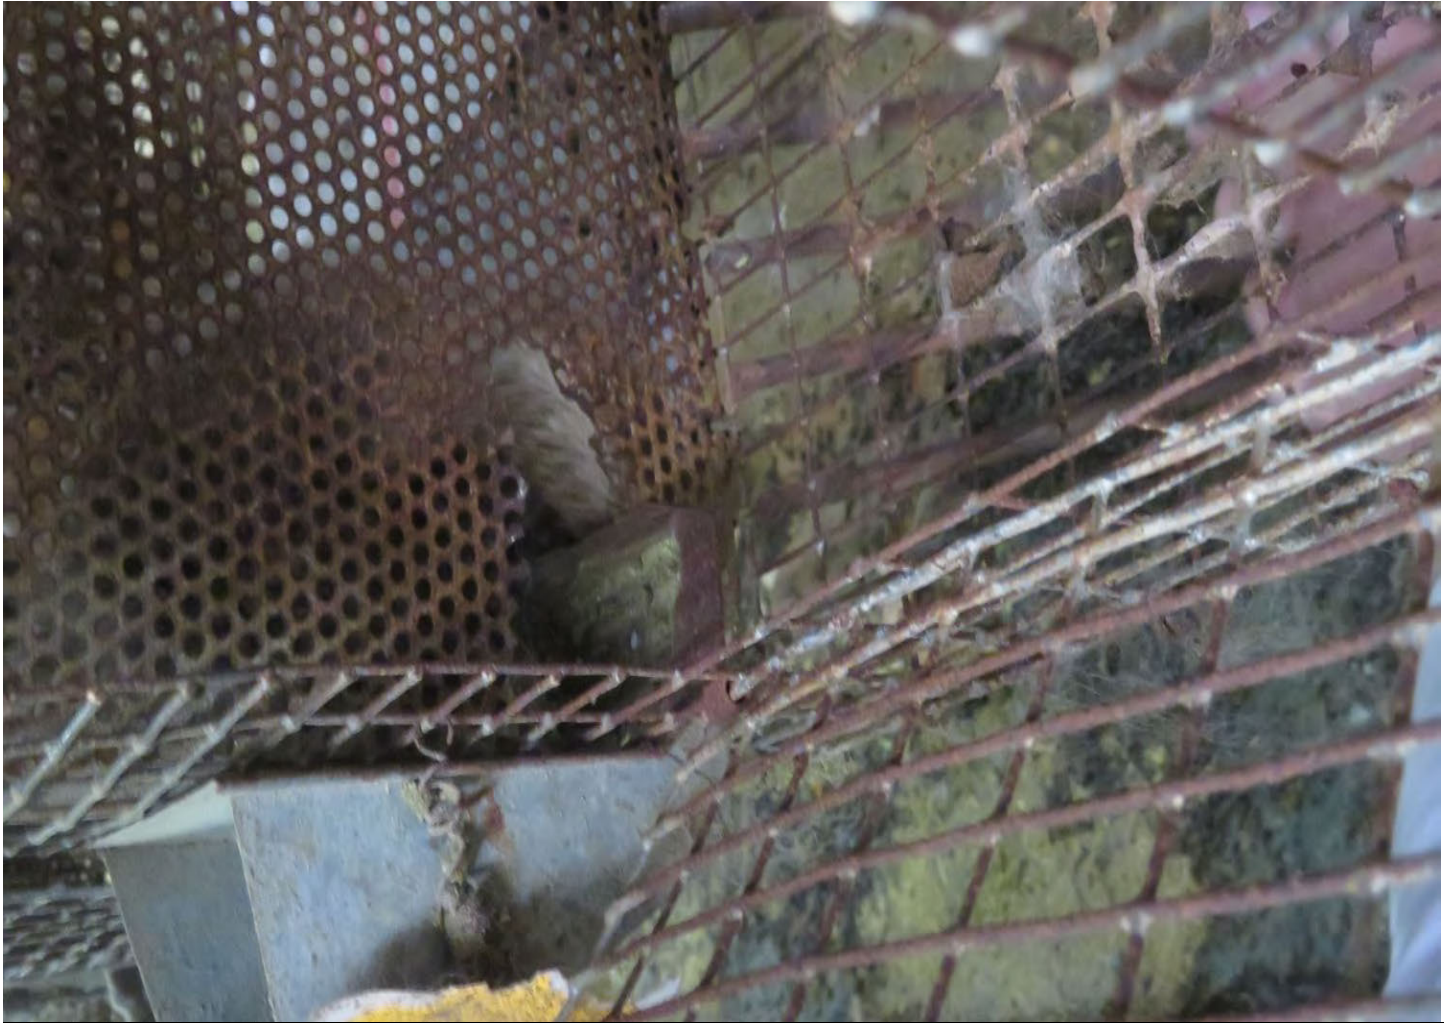
Hole that young chinchilla was using to go through feeder area to neighboring enclosure.

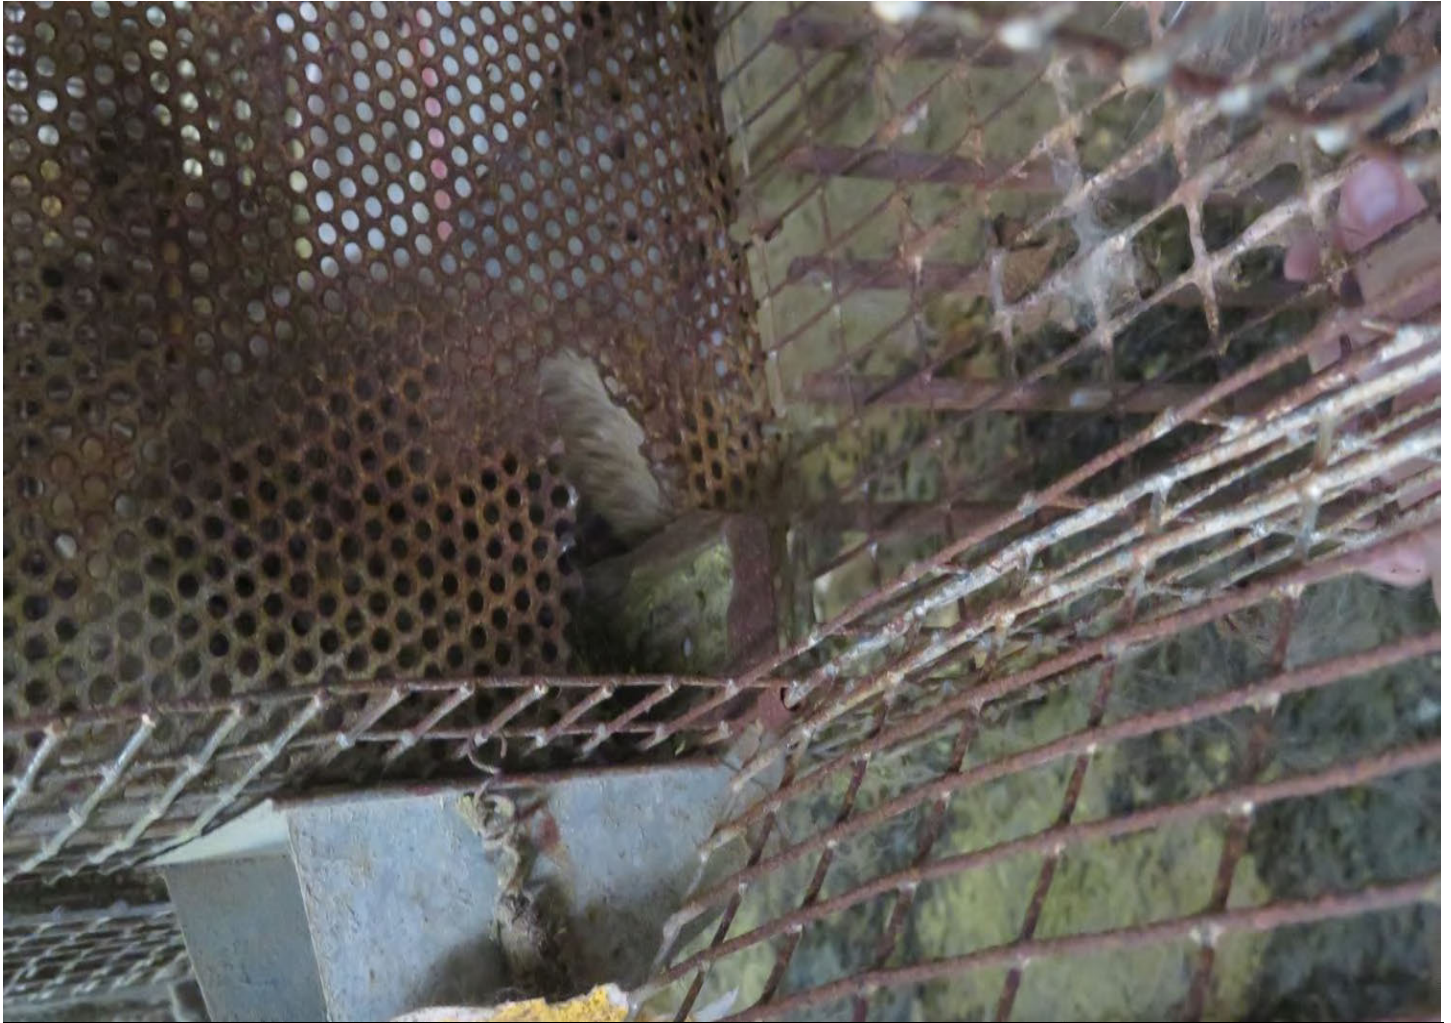
Hole that young chinchilla was using to go through feeder area to neighboring enclosure.

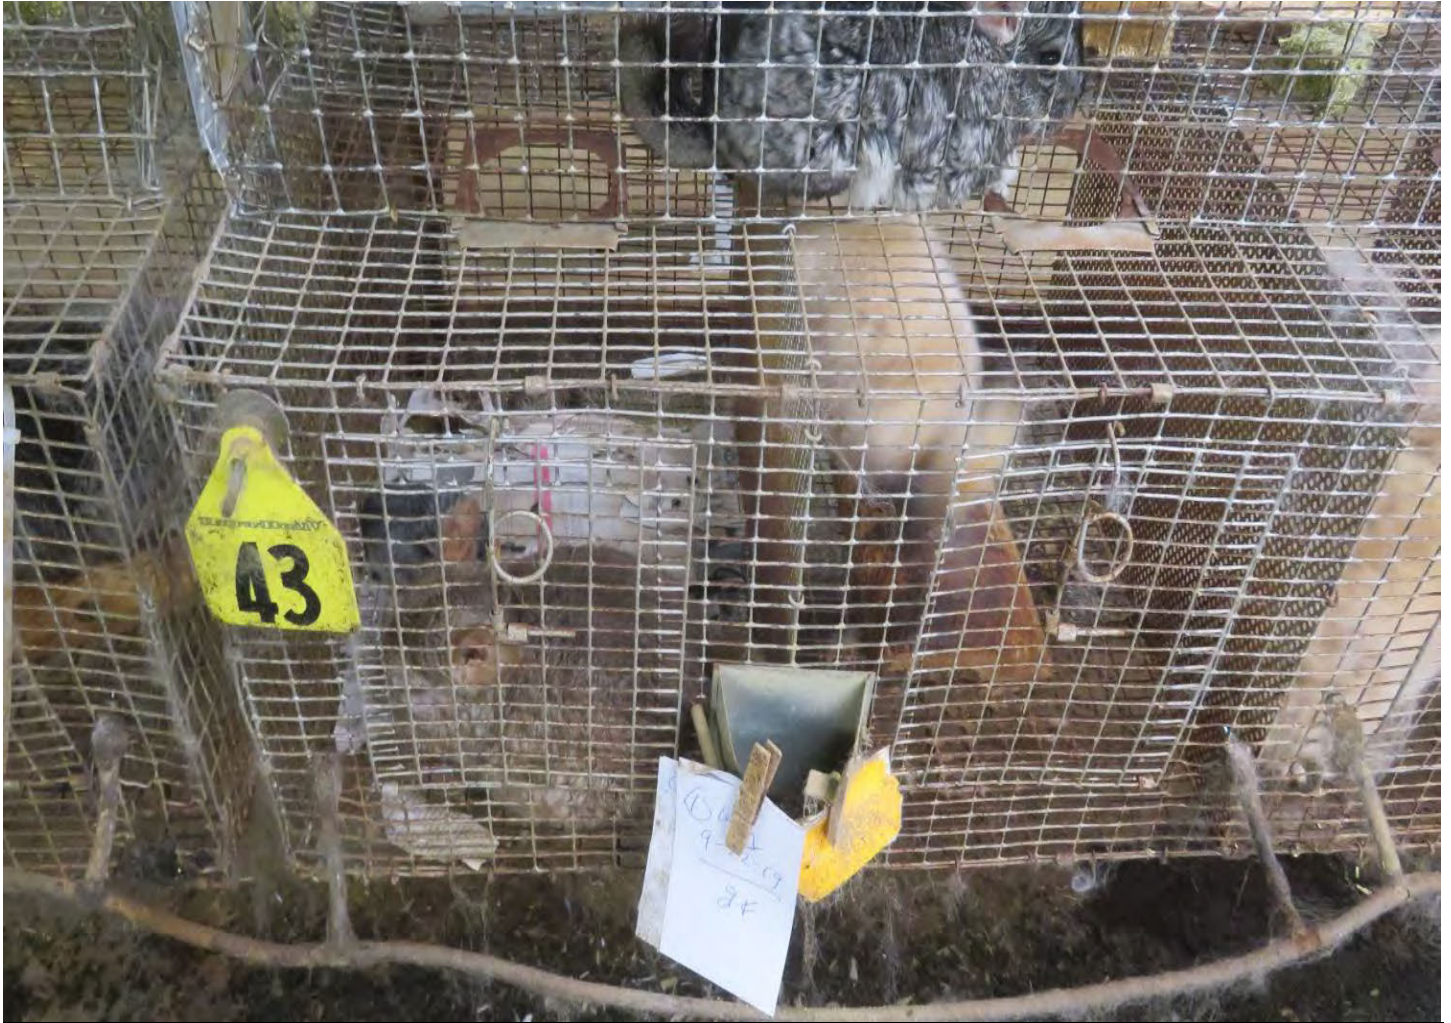
Mother chinchilla 43A with young chinchilla and 43B; young was passing over through feeder hole to 43B. Young went back with mother and then licensee patched hole during inspection.

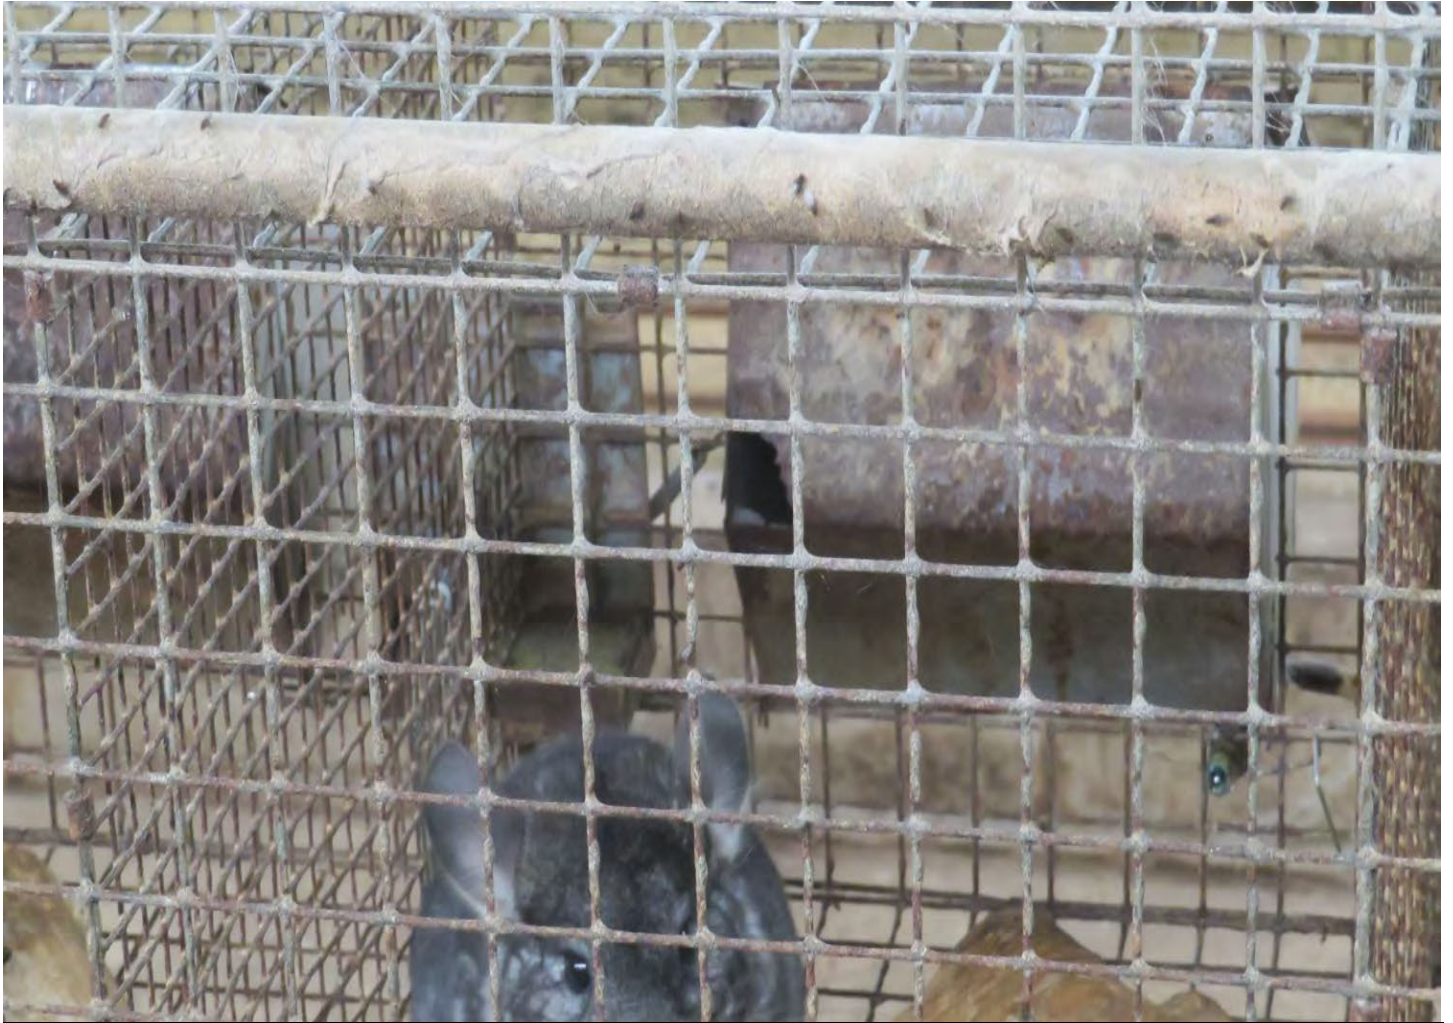
Rusted hole in dust box with edges exposed to animal.

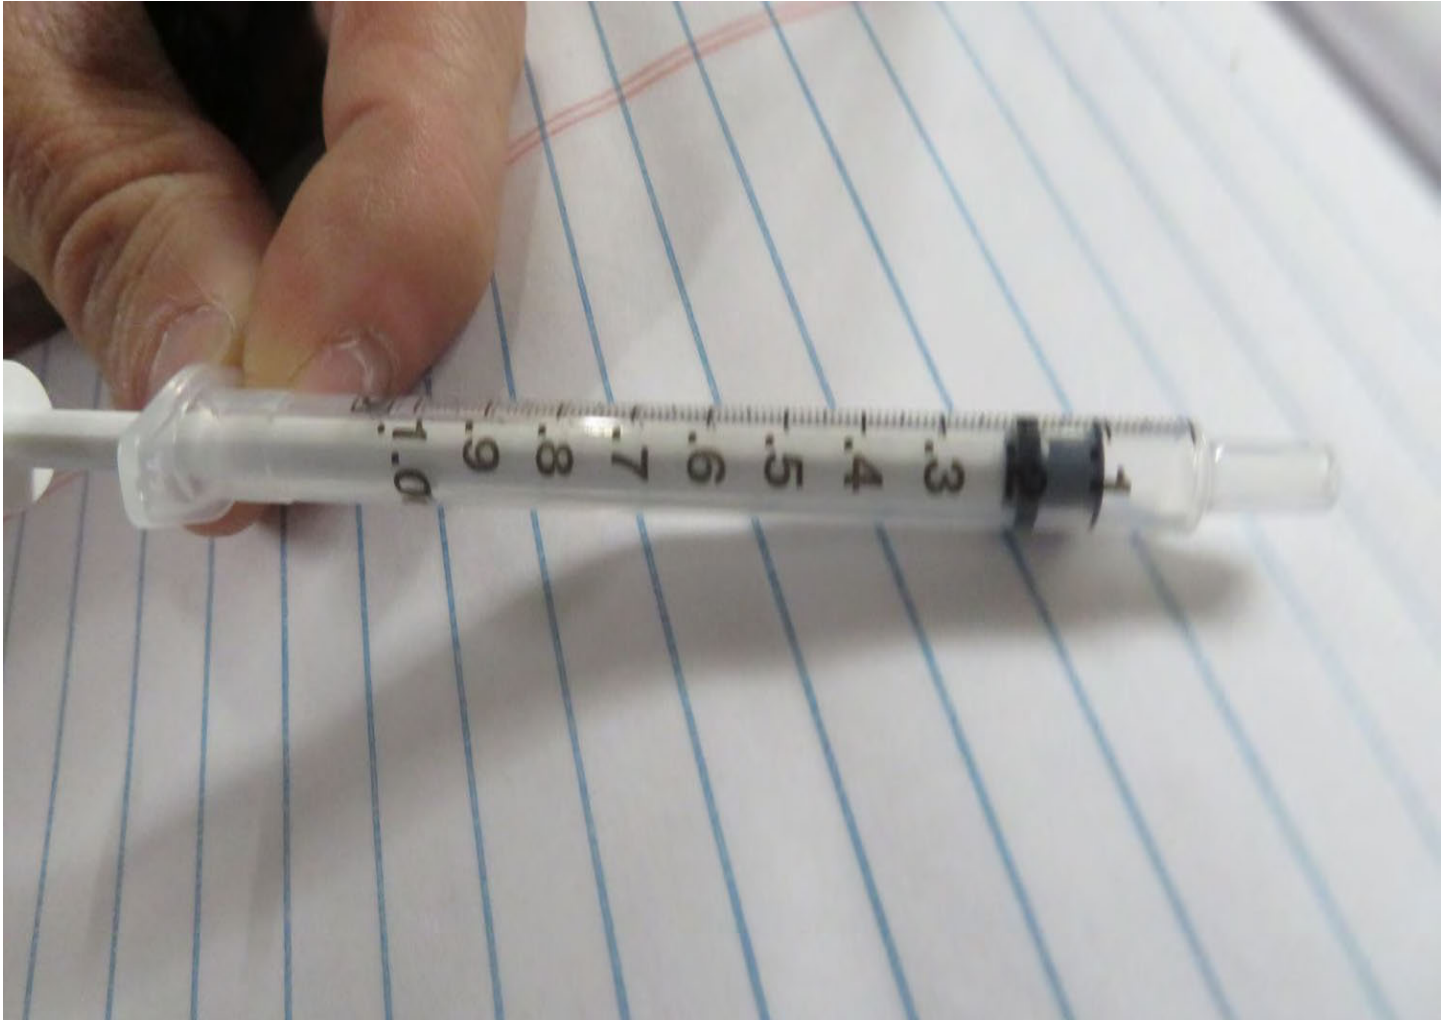
Syringe licensee showed us that uses for oxytetracycline, said gives each affected animal '1' which is 0.1 mL on these syringes. Licensee said that they treat on Saturdays. Also at one time said they sometimes they treat every other day.

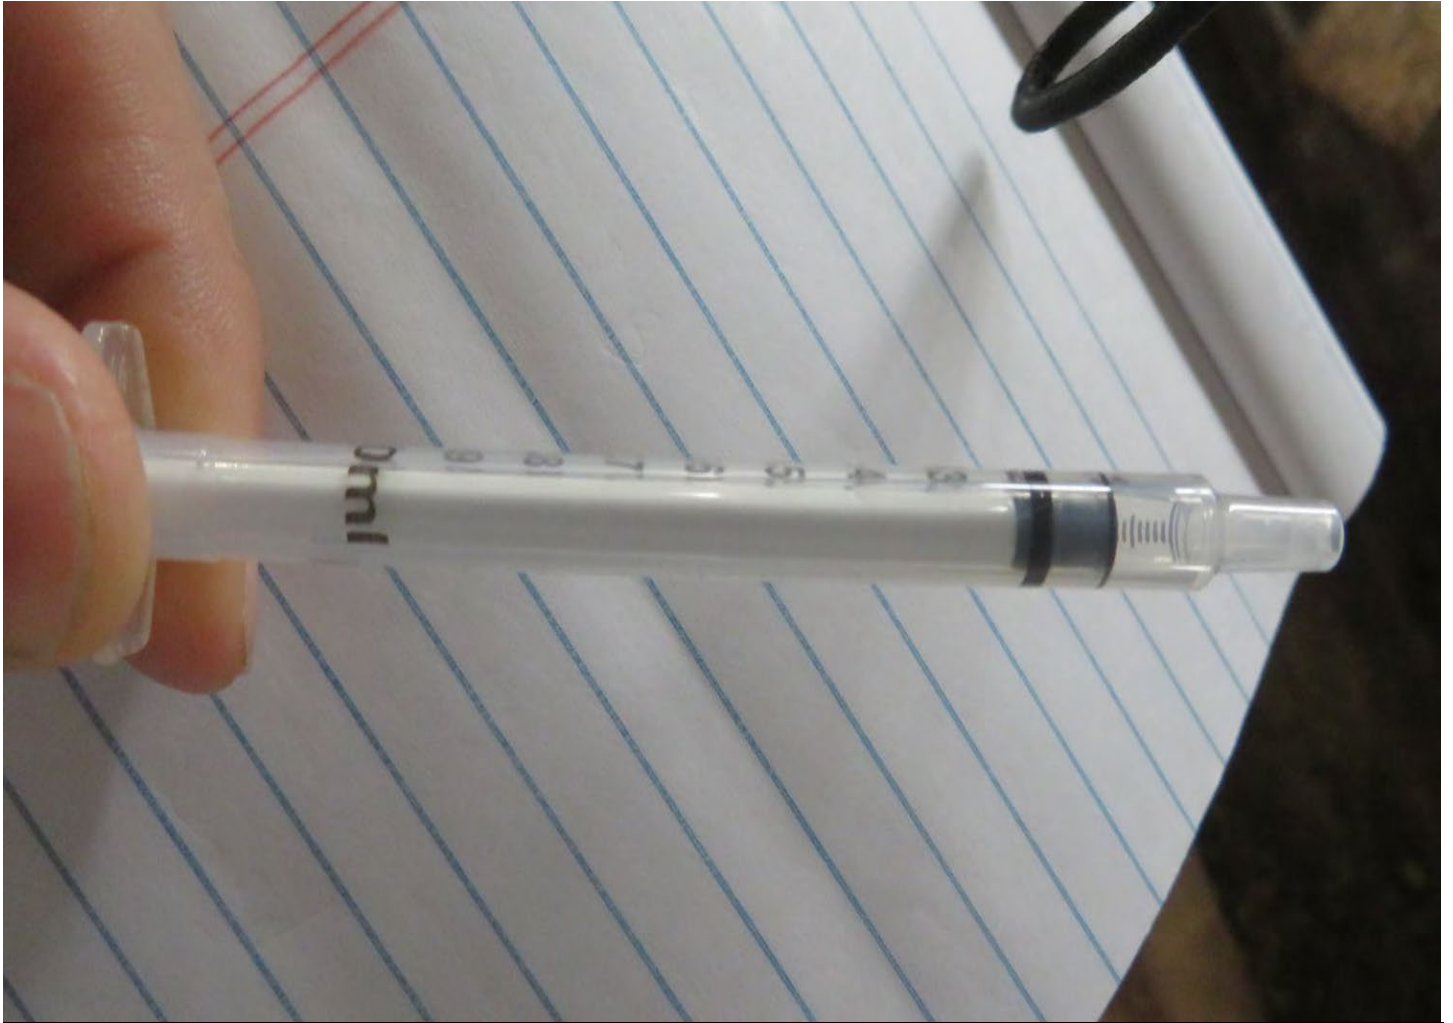
Syringe licensee showed us that uses for oxytetracycline, said gives each affected animal '1' which is 0.1 mL on these syringes.

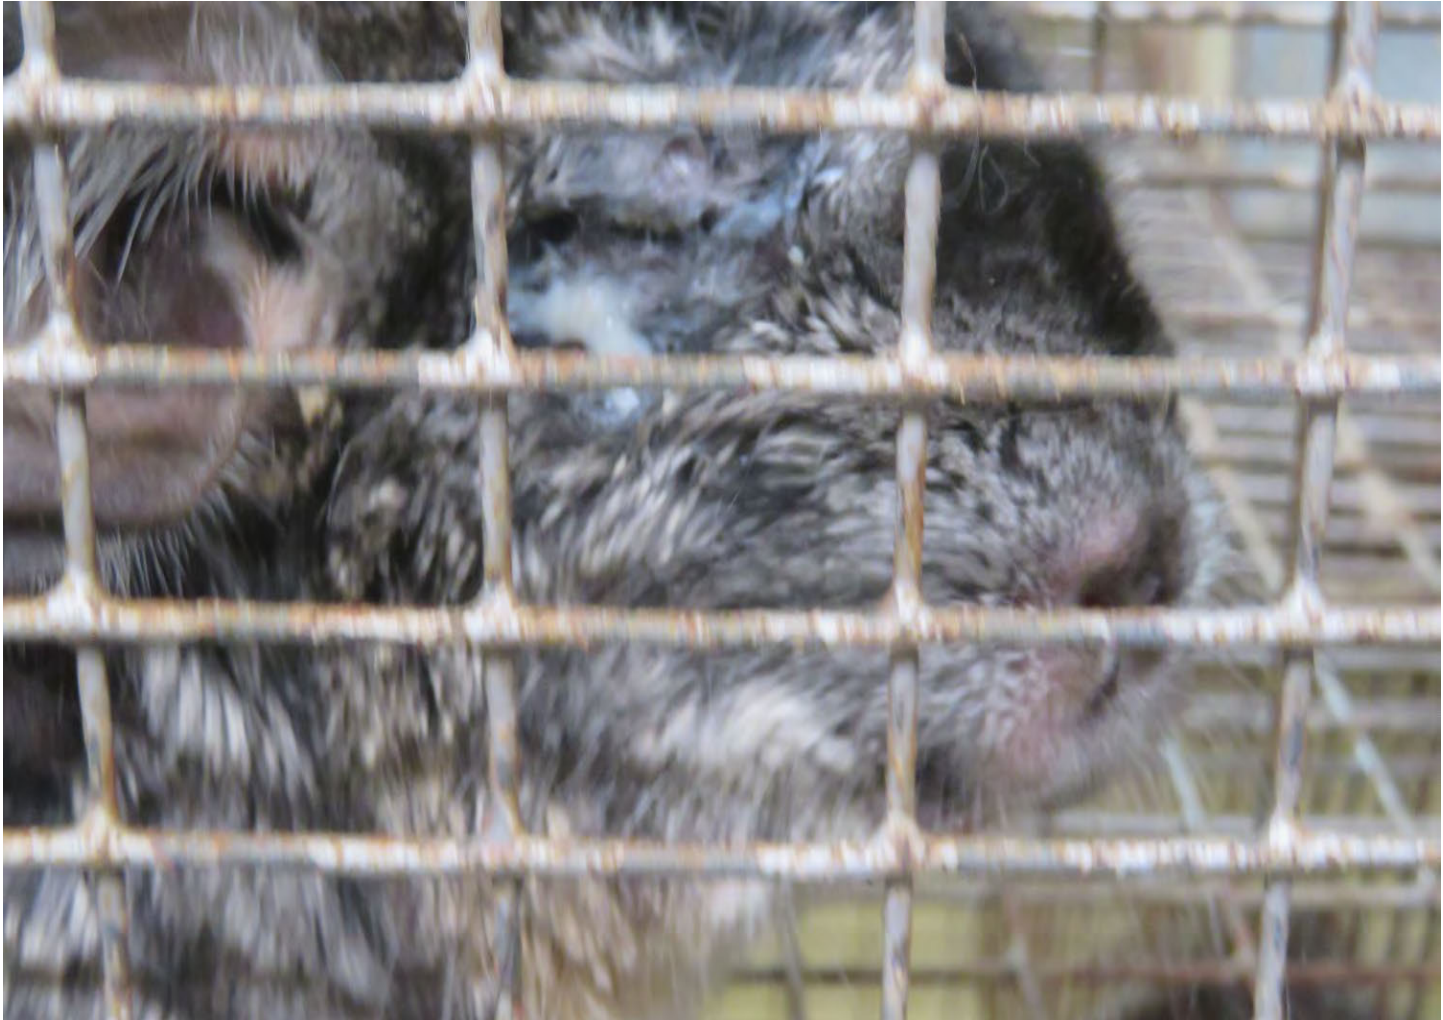
Male that we observed licensee treat; it was given about 0.1 mL Oxytet 100 orally.  
(animal has been on treatment protocol for undetermined amount of time).
