**Inspection No:** 2016082569612273

**Certificate:** 41-B-0239

**DAN MOULTON**

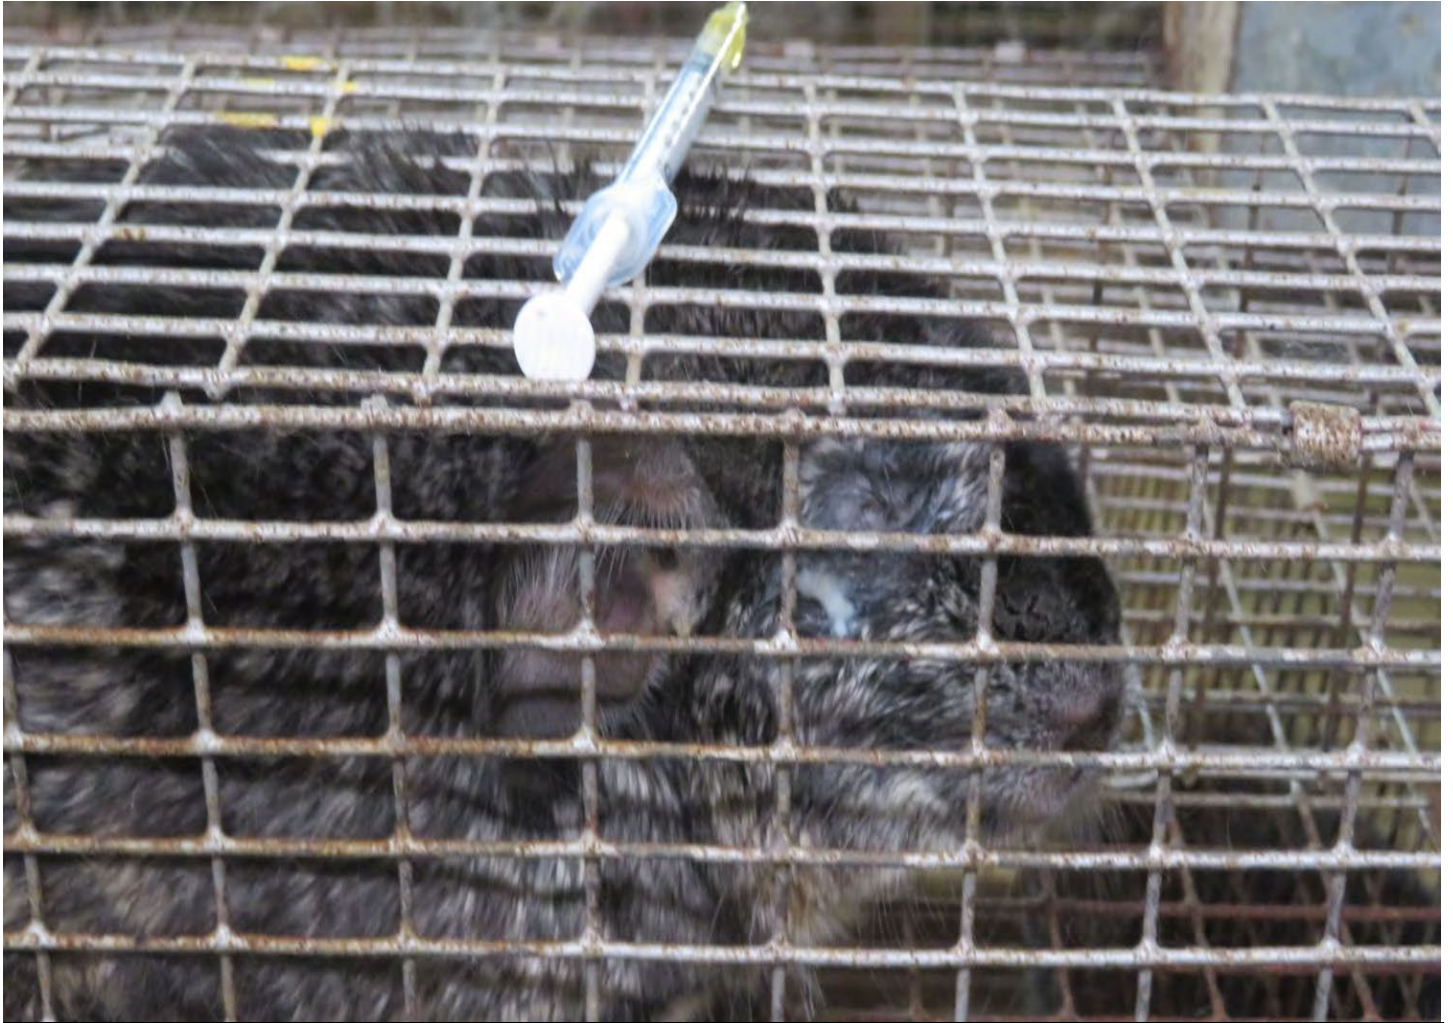
Male that we observed licensee treat; it was given about 0.1 mL Oxytet 100 orally.  
(animal has been on treatment protocol for undetermined amount of time).

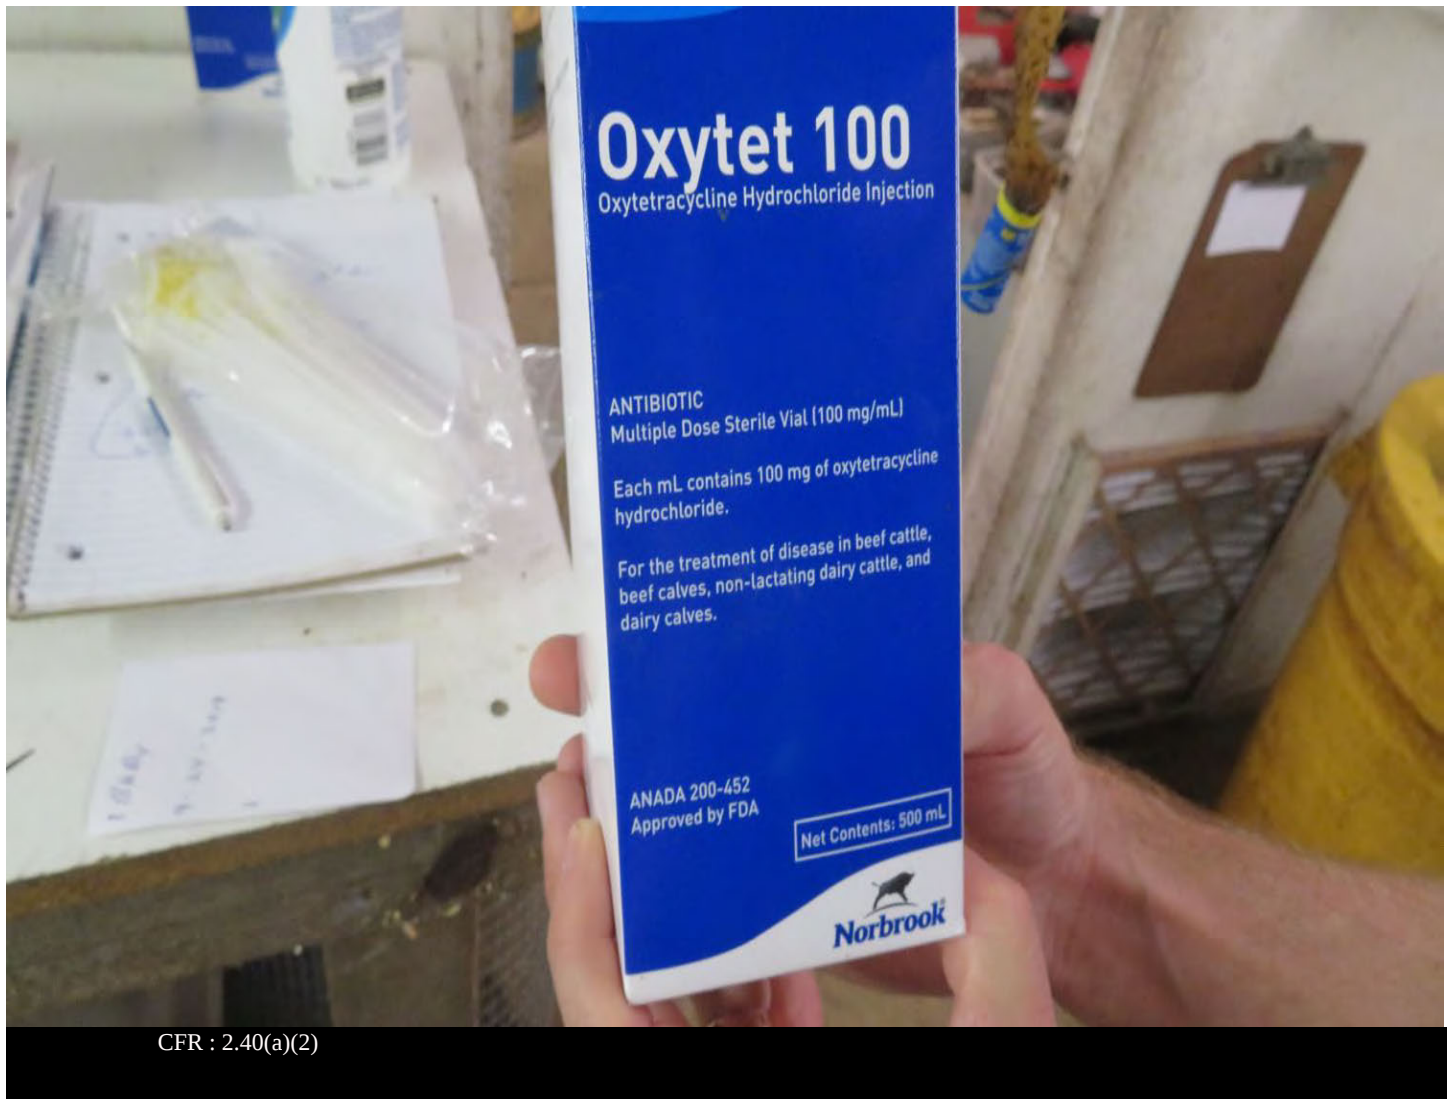
Product that facility has on hand and has been giving orally to chinchillas, reports giving 0.1 ml/cc once every Saturday or once every other day.

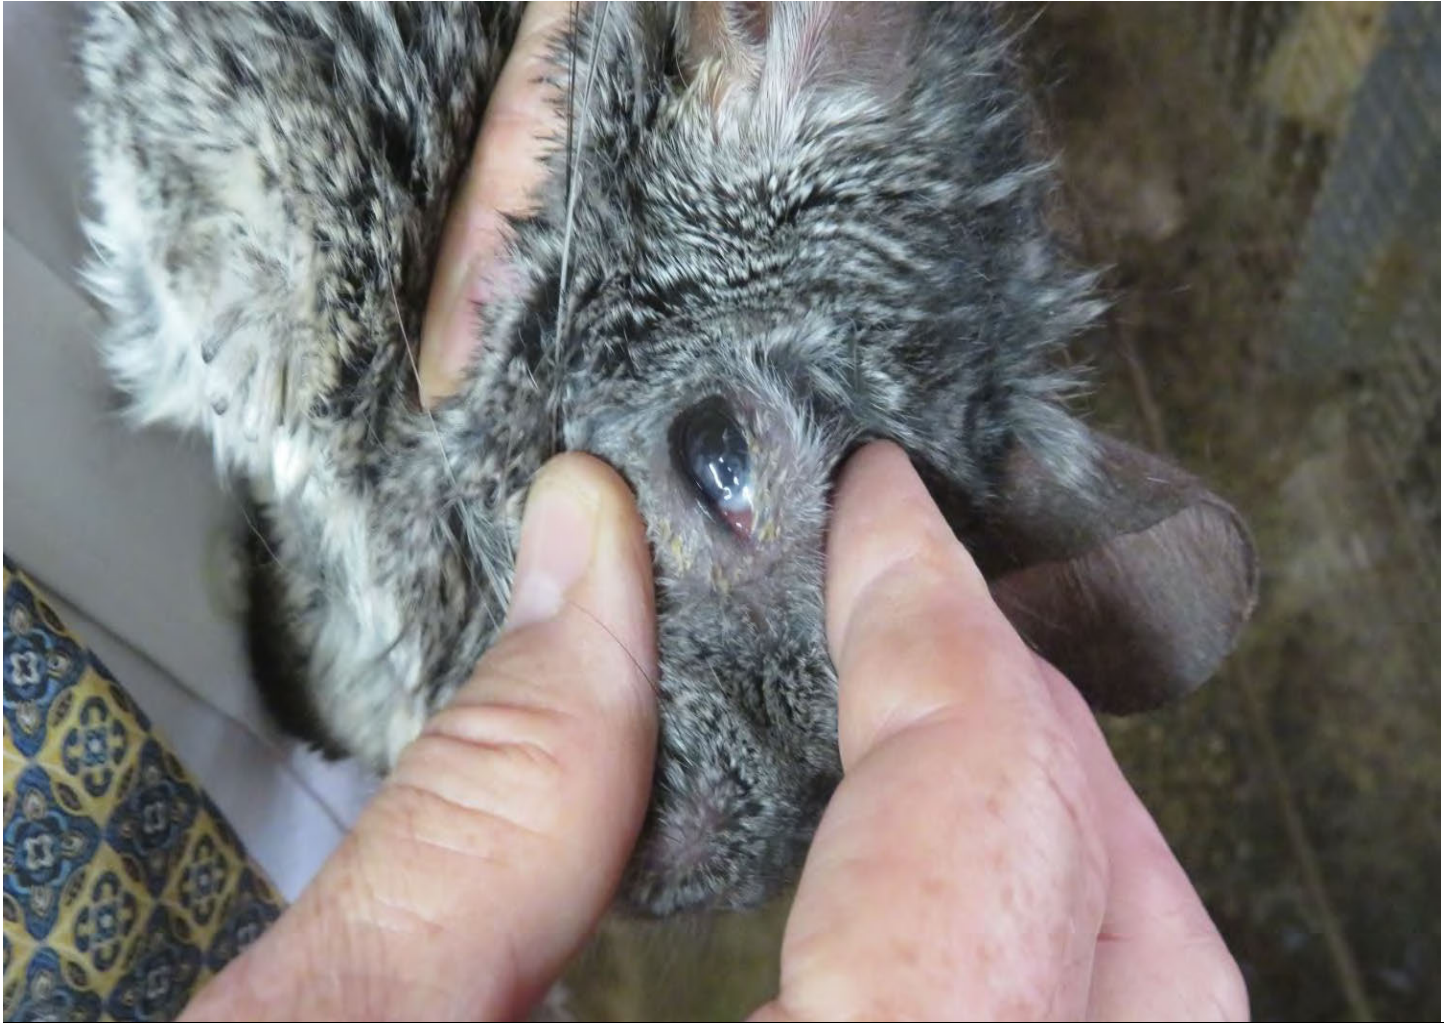
Male that wasn't on treatment yet, its right eye was squinting and he had some crusting and light discharge.

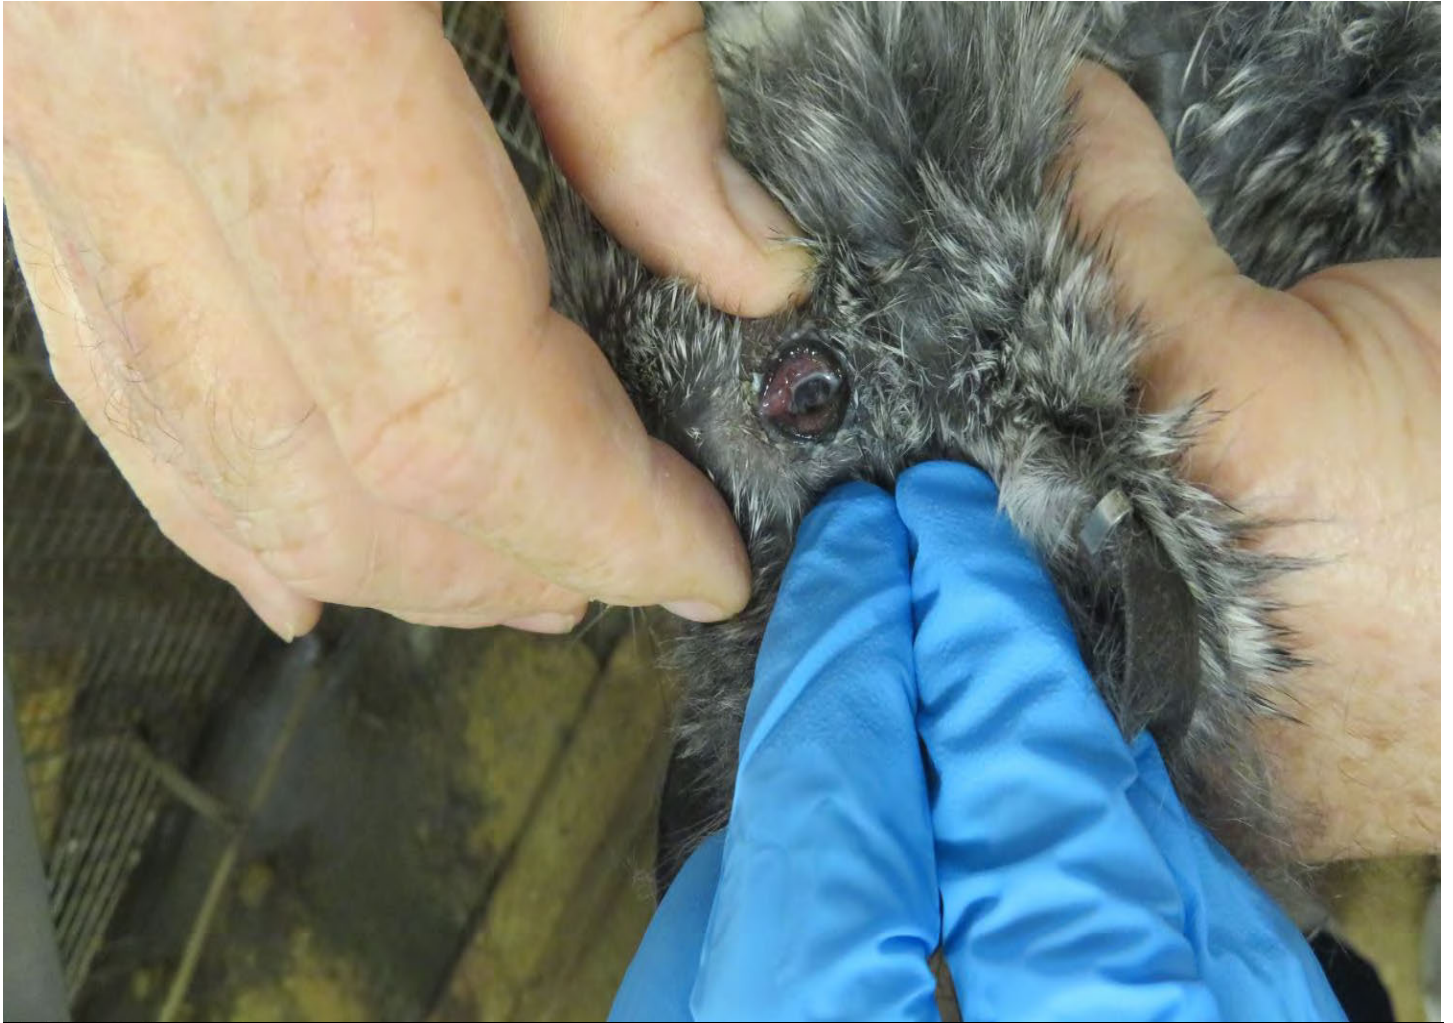
Female with eartag 805's right eye; not on treatment prior to inspection; right eye was squinting while in cage; mild discharge and crusting seen.

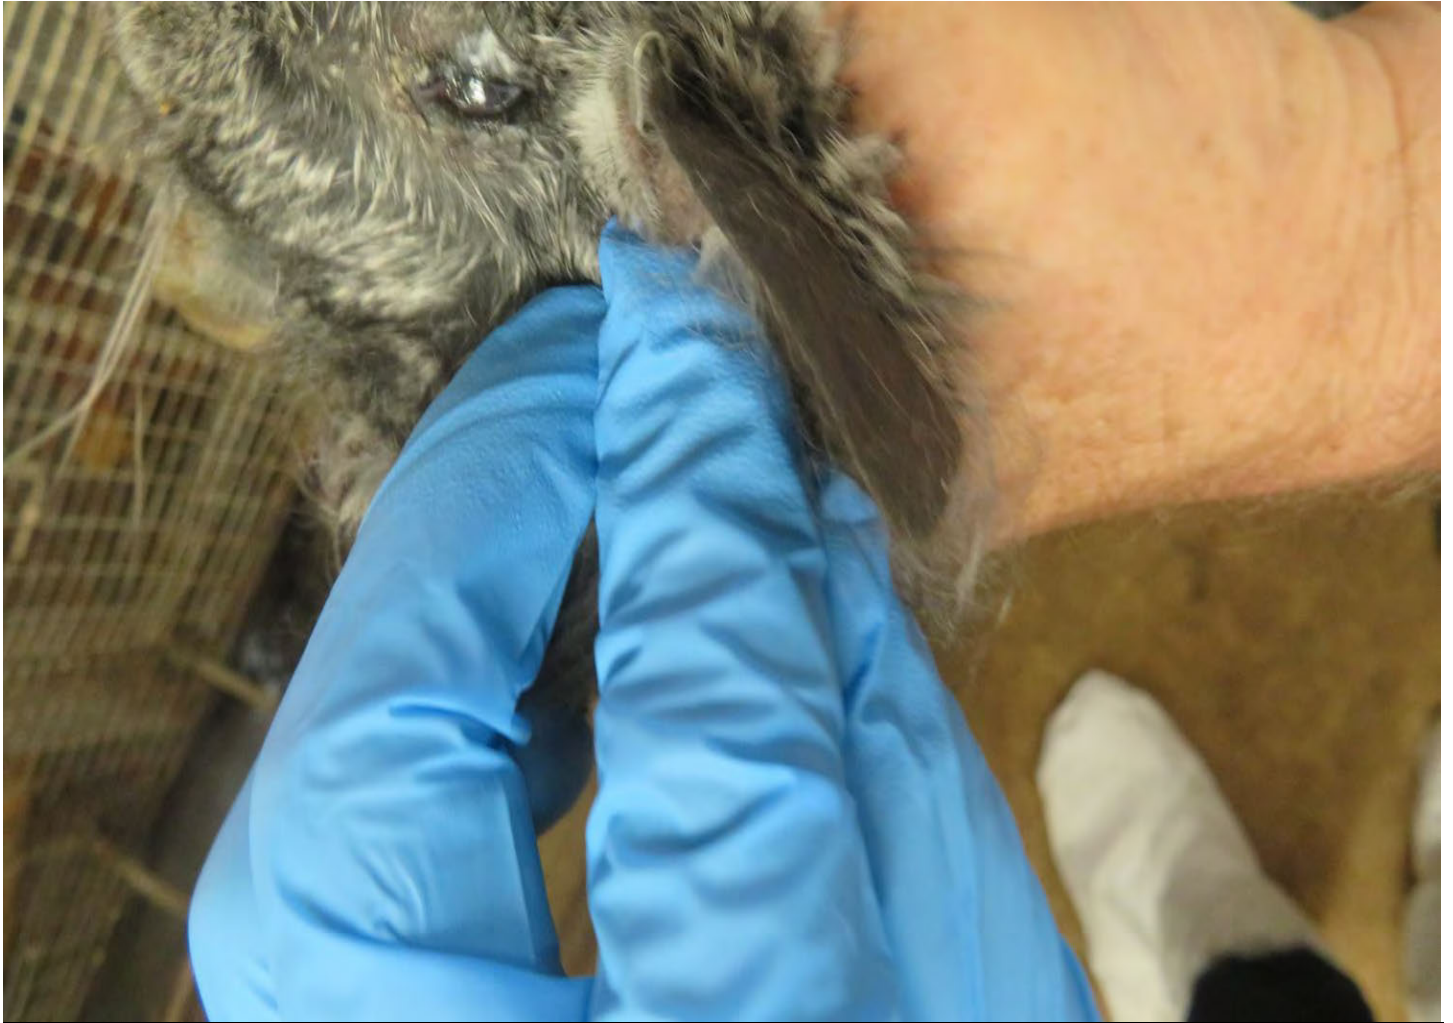
Female with eartag 805's right eye; not on treatment prior to inspection; right eye was squinting while in cage; mild discharge and crusting seen.

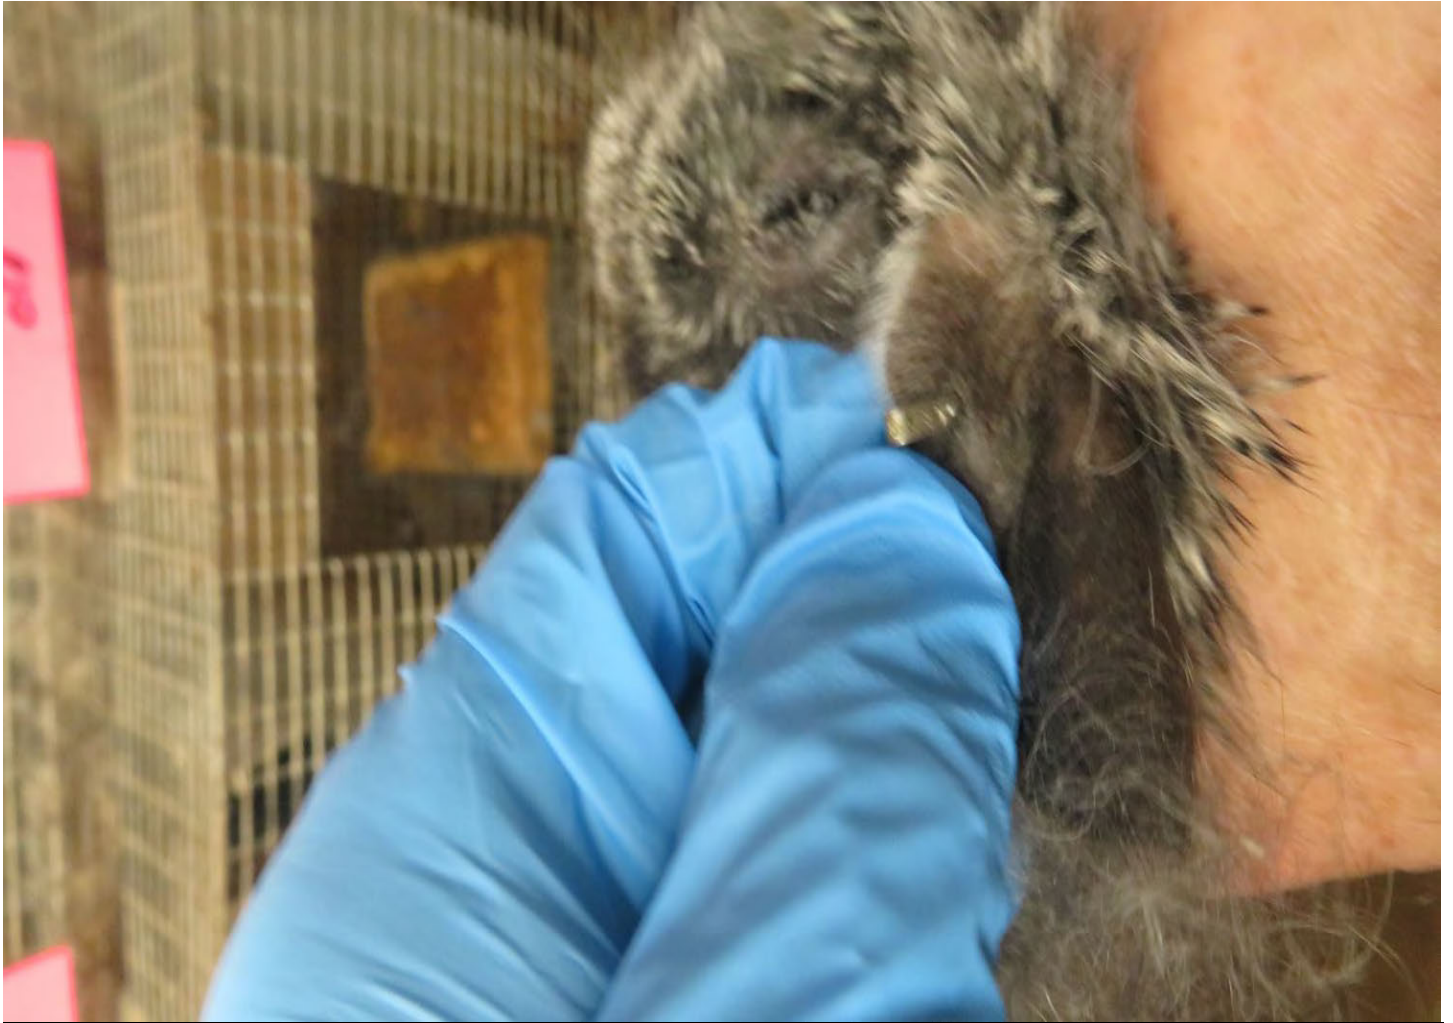
Female with eartag 805's right eye; not on treatment prior to inspection; right eye was squinting while in cage; mild discharge and crusting seen.

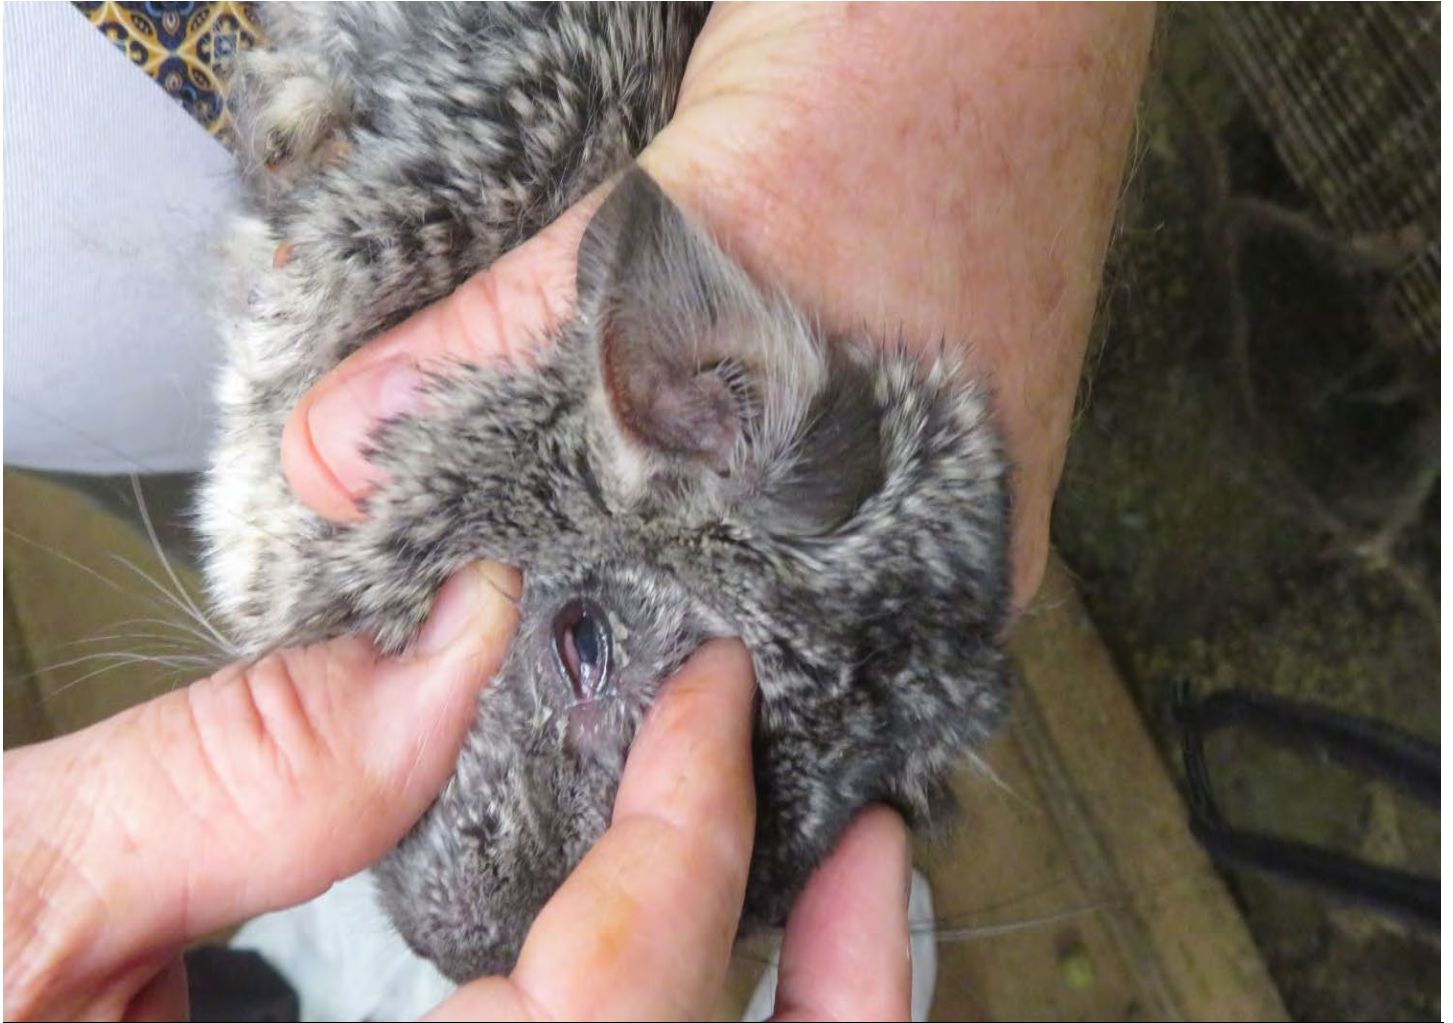
Male housed in 59; his right eye had some crusting and discharge. Wasn't on treatment prior to inspection.

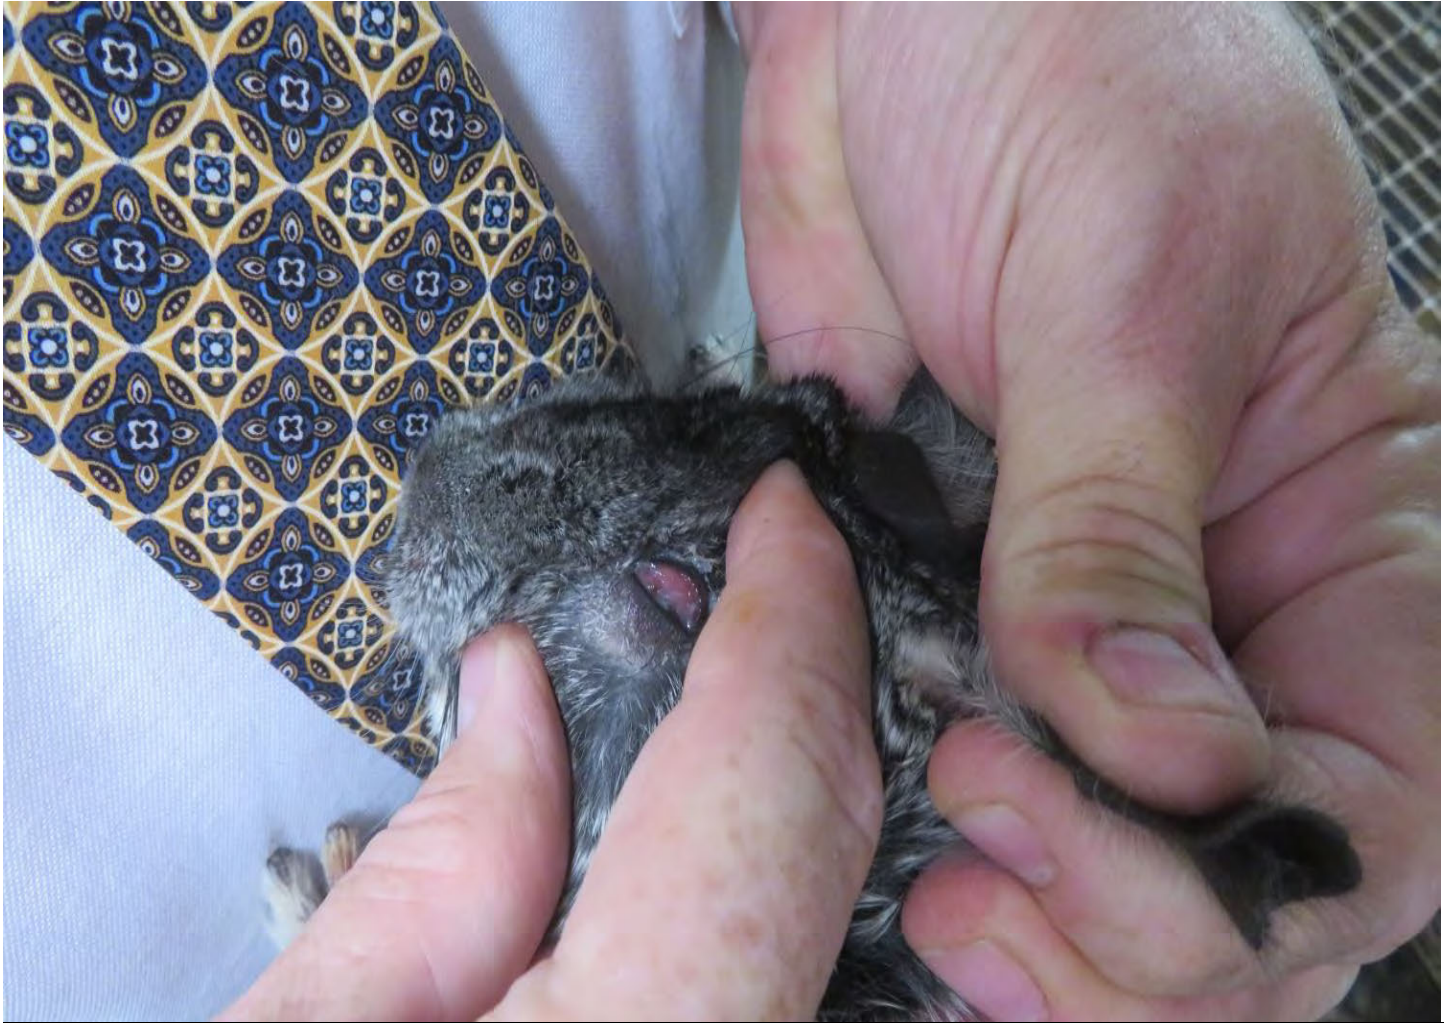
Male housed in 59; his left eye had some crusting and discharge. Wasn't on treatment prior to inspection.

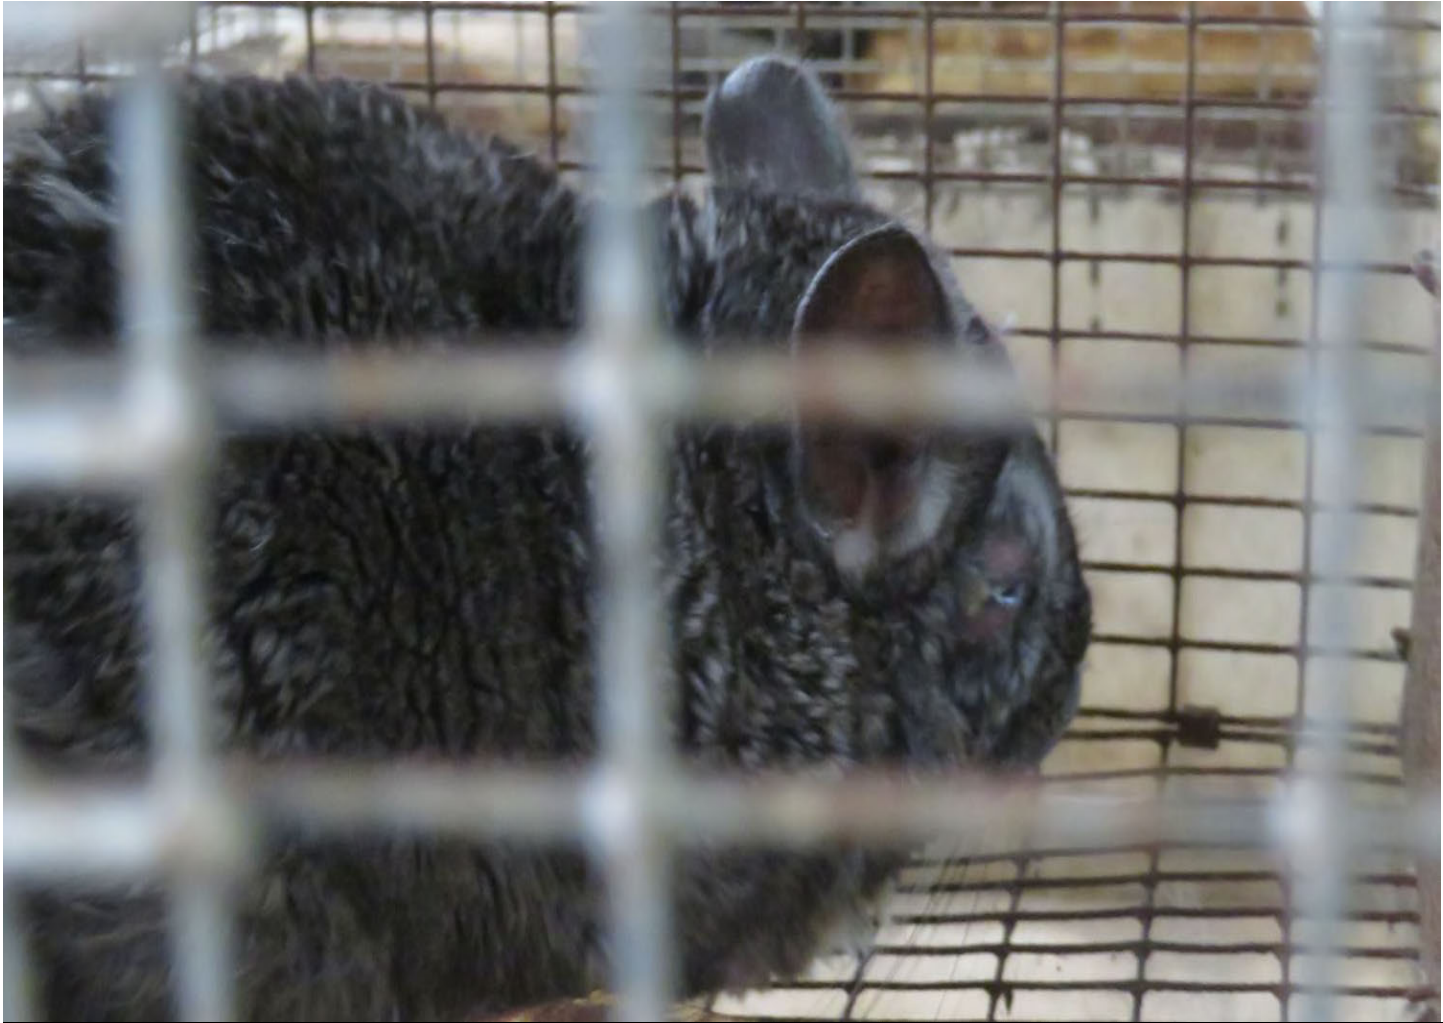
Cageside observation of right eye on chinchilla in 39B that wasn't on treatment yet;  
squinting, discharge and crusting present.

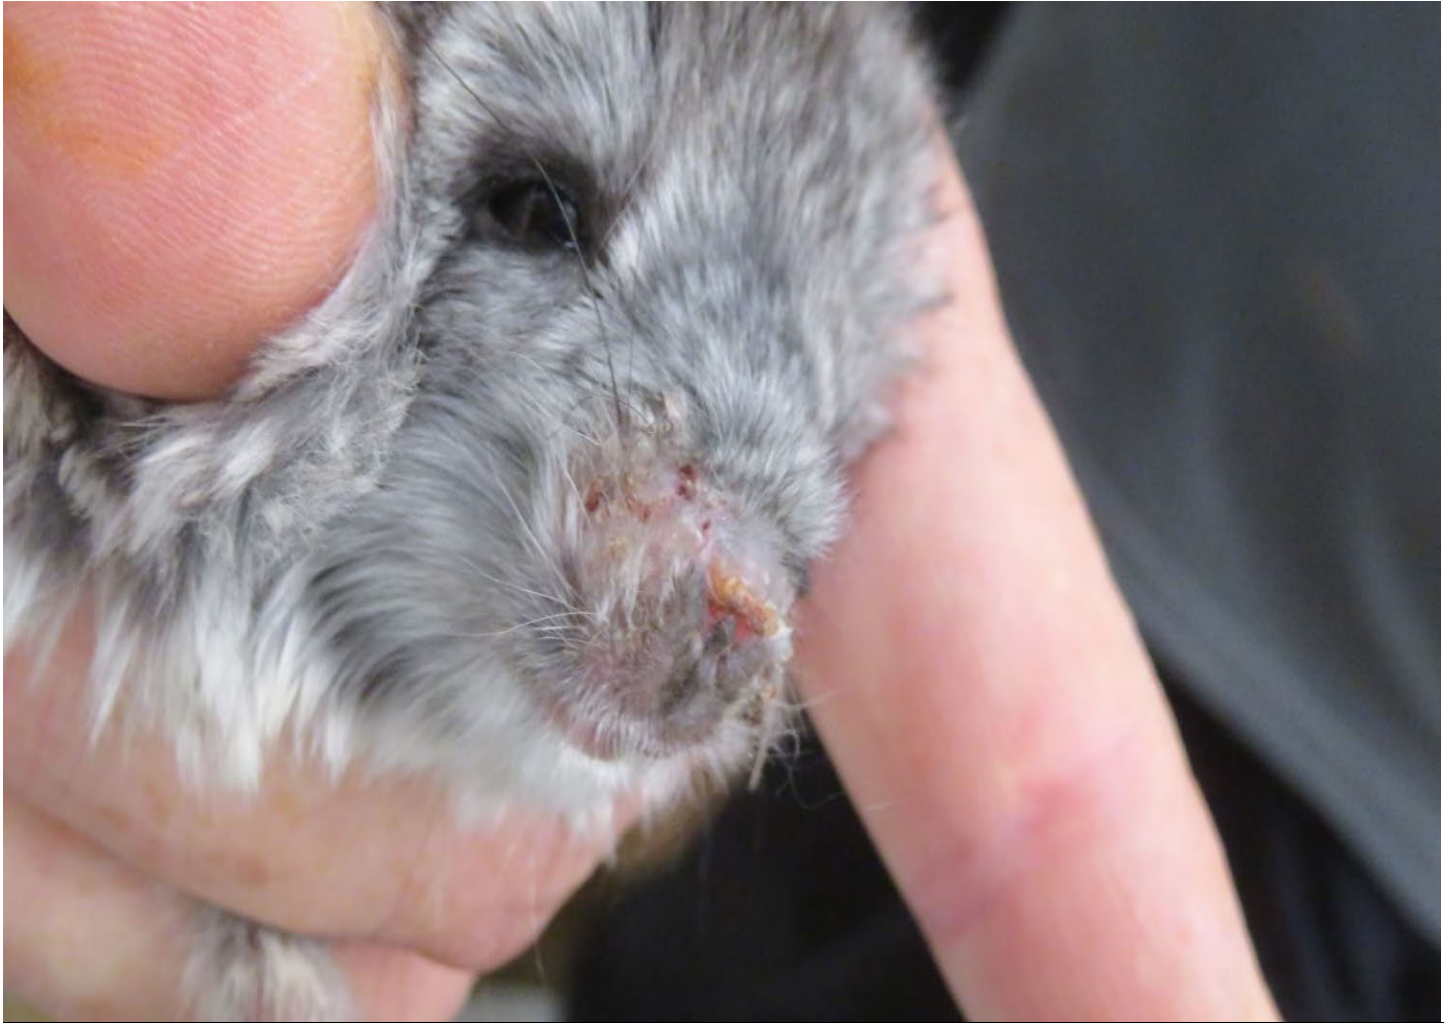
Nose on juvenile (smaller one of triplets in 78B) that was had hair loss, crusting/scabs on nose; issue pointed out to licensee during inspection.

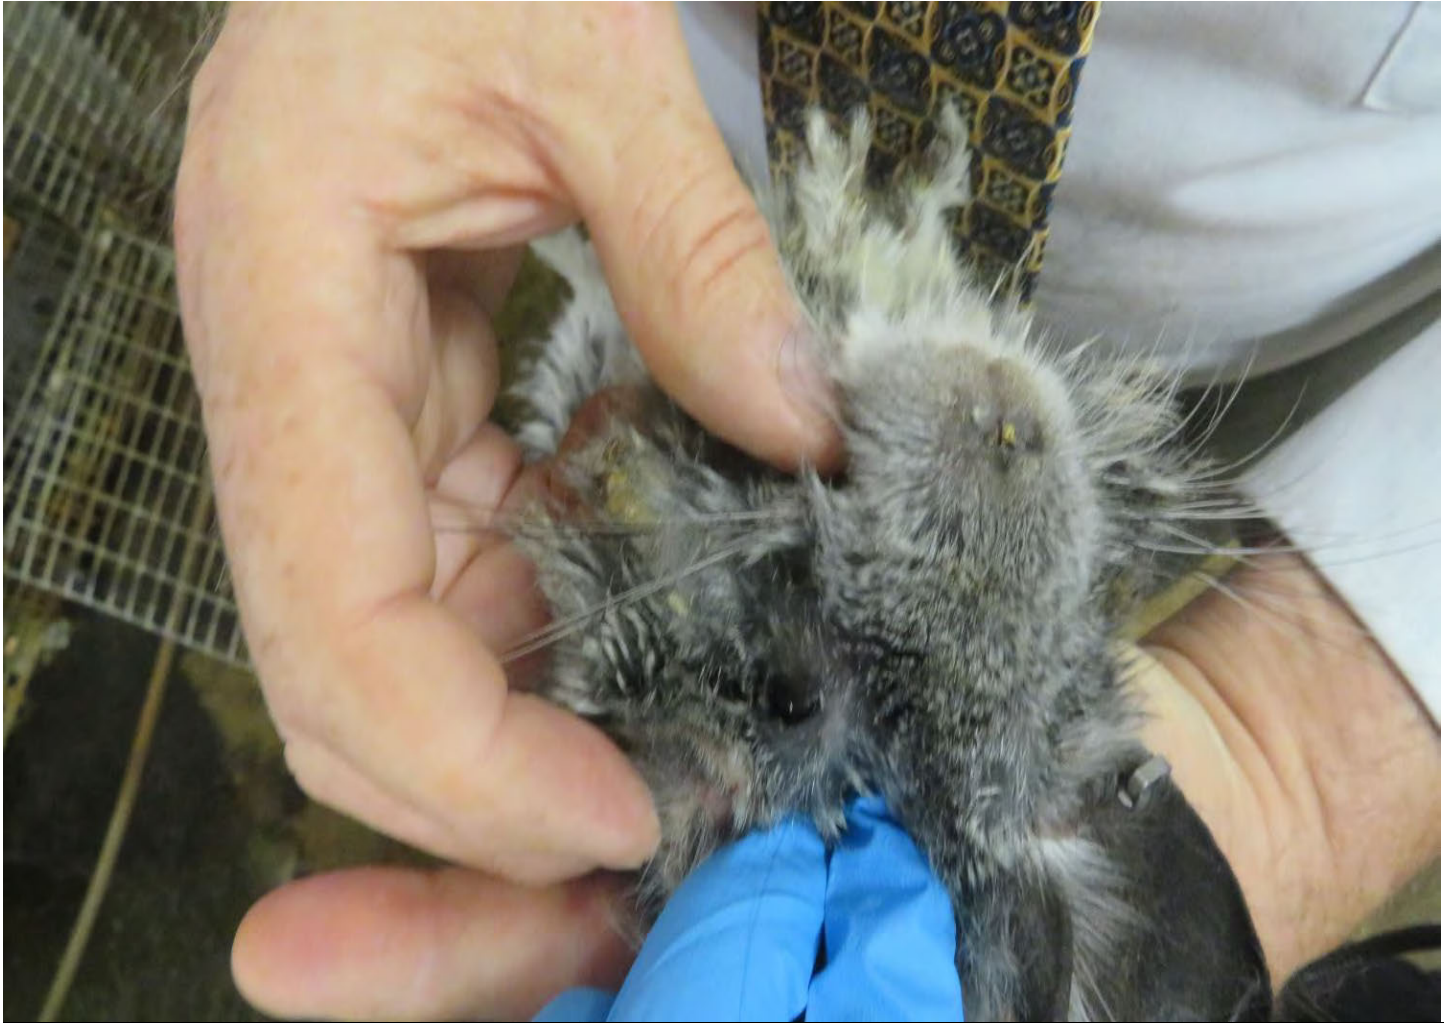
Female with ear tag 805's left eye; not on treatment prior to inspection; hair around left eye had some crusting around it.

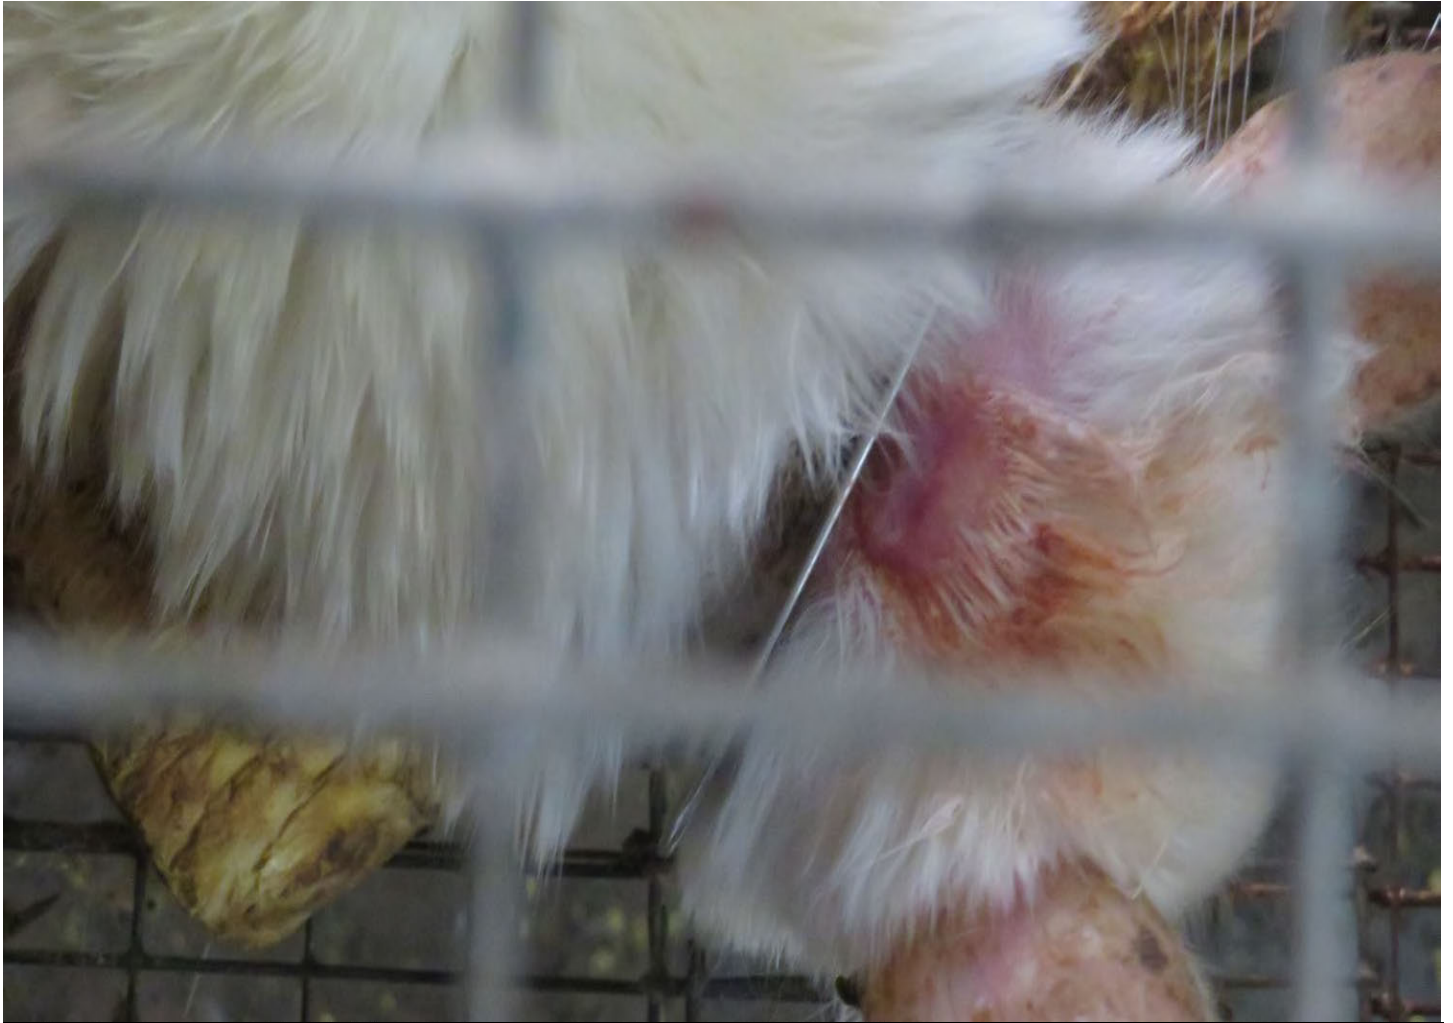
Female housed under tag 146A; close-up image during cageside observations prior to confirming the collar was embedded.

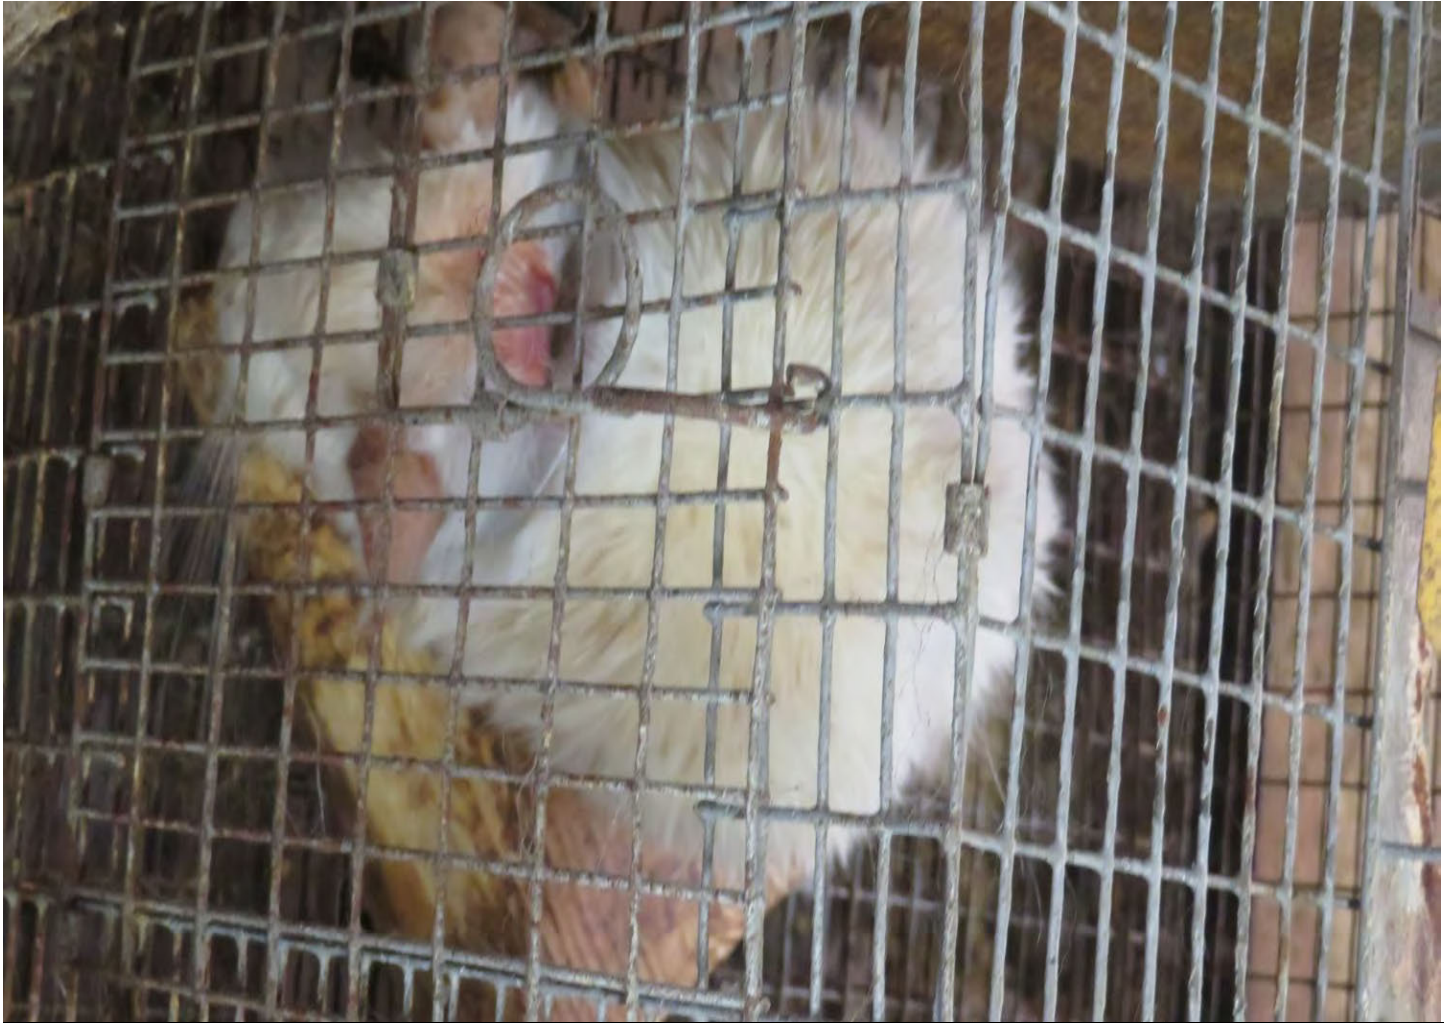
Female housed under tag 146A; cageside observation prior to confirming that the collar was embedded; reddened area on top of neck is visible.

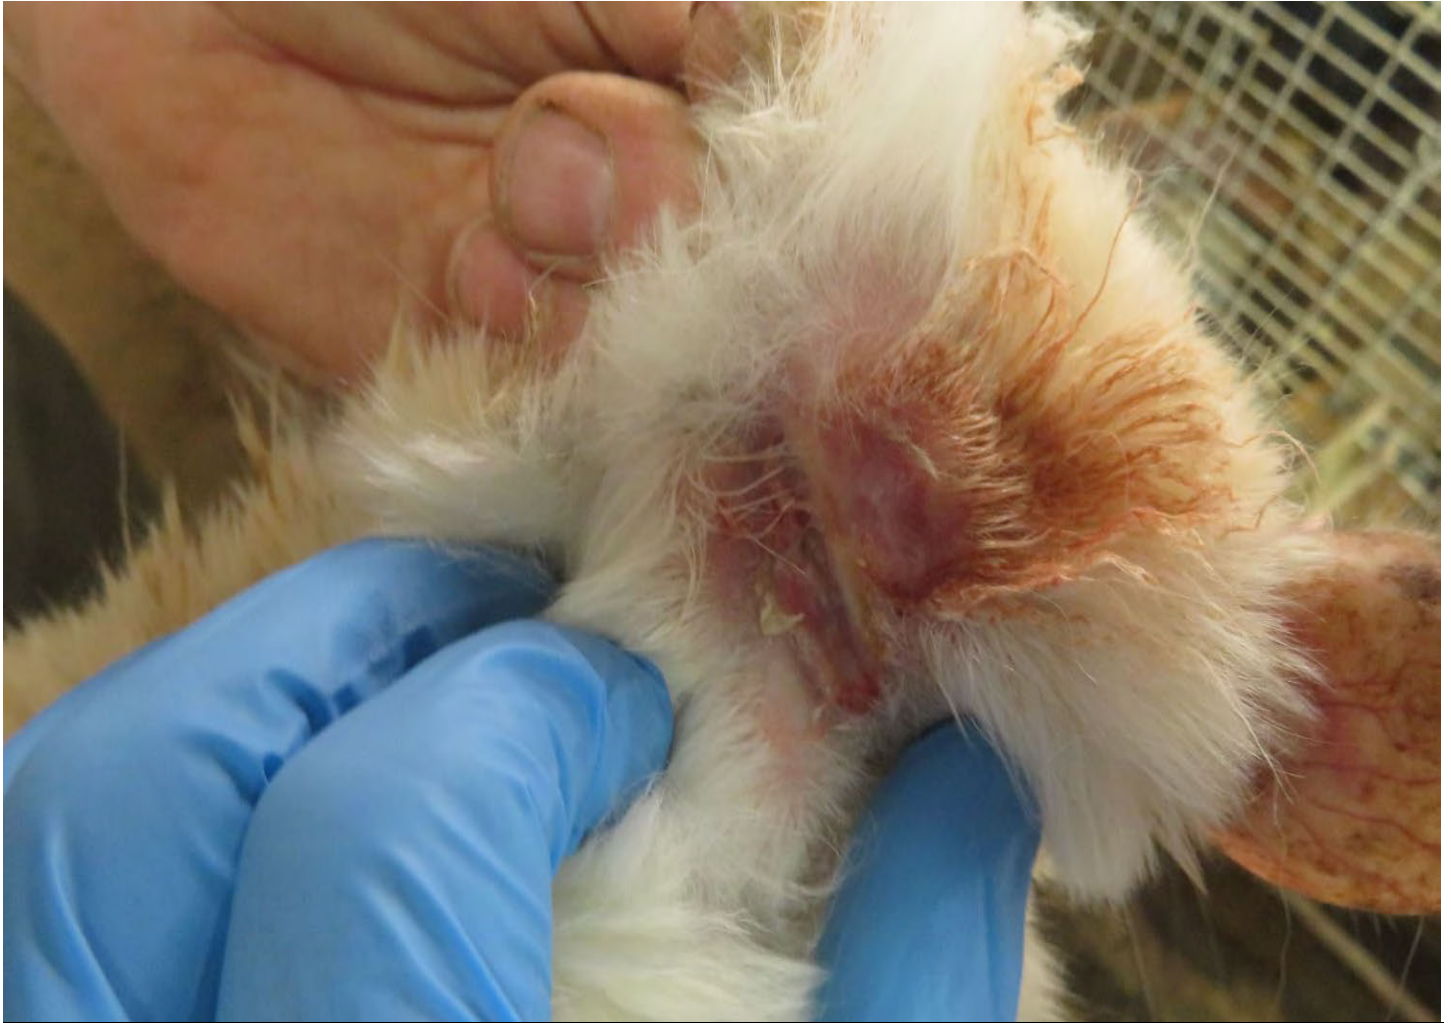
Top of neck of female housed under tag 146A after embedded collar was removed, eroded skin, discharge visible.

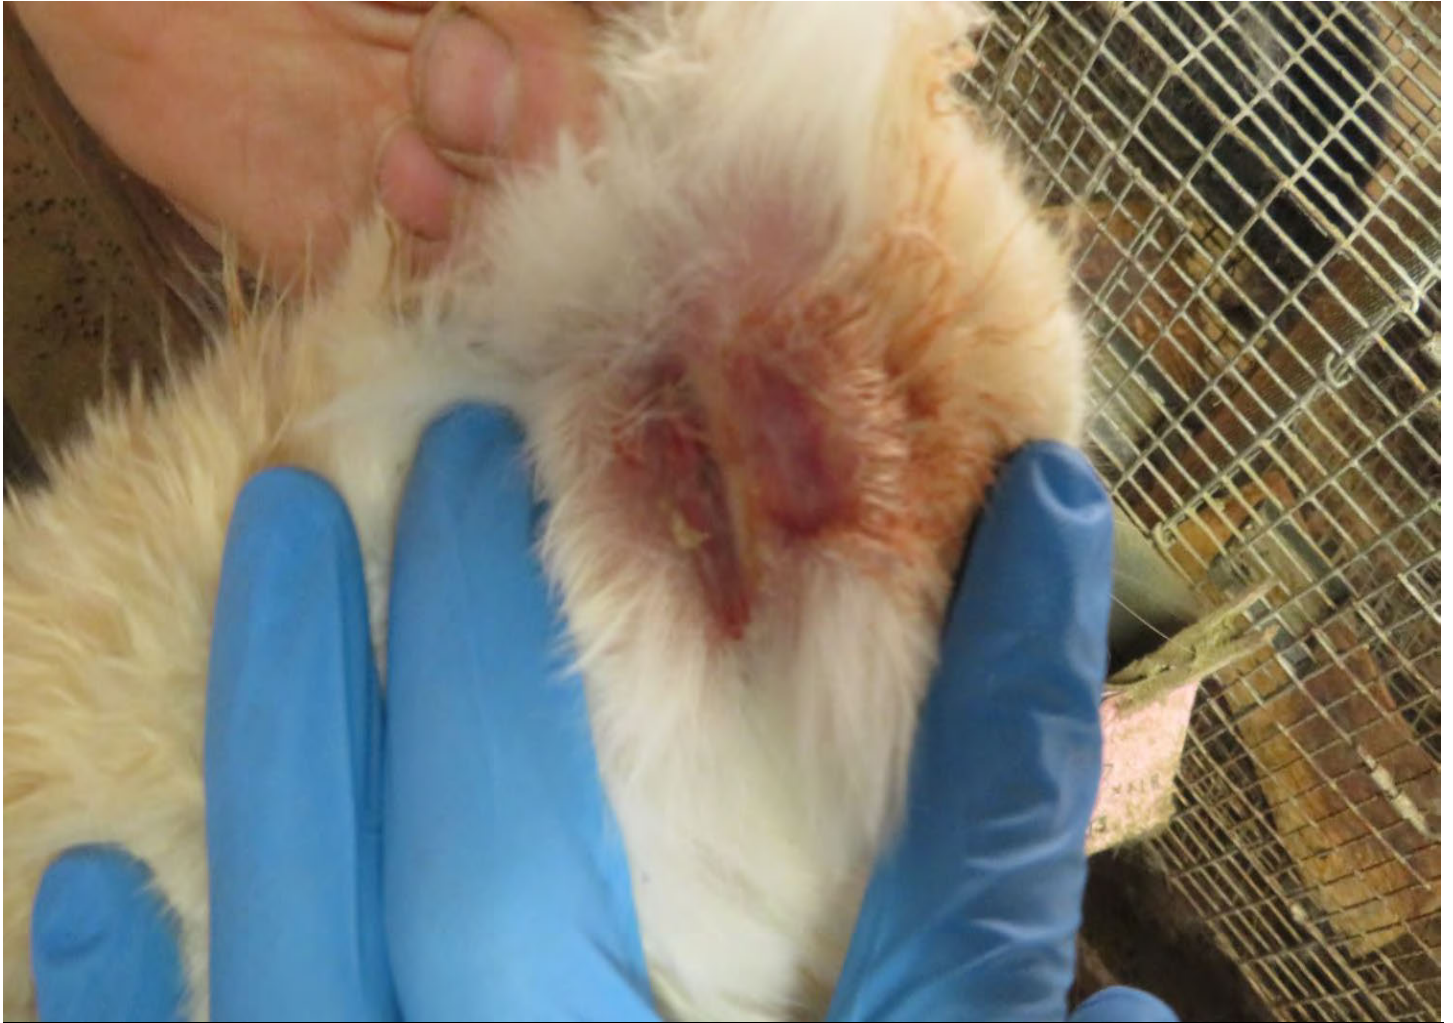
Top of neck of female housed under tag 146A after embedded collar was removed, eroded skin, discharge visible.
