**Inspection No:** 2016082569612273

**Certificate:** 41-B-0239

**DAN MOULTON**

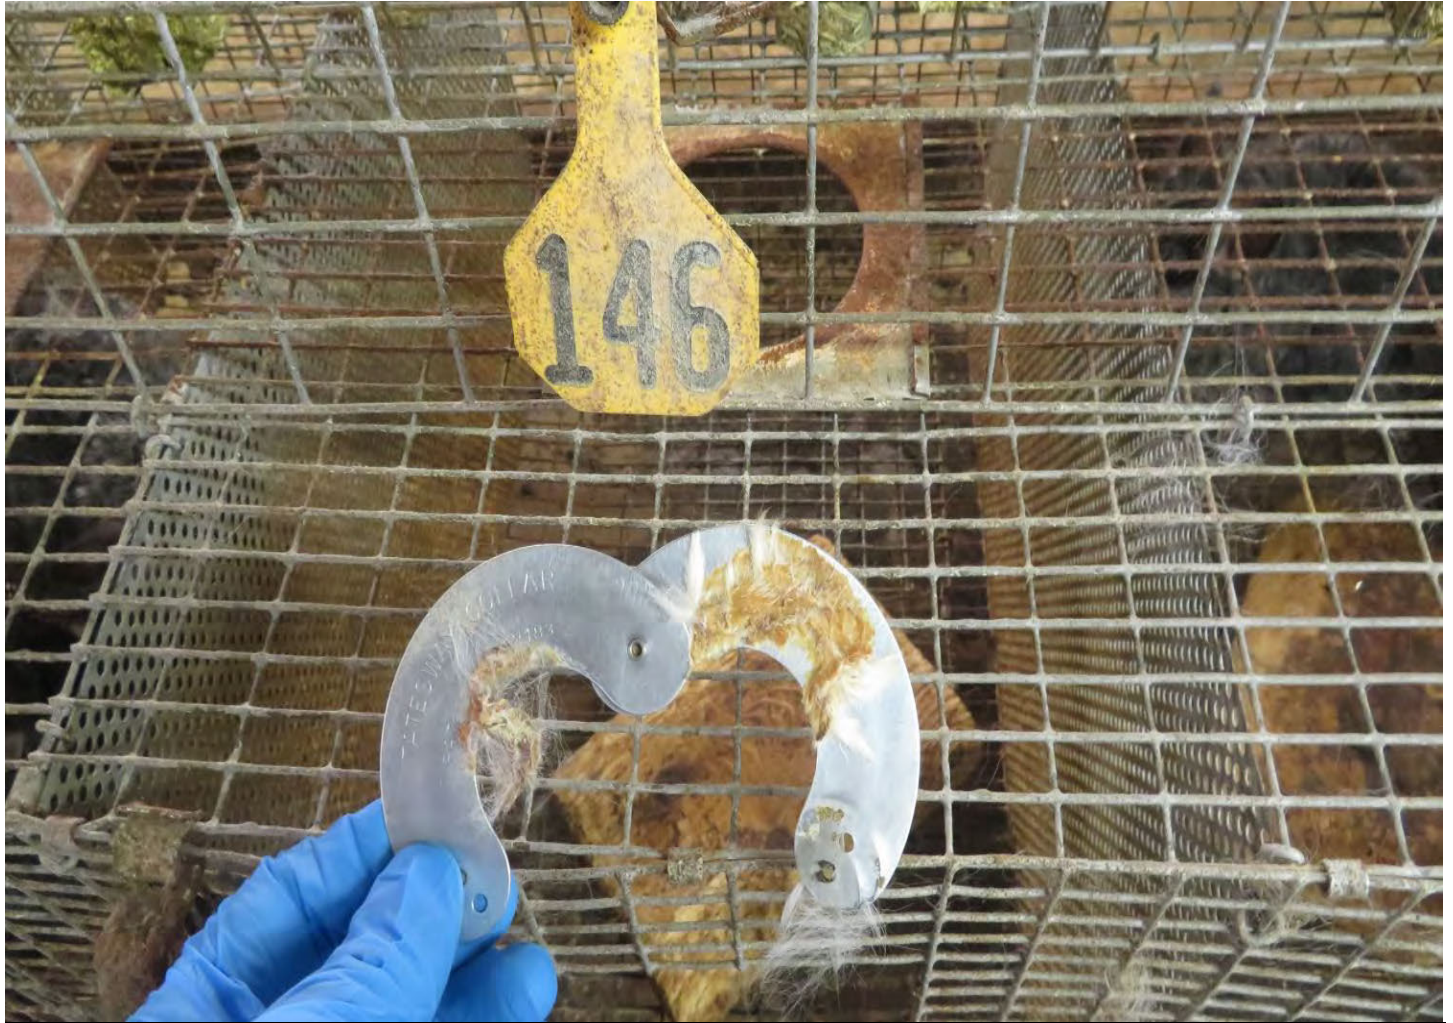
Embedded collar that was removed from female housed under tag 146A.

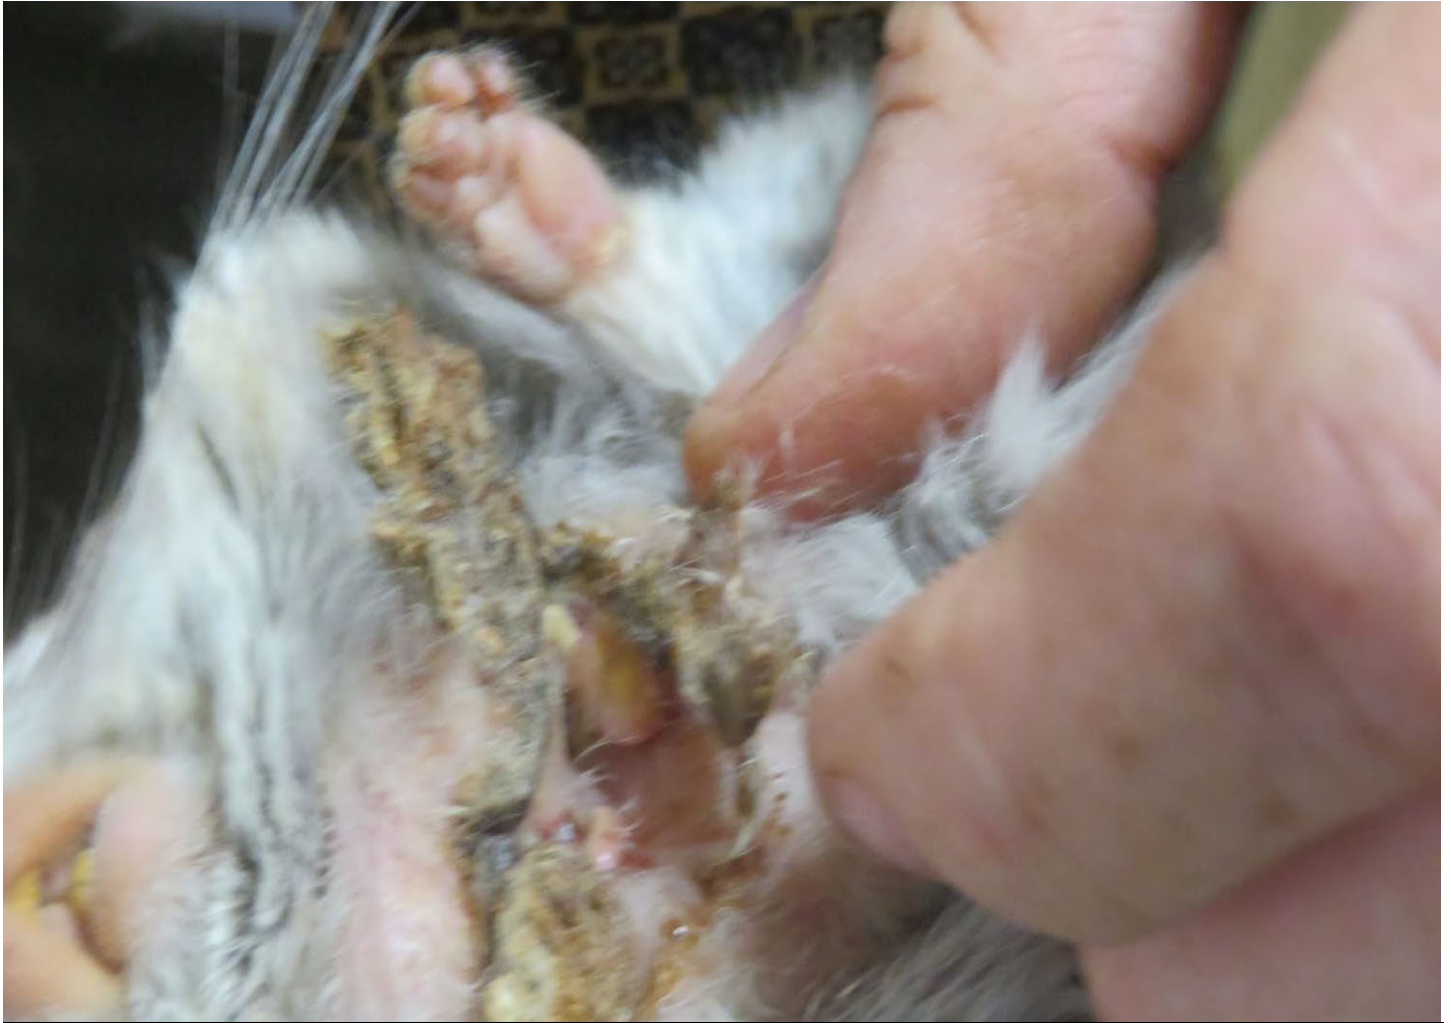
Area under neck on female chinchilla housed in 107A, right after embedded collar removed by licensee; matted hair and eroded skin visible.

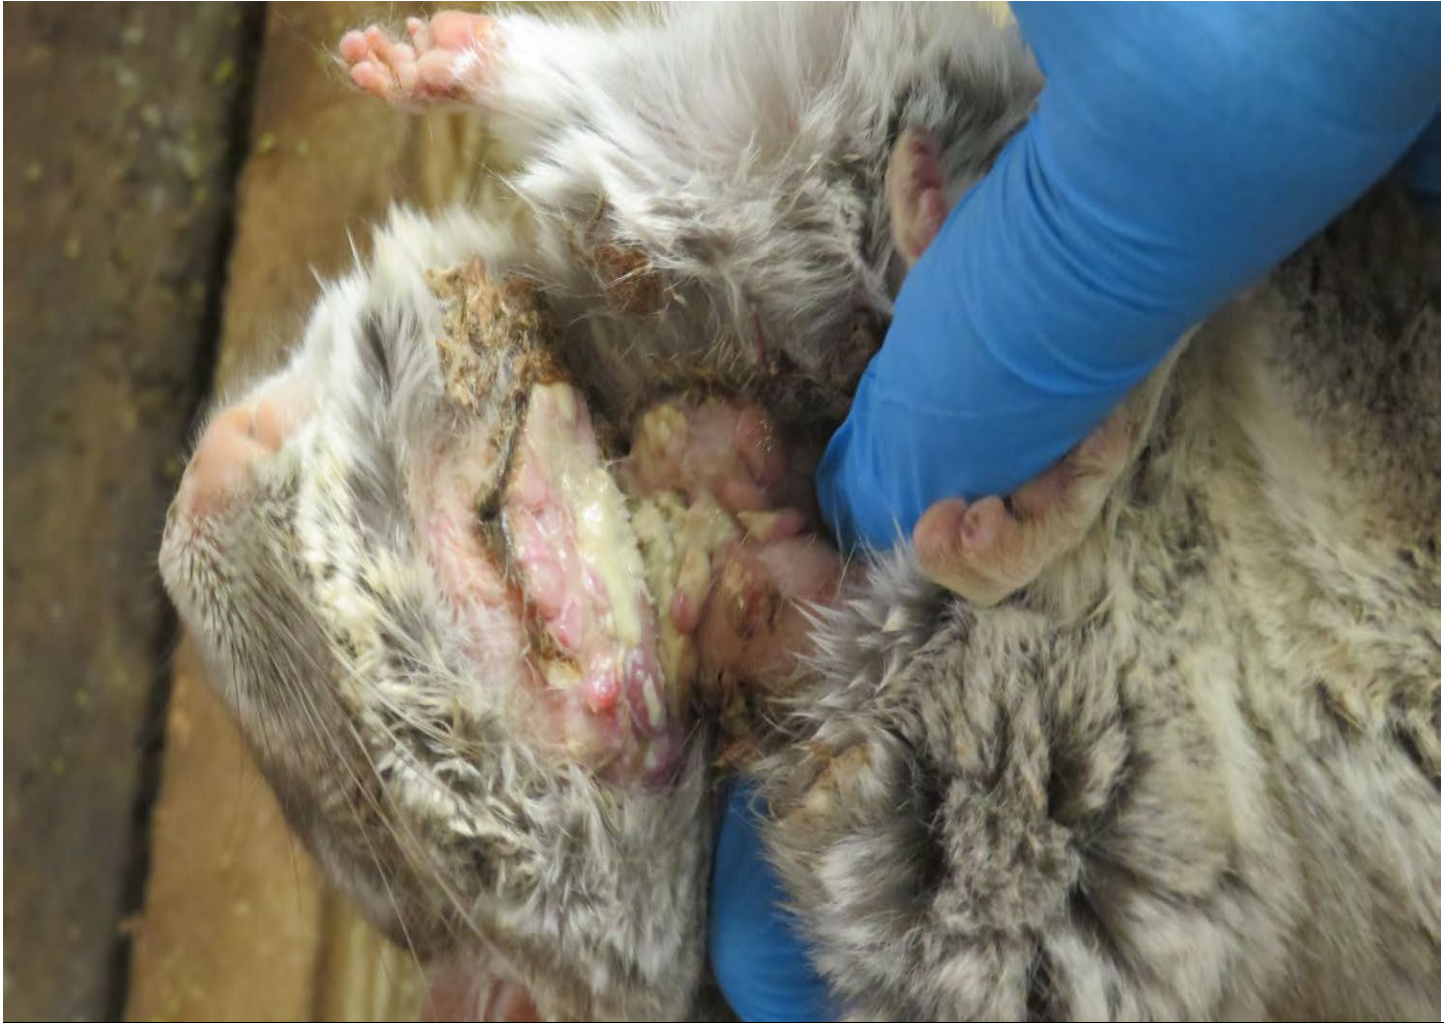
Area under neck on female chinchilla housed in 107A after embedded collar removed; matted hair, eroded skin, pale liquid and granular discharge visible with areas of reddened skin.

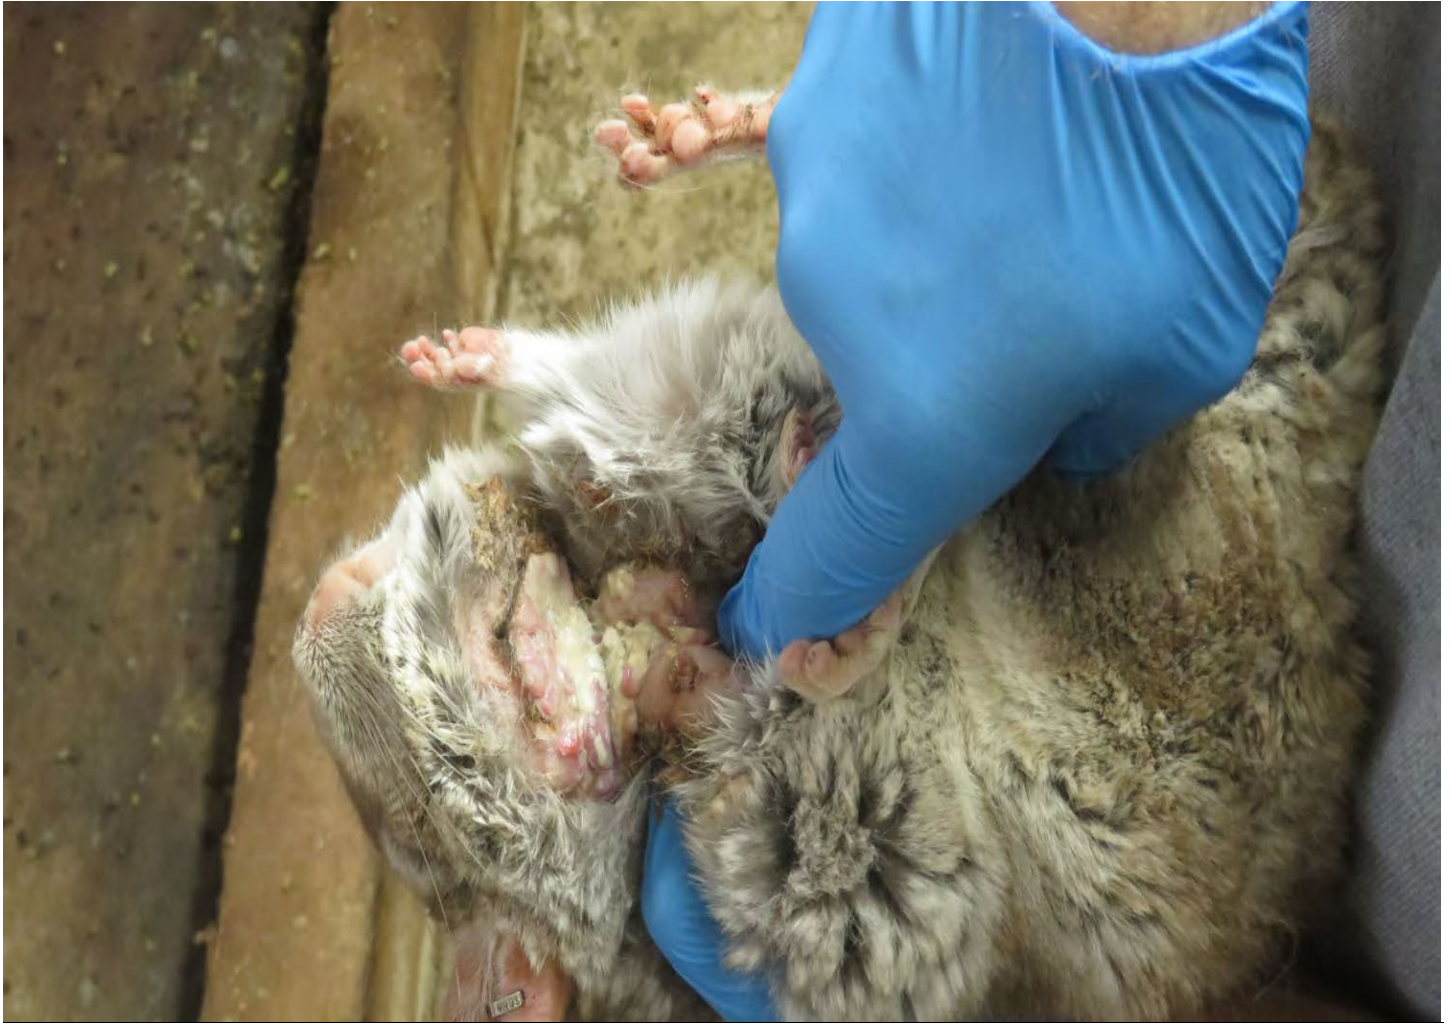
Area under neck on female chinchilla housed in 107A after embedded collar removed; matted hair, eroded skin, pale liquid and granular discharge visible with areas of reddened skin.

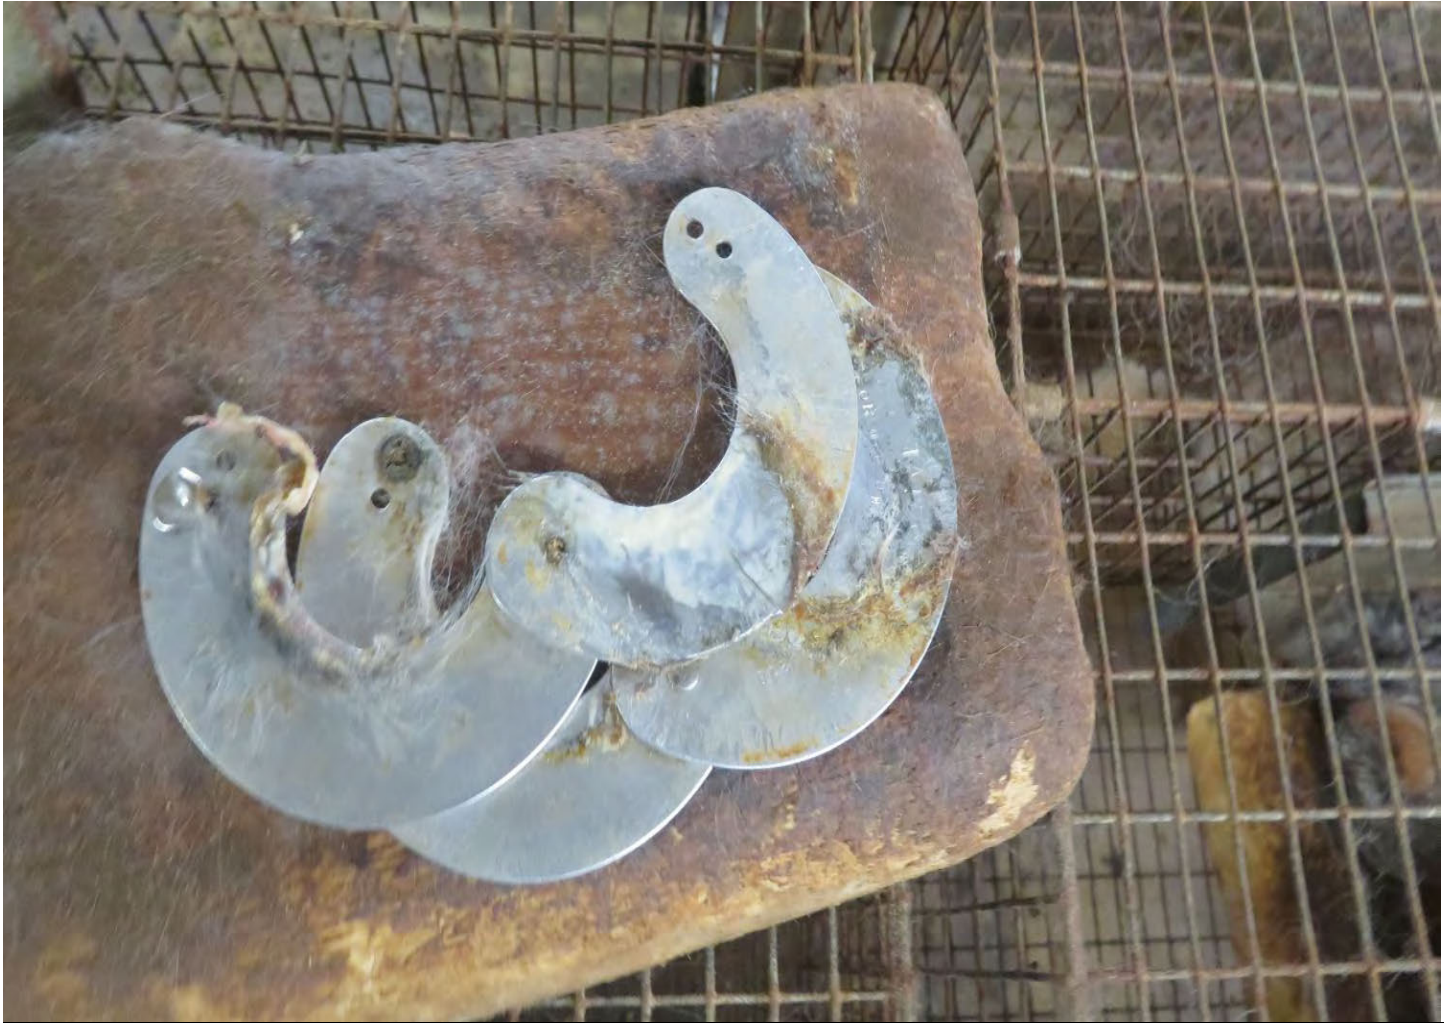
Collars removed from female chinchillas in 107A and 106C.

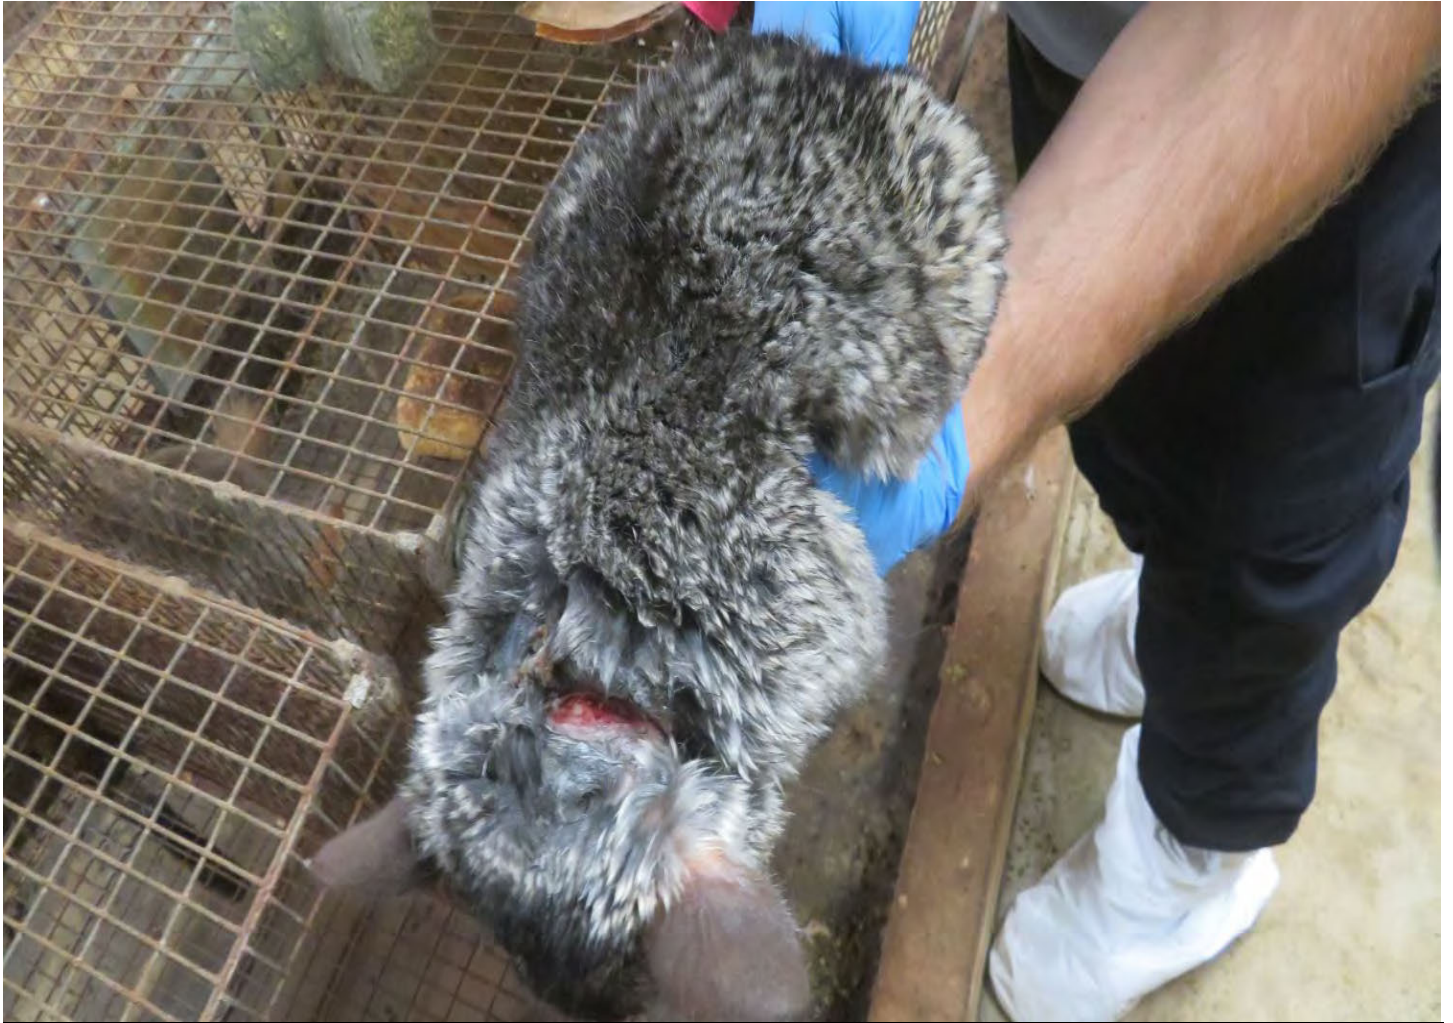
Female chinchilla housed in 106C after embedded collar removed; top of neck has eroded skin, matted hair, discharge and reddened areas.

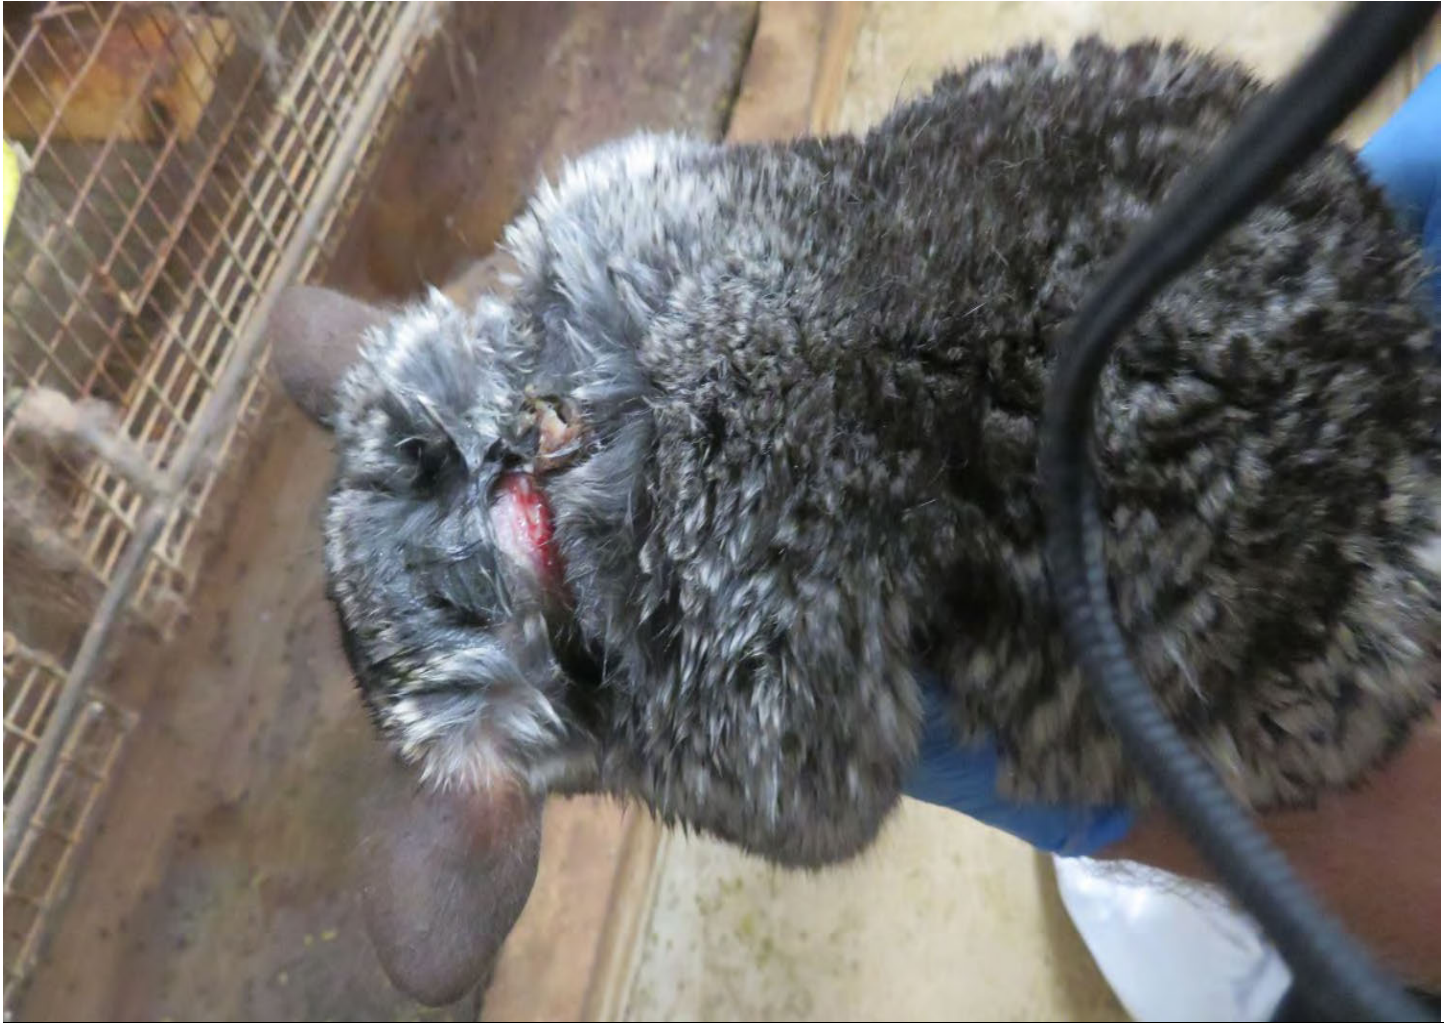
Female chinchilla housed in 106C after embedded collar removed; top of neck has eroded skin, matted hair, discharge and reddened areas.

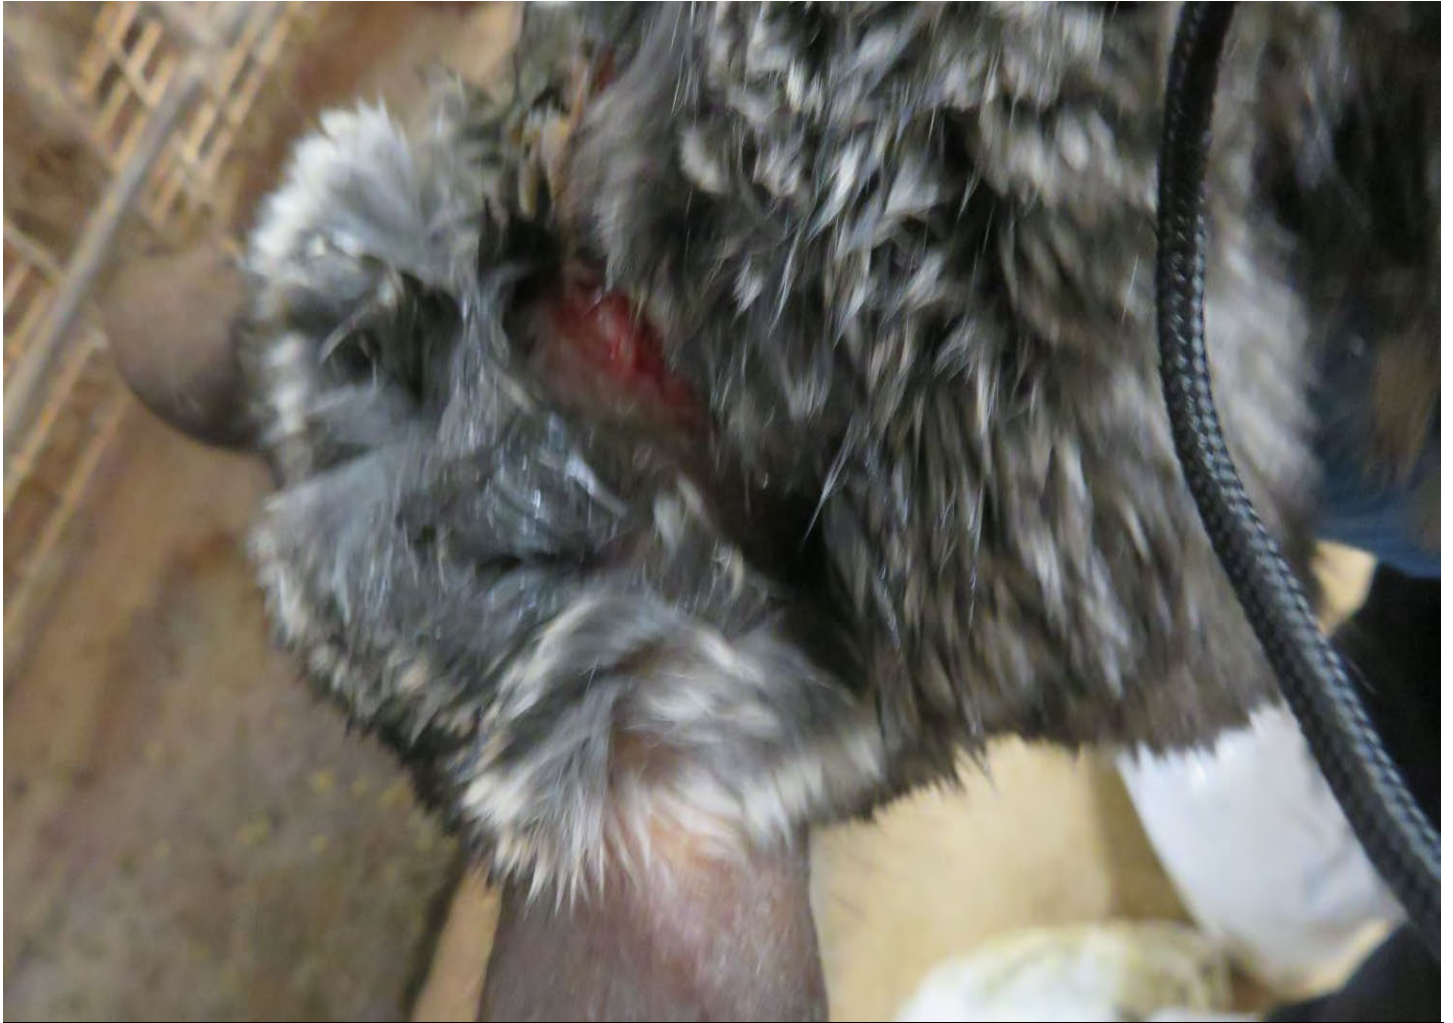
Female chinchilla housed in 106C after embedded collar removed; top of neck has eroded skin, matted hair, discharge and reddened areas.

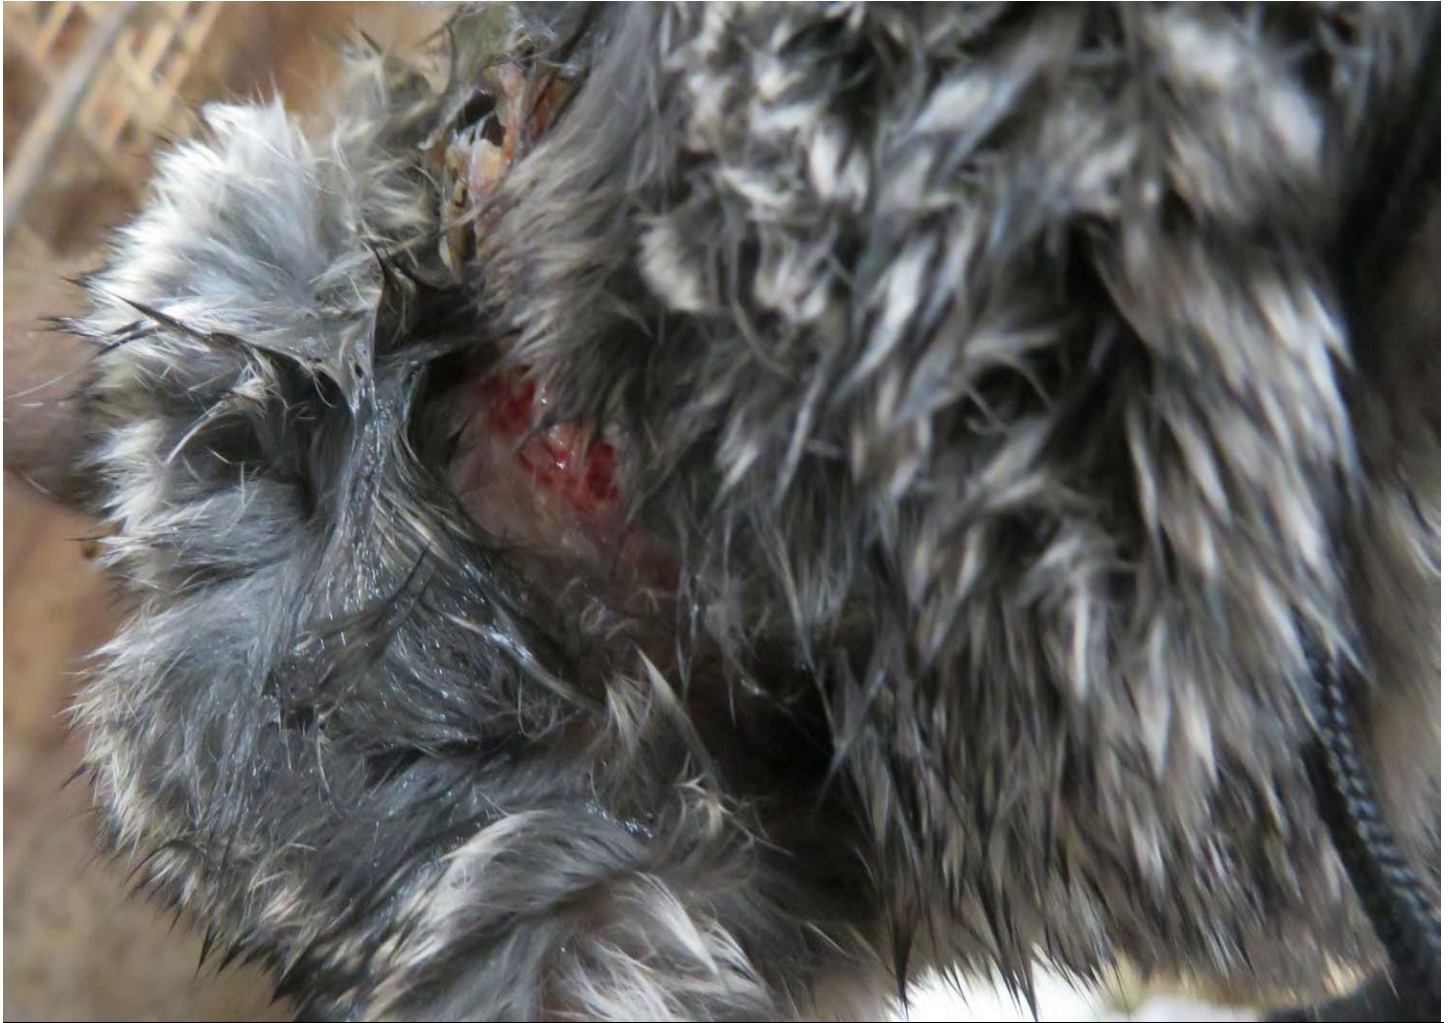
Female chinchilla housed in 106C after embedded collar removed; top of neck has eroded skin, matted hair, discharge and reddened areas.

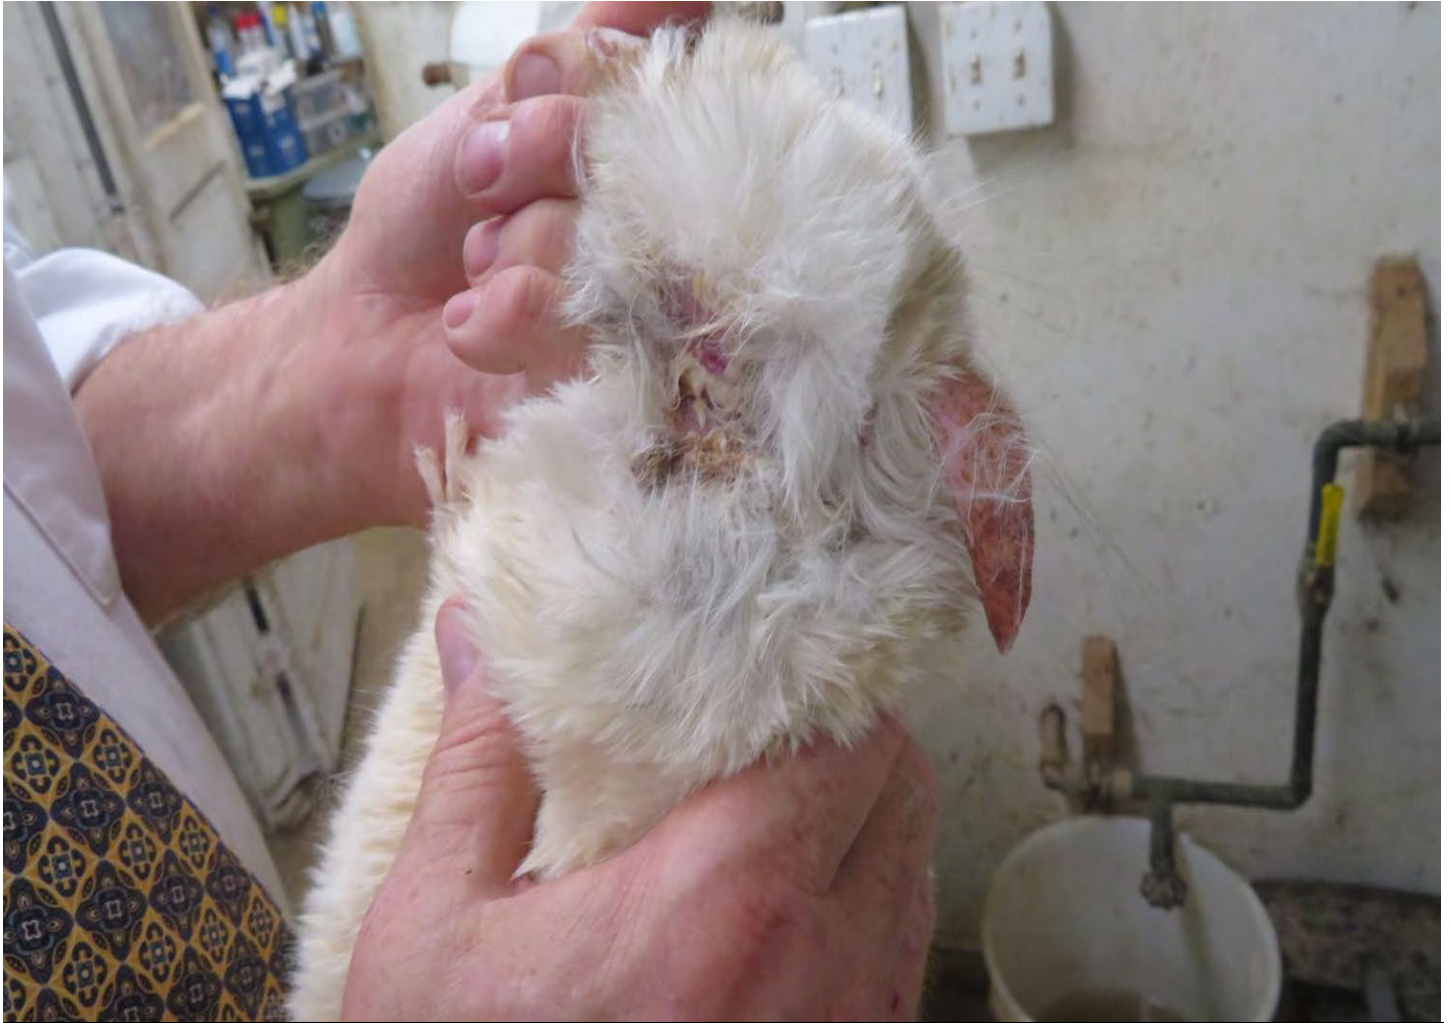
Top of neck of female chinchilla housed in 119A after collar was removed; area has matted hair, eroded skin, reddened skin and liquid/granular pale discharge.

VMO could note a putrid odor as well.

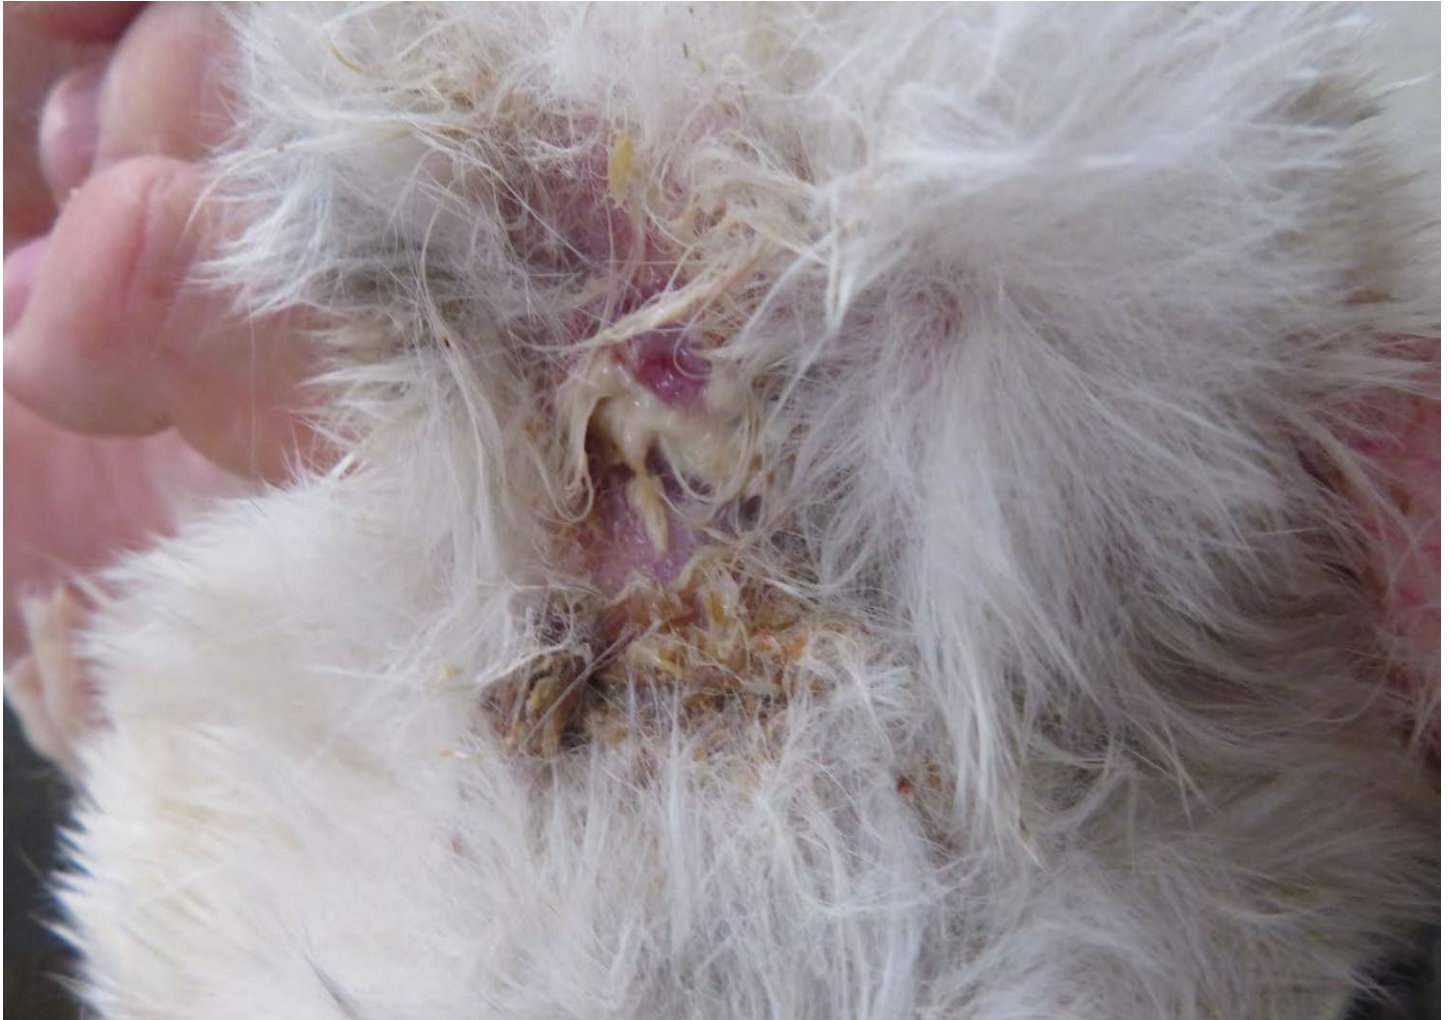
Top of neck of female chinchilla housed in 119A after collar was removed; area has matted hair, eroded skin, reddened skin and liquid/granular pale discharge.

VMO could note a putrid odor as well.

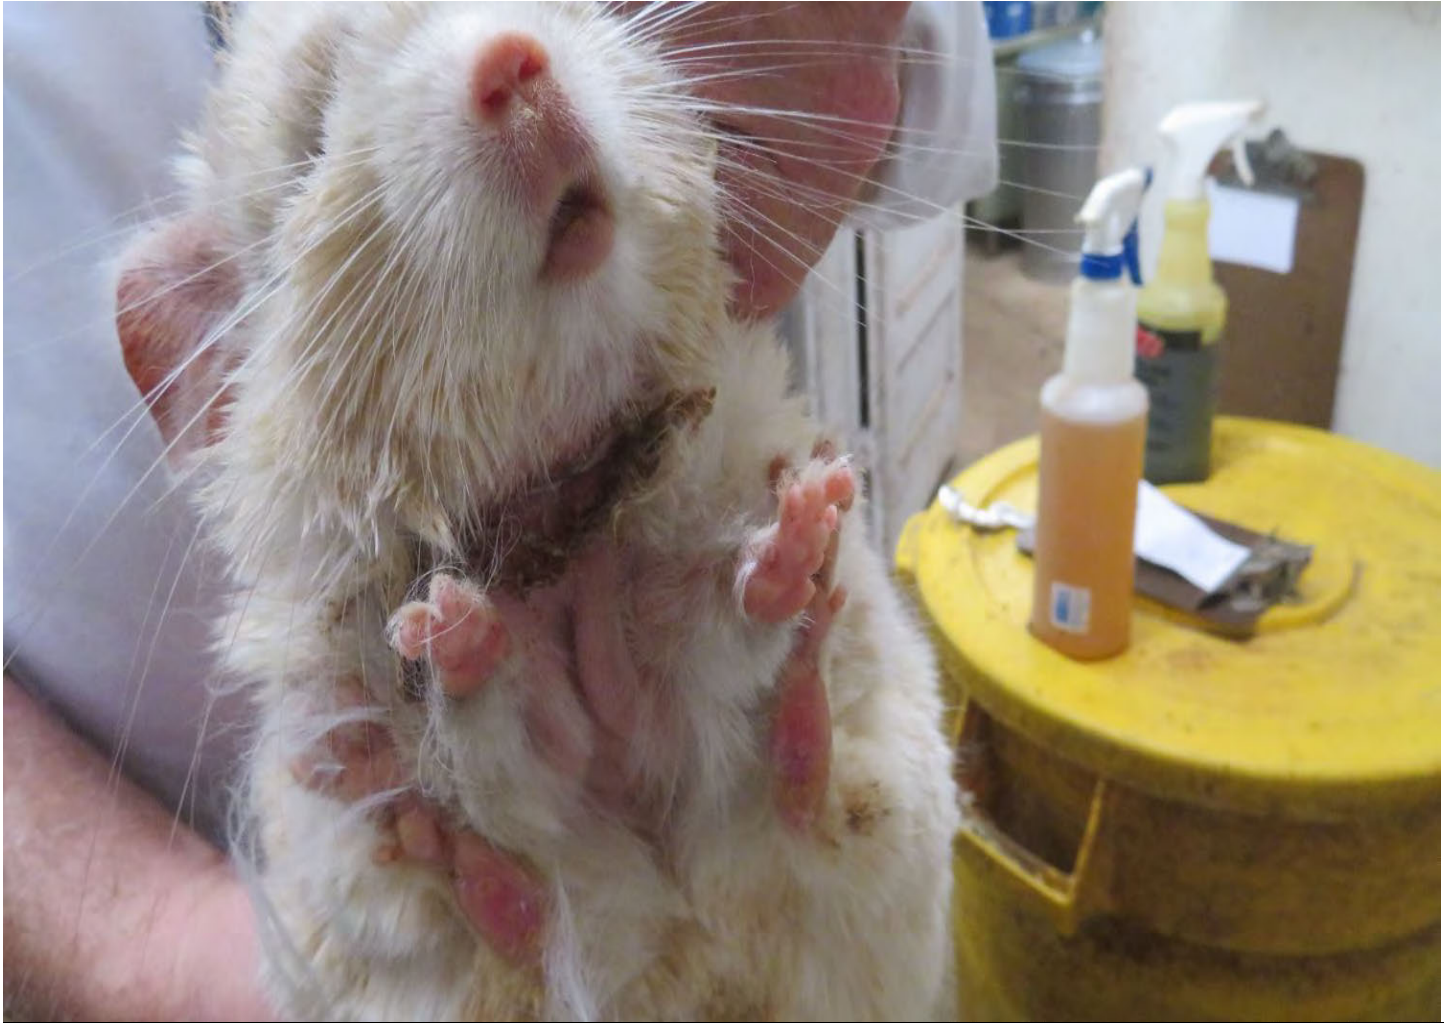
Bottom of neck of female chinchilla housed in 119A after collar was removed; matted hair, eroded skin seen. VMO could note a putrid odor as well.

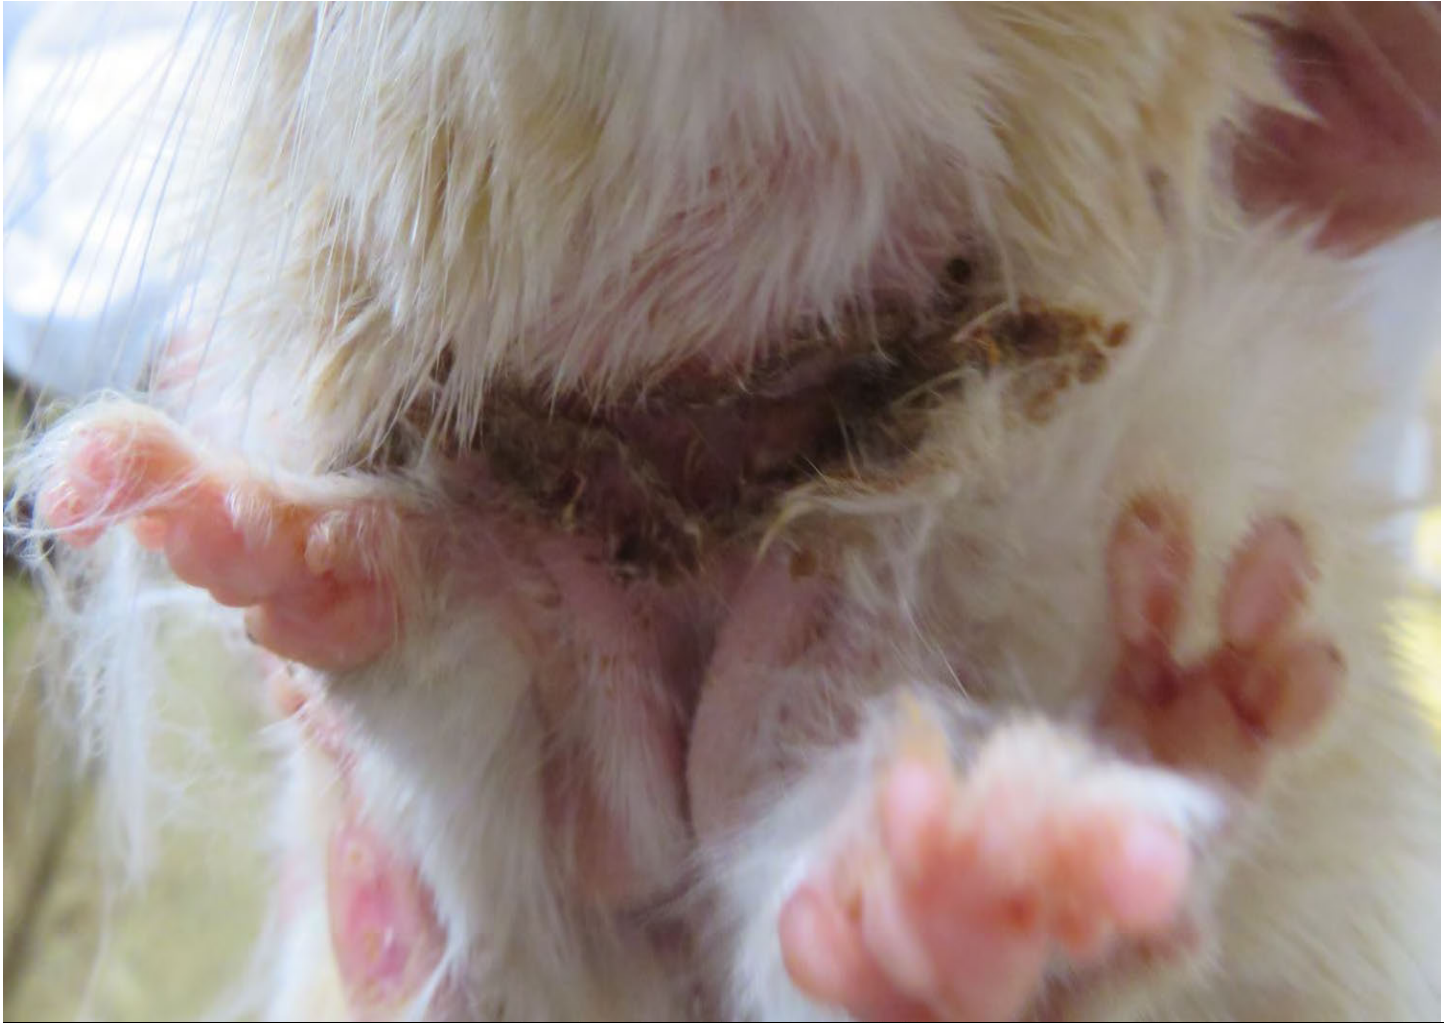
Bottom of neck of female chinchilla housed in 119A after collar was removed;  
matted hair, eroded skin seen. VMO could note a putrid odor as well.

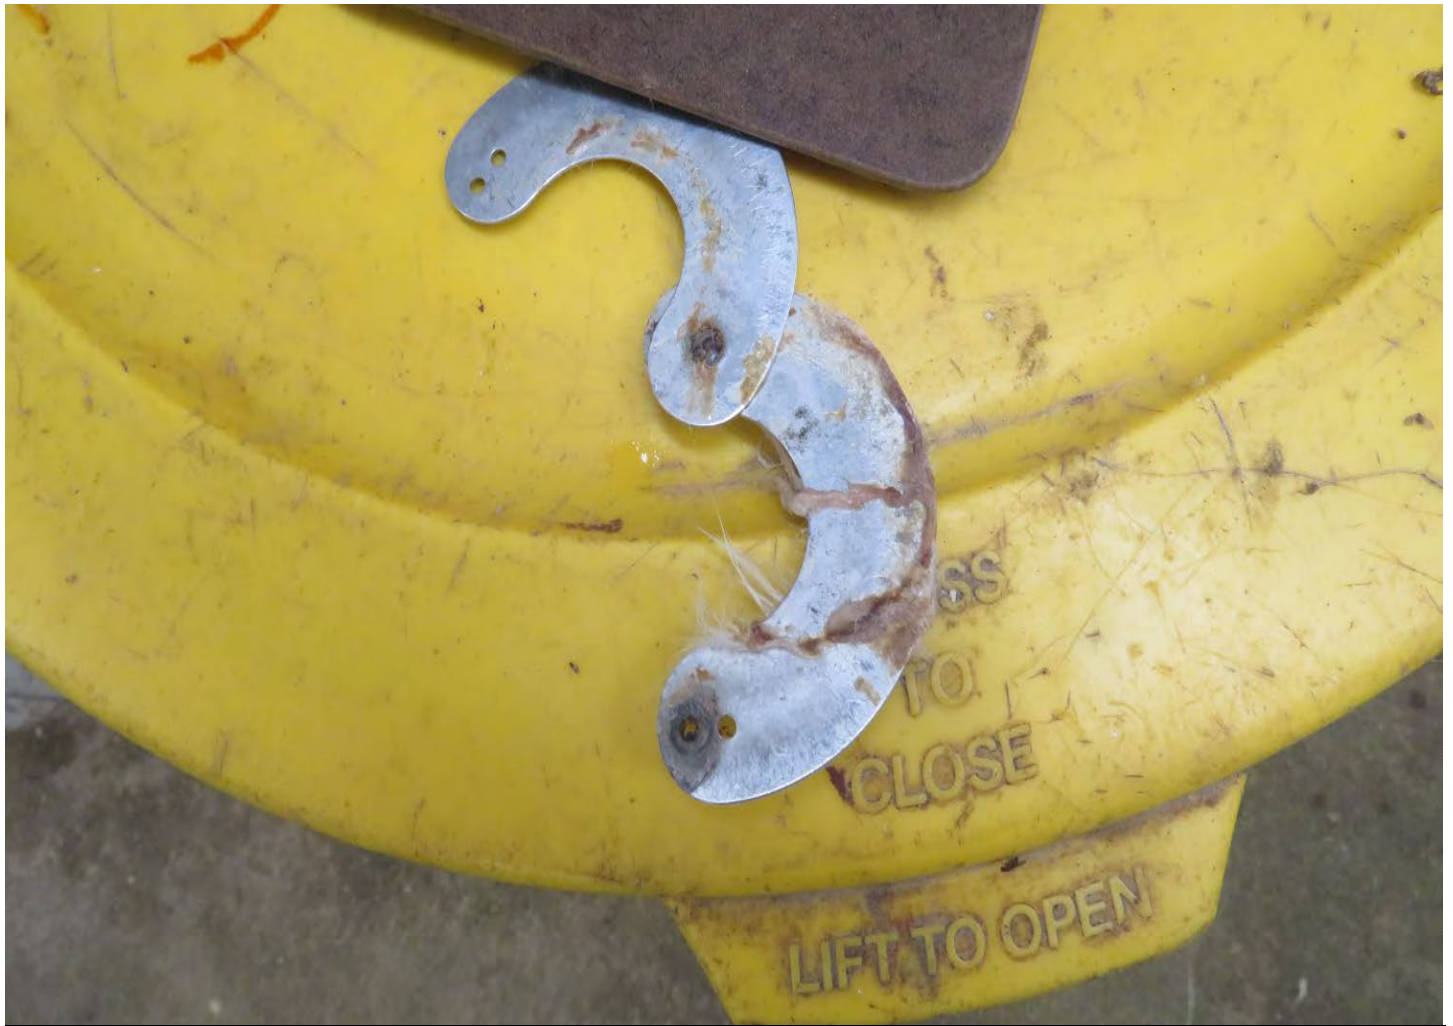
Collar that was on female housed in 119A.
