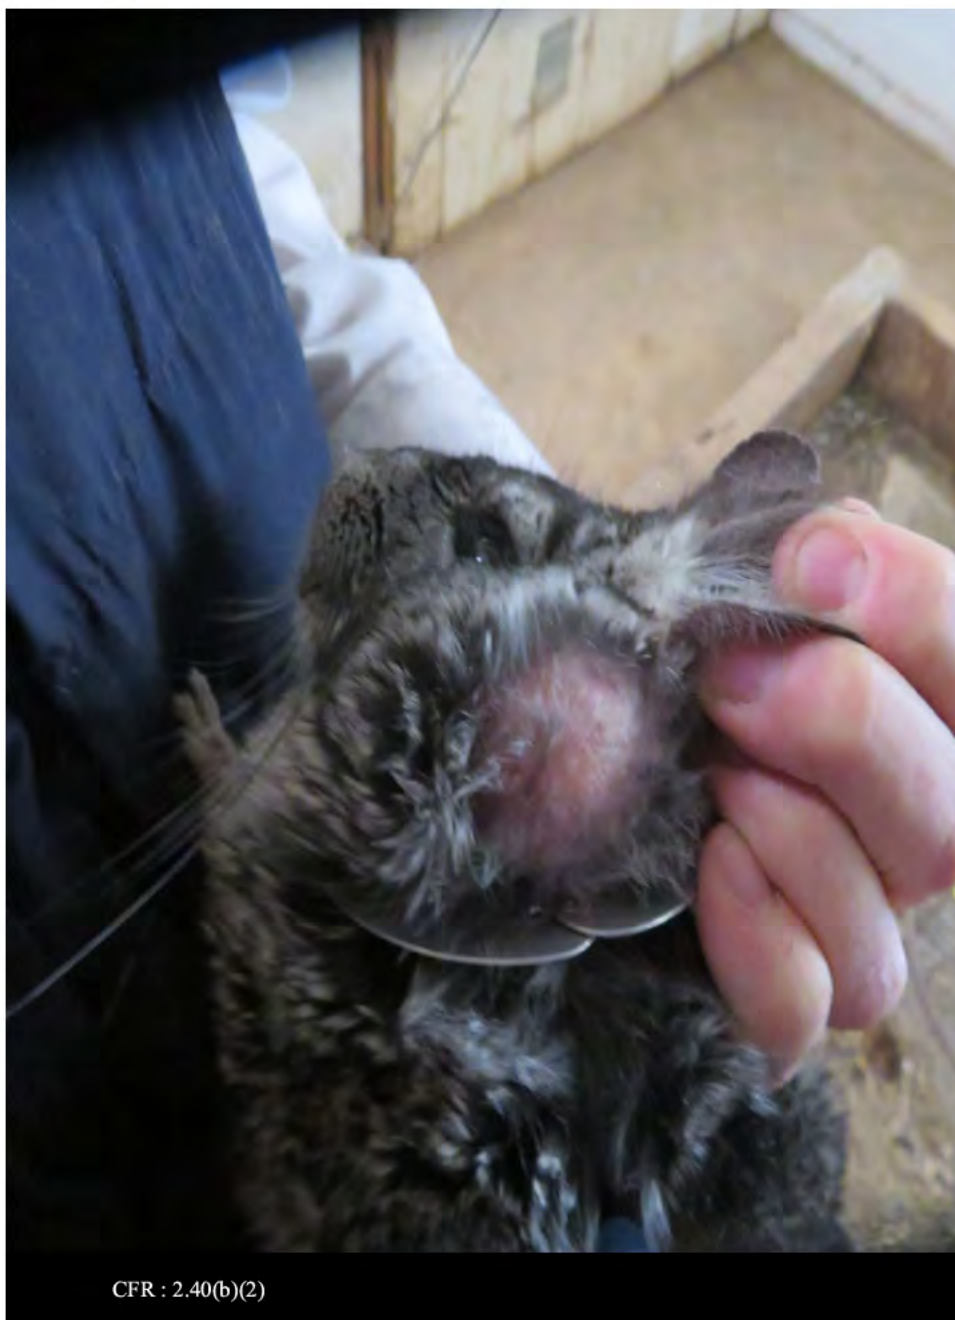
Female grey chinchilla with a swollen area under her left side of her jaw. Facility assigned her treatment tag #65 after we pointed the problem out.

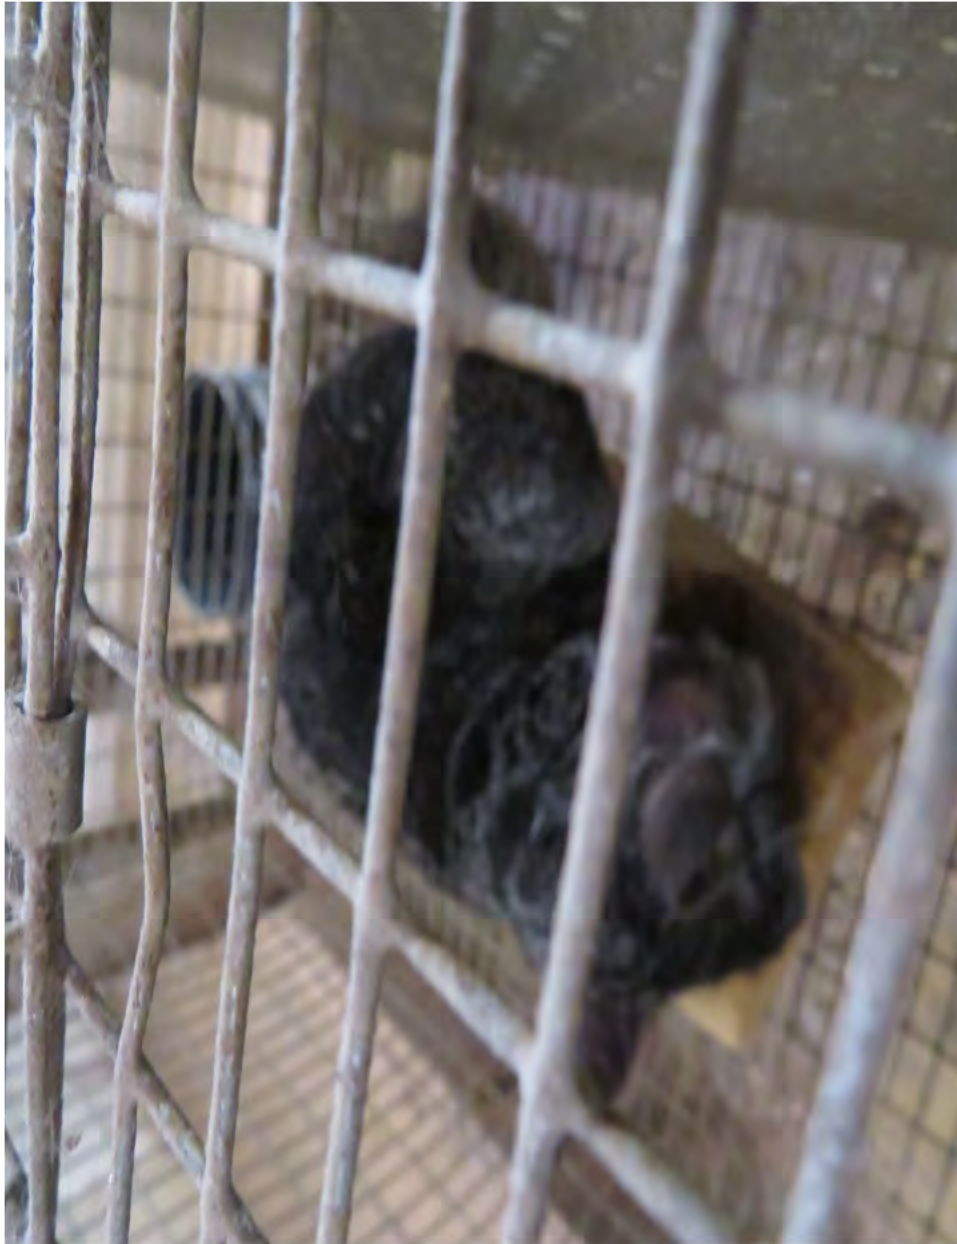
Female grey chinchilla with a swollen area under her left side of her jaw. Facility assigned her treatment tag #65 after we pointed the problem out. Picture is taken looking at chinchilla from above.

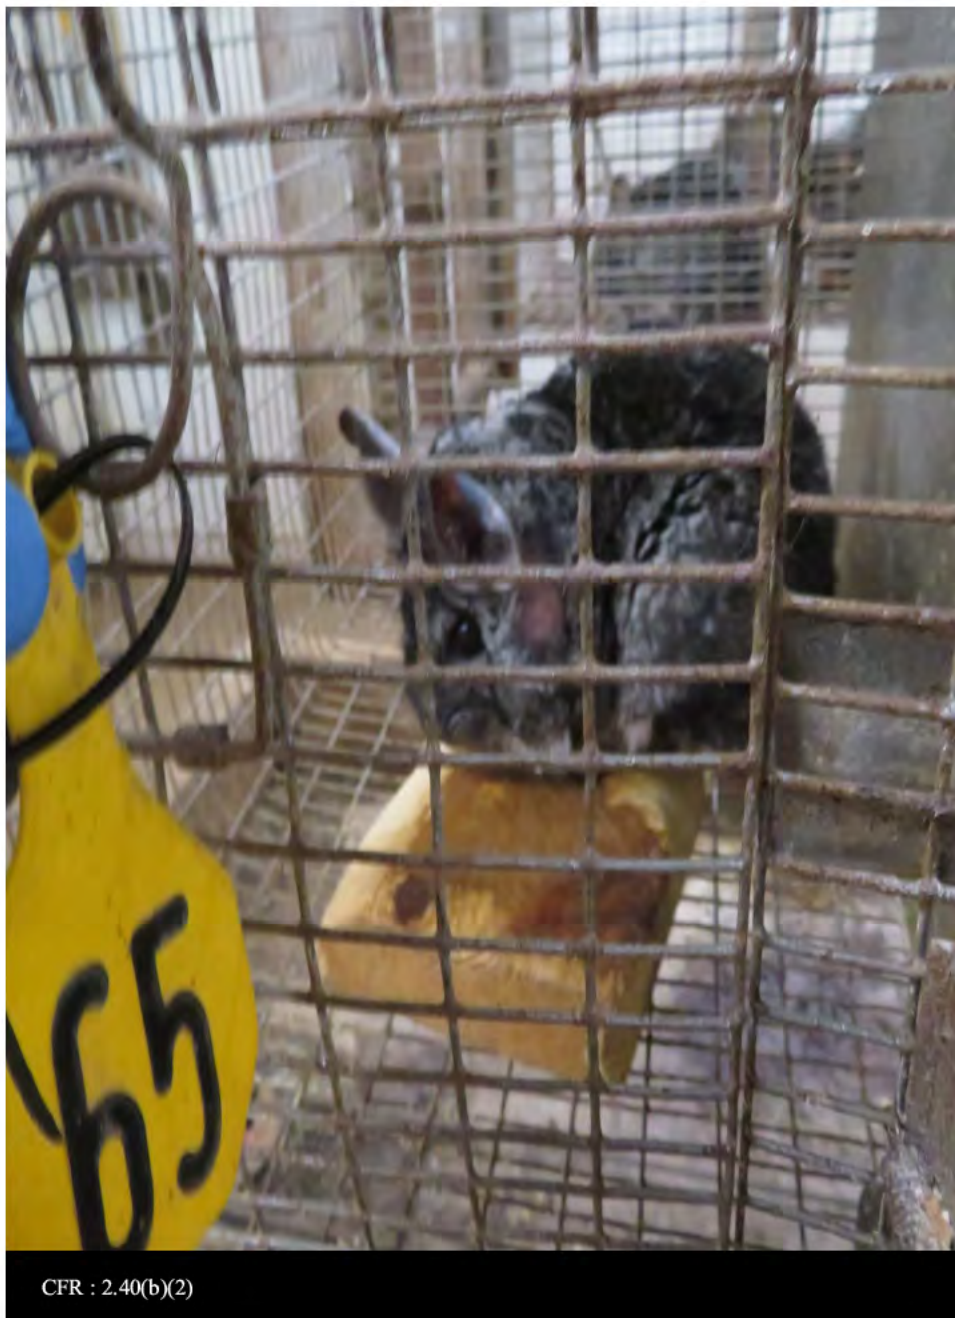
Female grey chinchilla with a swollen area under her left side of her jaw. Facility assigned her treatment tag #65 after we pointed the problem out. Picture is looking at chinchilla from front of enclosure.

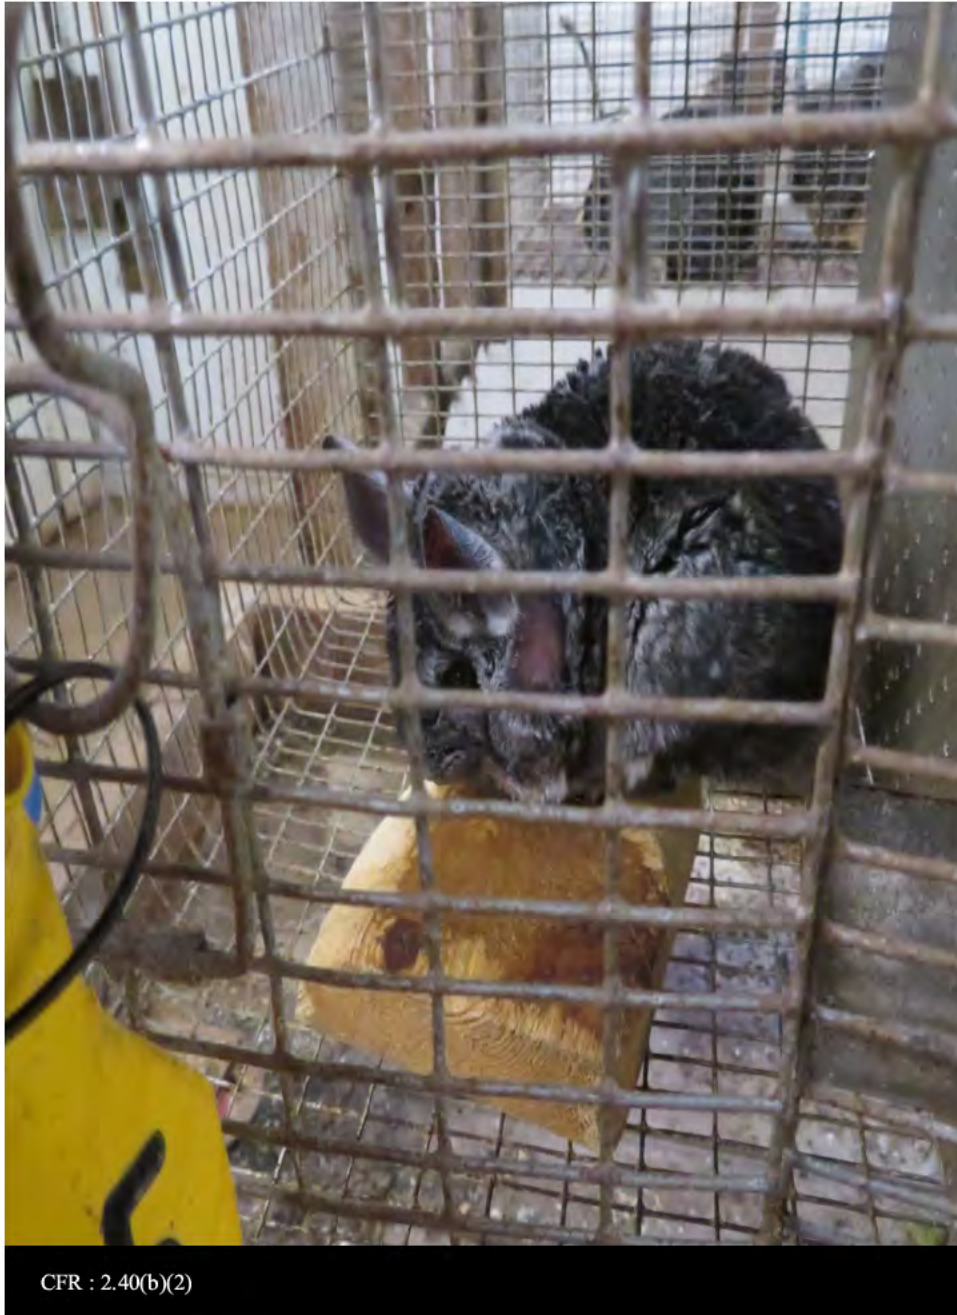
Female grey chinchilla with a swollen area under her left side of her jaw. Facility assigned her treatment tag #65 after we pointed the problem out. Picture is looking at chinchilla from the front of the enclosure.

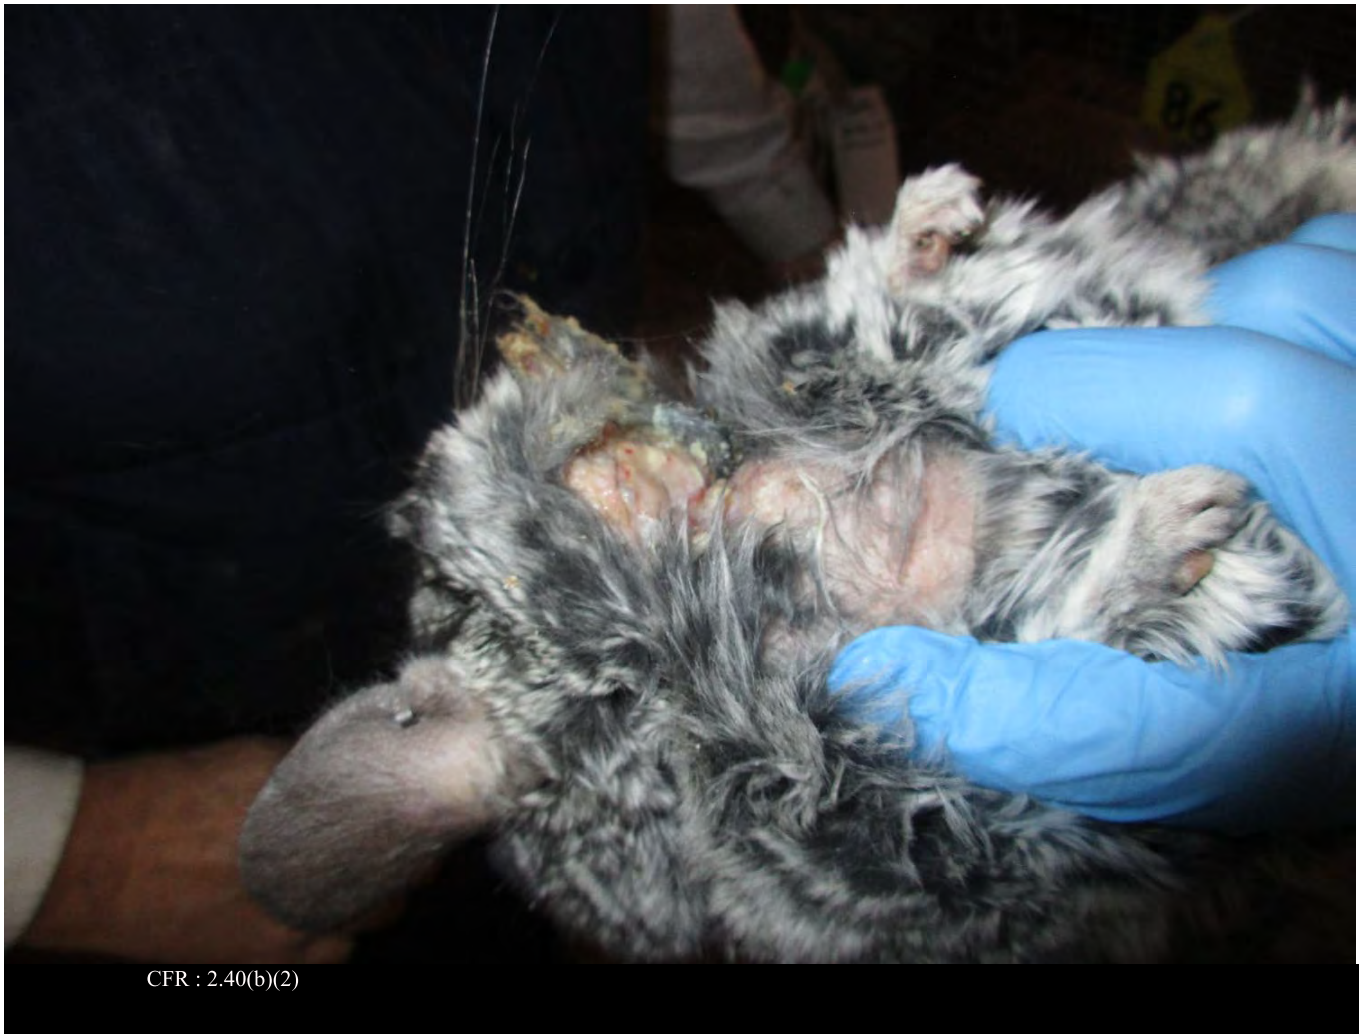
Ventral neck (lower neck) of chinchilla (eartag PMR 683) that had swollen skin and eroded skin under where collar was. Discharge can be seen in center of hairless area.

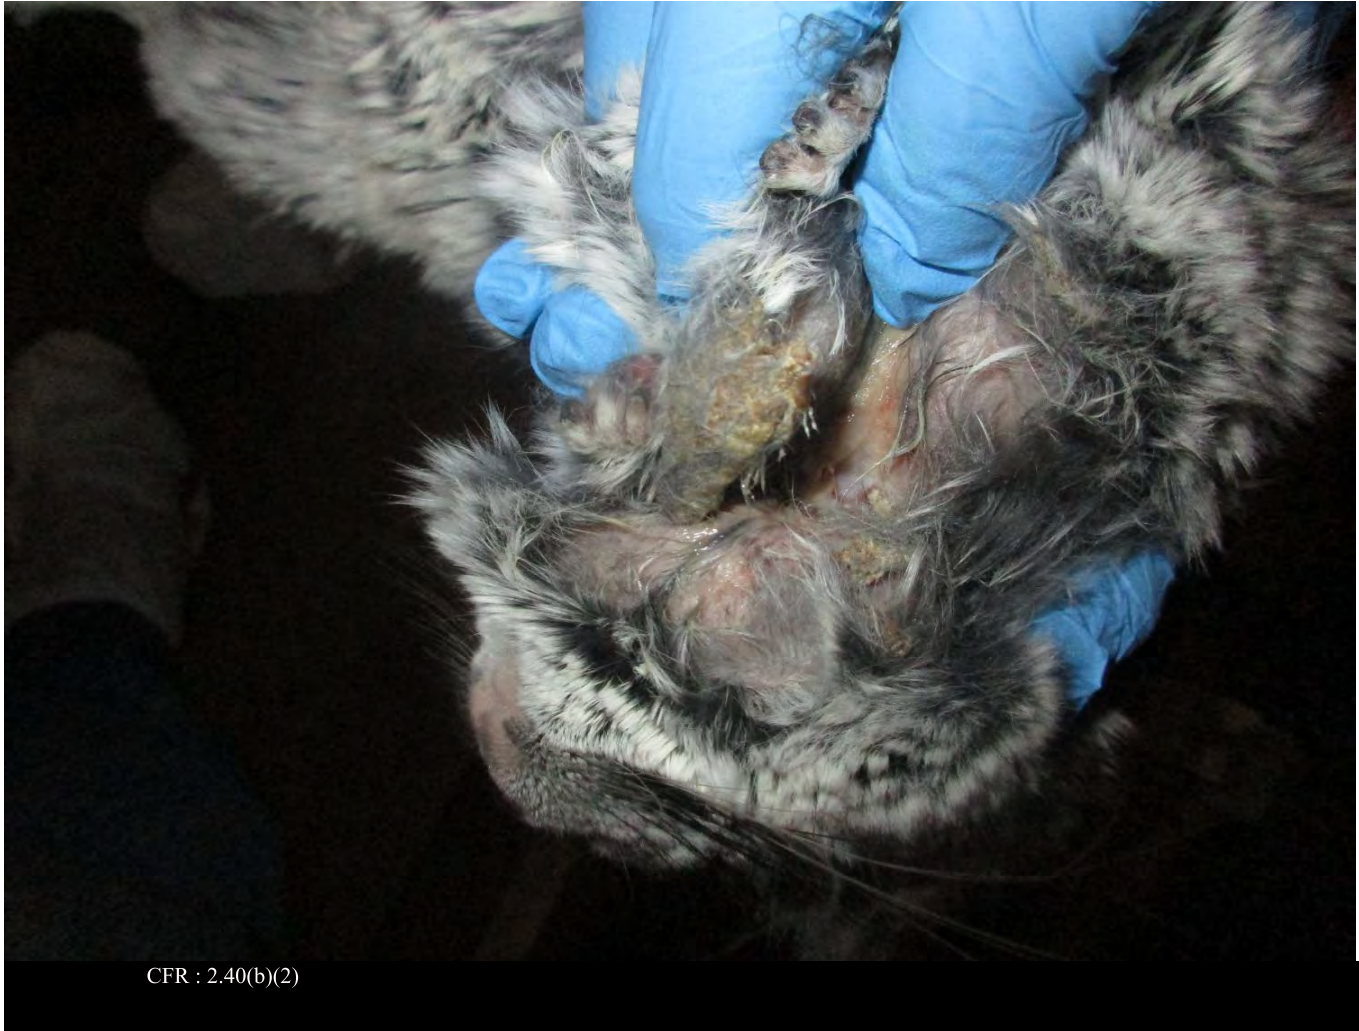
Ventral neck (lower neck) of chinchilla (eartag PMR 683) that had crusted hair around collar and found to have swollen skin and eroded skin under where collar was.

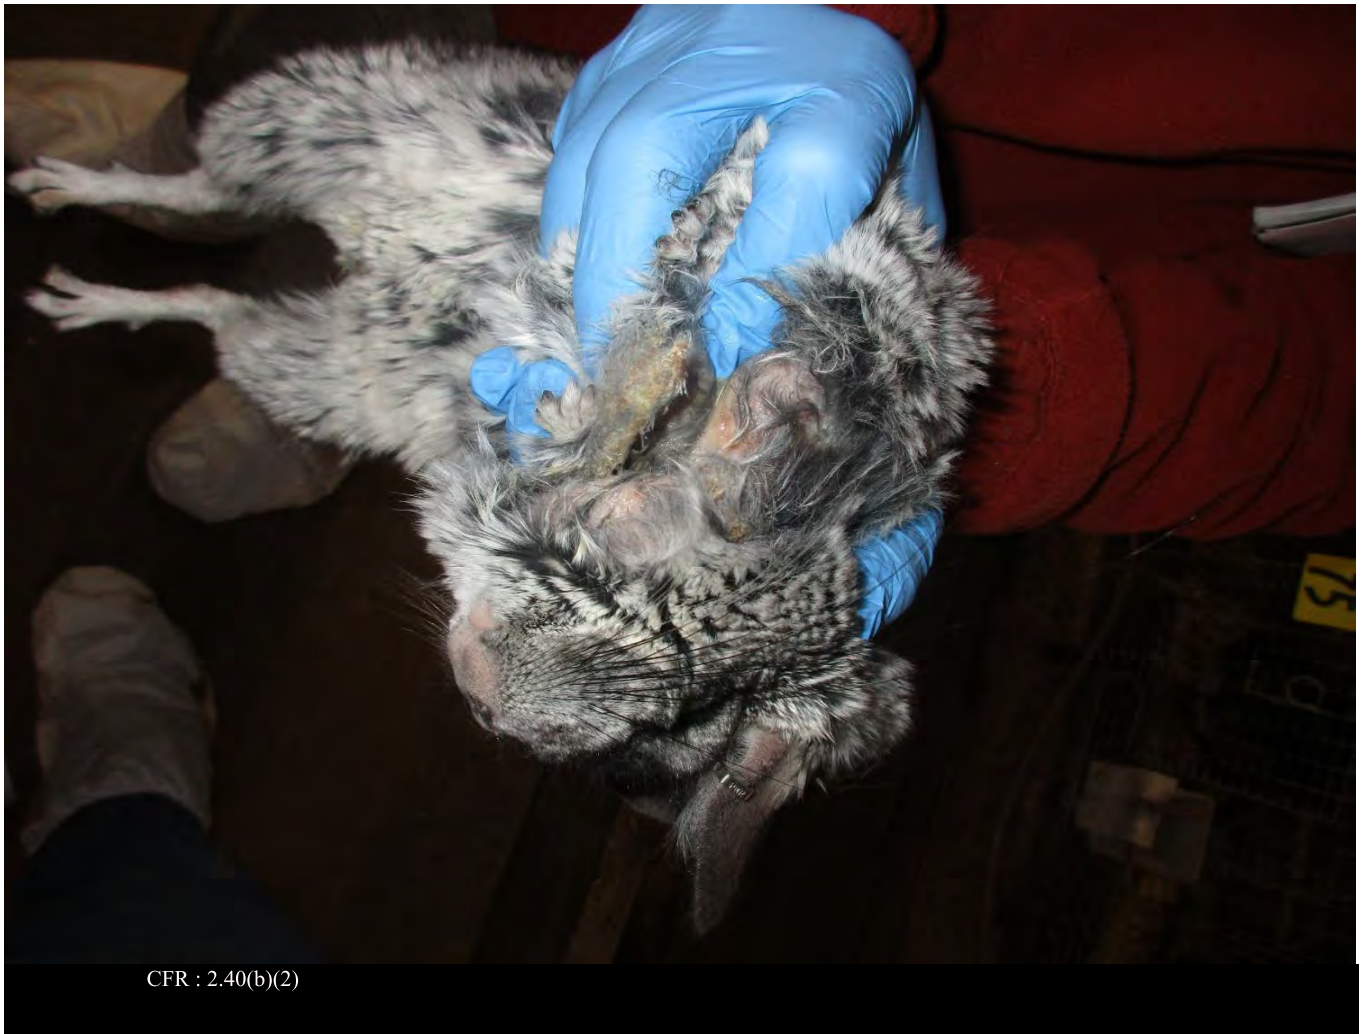
Ventral neck (lower neck) of chinchilla (eartag PMR 683) that had swollen skin and eroded area under where collar was.

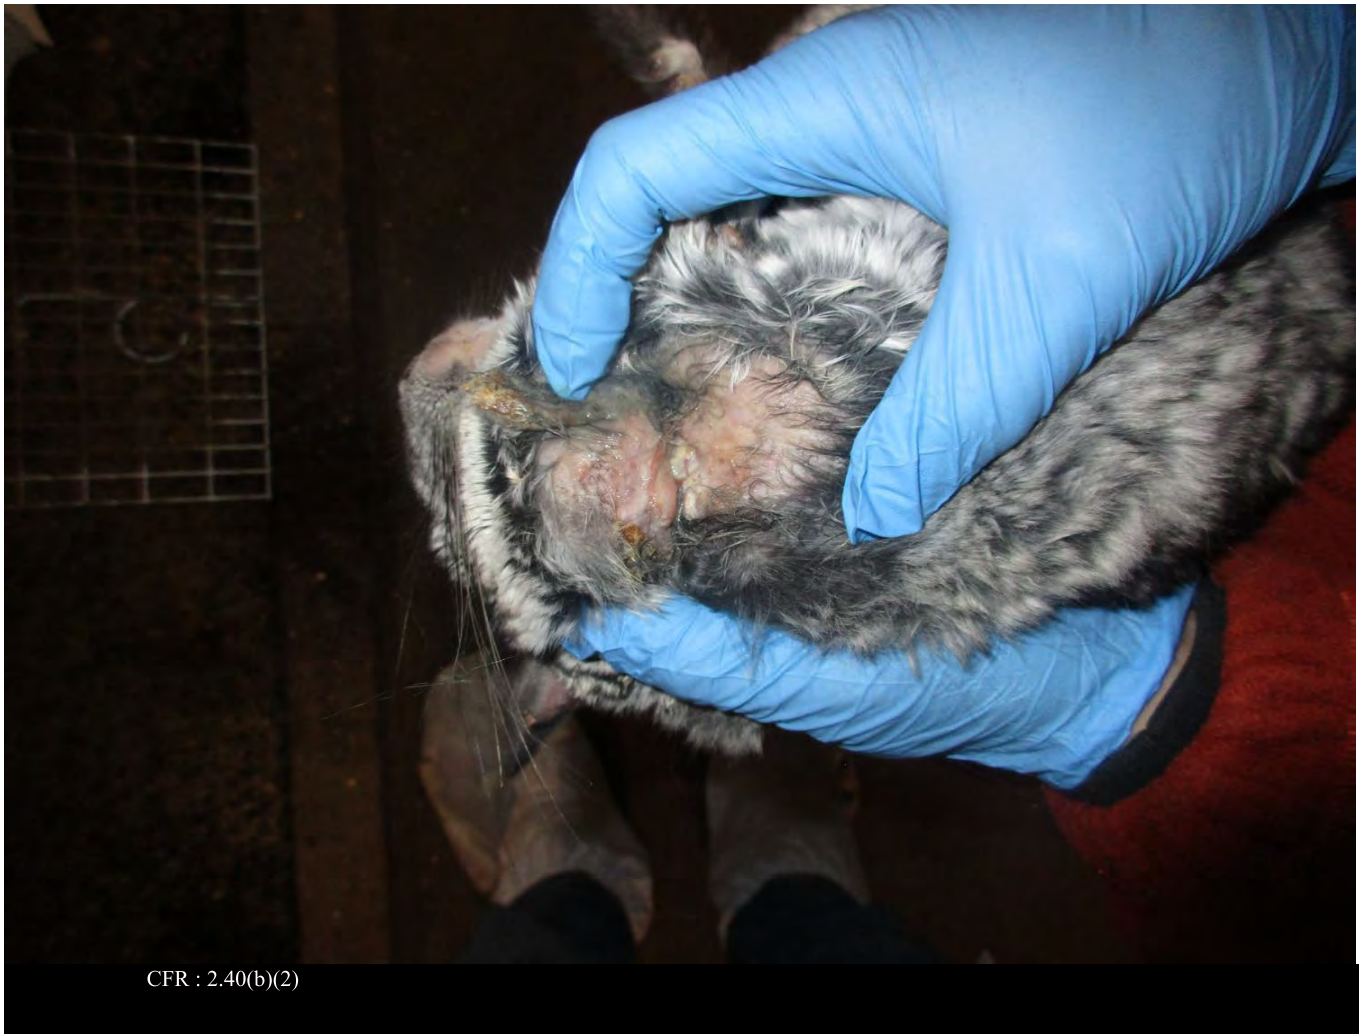
Ventral neck (lower neck) of chinchilla (eartag PMR 683) that had swollen skin, and eroded skin under collar with noticeable putrid odor on her lower neck.

Discharge can be seen in hairless area.

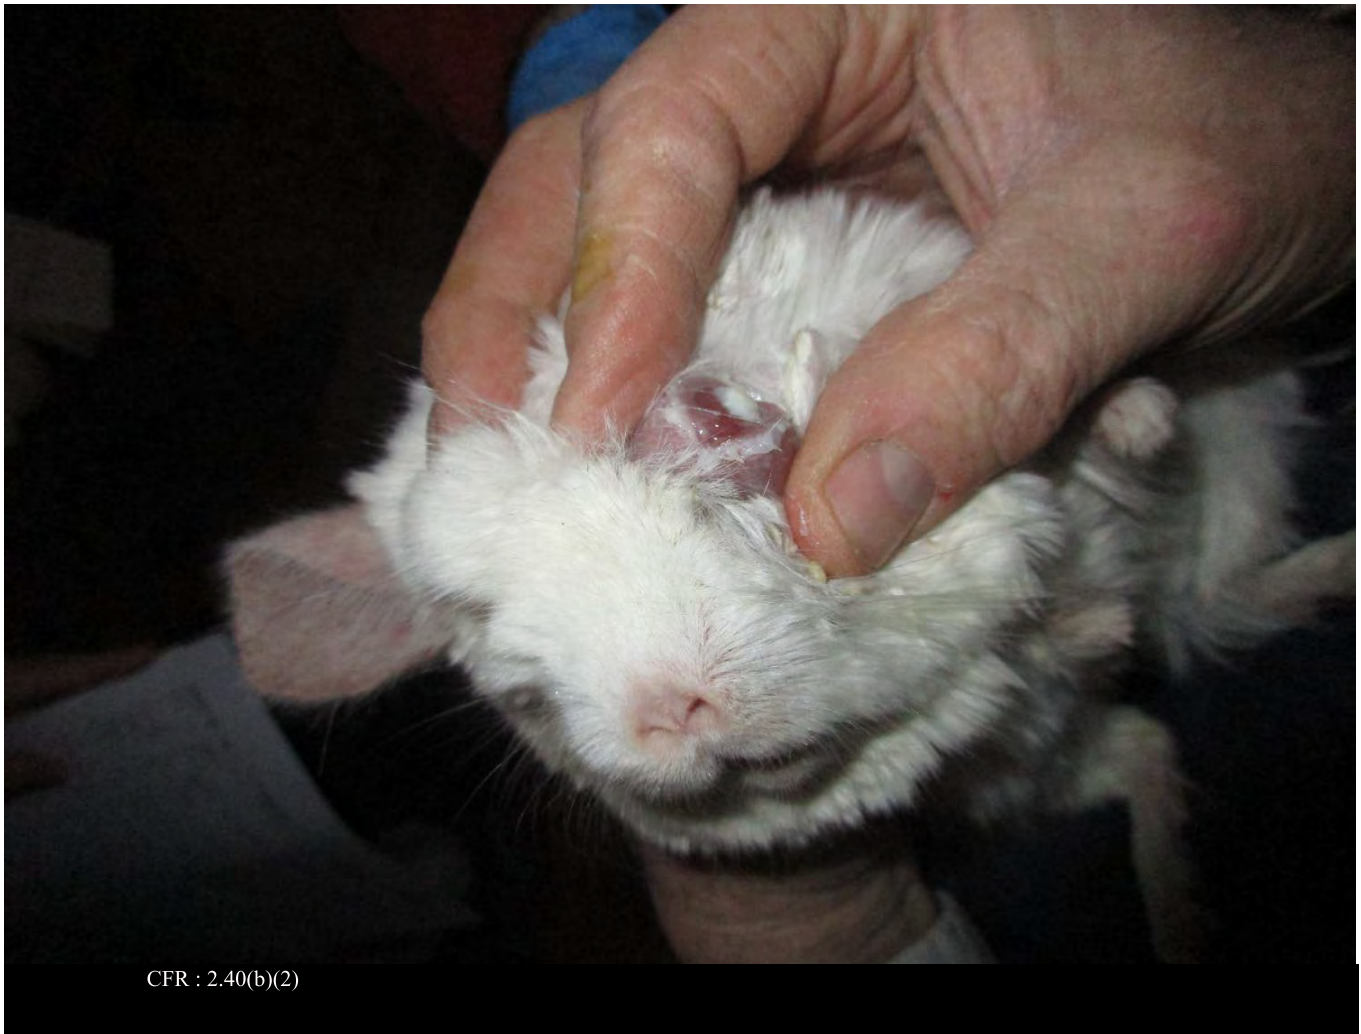
Female white (cartag RVW 109) chinchilla's left eye was swollen shut and when handled by licensee had some pale discharge.

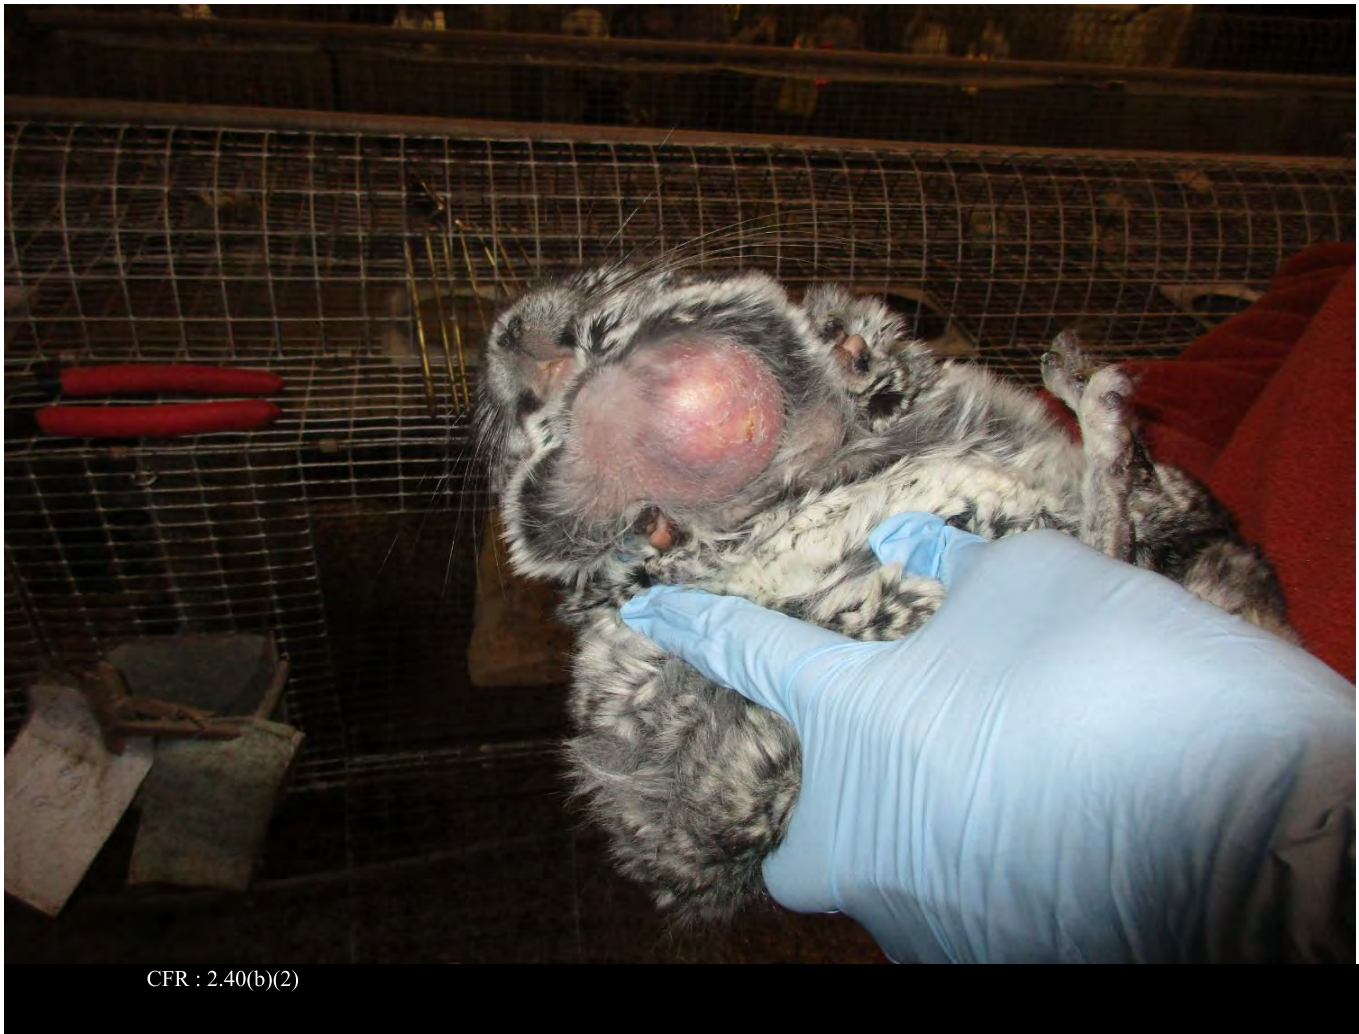
Grey female chinchilla (no tag, housed in 59B) had a swollen, red, hairless area under her neck.

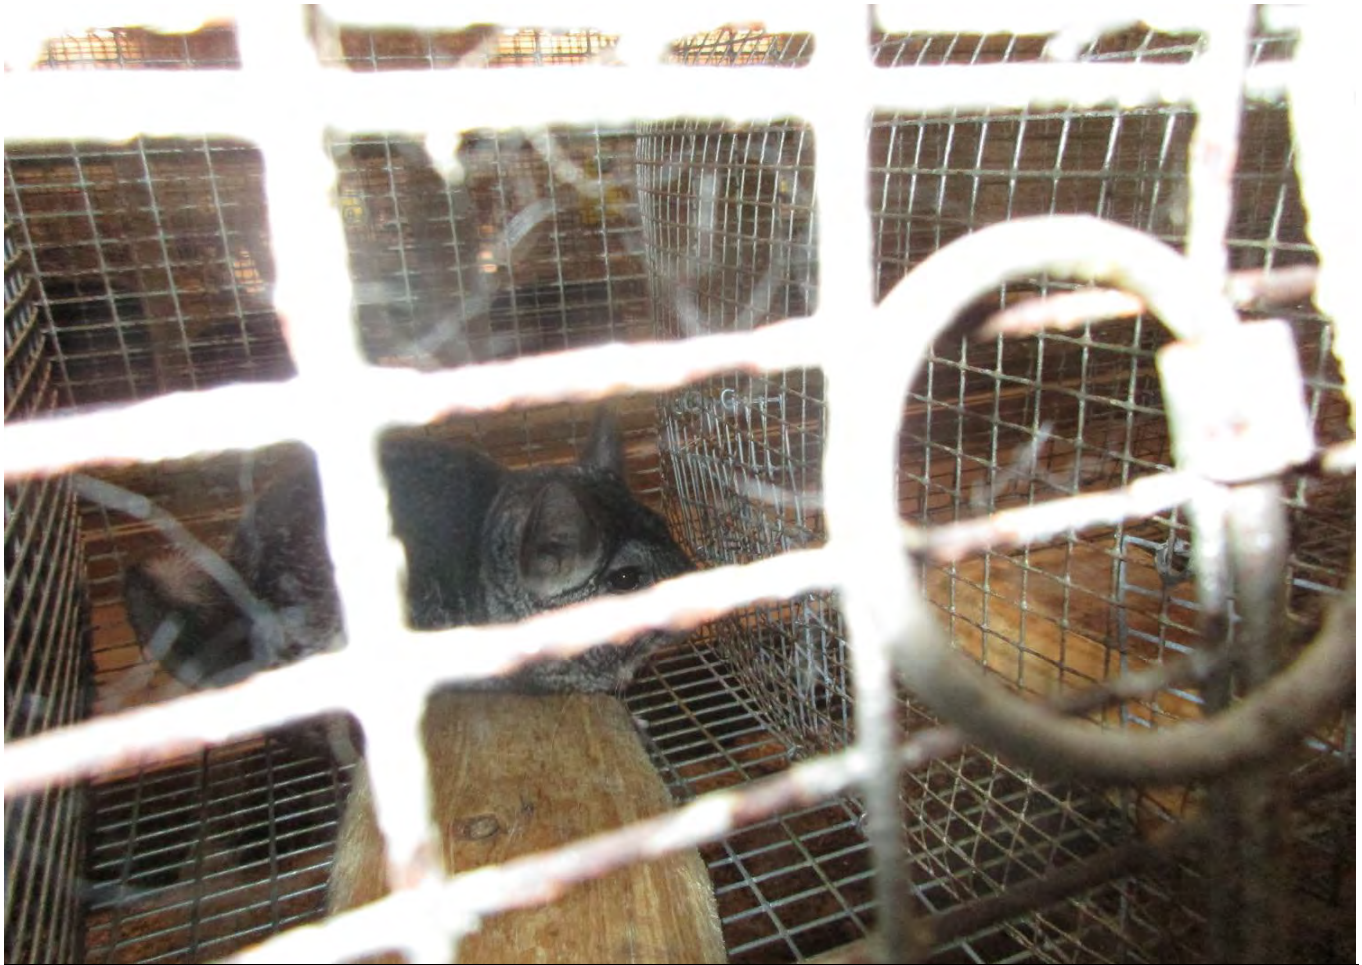
Wire points protruding from divider in front of chinchilla.

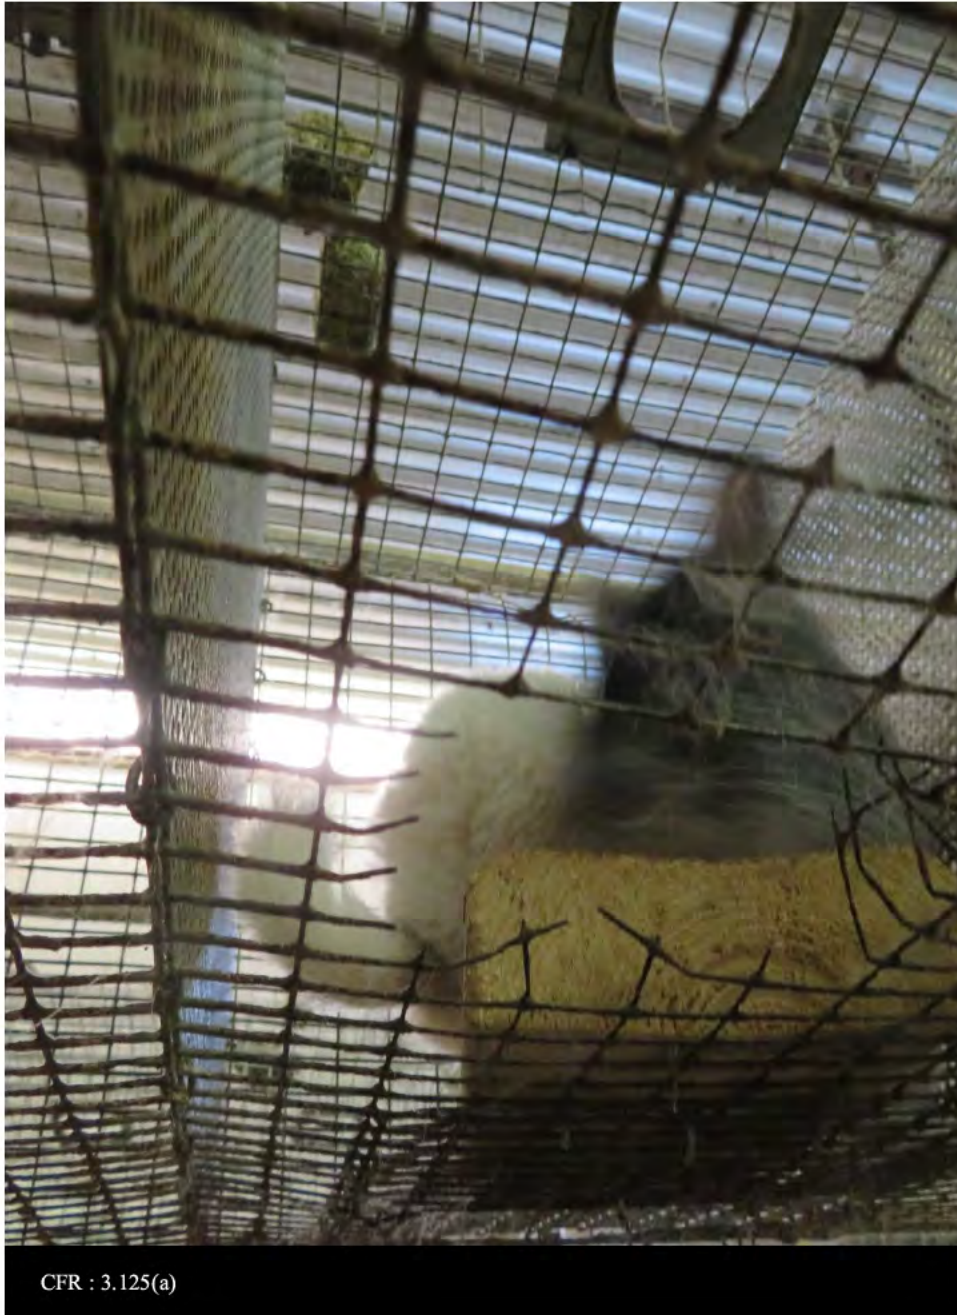
Hole in floor of enclosure with sharp points creating escape/injury hazards.

Licensee patched hole and removed points during inspection.

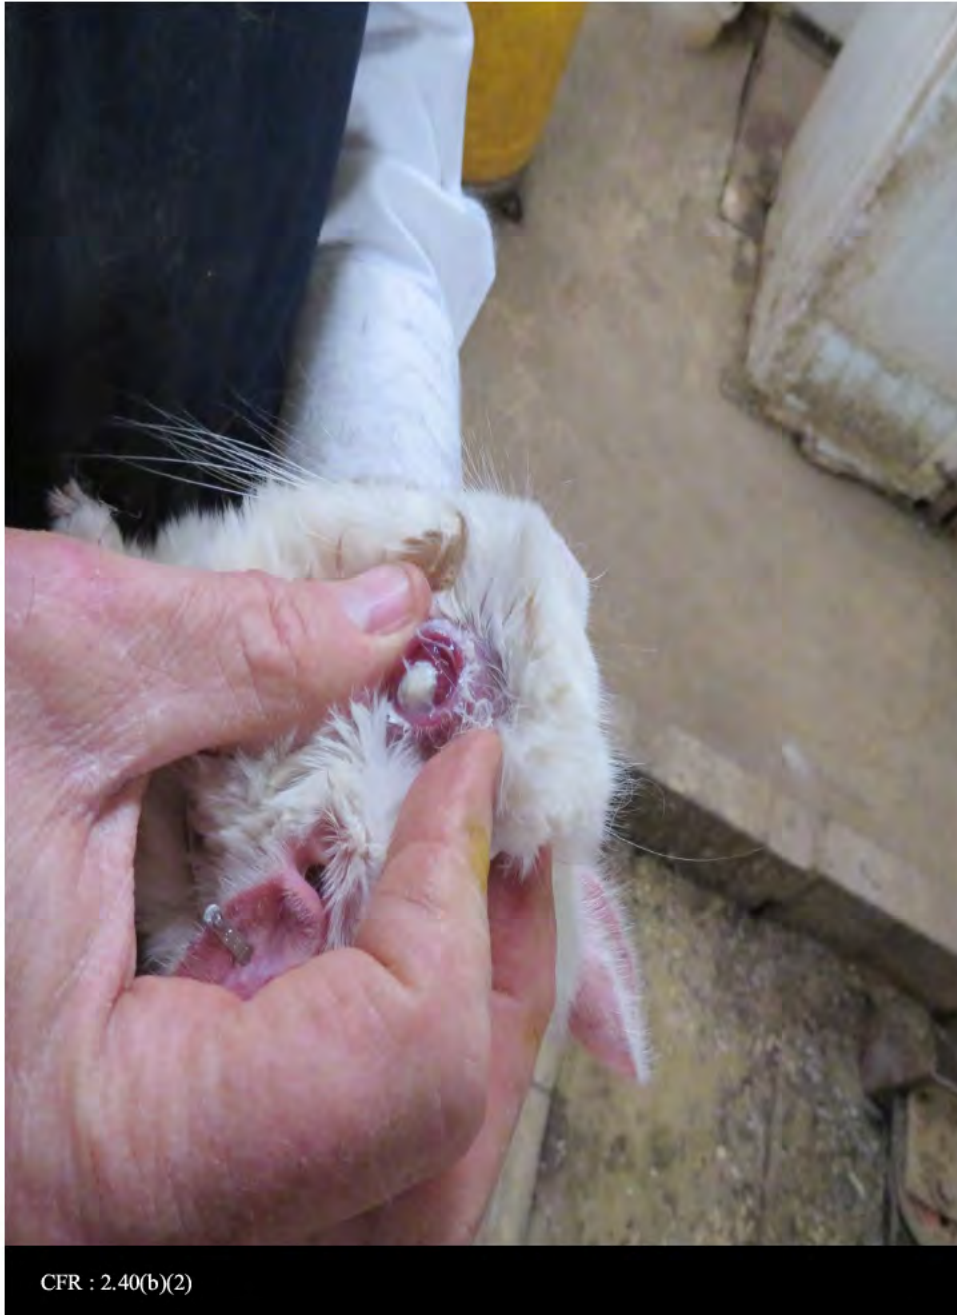
Female white (eartag RVW 109) chinchilla's left eye was swollen shut and when handled by licensee had some pale discharge; the pale material in the center surface of the eyeball (seen in photo) appeared adhered to it while the licensee handled it.

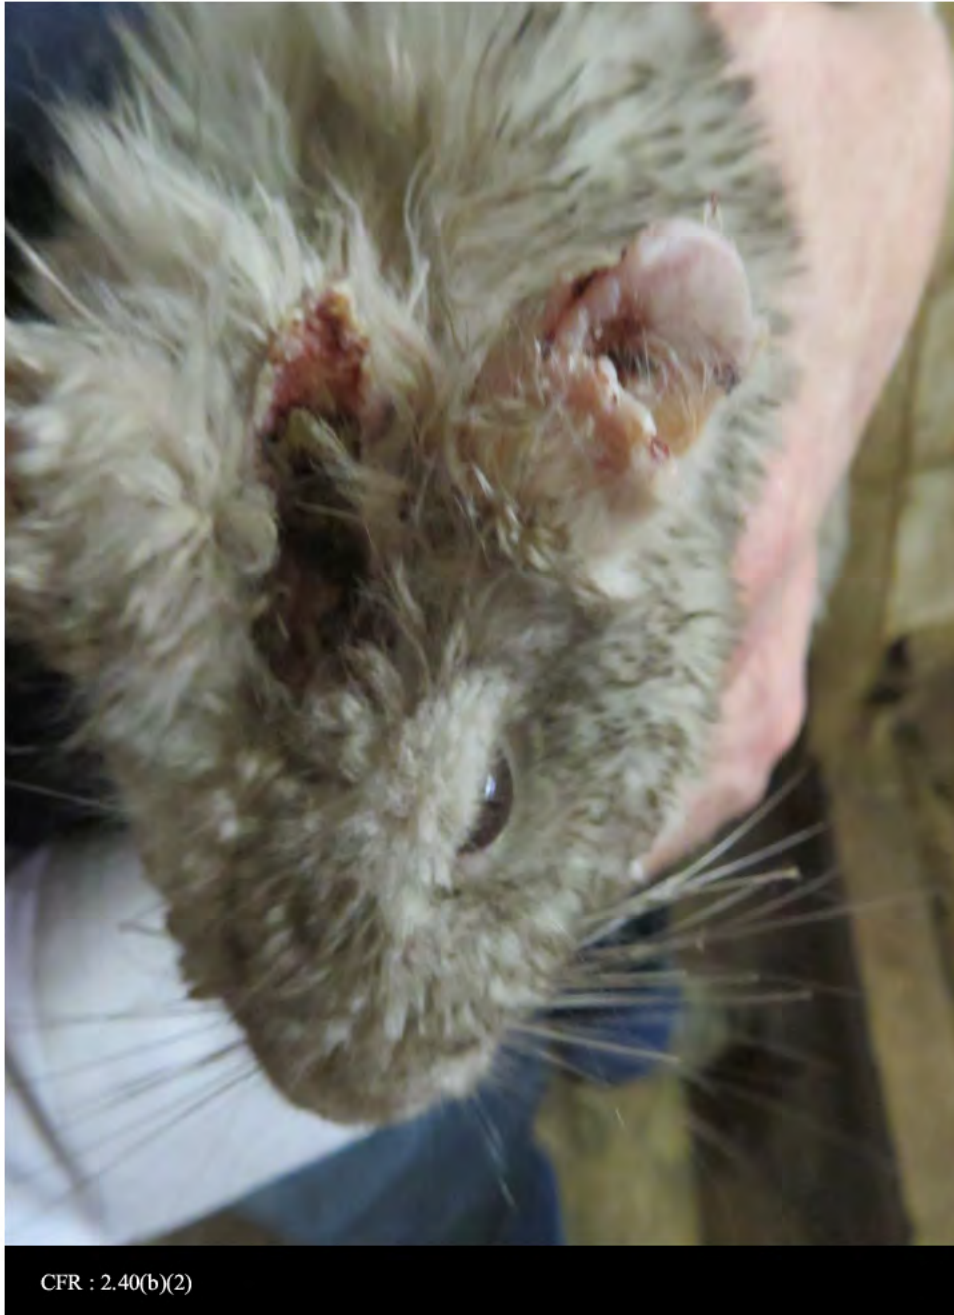
Male chinchilla (no eartag, housed in bank 101) open wound on top of head.

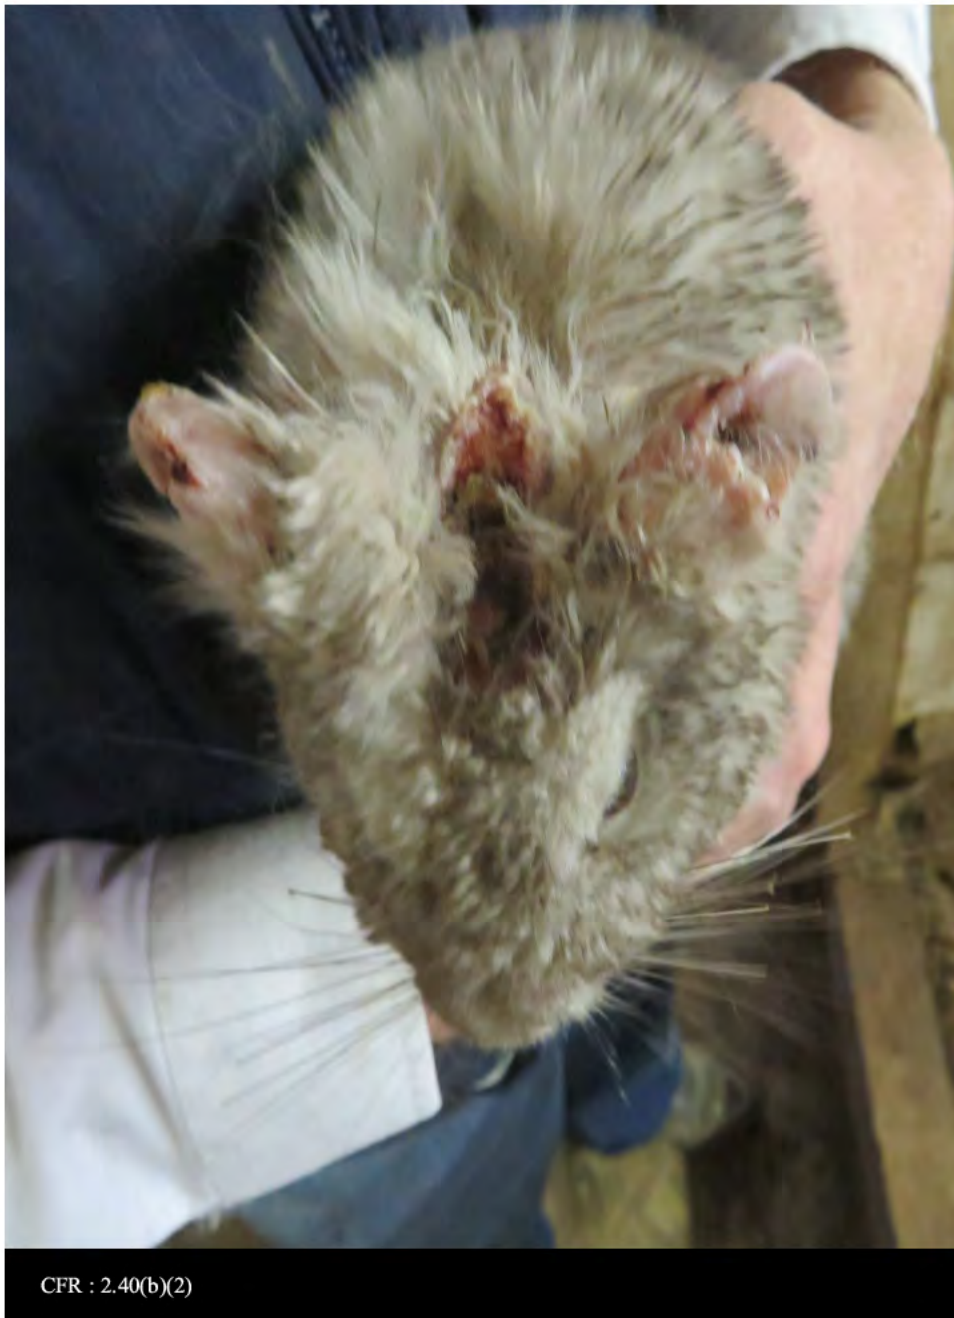
Male chinchilla (no eartag, housed in bank 101) open wound on top of head.

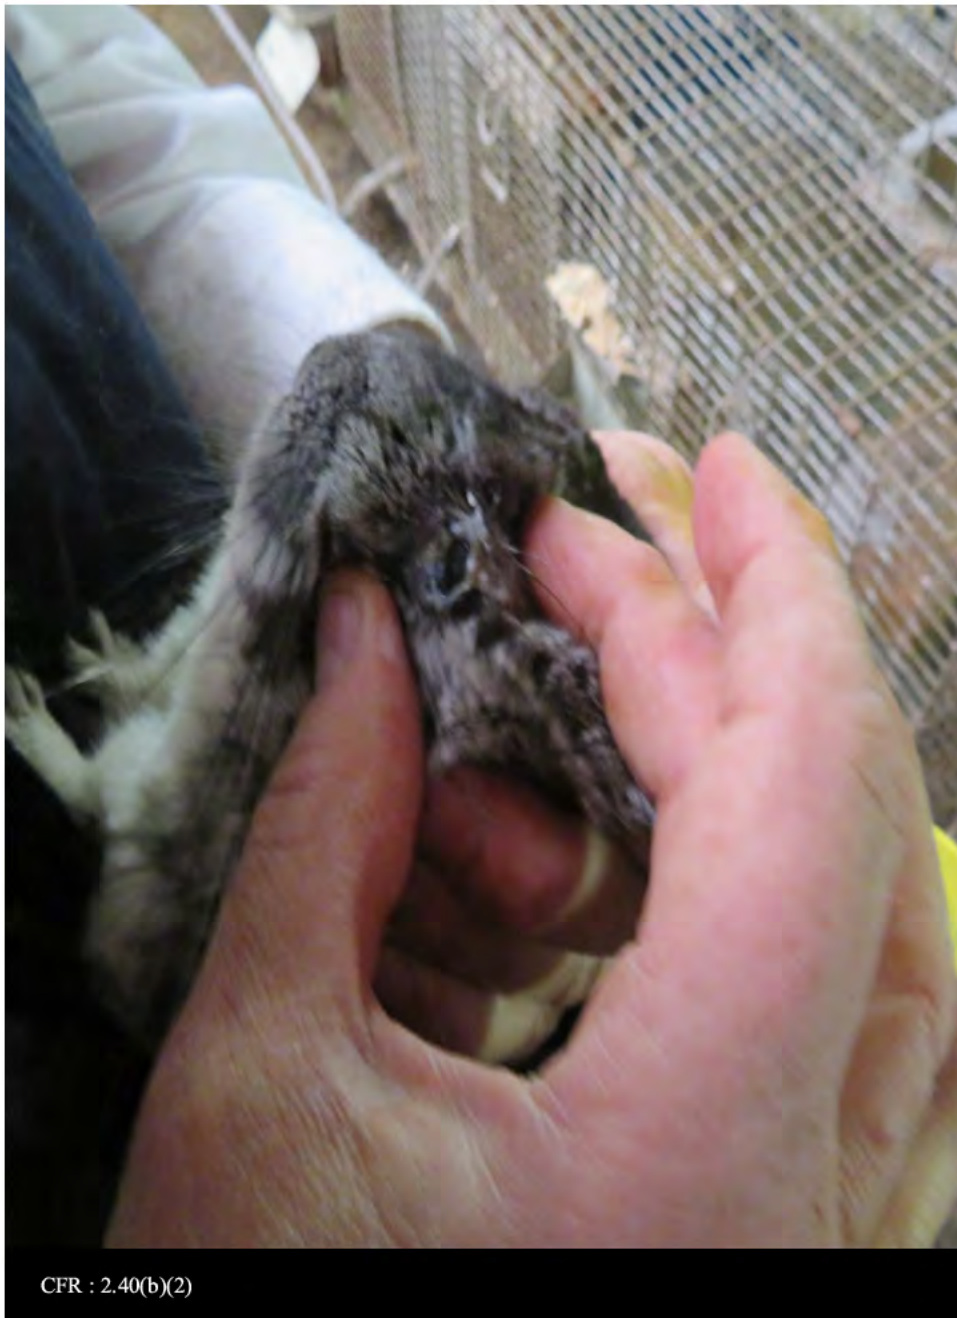
A female grey (eartag DJM 122) chinchilla's left eye was crusted shut; the licensee opened it and there was some pale discharge in it.

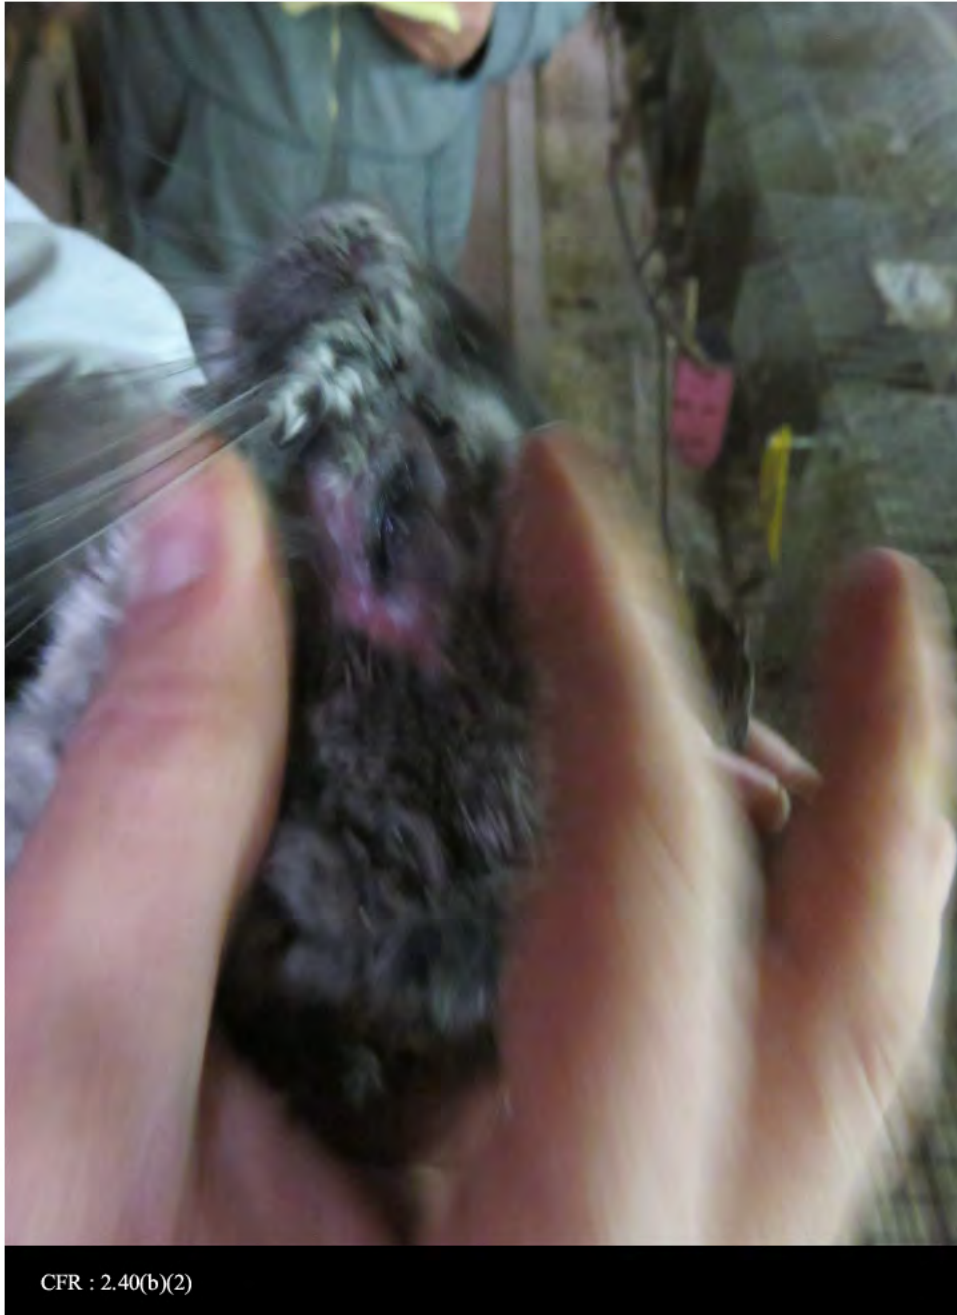
Male grey (eartag DJM 115) chinchilla's left eye seen while licensee removed crusted material--discharge present and note reddened, hairless eyelids.
