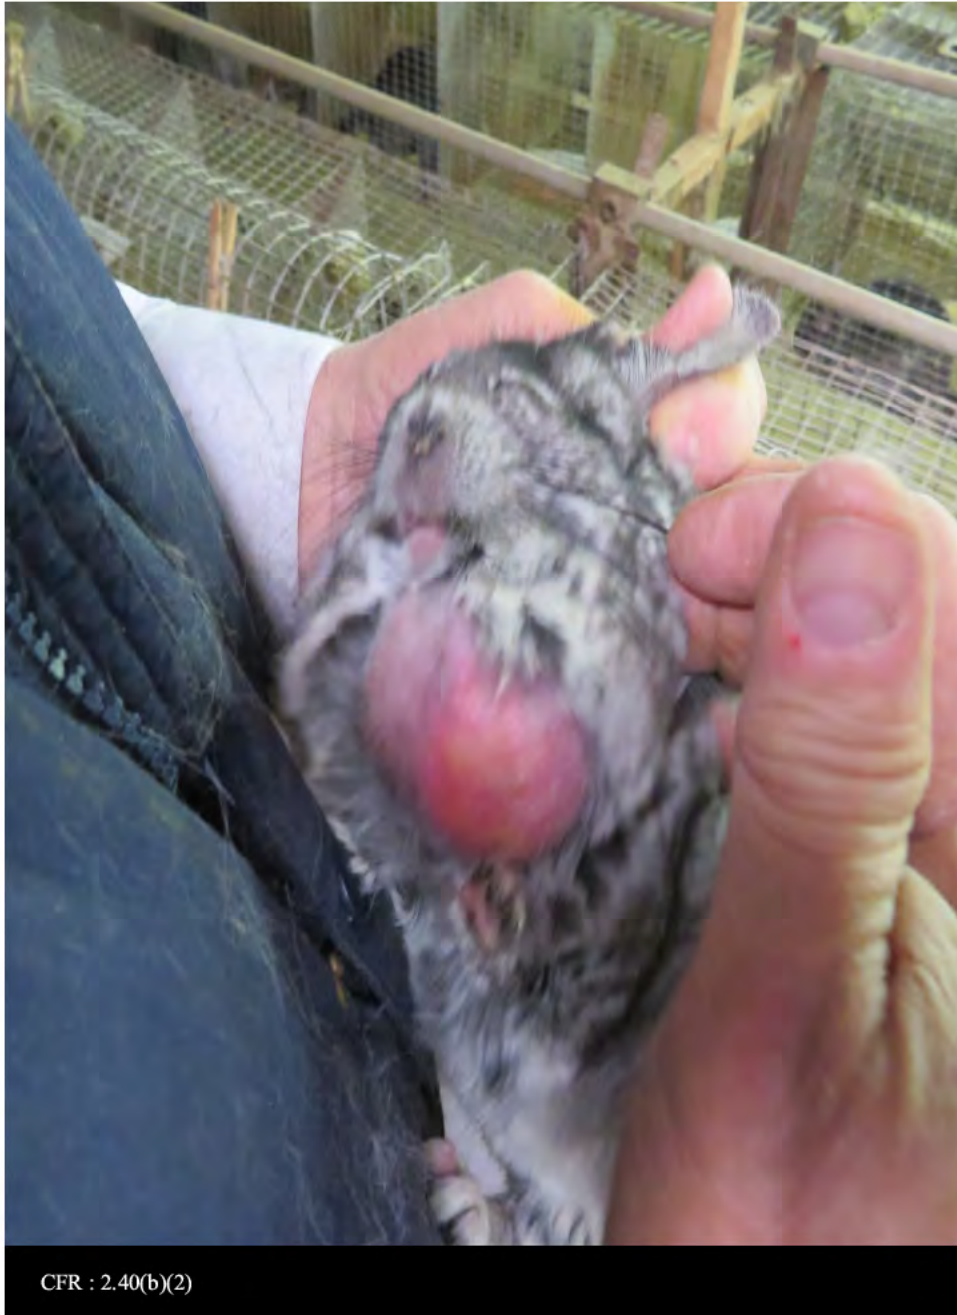
Grey female chinchilla (no tag, housed in 59B) had a swollen, red, hairless area under her neck.

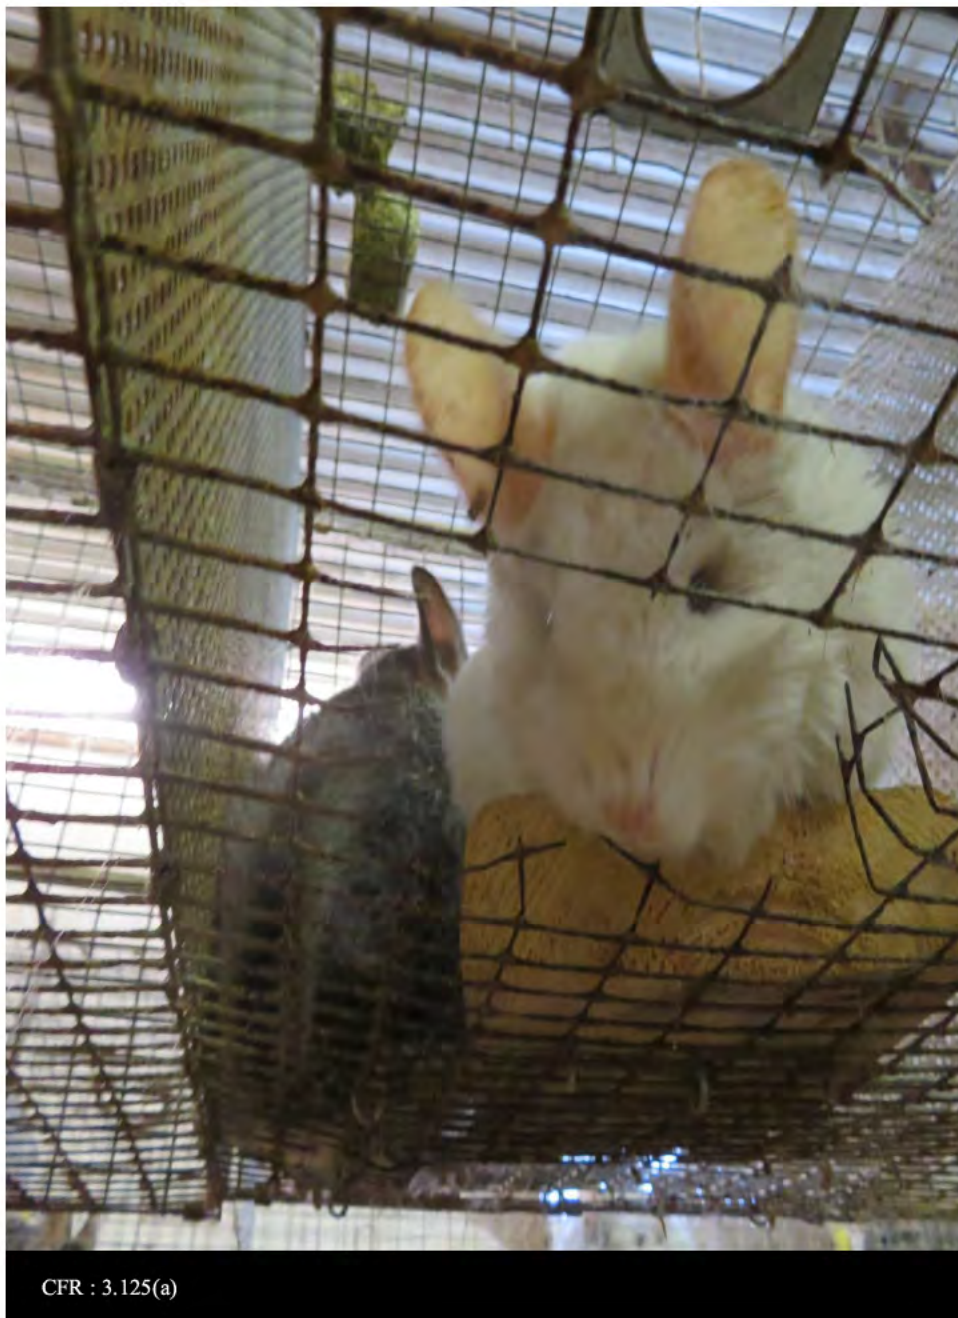
Hole in floor of enclosure with sharp points creating escape/injury hazards.

Licensee patched hole and removed points during inspection.

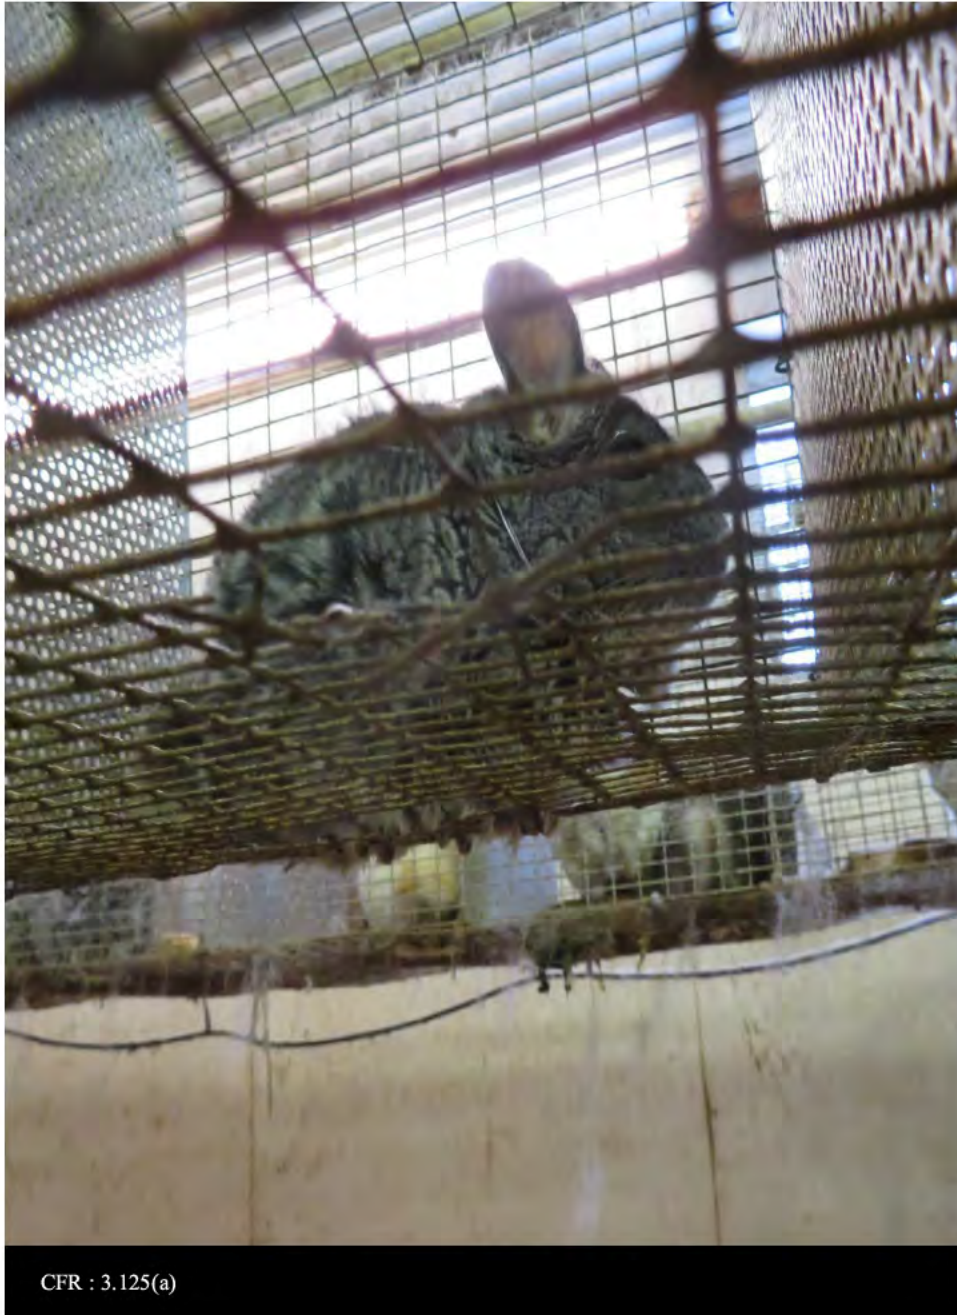
Broken wire on floor (center of image). Licensee removed broken wire and patched hole during inspection.

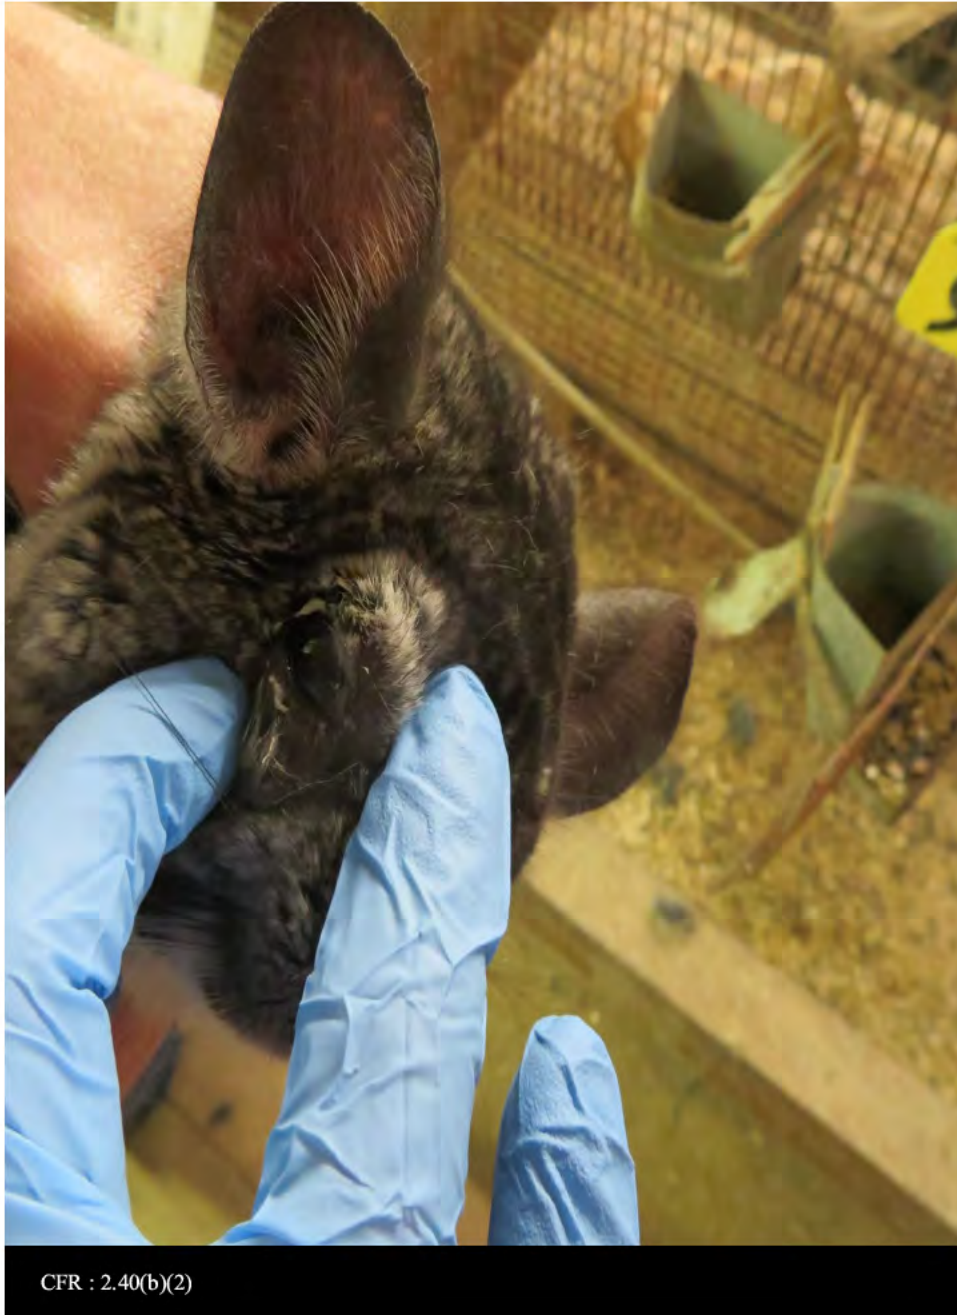
Female grey (no eartag, housed in 90A) chinchilla's right eye was crusted shut and had some discharge.

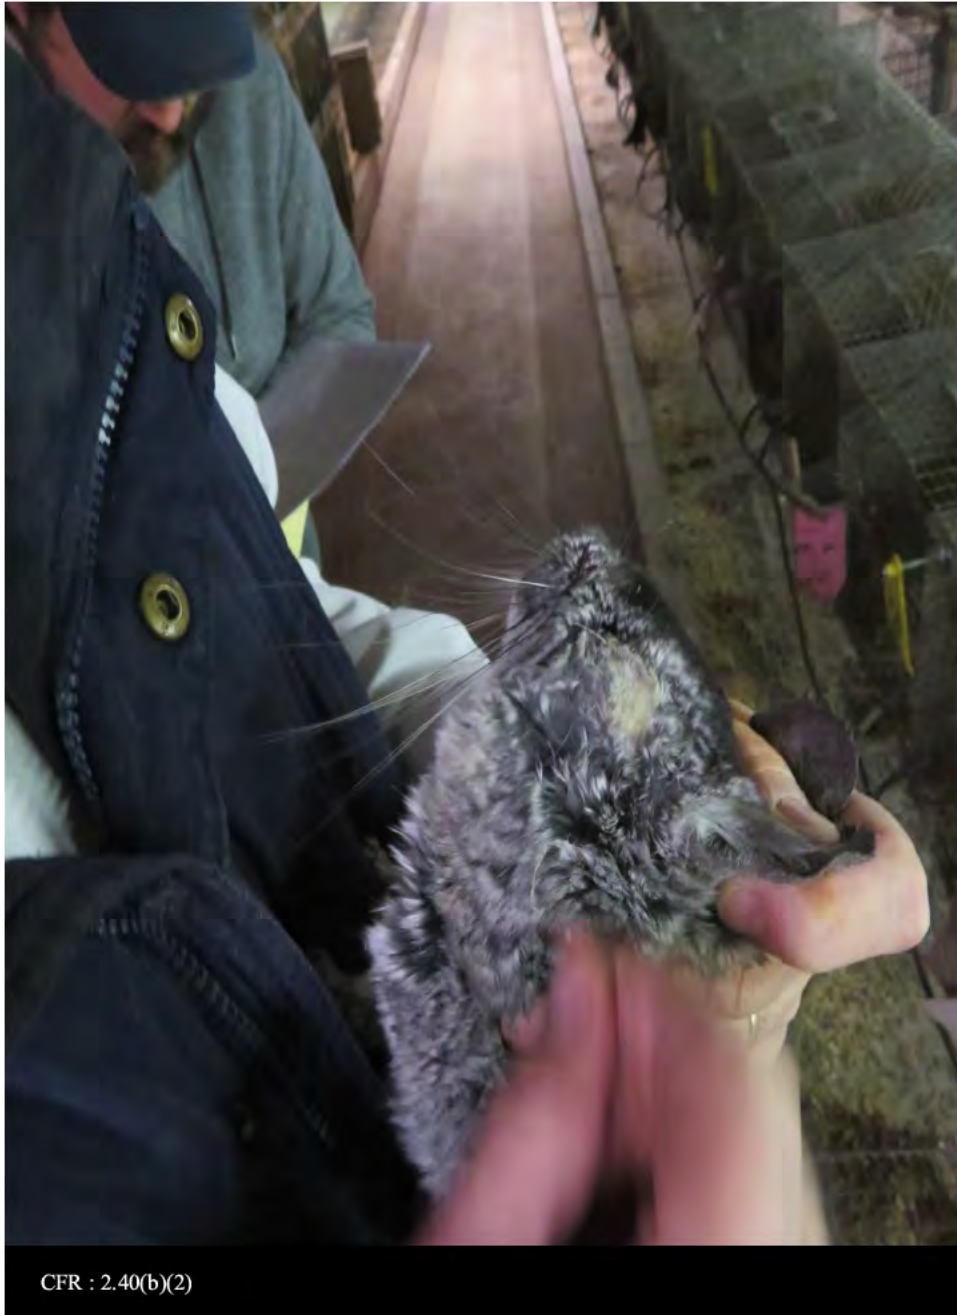
Male grey (eartag DJM 115) chinchilla's left eye sealed shut with a pale crusted material, taken prior to licensee removing crusted material.

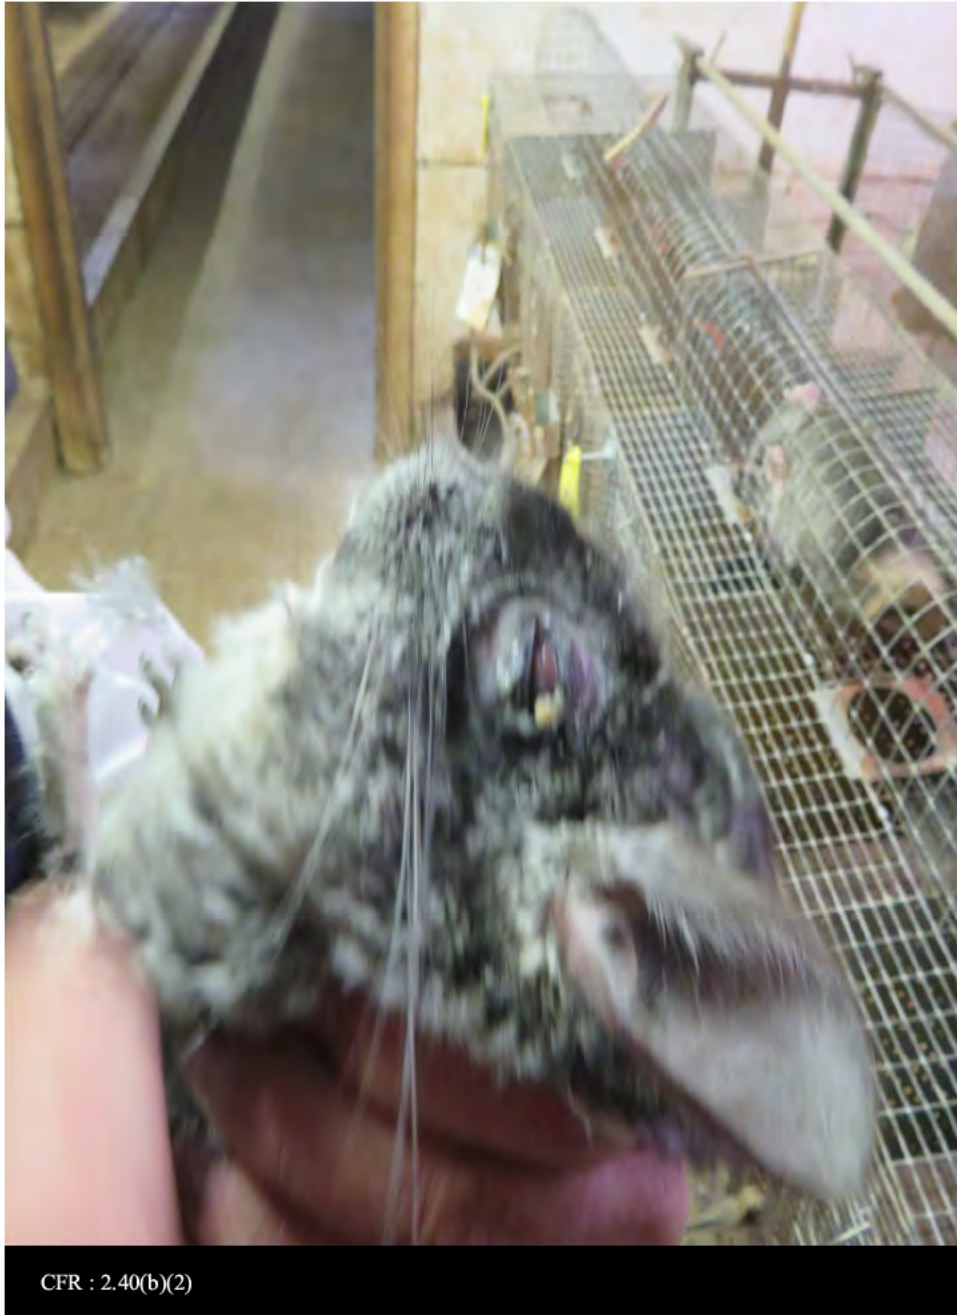
Chinchilla (eartag GROS 214) with discharge in her left eye.

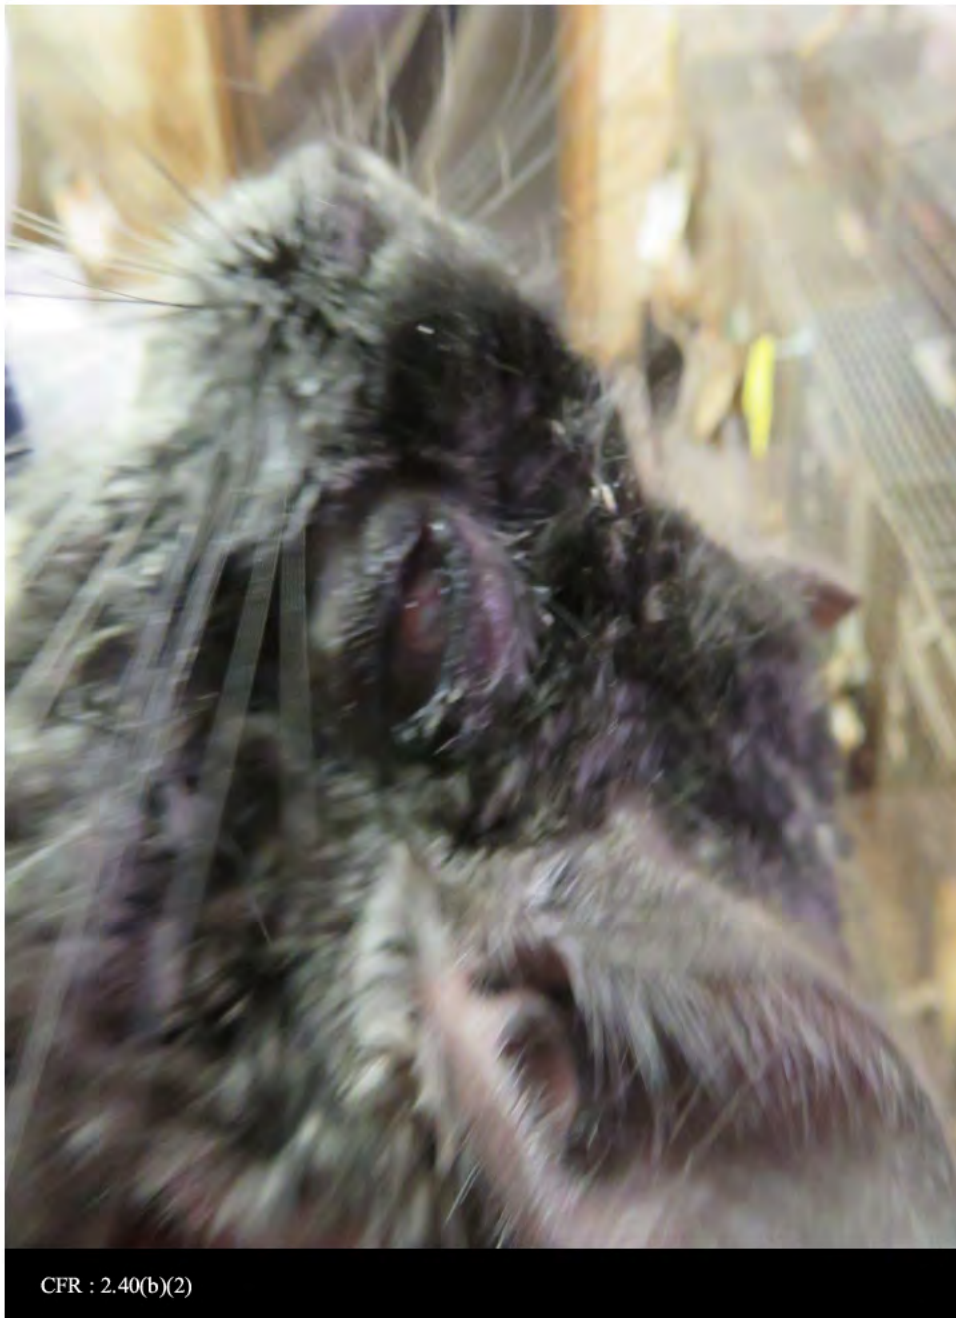
Close-up of GROS 214's left eye; swelling present and surface of eye is reddened.

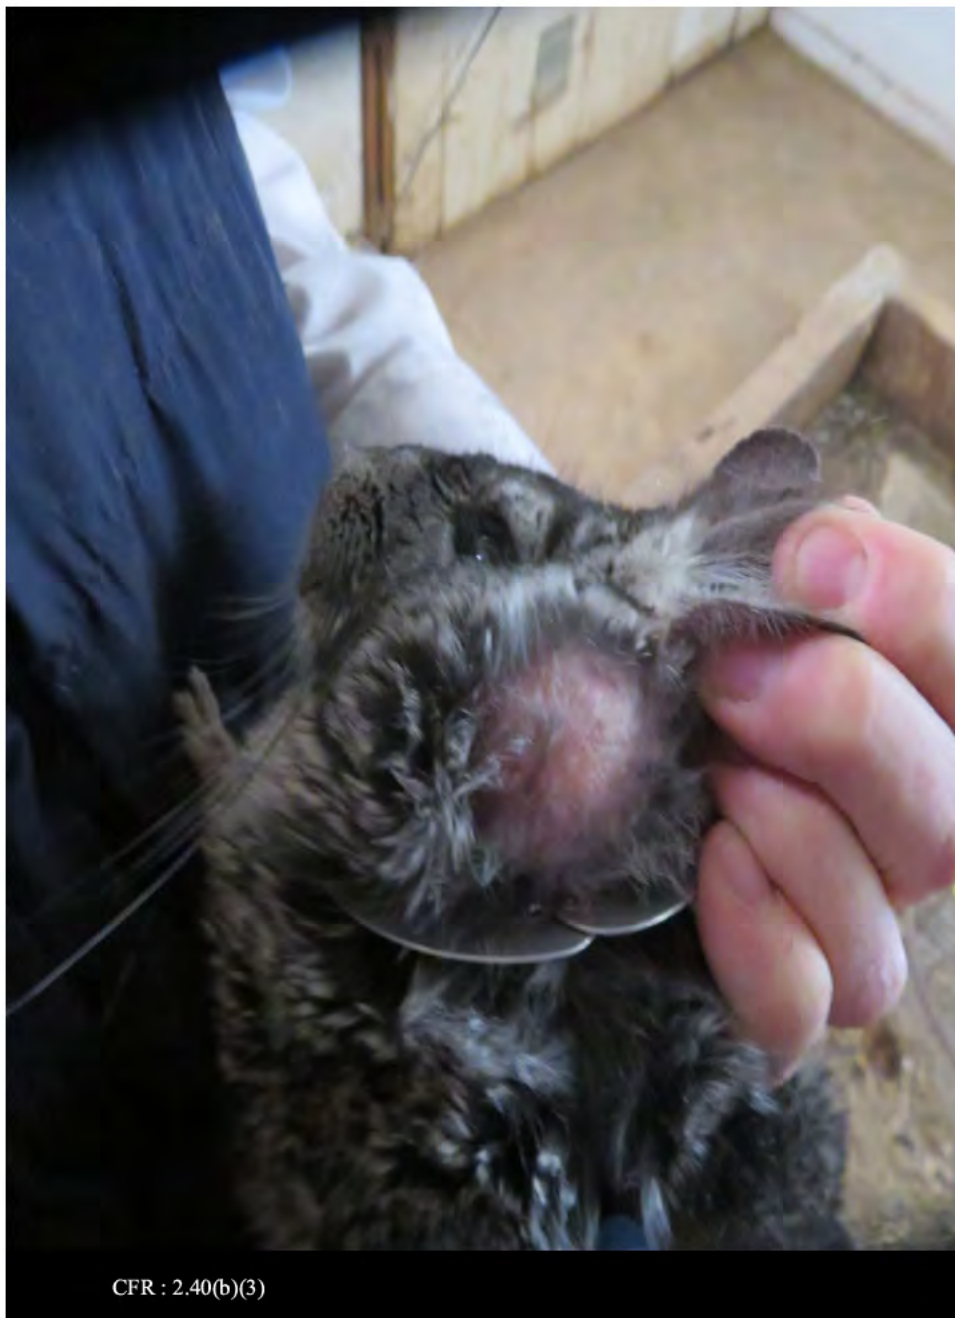
Female grey chinchilla with a swollen area under her left side of her jaw. Facility assigned her treatment tag #65 after we pointed the problem out.

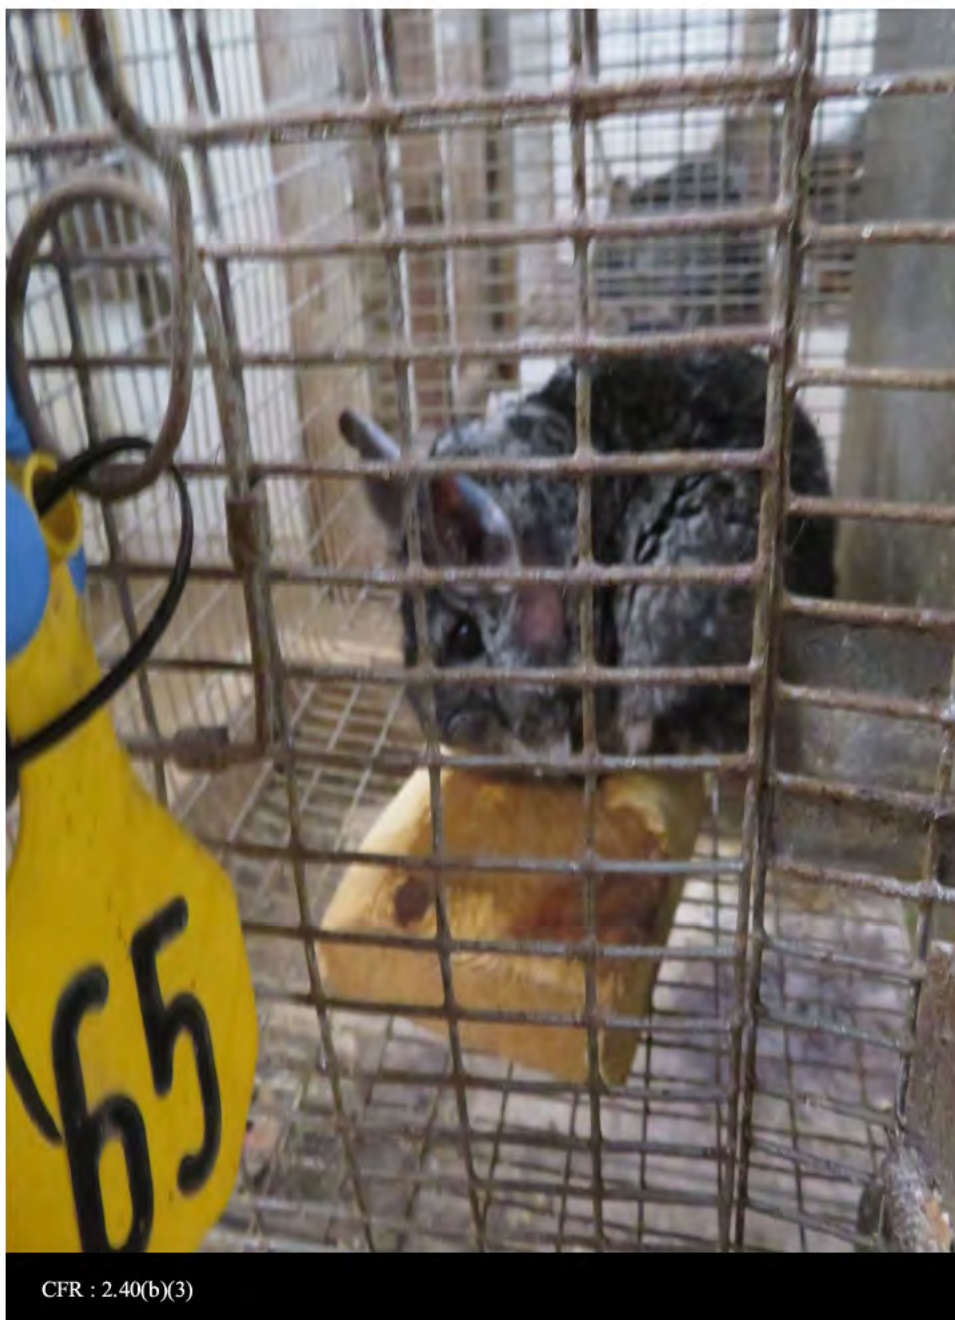
Female grey chinchilla with a swollen area under her left side of her jaw. Facility assigned her treatment tag #65 after we pointed the problem out. Picture is looking at chinchilla from front of enclosure.

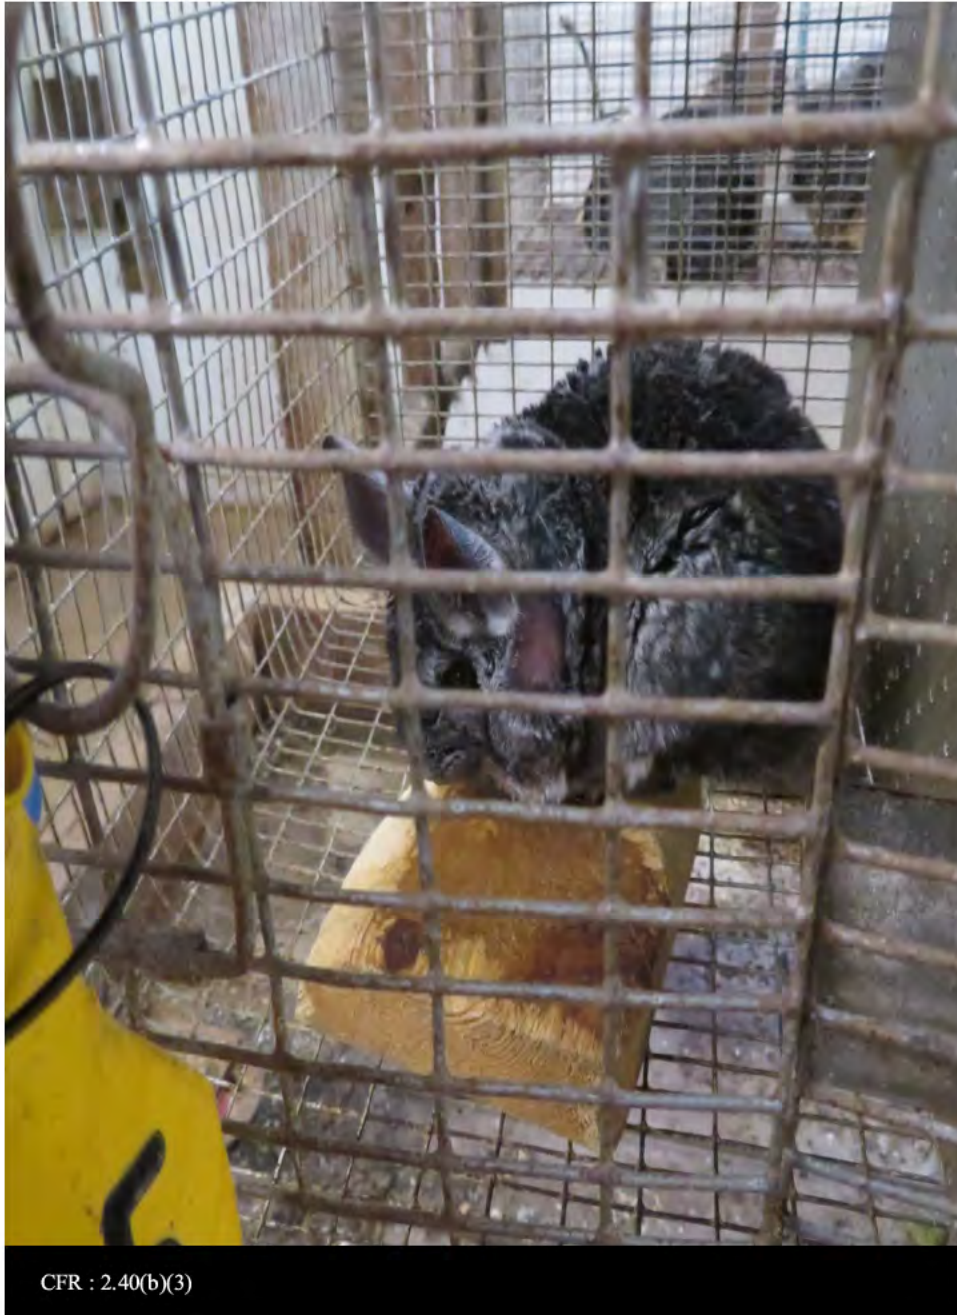
Female grey chinchilla with a swollen area under her left side of her jaw. Facility assigned her treatment tag #65 after we pointed the problem out. Picture is looking at chinchilla from the front of the enclosure.

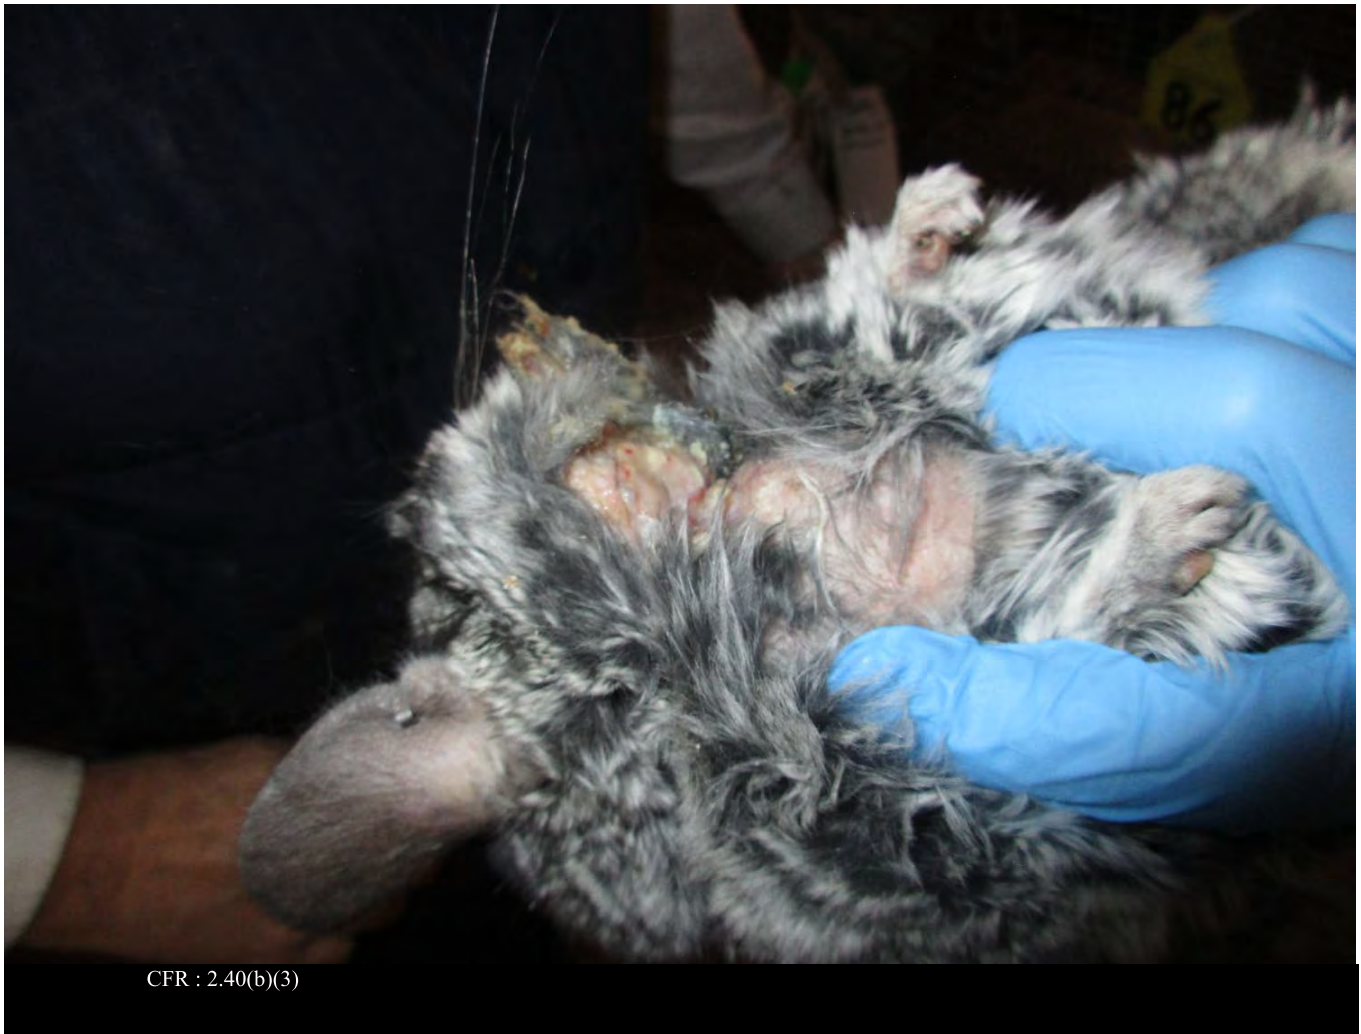
Ventral neck (lower neck) of chinchilla (eartag PMR 683) that had swollen skin and eroded skin under where collar was. Discharge can be seen in center of hairless area.

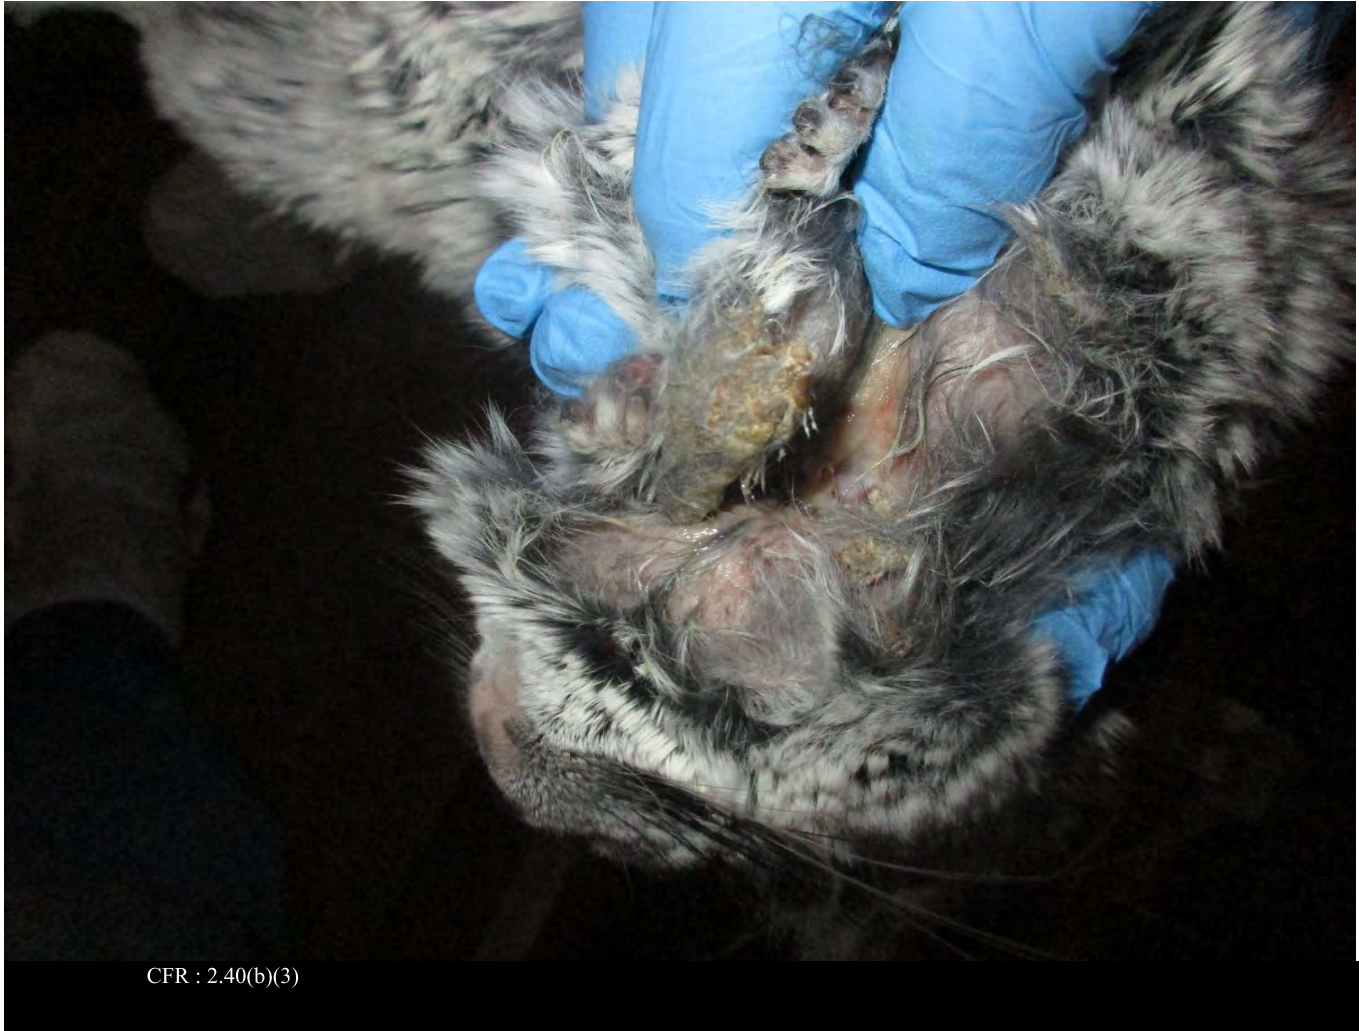
Ventral neck (lower neck) of chinchilla (eartag PMR 683) that had crusted hair around collar and found to have swollen skin and eroded skin under where collar was.

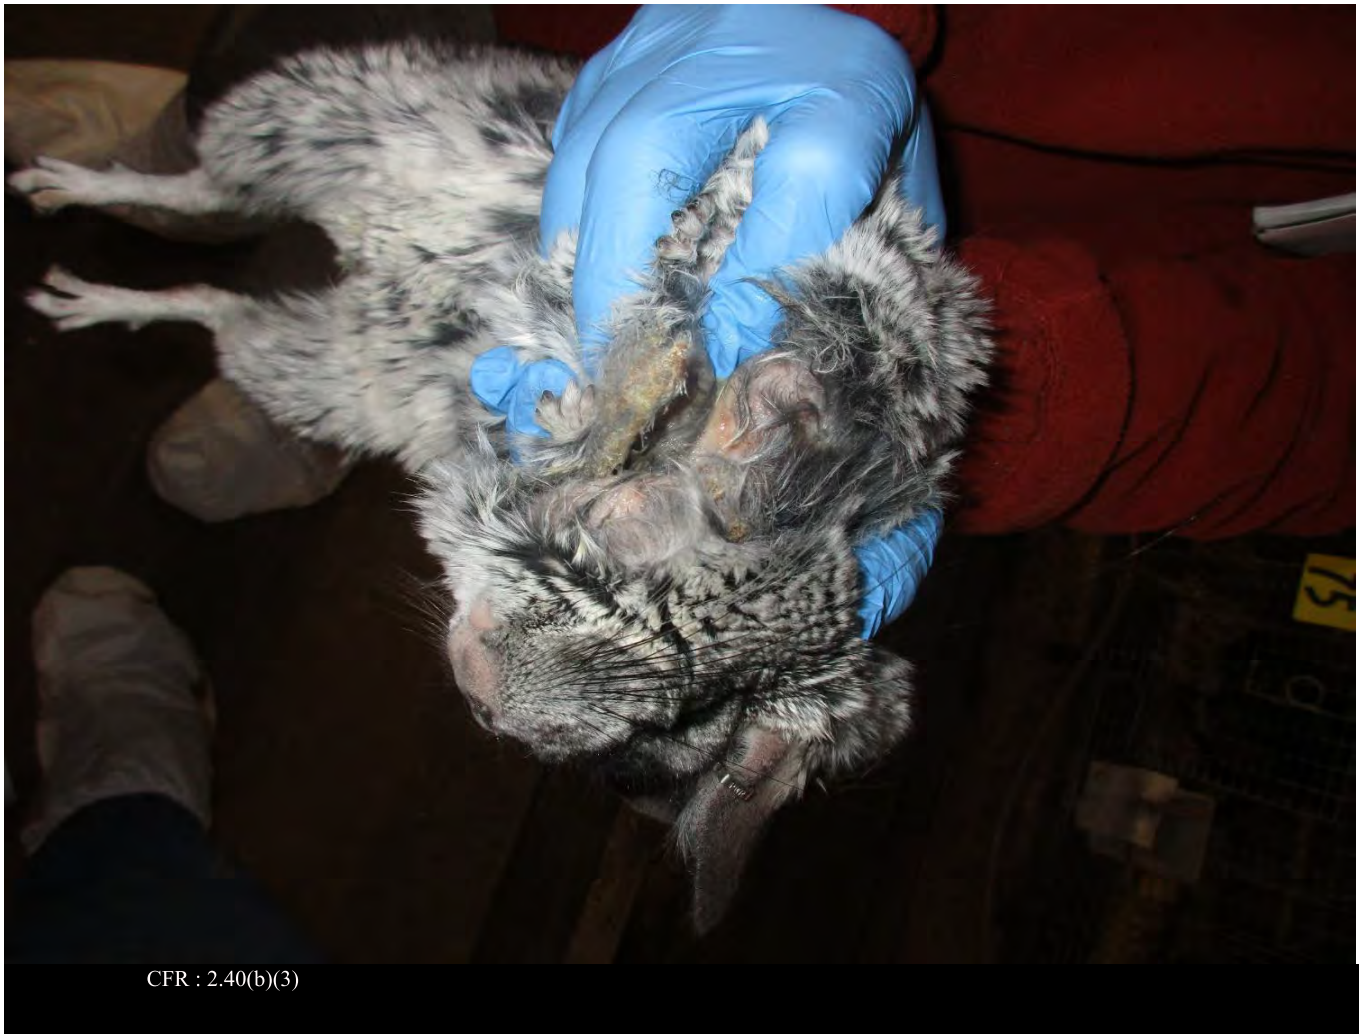
Ventral neck (lower neck) of chinchilla (eartag PMR 683) that had swollen skin and eroded area under where collar was.

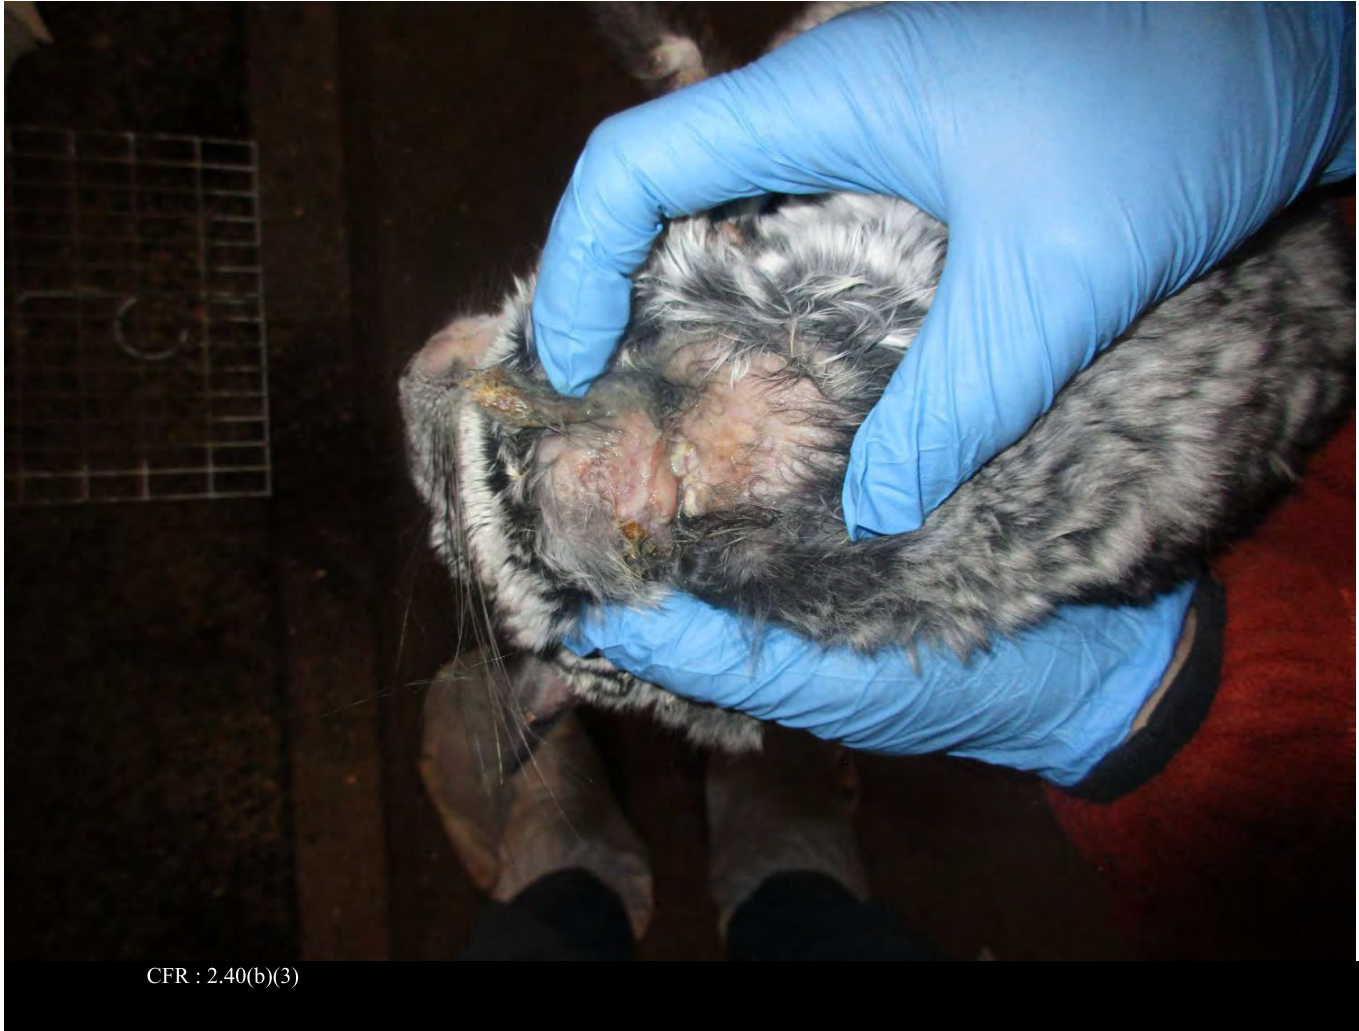
Ventral neck (lower neck) of chinchilla (eartag PMR 683) that had swollen skin, and eroded skin under collar with noticeable putrid odor on her lower neck.

Discharge can be seen in hairless area.

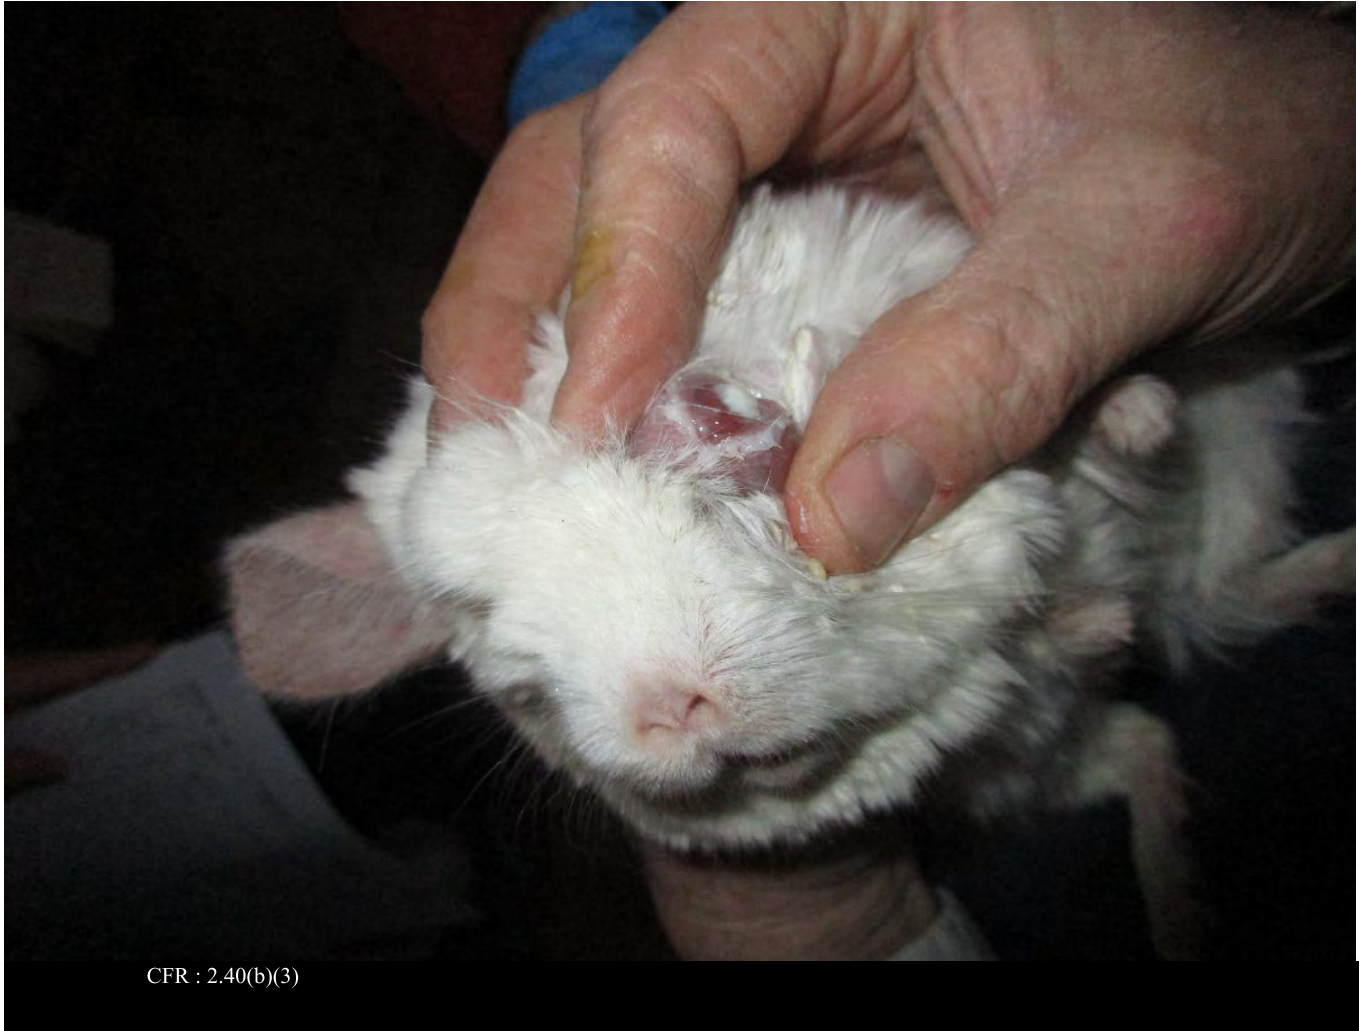
Female white (cartag RVW 109) chinchilla's left eye was swollen shut and when handled by licensee had some pale discharge.

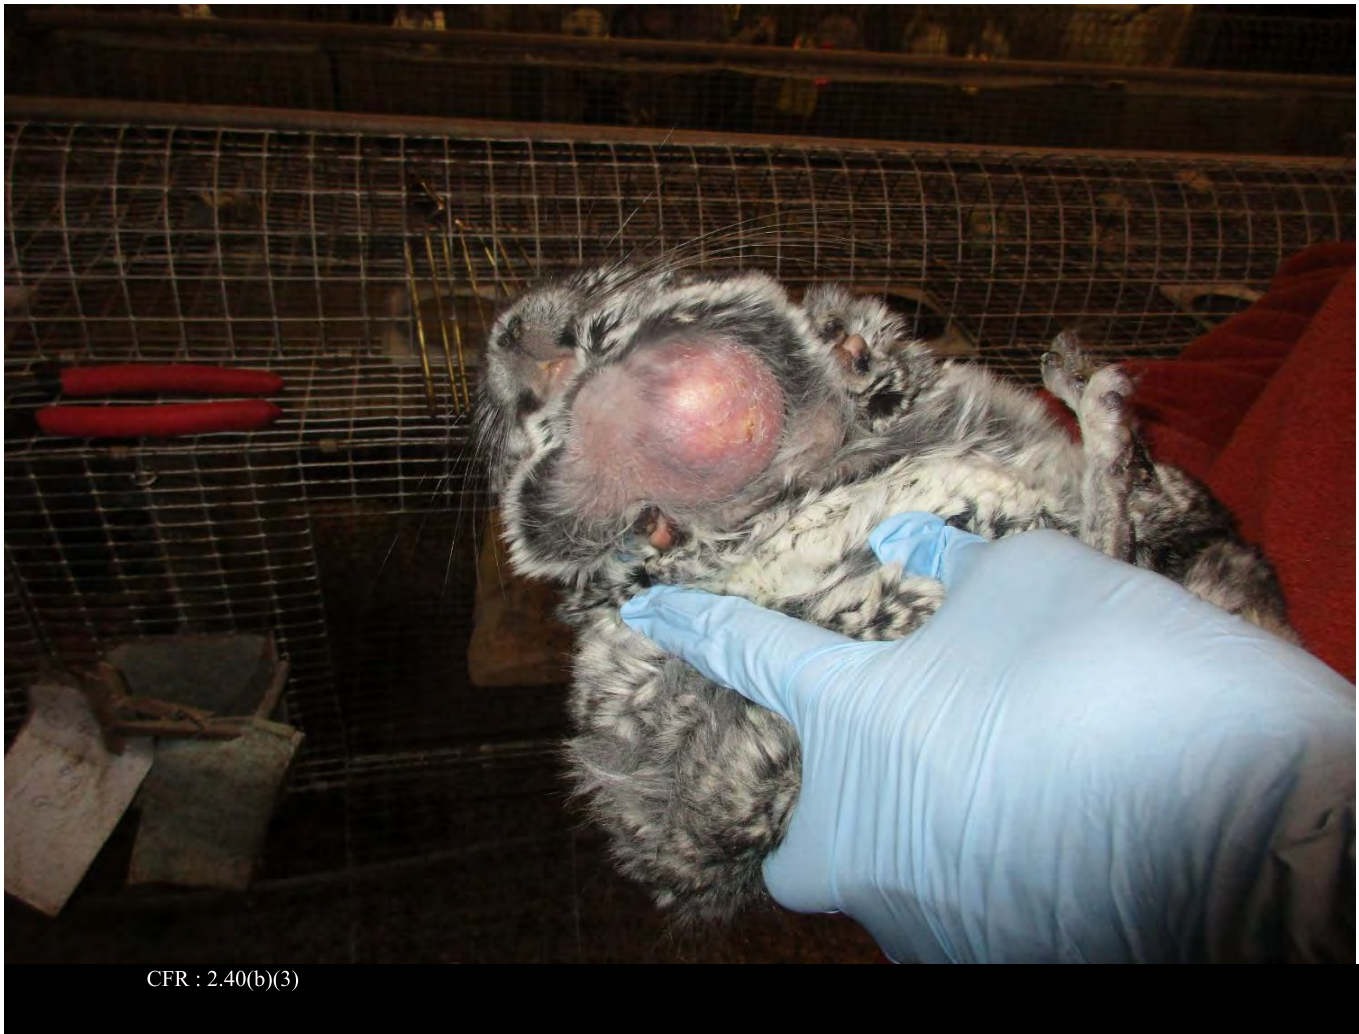
Grey female chinchilla (no tag, housed in 59B) had a swollen, red, hairless area under her neck.

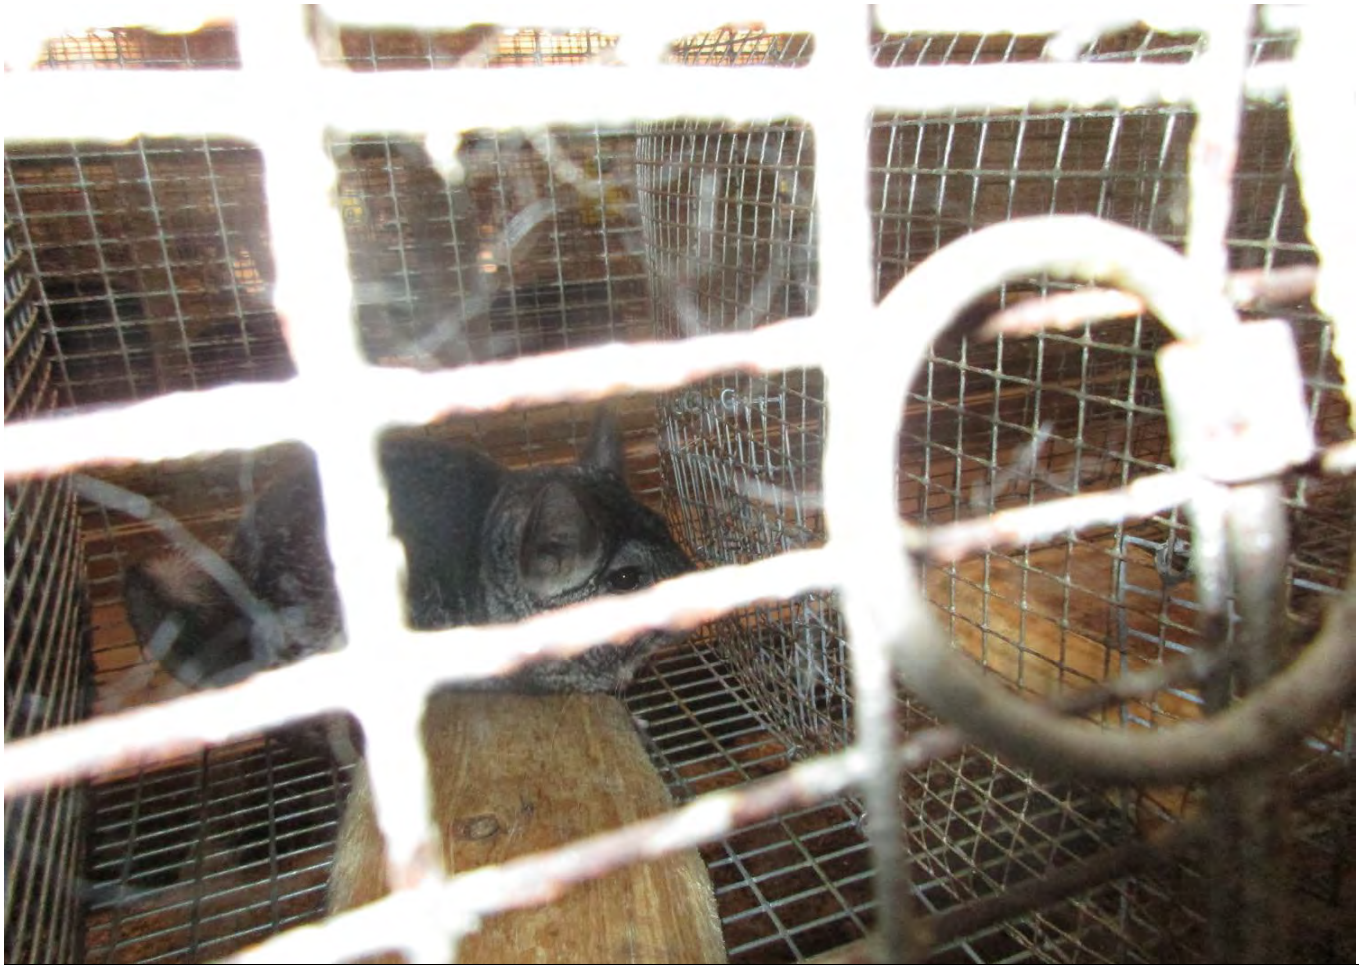
Wire points protruding from divider in front of chinchilla.
