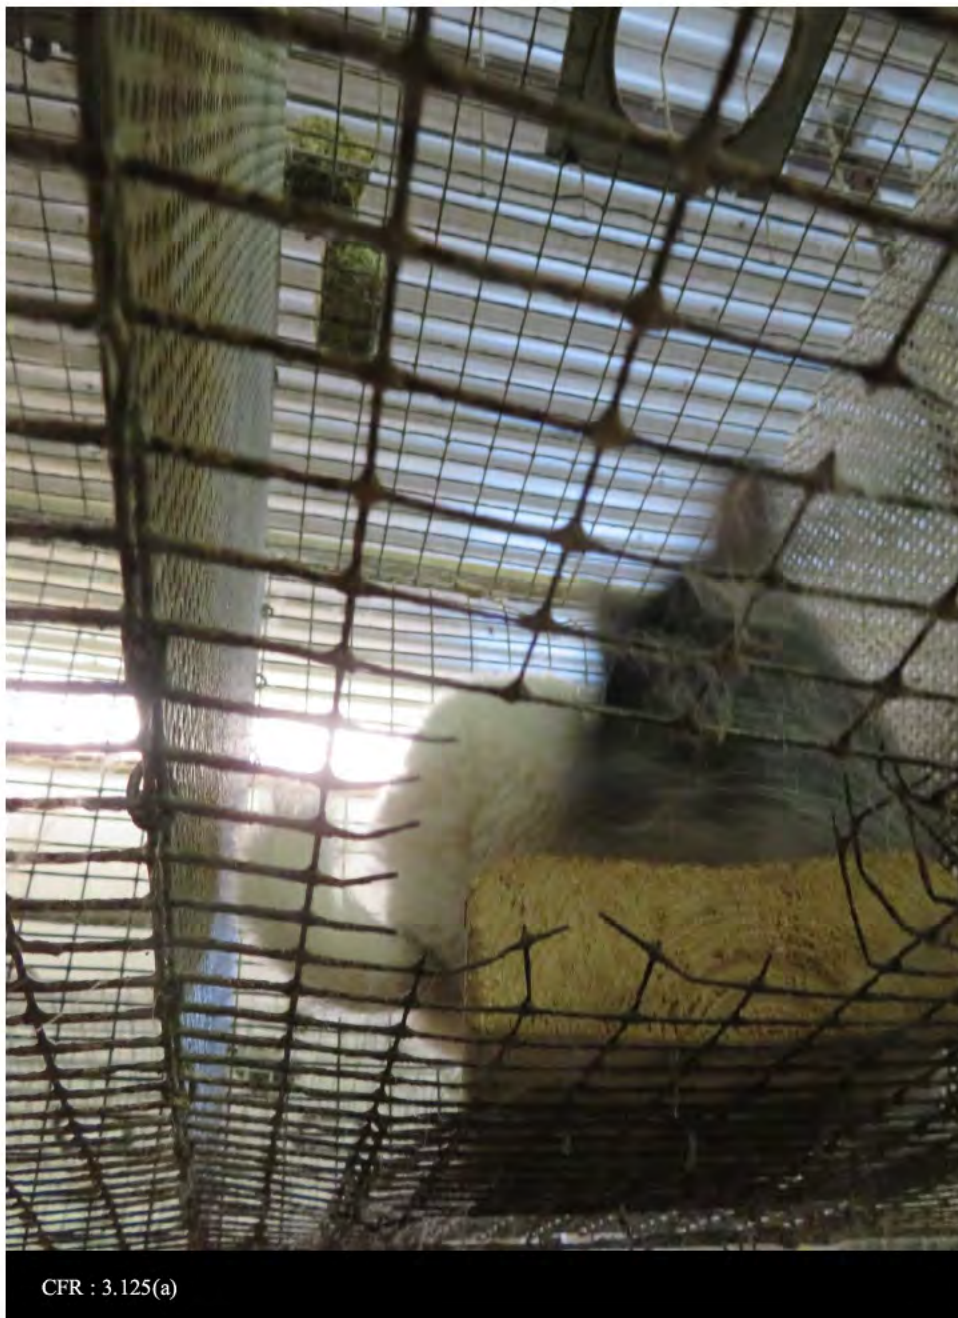
Hole in floor of enclosure with sharp points creating escape/injury hazards.

Licensee patched hole and removed points during inspection.

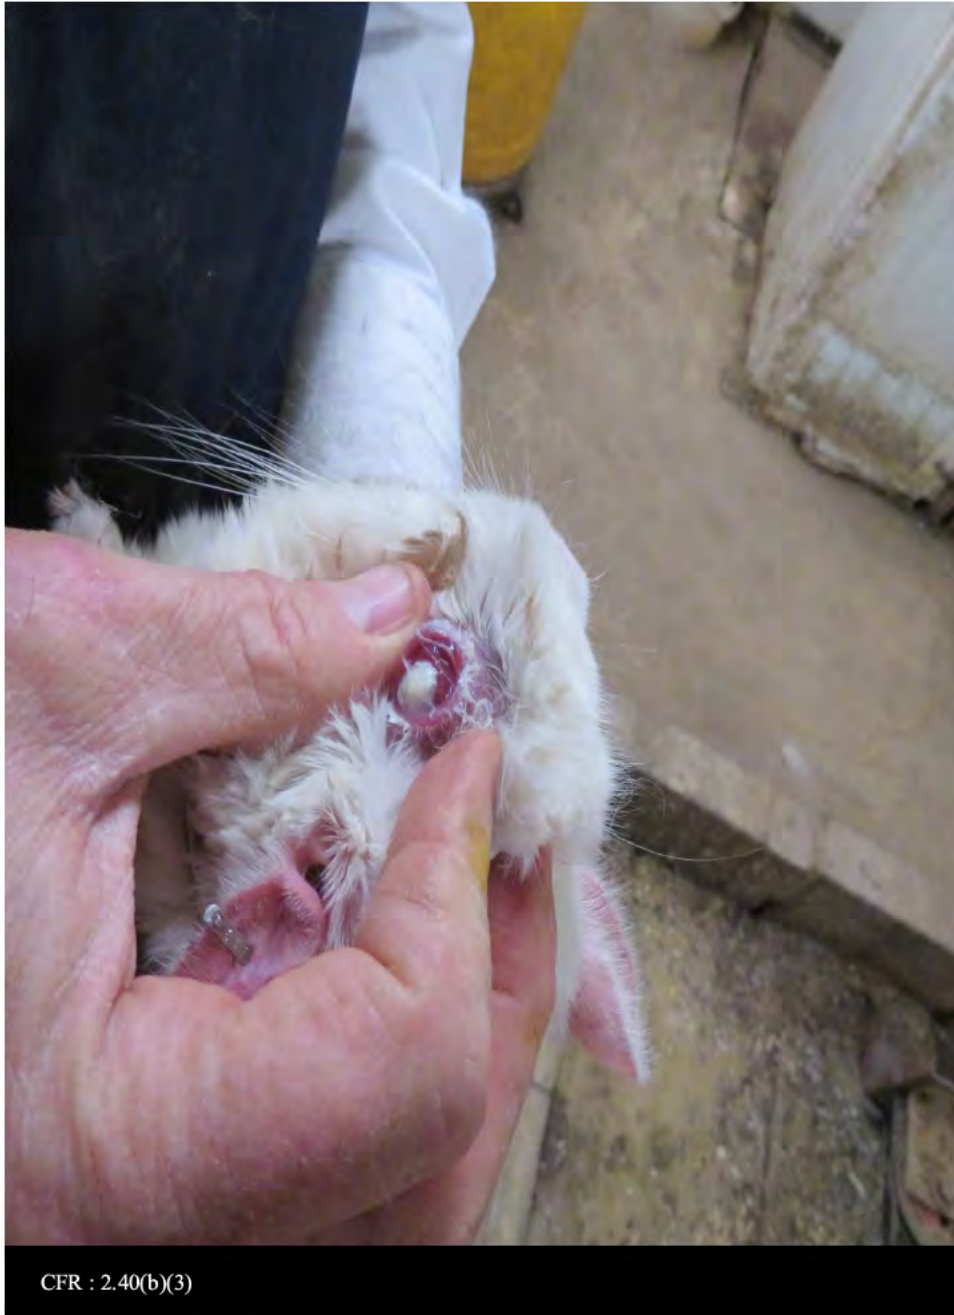
Female white (eartag RVW 109) chinchilla's left eye was swollen shut and when handled by licensee had some pale discharge; the pale material in the center surface of the eyeball (seen in photo) appeared adhered to it while the licensee handled it.

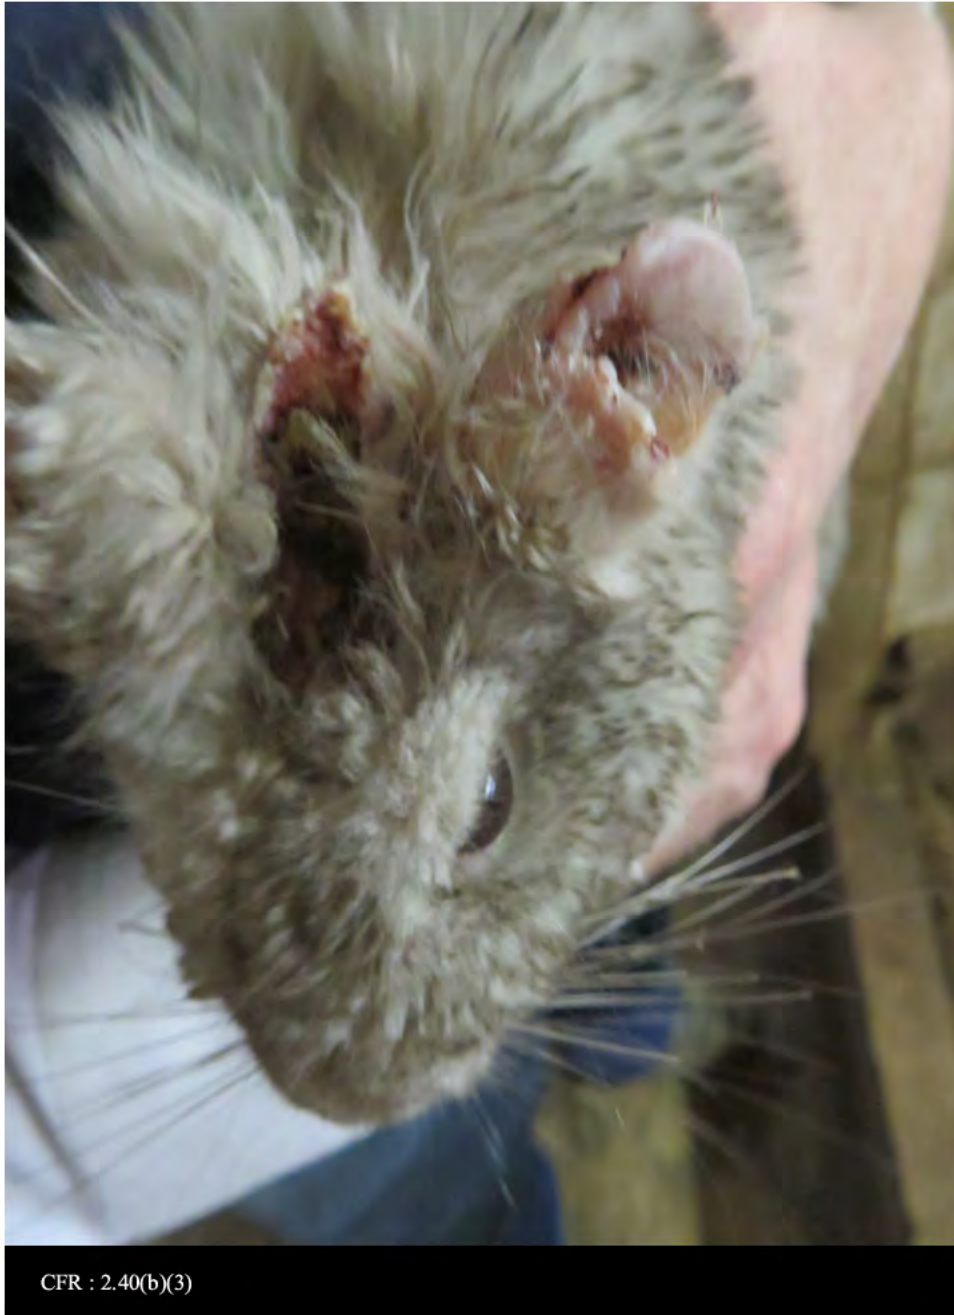
Male chinchilla (no eartag, housed in bank 101) open wound on top of head.

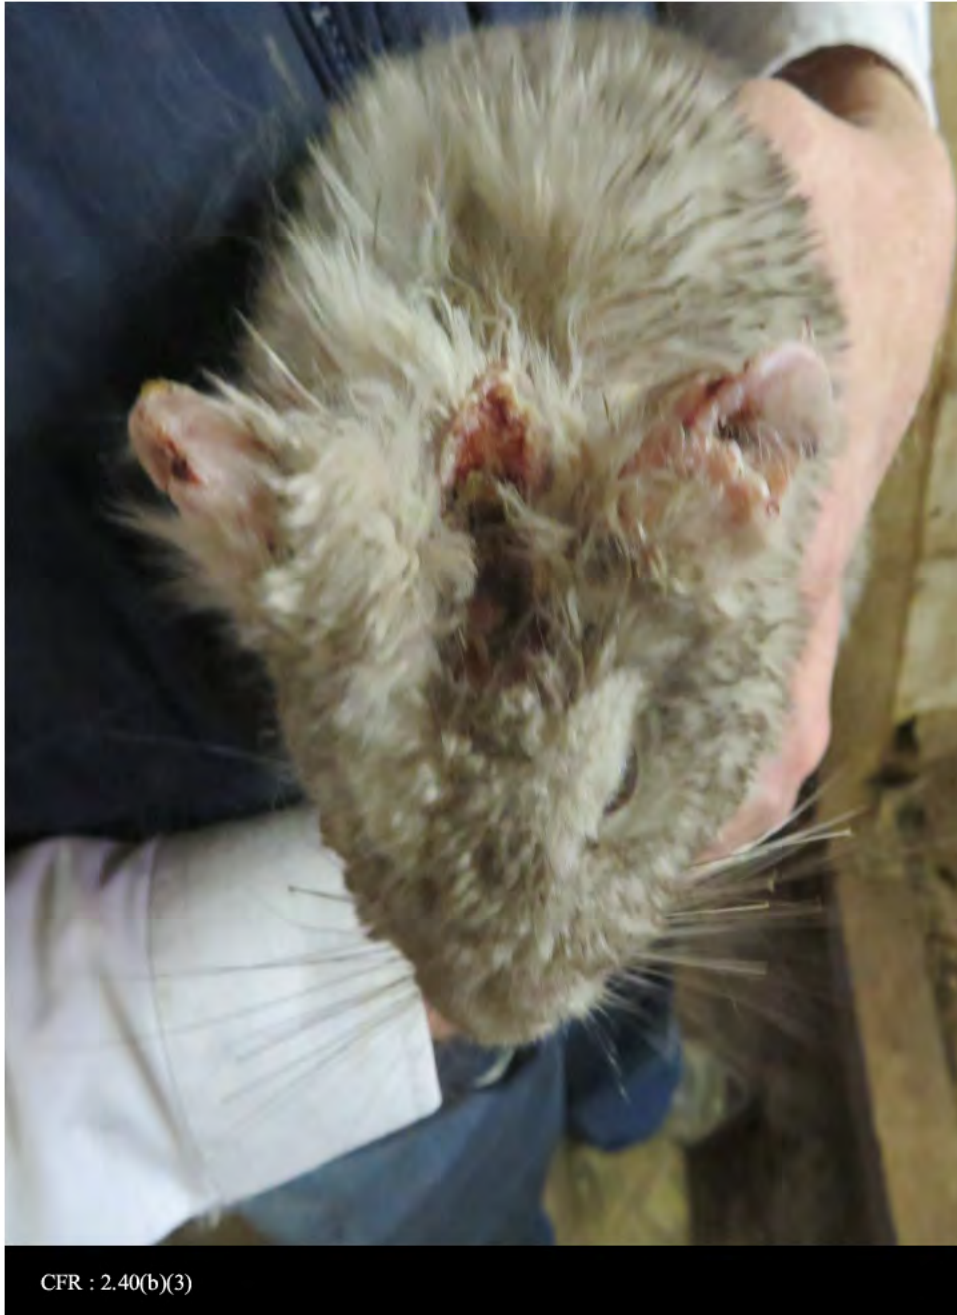
Male chinchilla (no eartag, housed in bank 101) open wound on top of head.

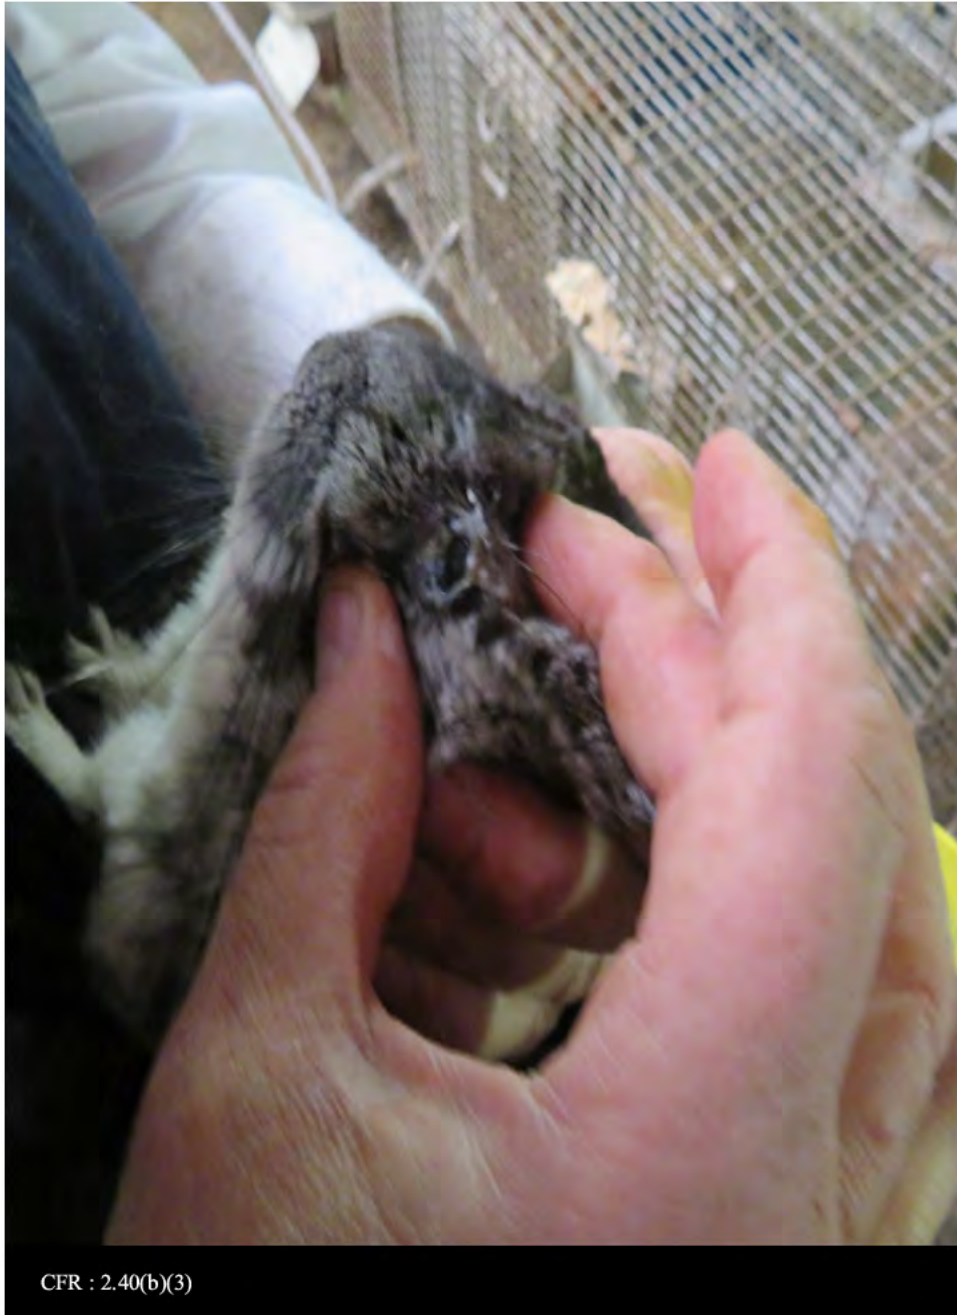
A female grey (eartag DJM 122) chinchilla's left eye was crusted shut; the licensee opened it and there was some pale discharge in it.

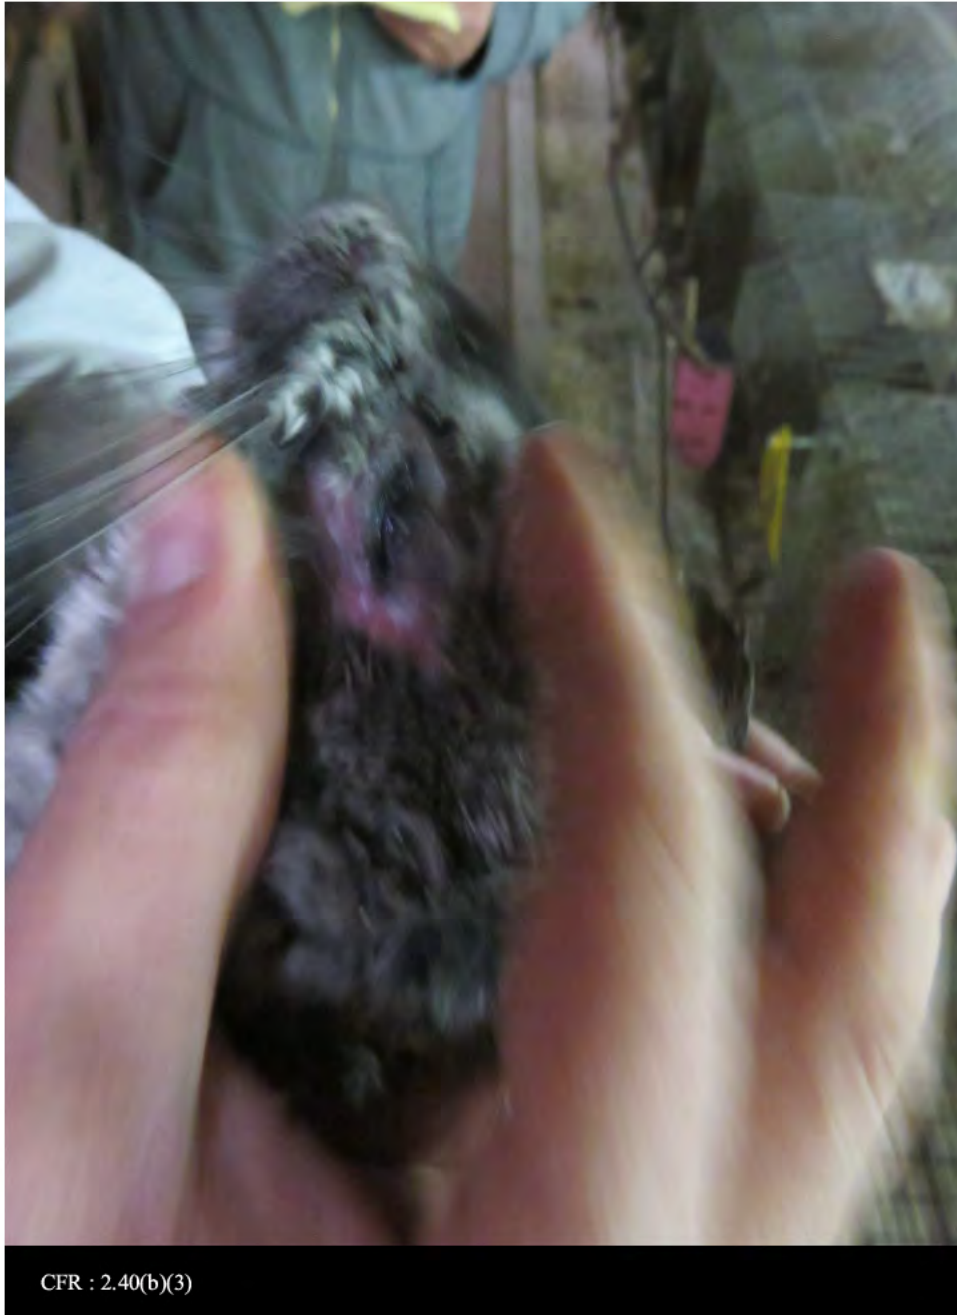
Male grey (eartag DJM 115) chinchilla's left eye seen while licensee removed  
crusted material--discharge present and note reddened, hairless eyelids.

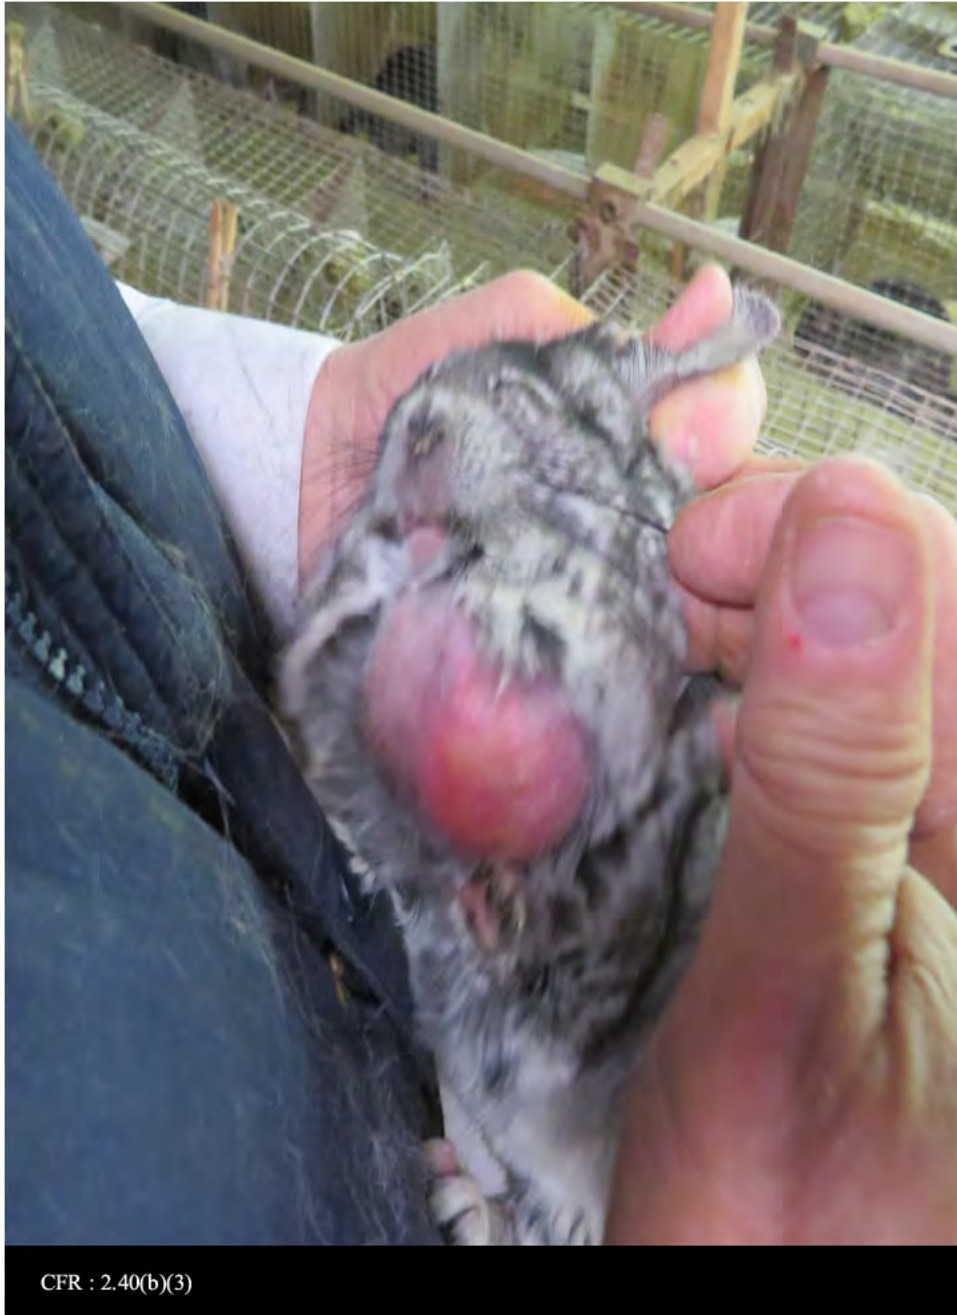
Grey female chinchilla (no tag, housed in 59B) had a swollen, red, hairless area under her neck.

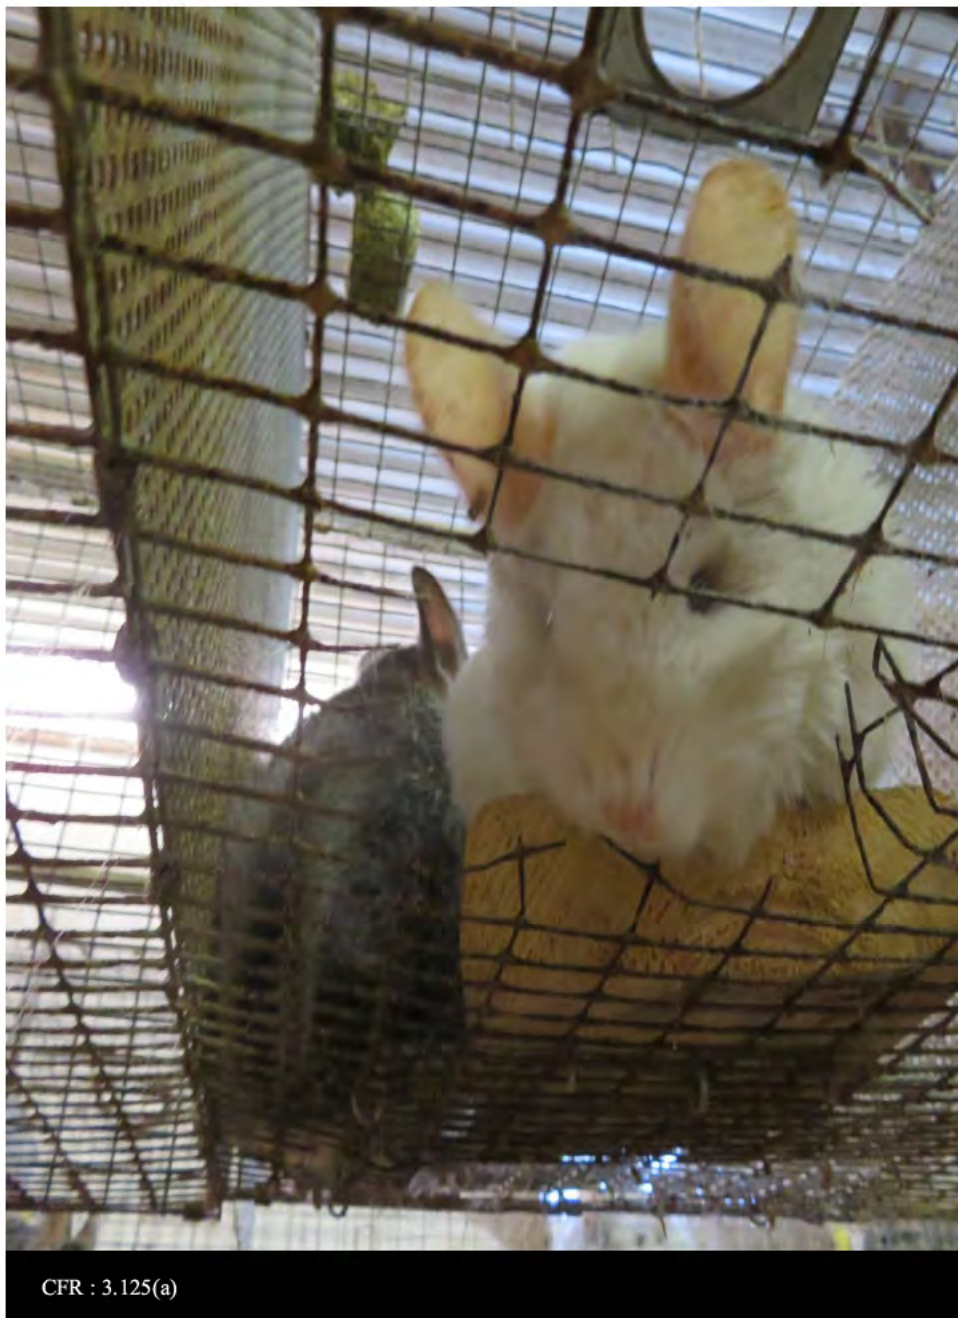
Hole in floor of enclosure with sharp points creating escape/injury hazards.

Licensee patched hole and removed points during inspection.

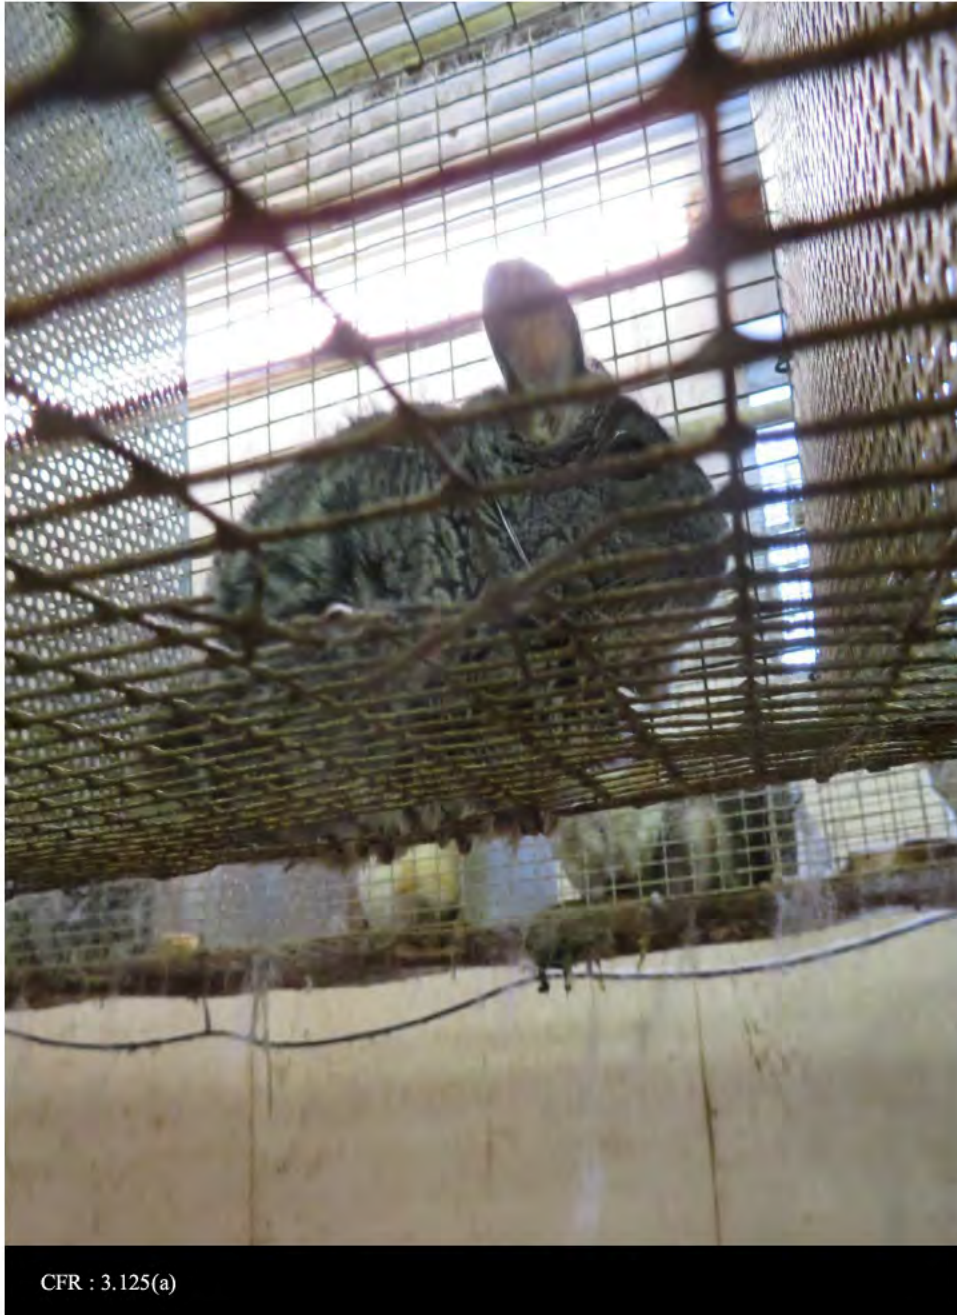
Broken wire on floor (center of image). Licensee removed broken wire and patched hole during inspection.

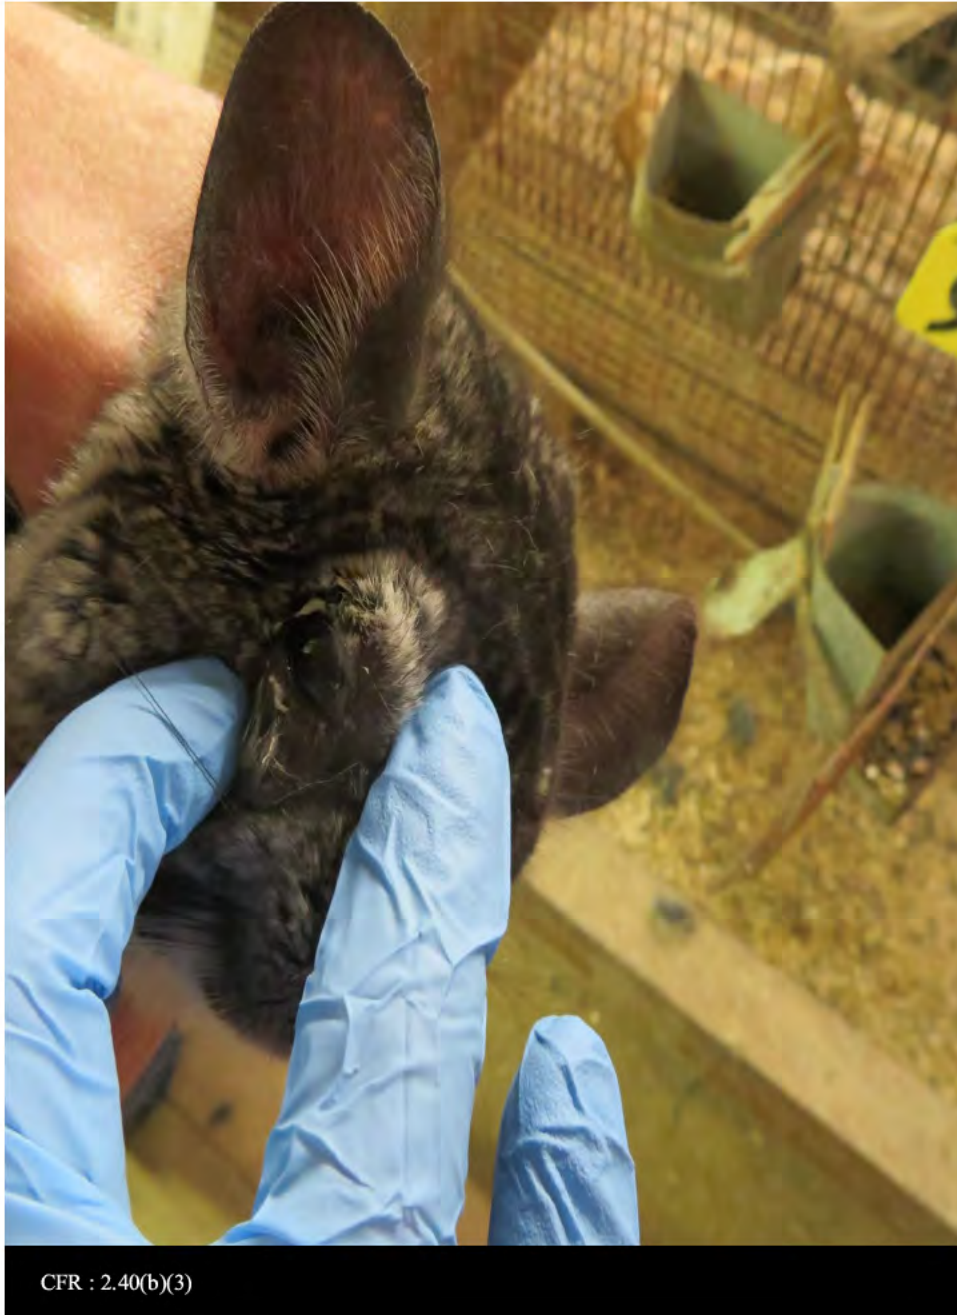
Female grey (no eartag, housed in 90A) chinchilla's right eye was crusted shut and had some discharge.

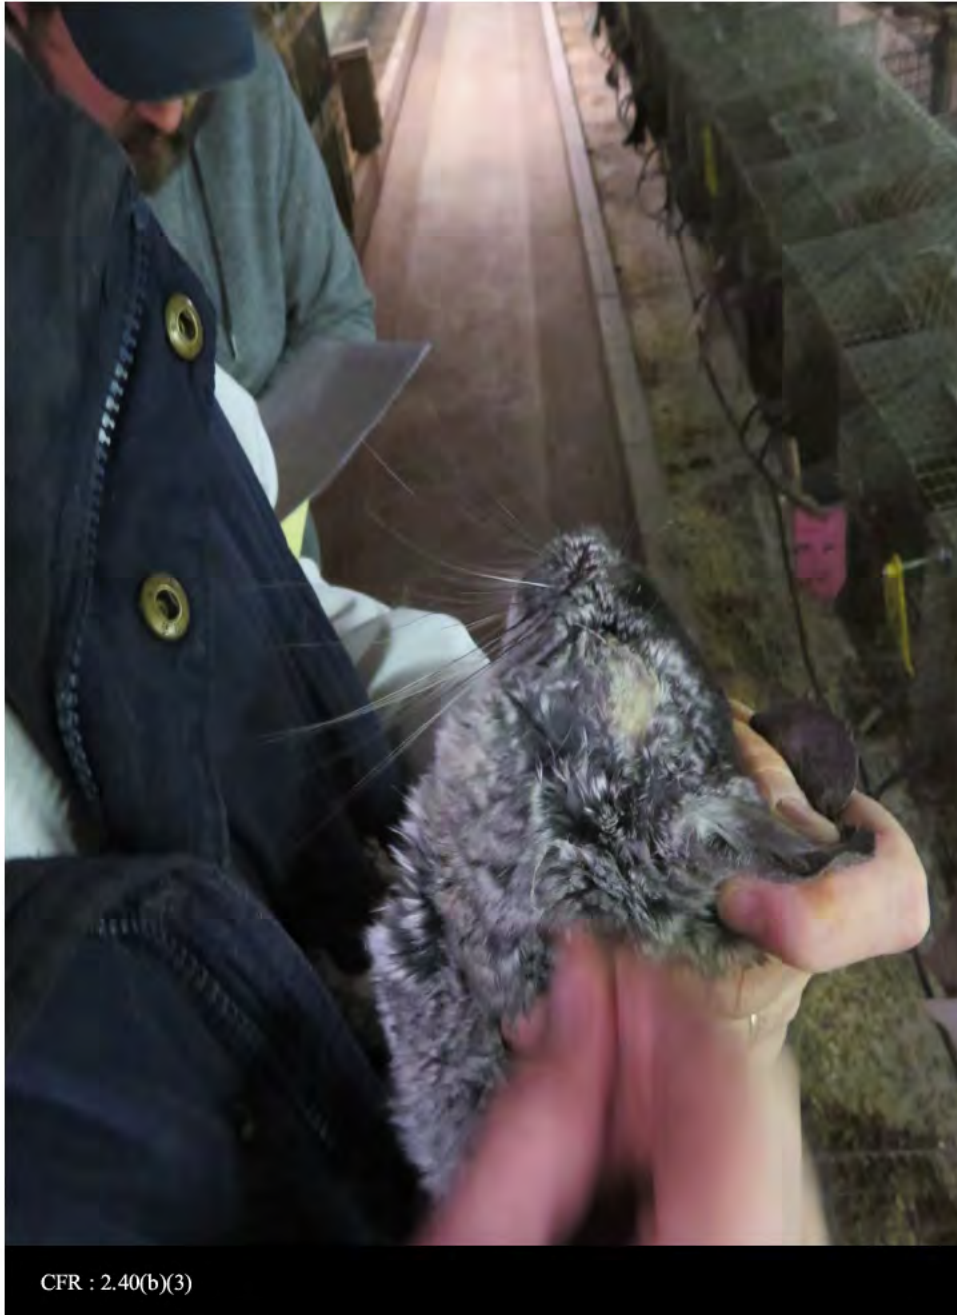
Male grey (eartag DJM 115) chinchilla's left eye sealed shut with a pale crusted material, taken prior to licensee removing crusted material.

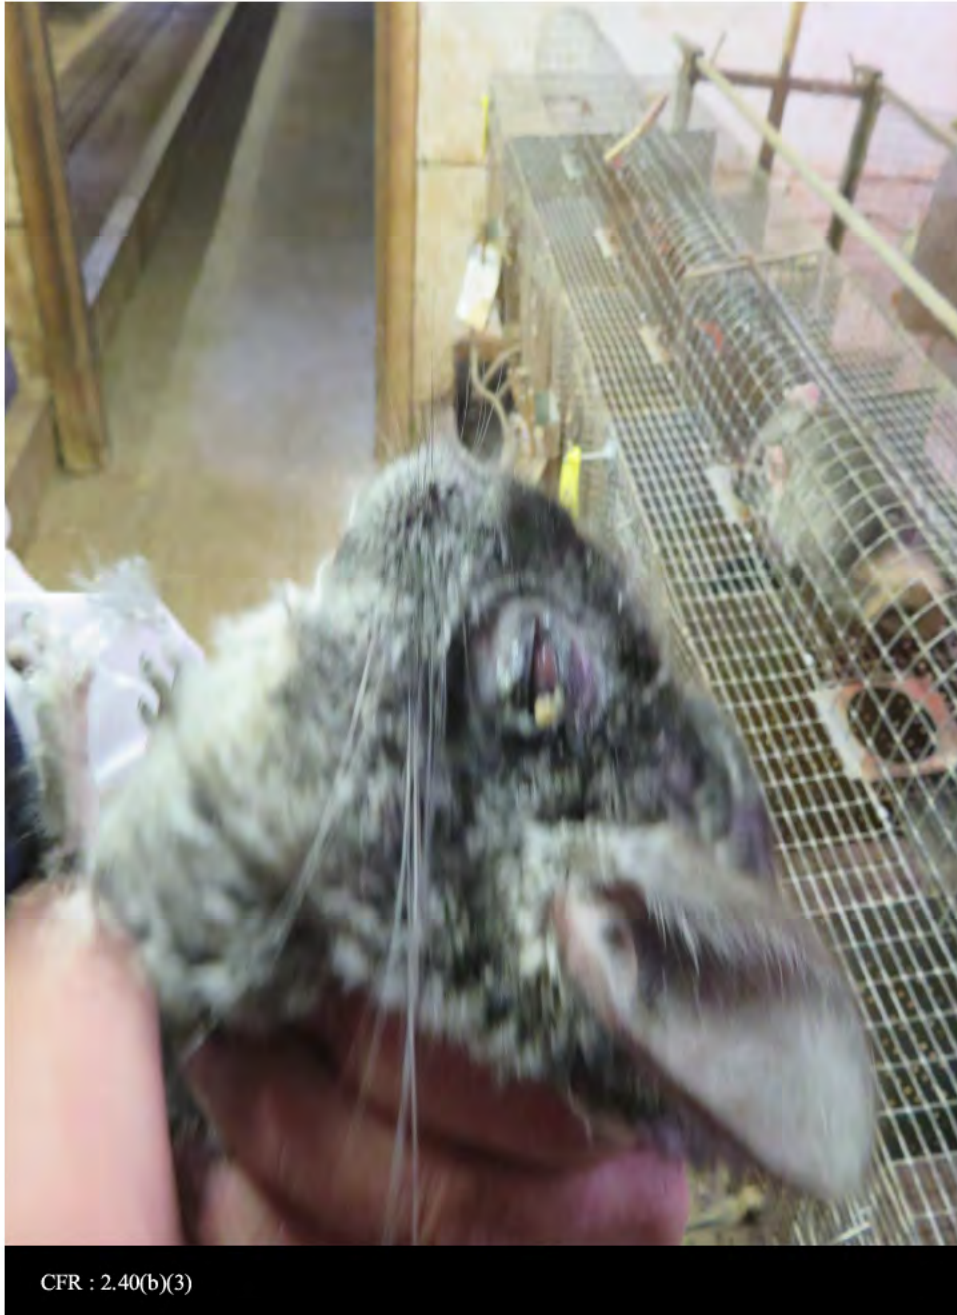
Chinchilla (eartag GROS 214) with discharge in her left eye.

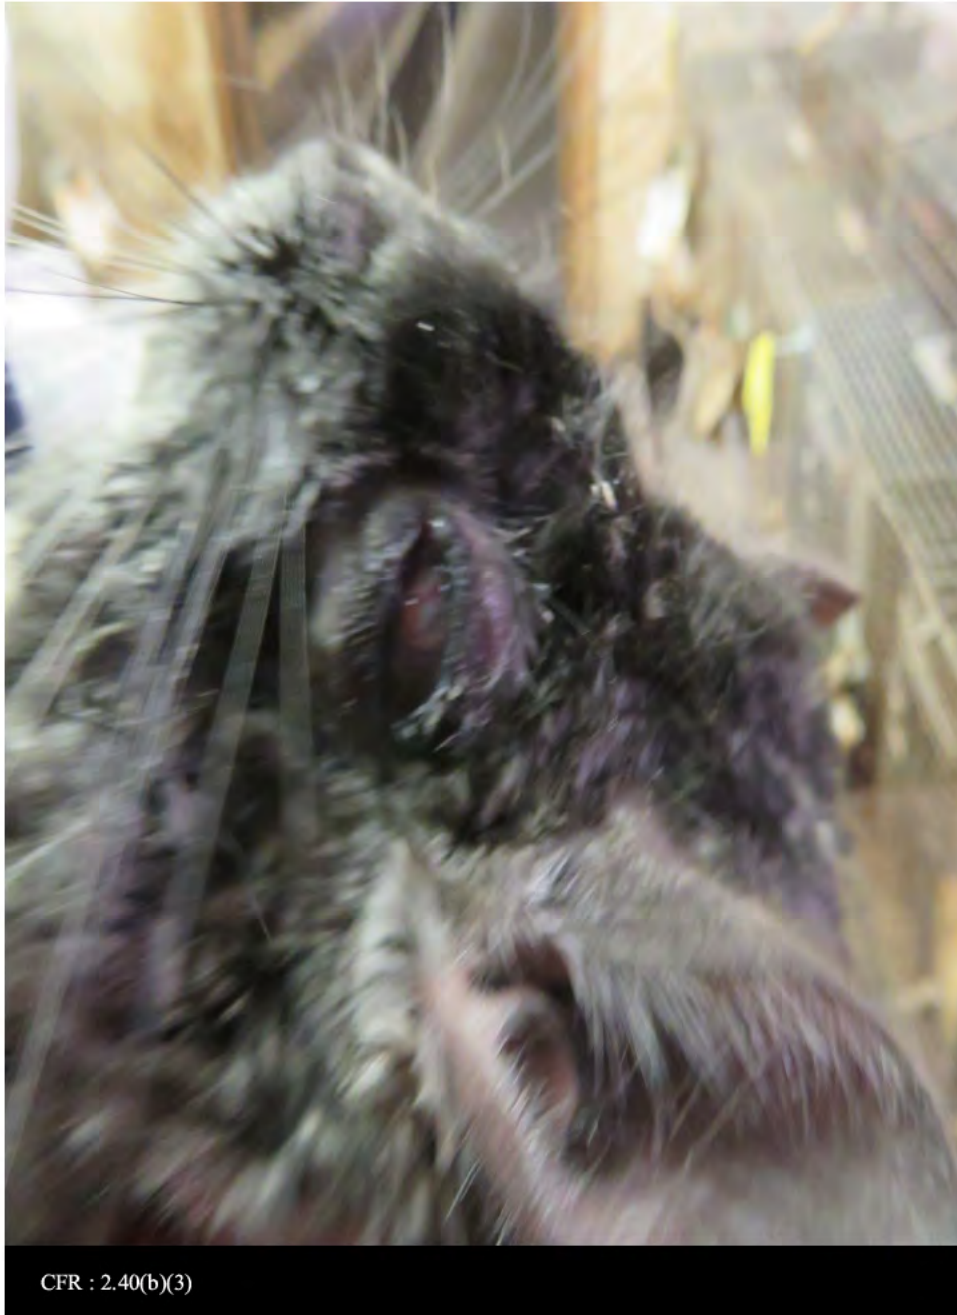
Close-up of GROS 214's left eye; swelling present and surface of eye is reddened.

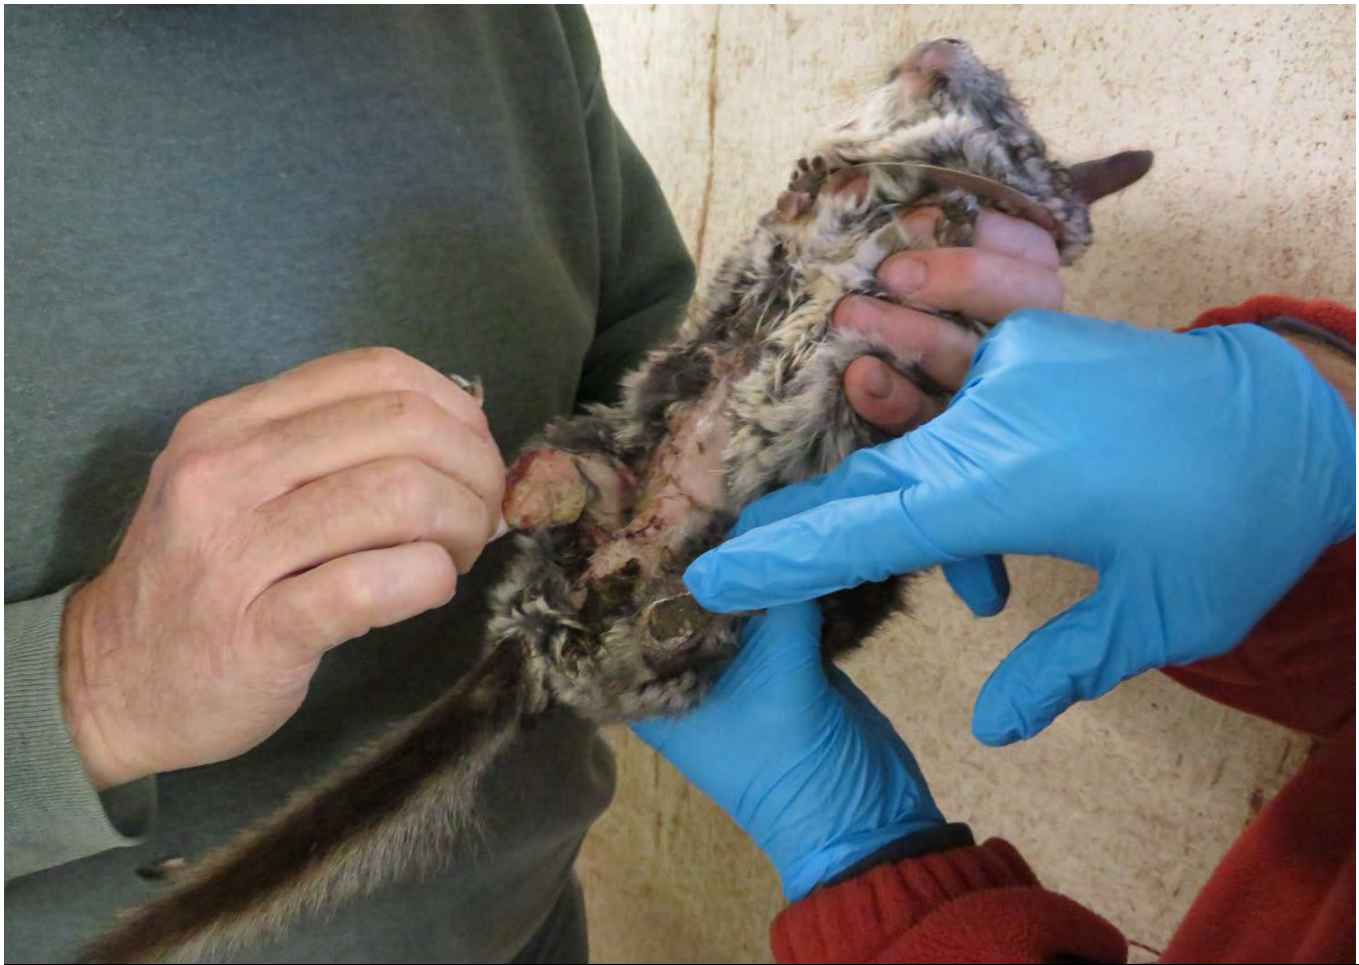
Pen 110c F- RR leg with large wound on inside, some drainage, low weight and signs of scours

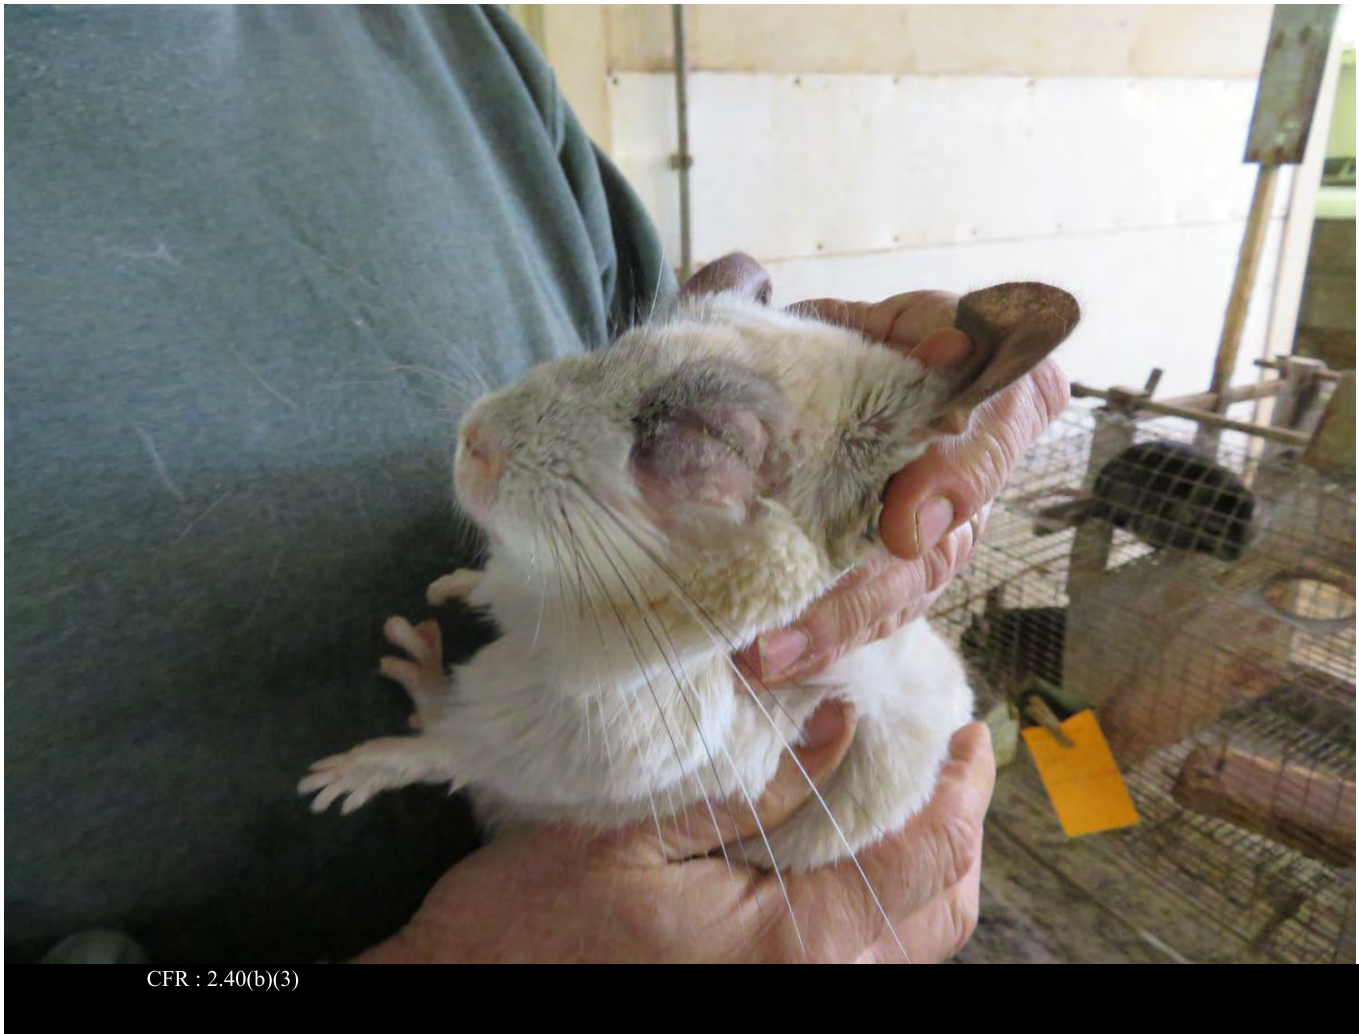
100b F swollen, pus filled left eye

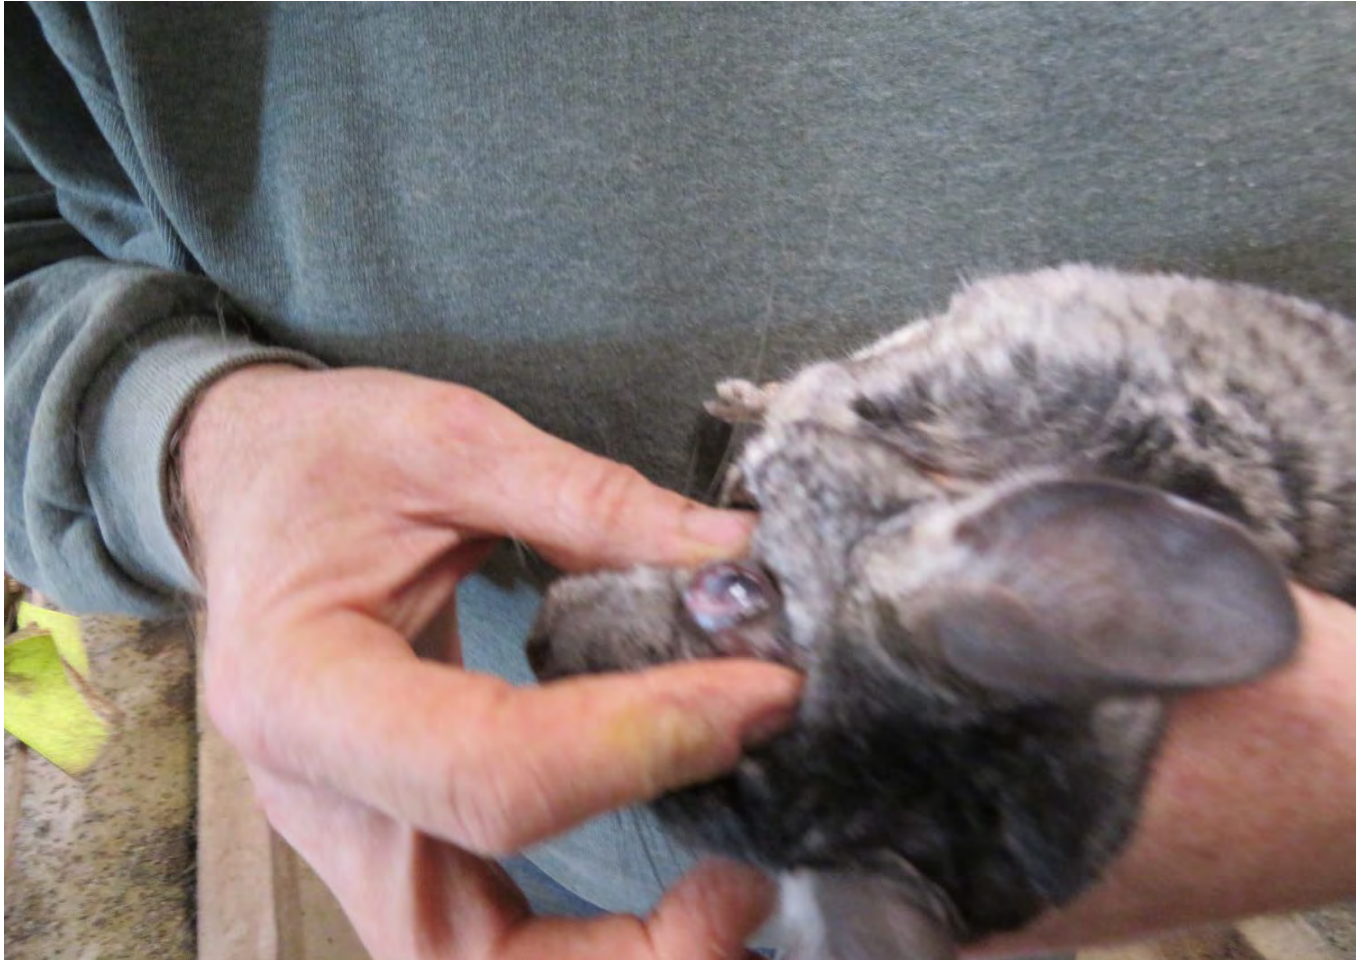
76a M right eye swollen beginning of pus like material starting in eye

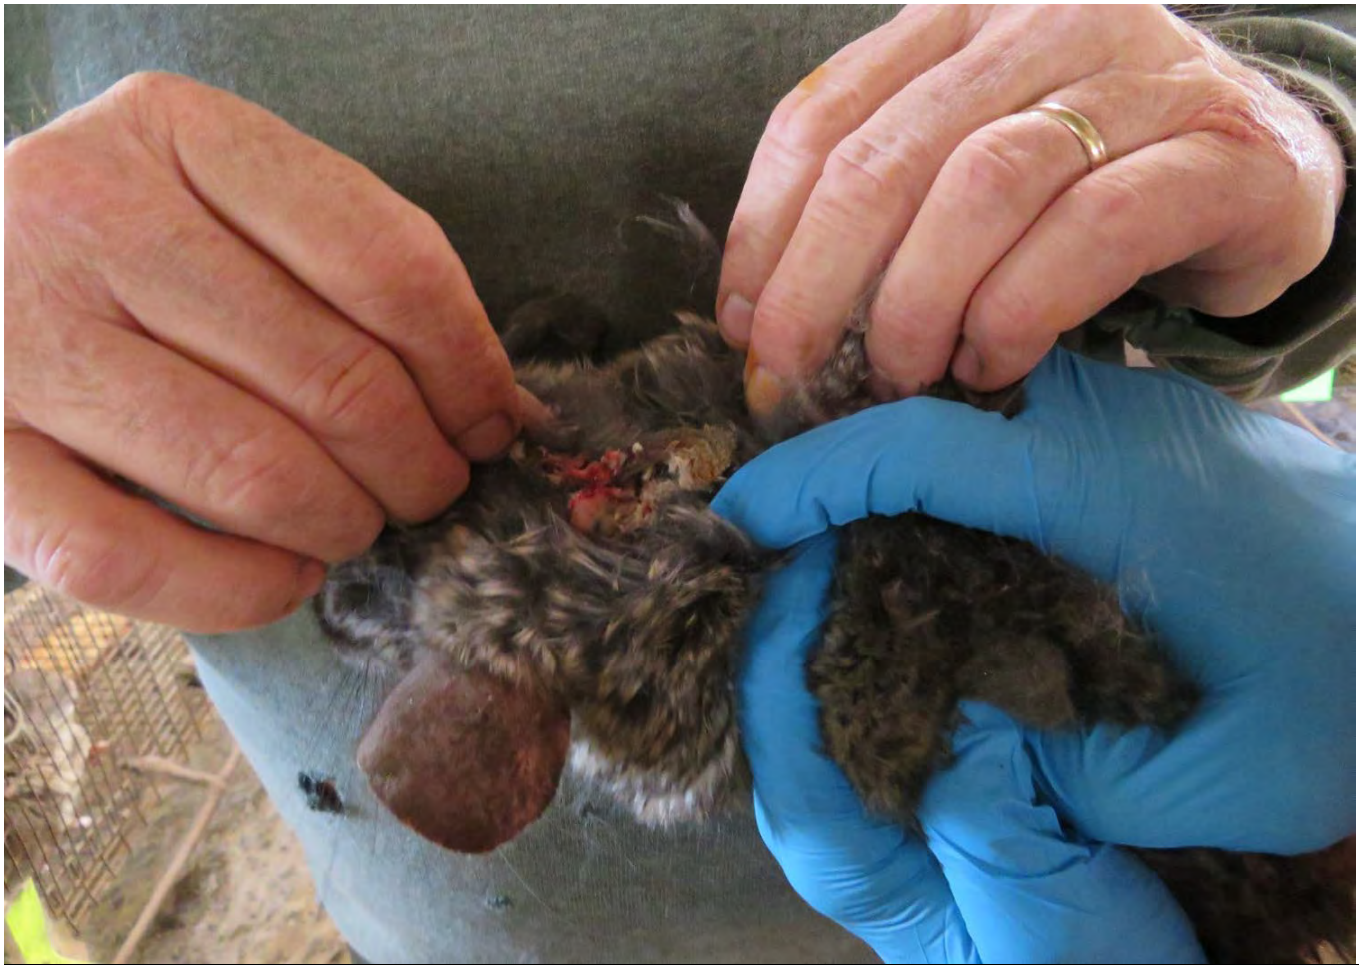
76a F collar on too tight, crusty scab with open wound into top of neck. when collar removed a large piece of dead skin came off stuck to collar exposing red, raw inside of neck
