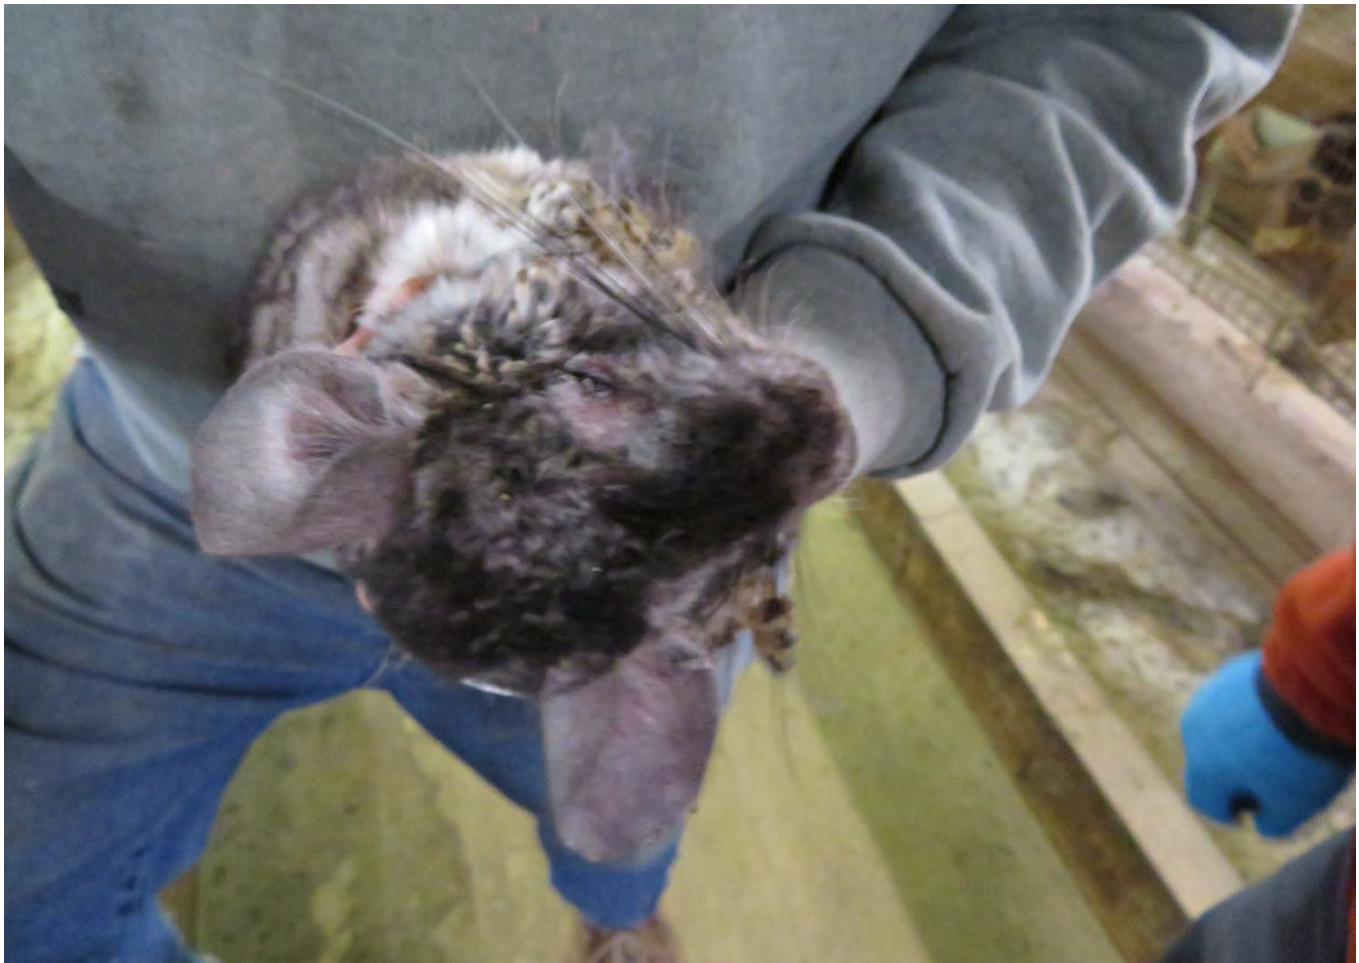
71b F swollen right eye-closed

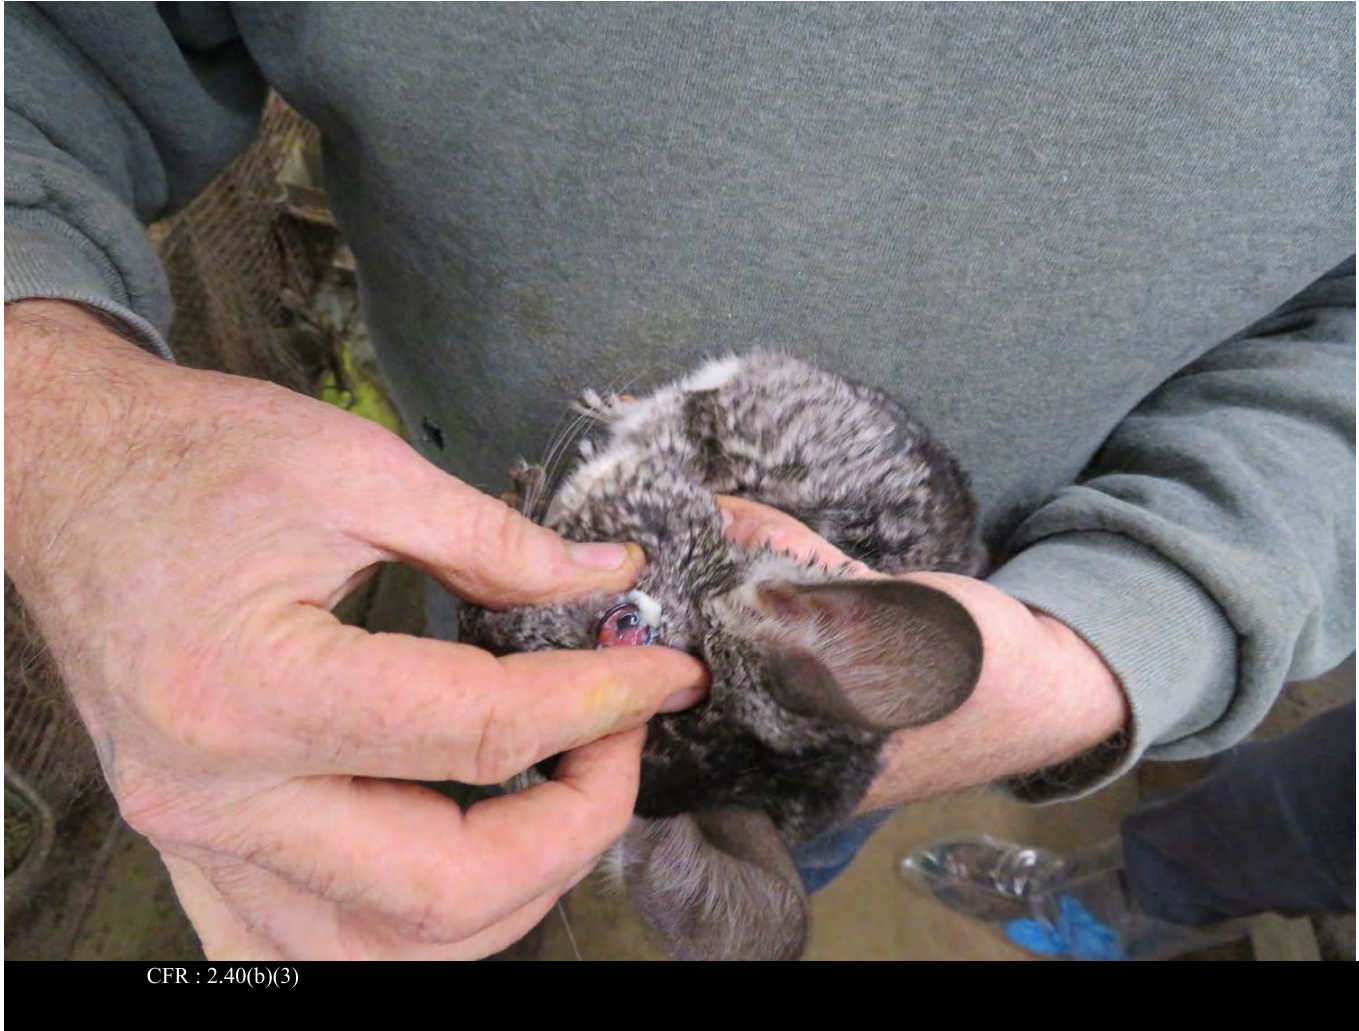
70b M right eye swollen with pus like material

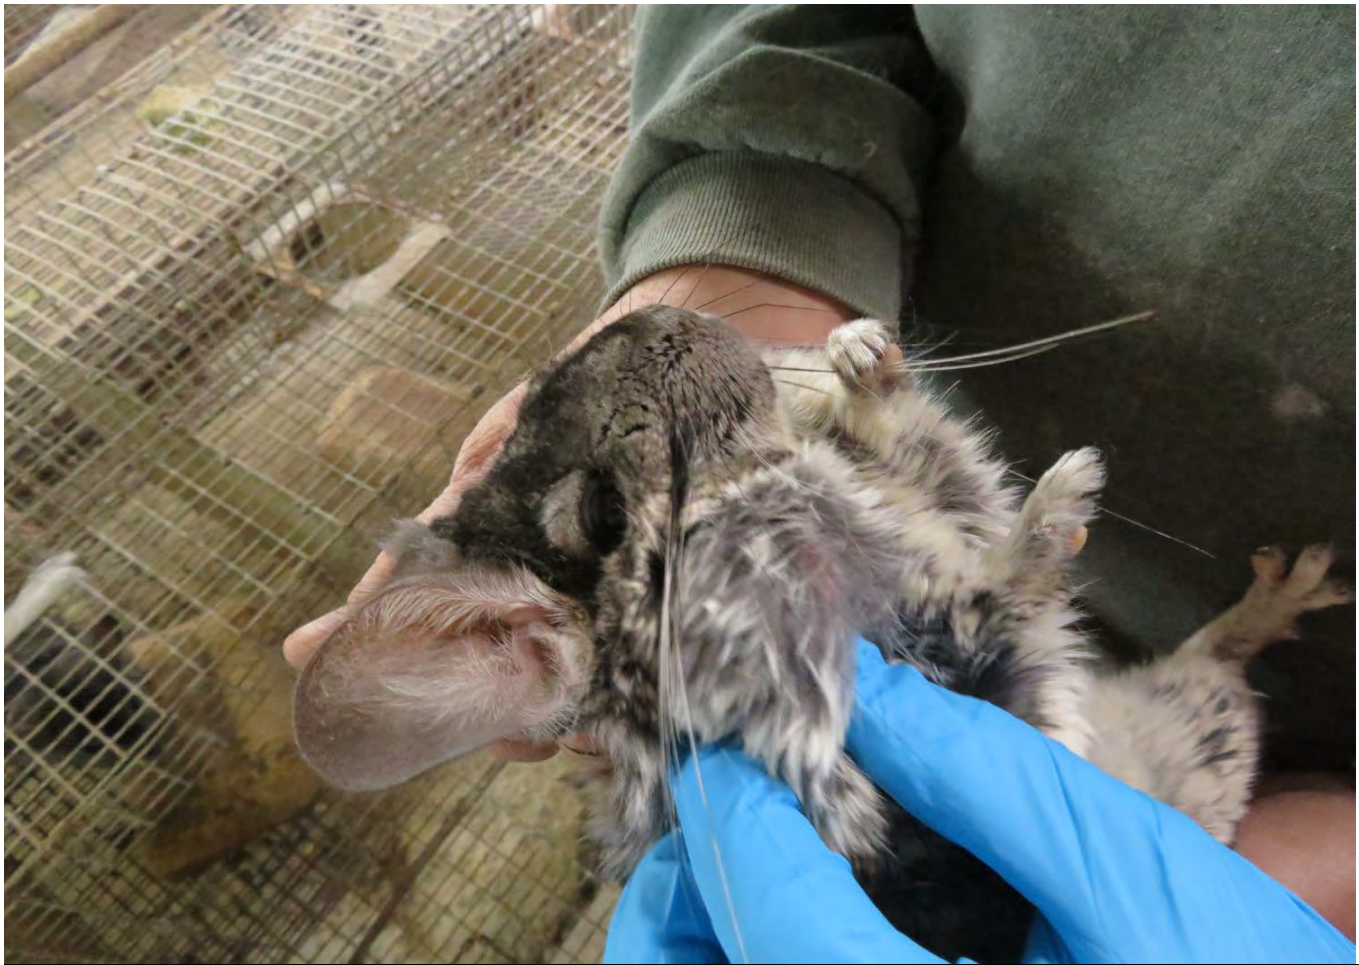
68b M with abscess under chin on right side approx 1 inch in diameter

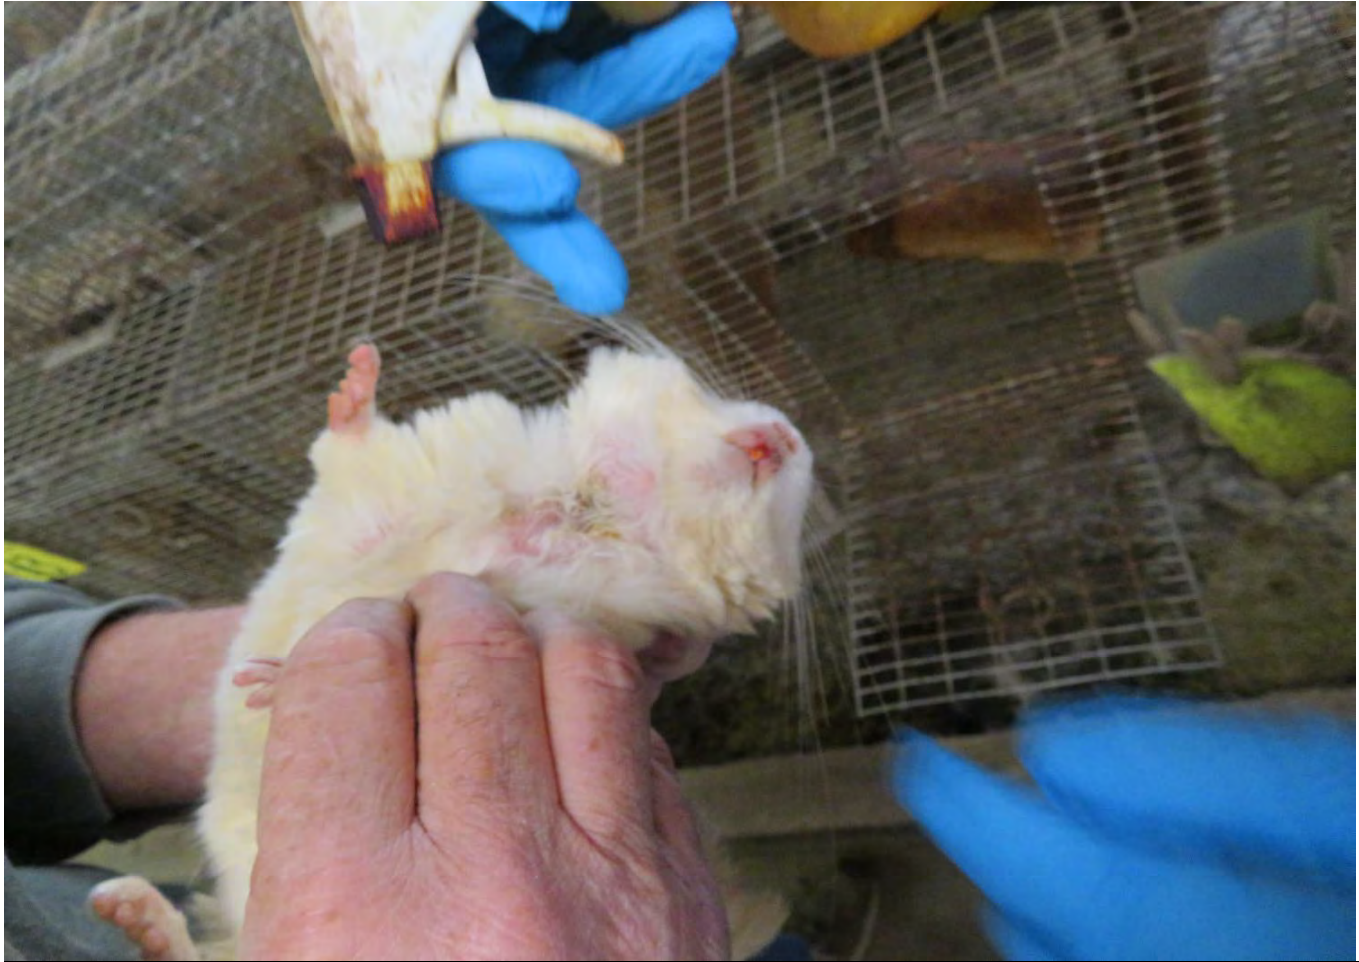
43c F with collar on too tight breaking skin under and on top of the neck leaving crusty scab and small wound

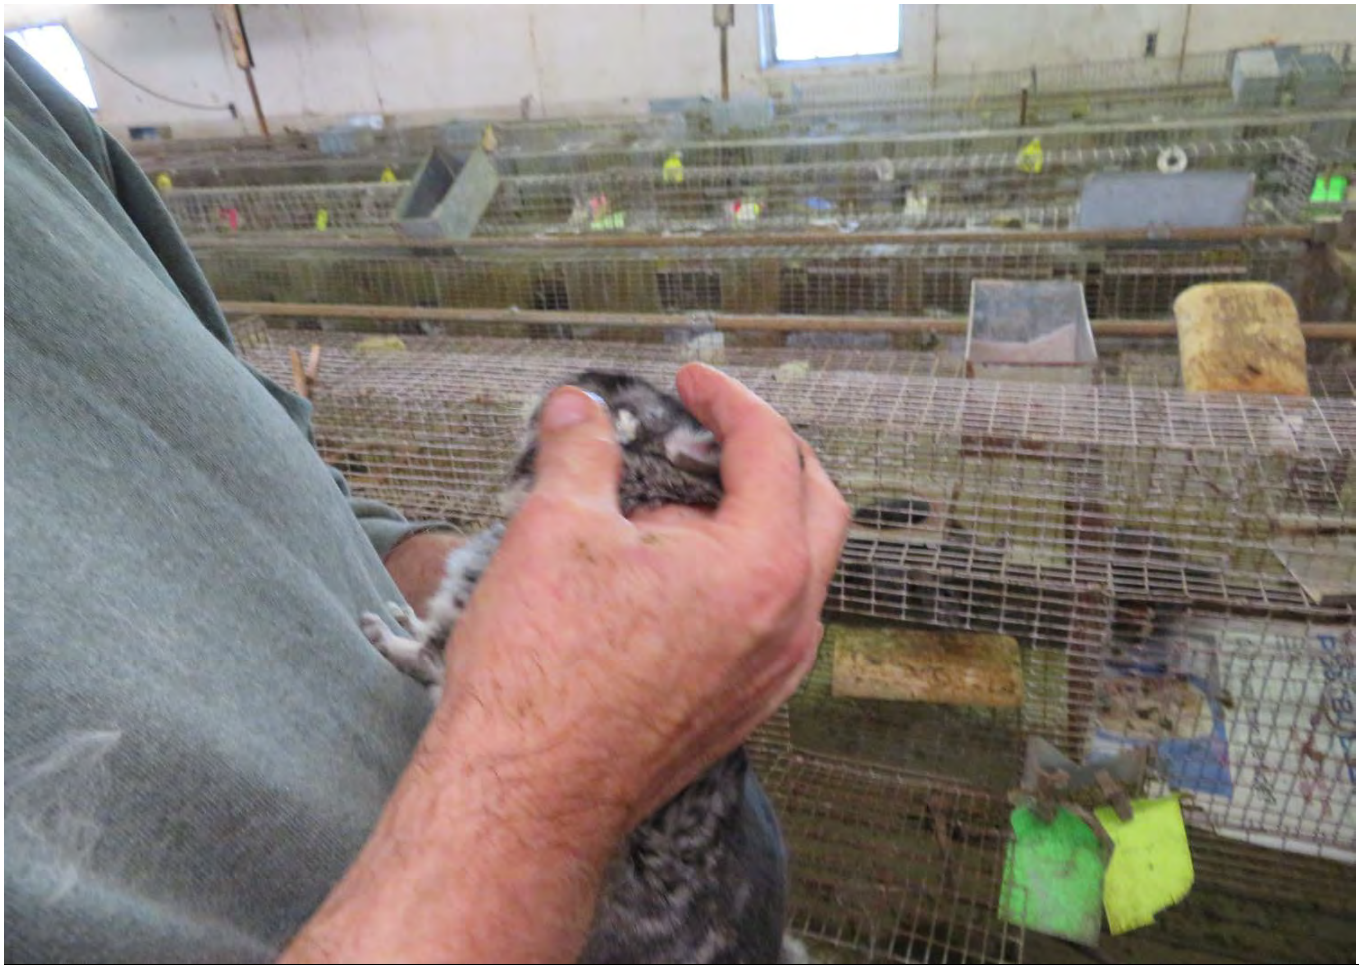
48c M swollen left eye with pus like material oozing from it
