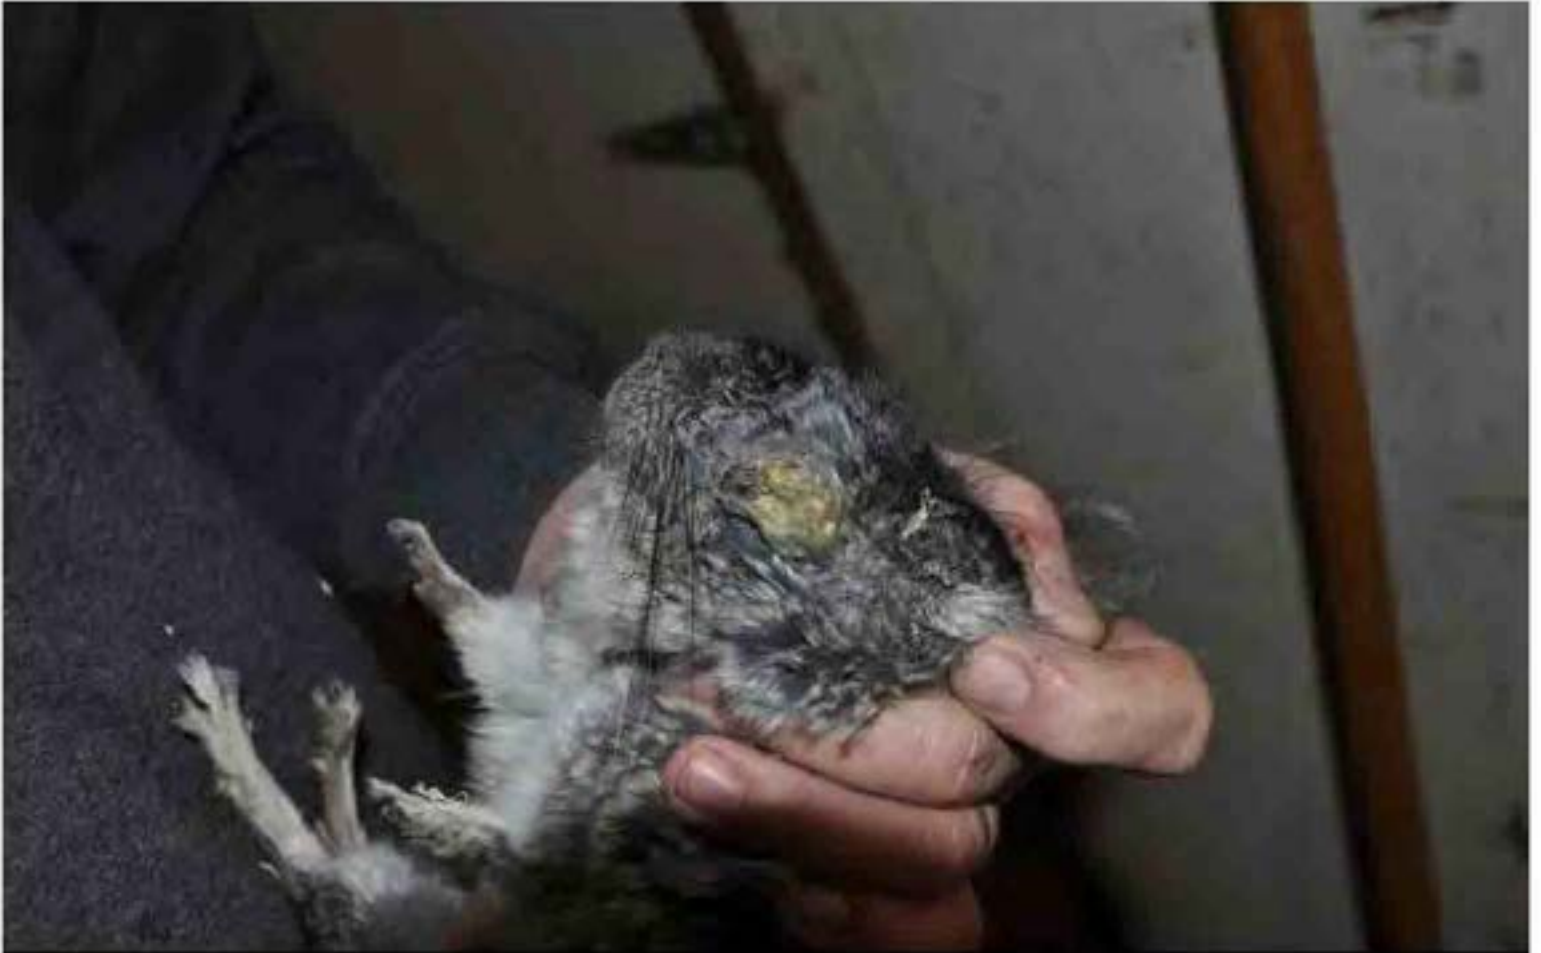
CFR: 2.40 (b) (2), 2.40 (b) (3)

| Description: | Female (eartag "DJM 131"); crusty material covering left eye. | | |

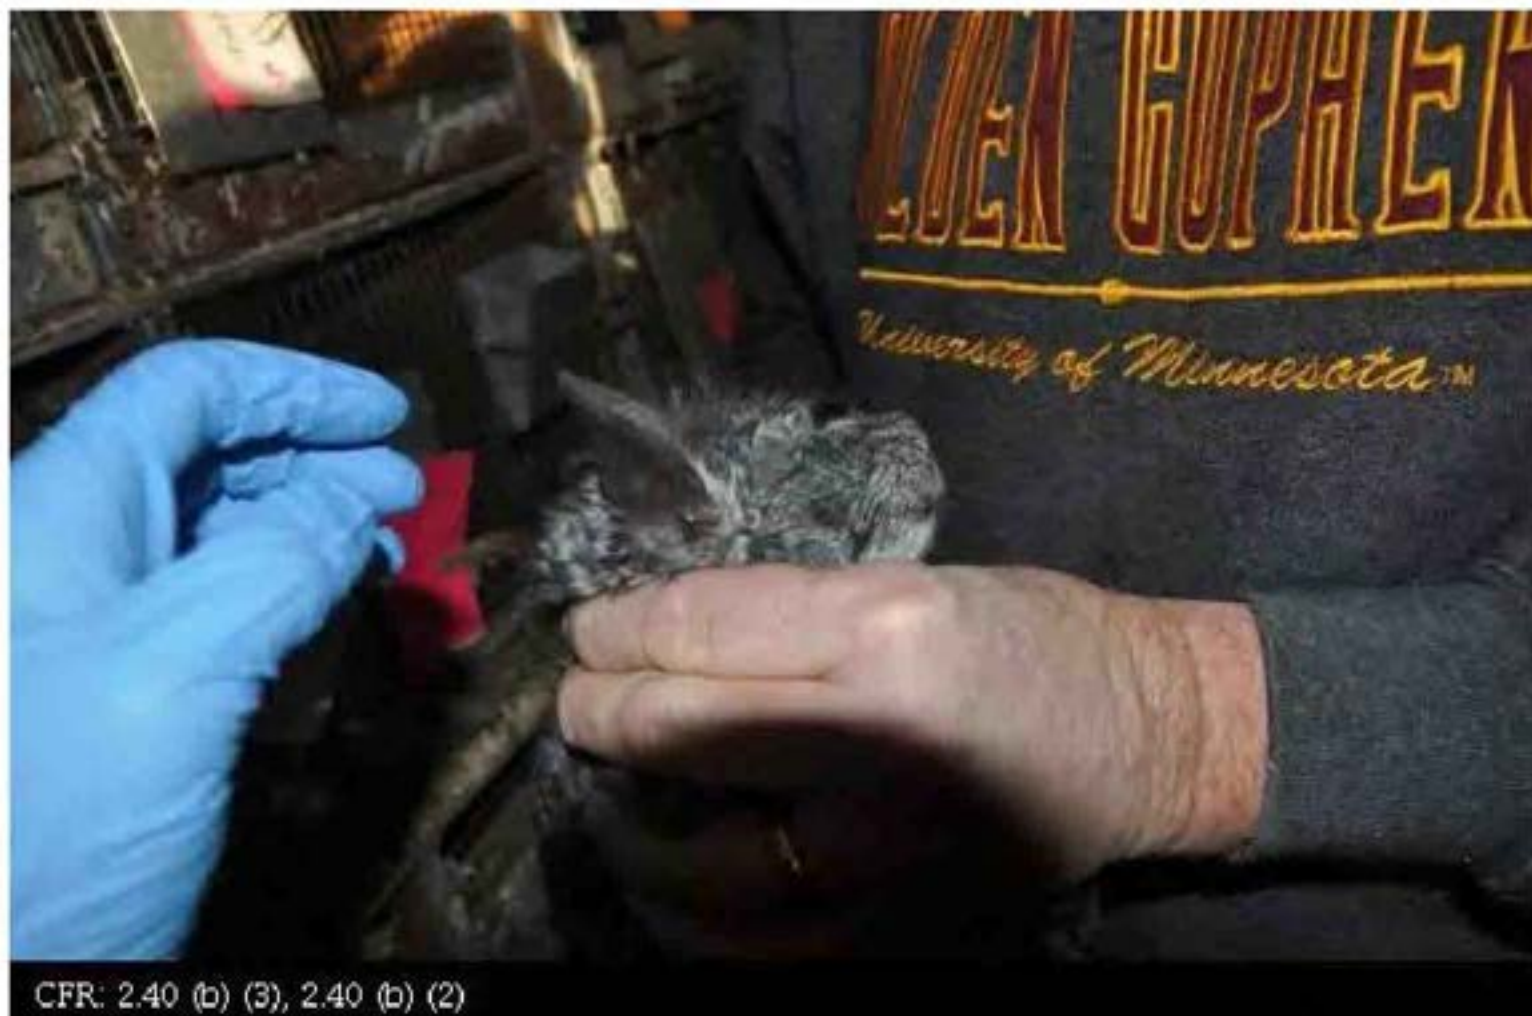
CFR: 2.40 (b) (3), 2.40 (b) (2)

| Description: | Female (eartag "DJM 131"); right eye sealed shut. | | |

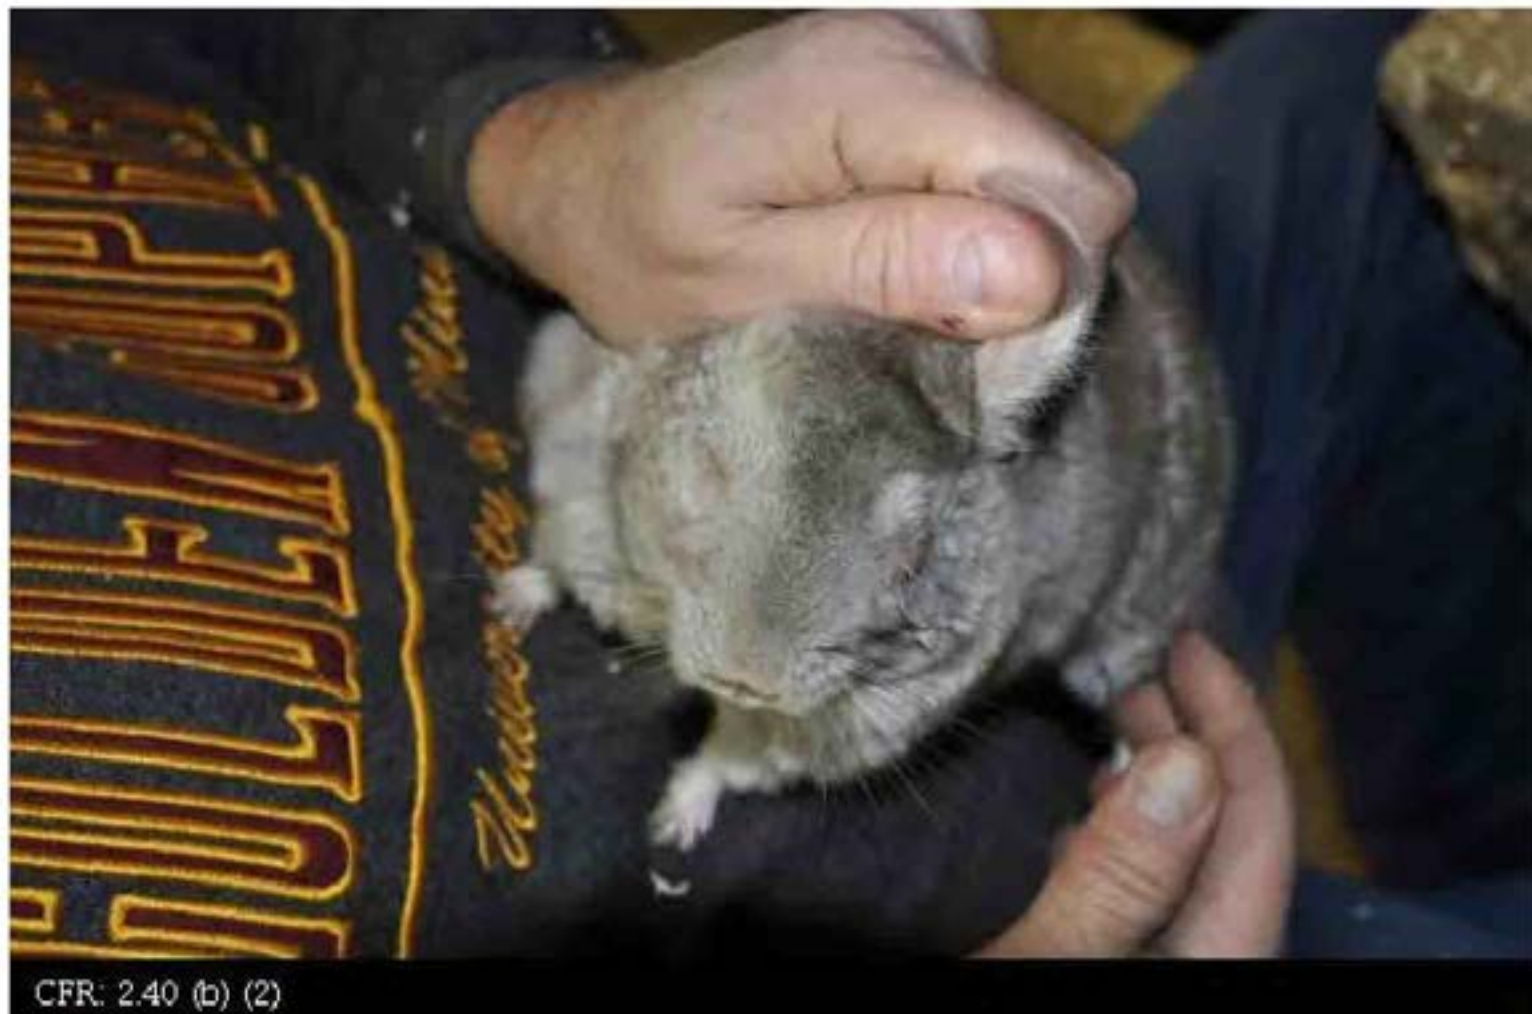
CFR: 2.40 (b) (2)

| Description: | Beige color female (no ID; pen 166 on south wall stacked cages); right eye sealed shut with crusted material. Licensee had cage marked and said he was watching this one, but not giving medicine. | | |

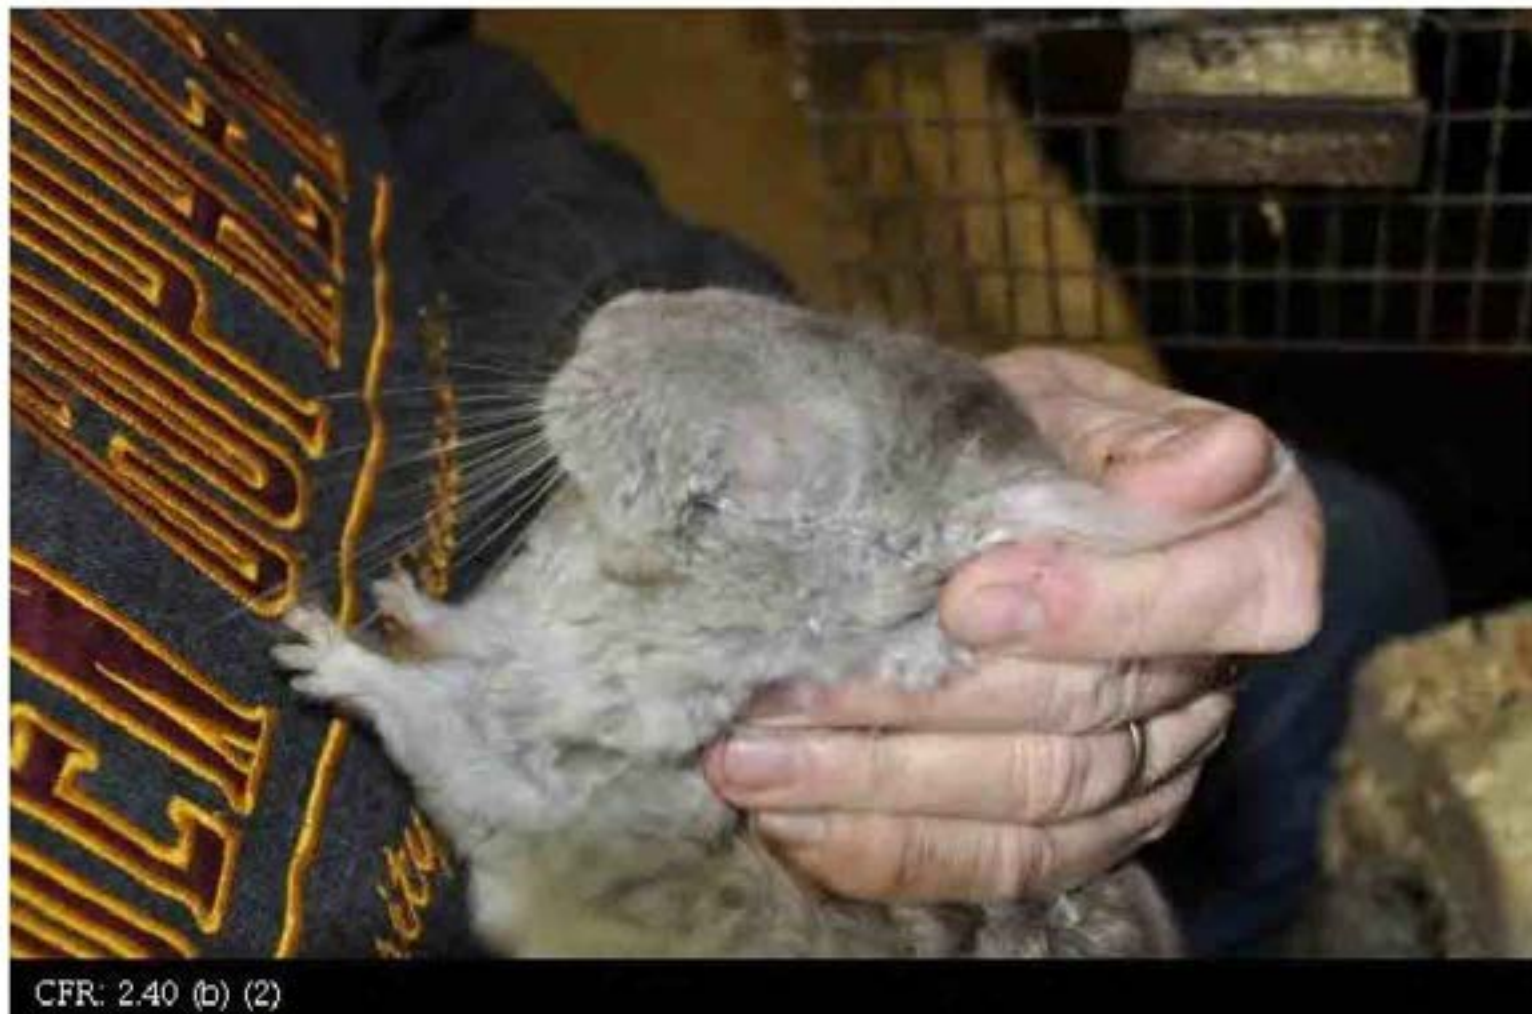
CFR: 2.40 (b) (2)

| Description: | Beige color female (no ID; pen 166 on south wall stacked cages); left eye sealed shut with crusted material, eyelids swollen with hair-loss. Licensee reported watching this one but not giving medicine | | |

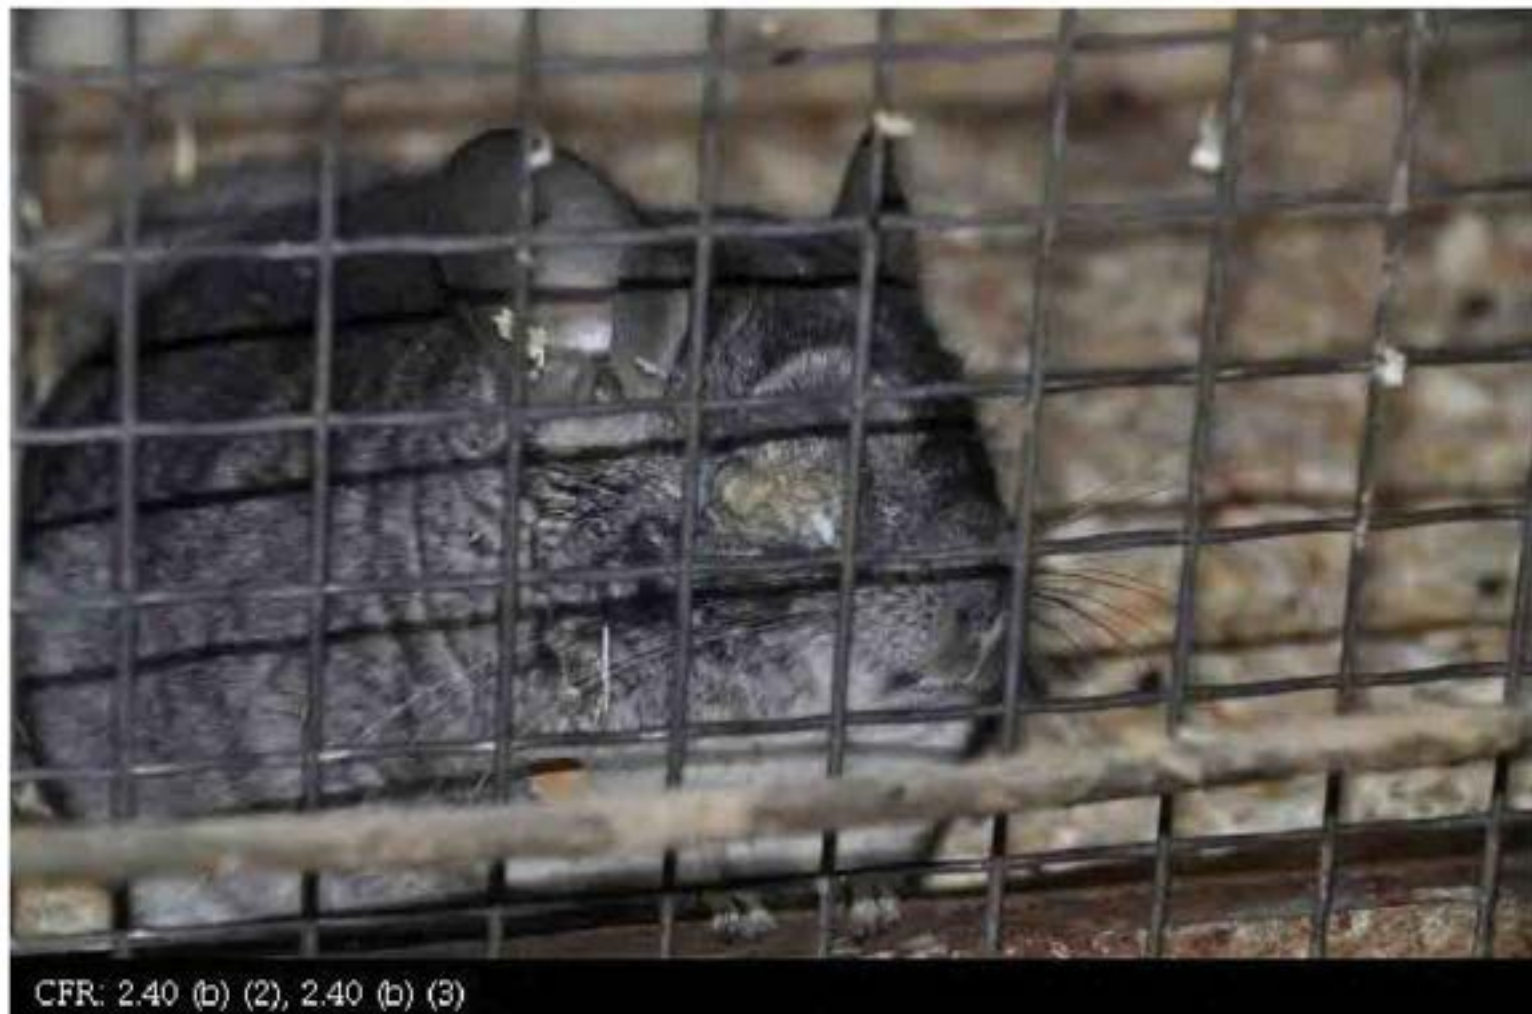
| Description: | Silver-colored female with card #580 housed on south wall; prior to owner handling; its right eye crusted shut and pale creamy discharge (pus). | | |

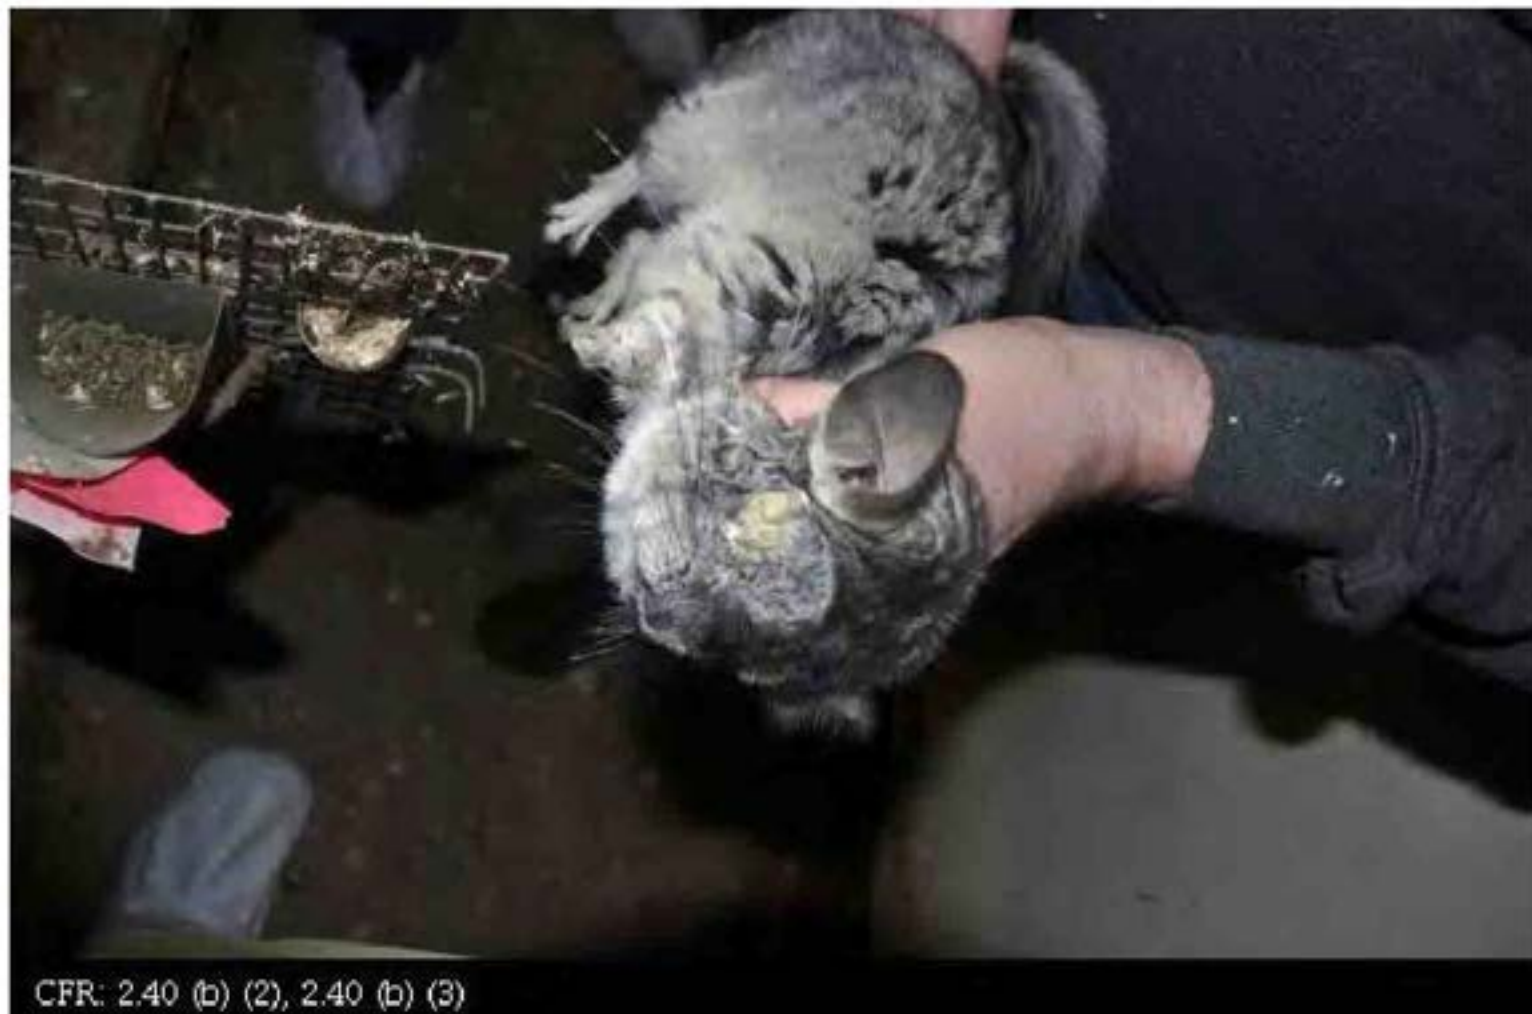
CFR: 2.40 (b) (2), 2.40 (b) (3)

| Description: | Silver-colored female with card #580 housed on south wall; its right eye crusted shut and pale creamy discharge (pus). | | |

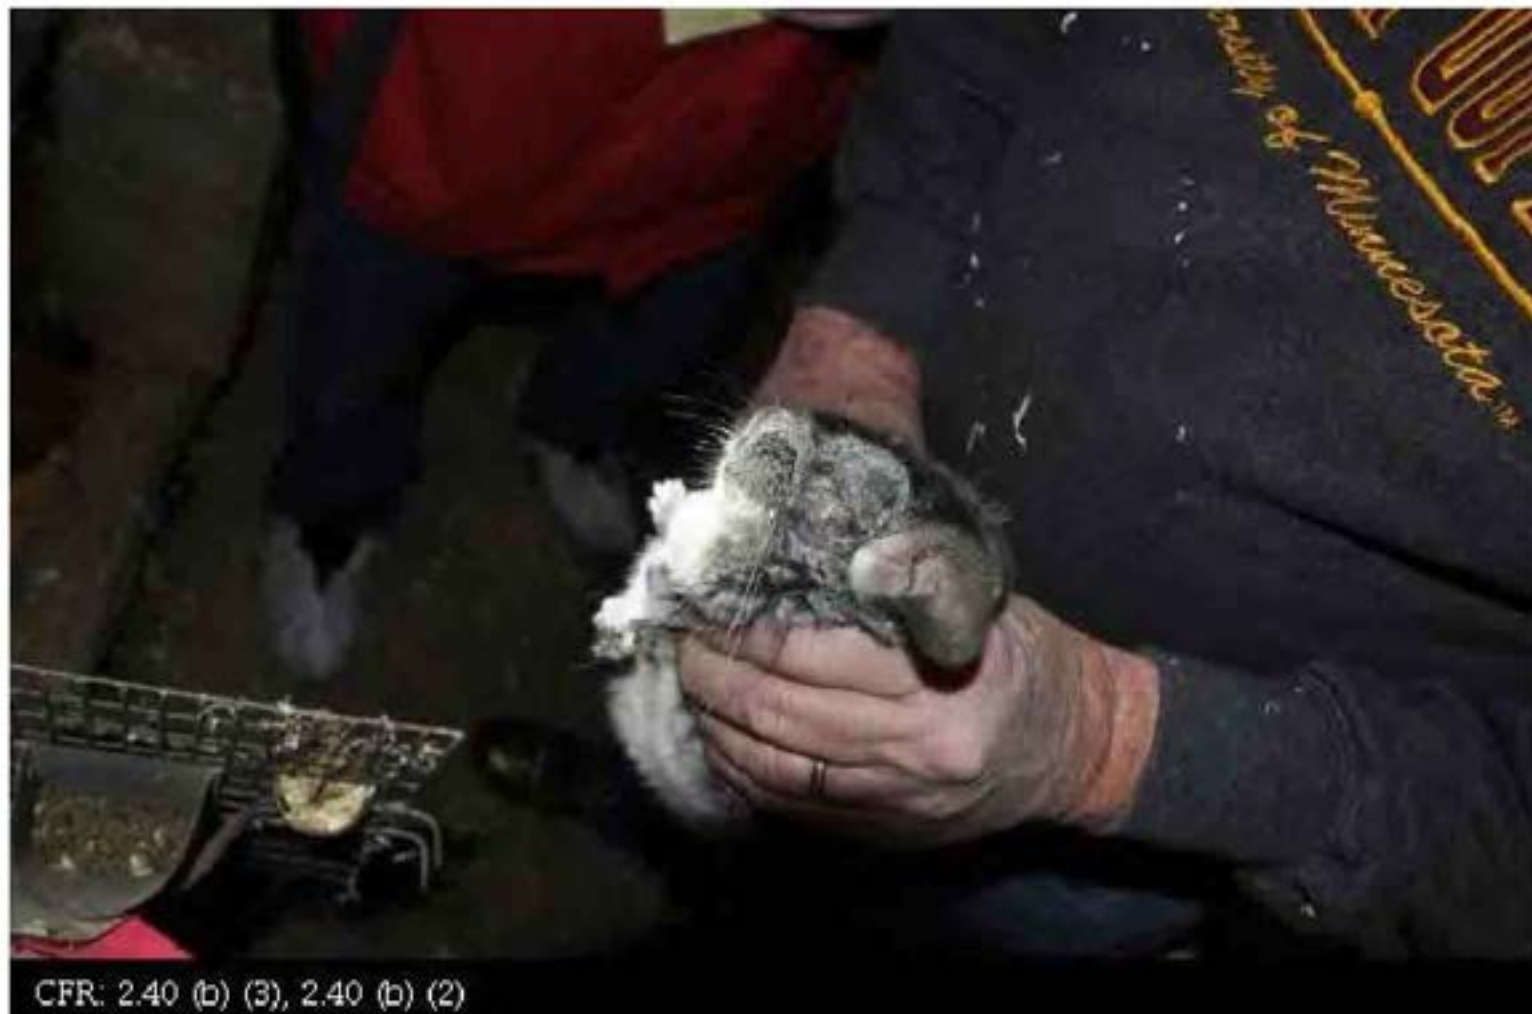
CFR: 2.40 (b) (3), 2.40 (b) (2)

| Description: | Silver-colored female with card #580 housed on south wall; left eye sealed shut with crusted material. | | |

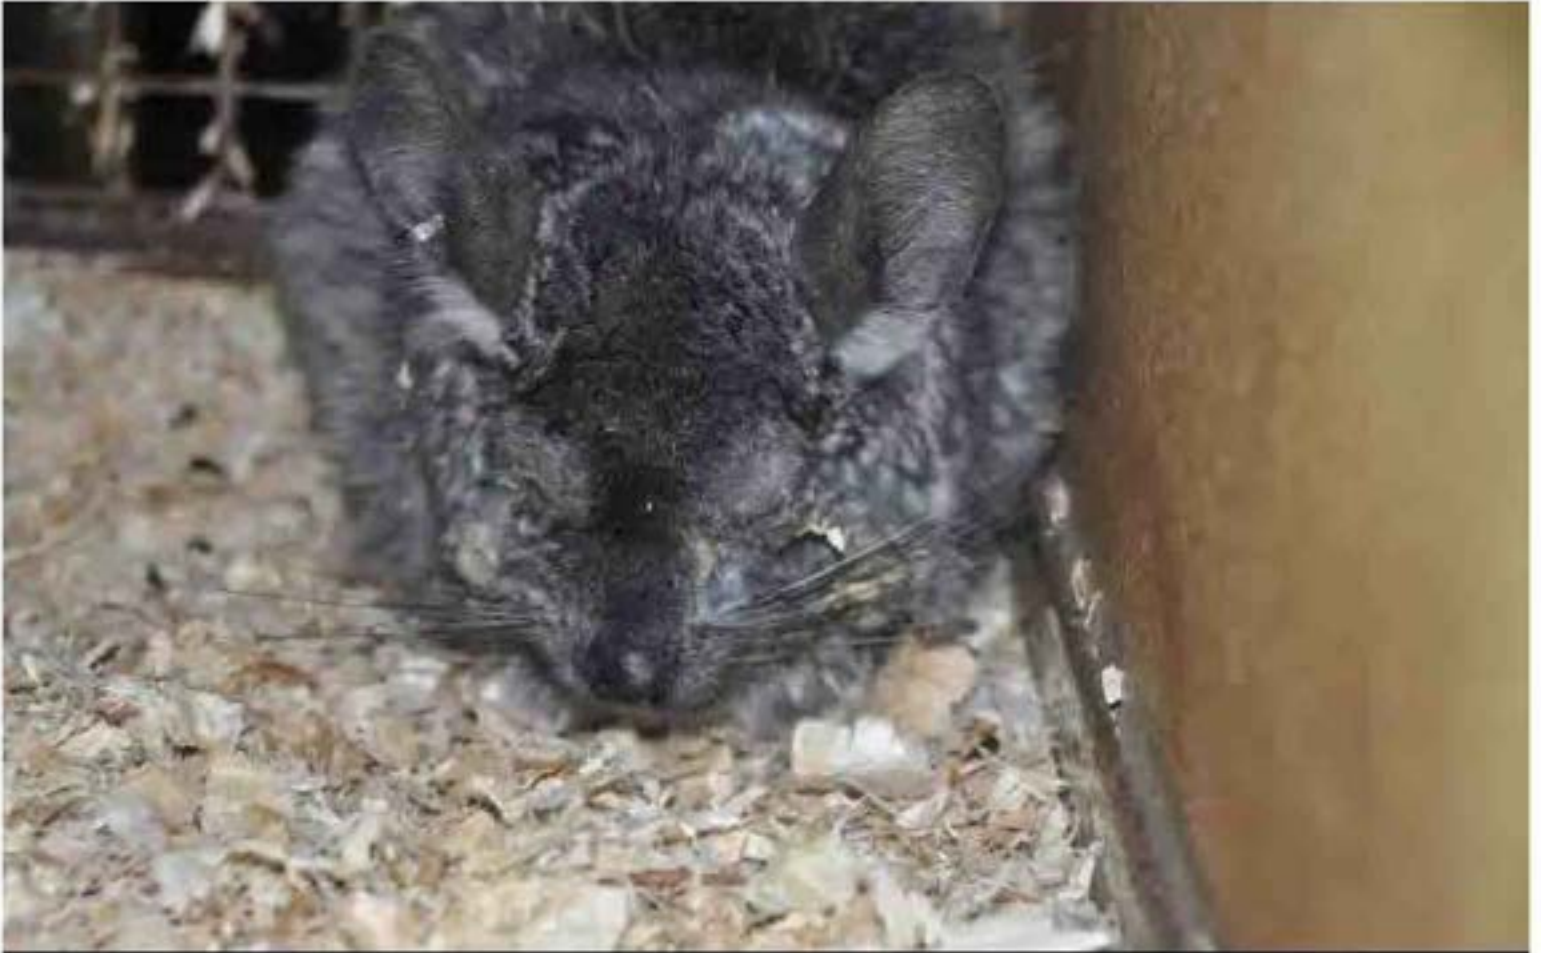
CFR: 2.40 (b) (2), 2.40 (b) (3)

| Description: | Female with eartag "DJM 145"; both eyes seen crusted shut. Note its left eyelids are swollen and with hair loss. | | |

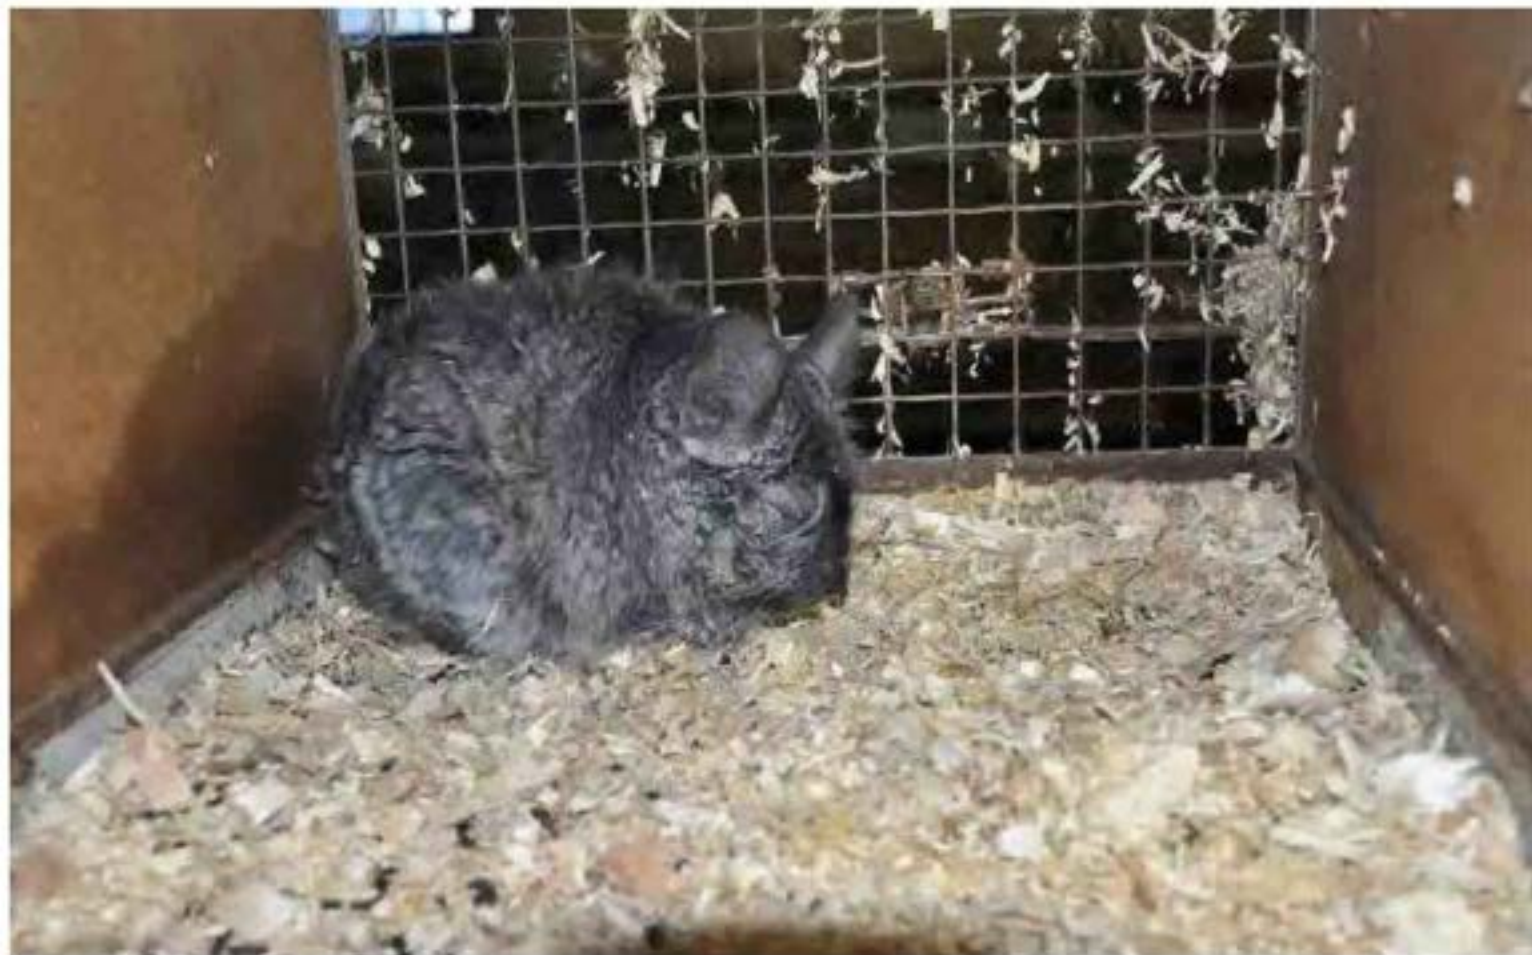
CFR: 2.40 (b) (3), 2.40 (b) (2)

| Description: | Female with eartag "DJM 145"; right eye seen crusted shut. | | |

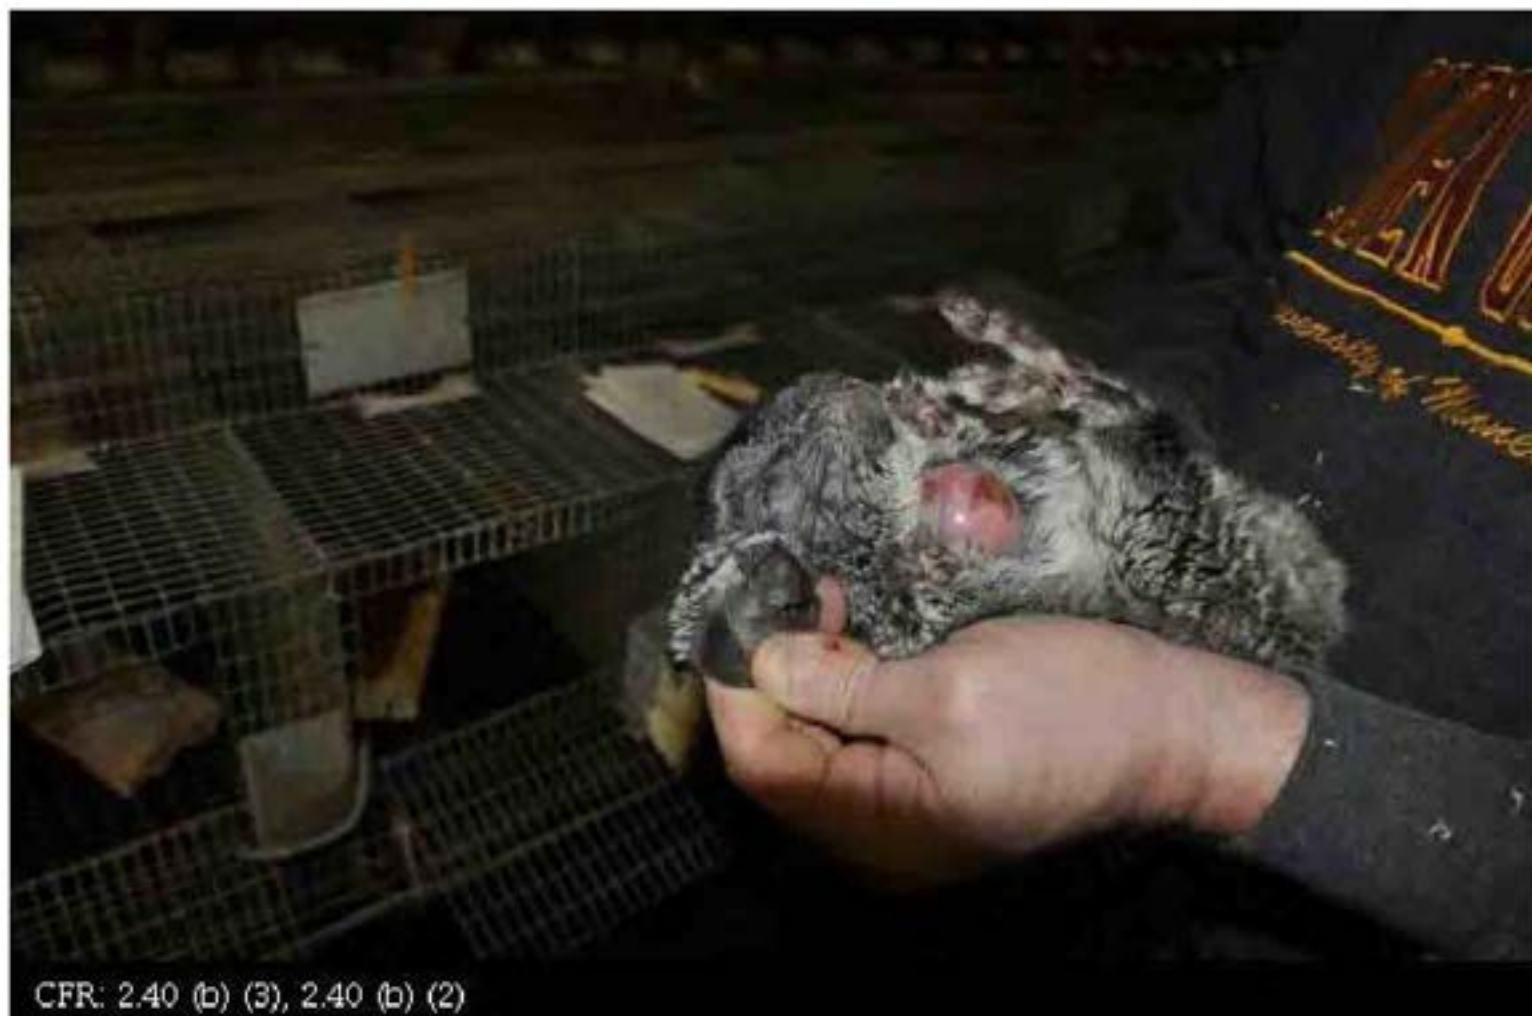
CFR: 2.40 (b) (3), 2.40 (b) (2)

| Description: | Female with eartag "OKES 108" (or "801"). Note large, scabbed swelling under chin and right eyelids that are swollen with hair loss and discharge in eye. | | |

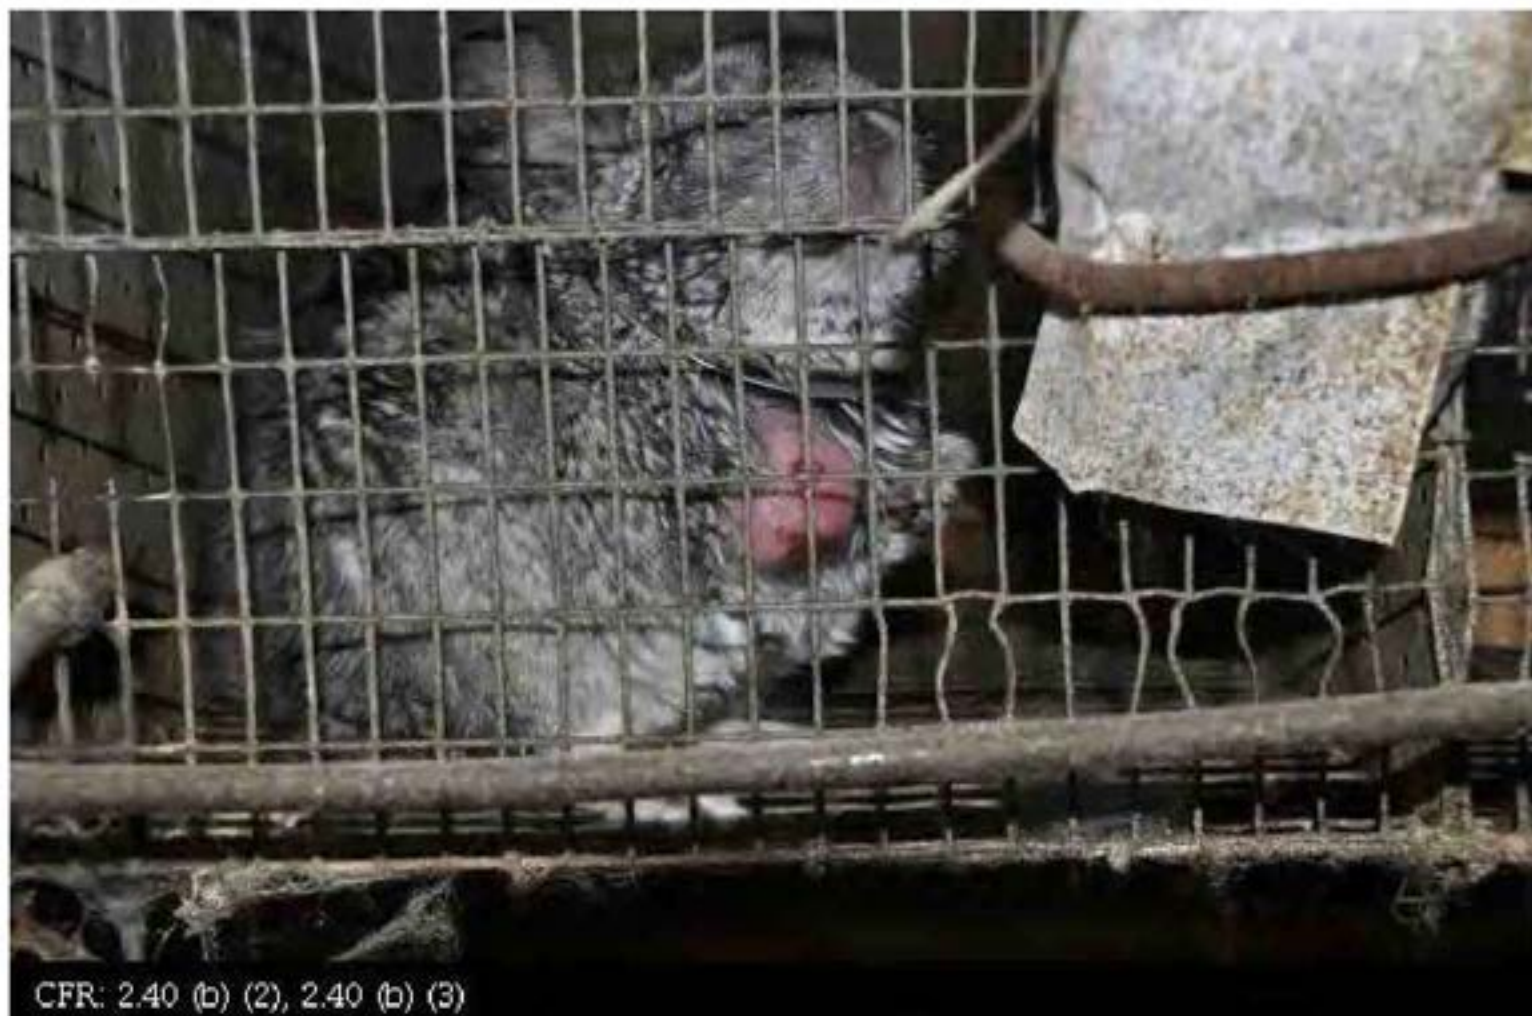
CFR: 2.40 (b) (2), 2.40 (b) (3)

| Description: | Female with eartag "OKES 108" (or "801") in cage. | | |

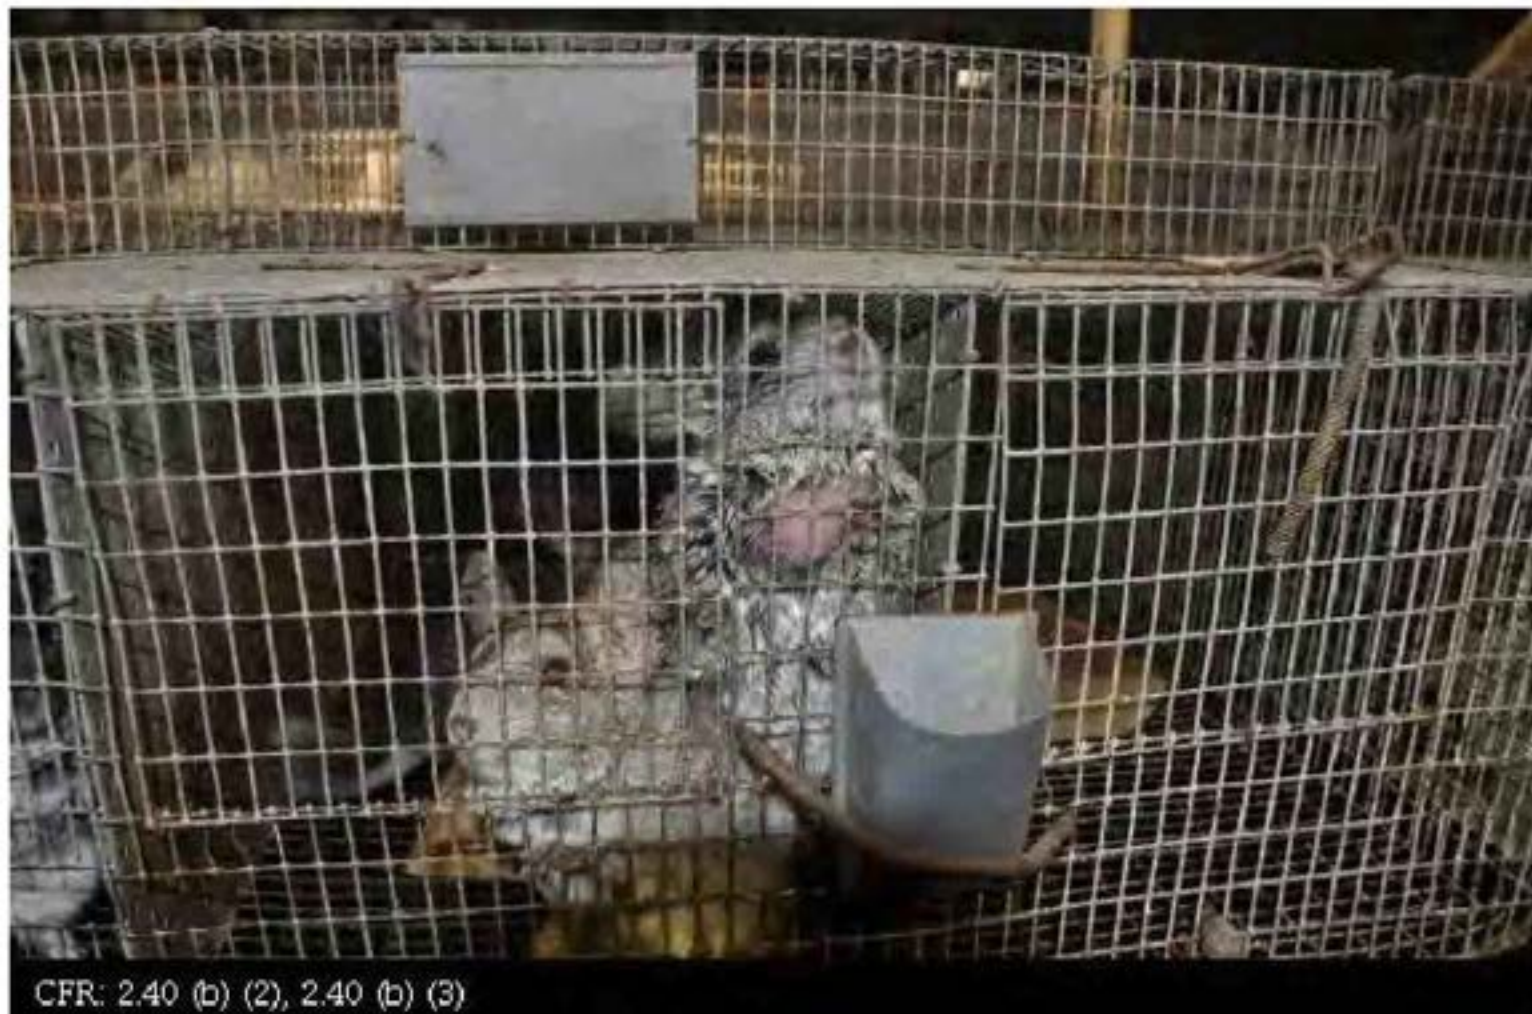
CFR: 2.40 (b) (2), 2.40 (b) (3)

| Description: | Male with eartag 147; large swelling under its chin with reddened skin and hair loss. | | |

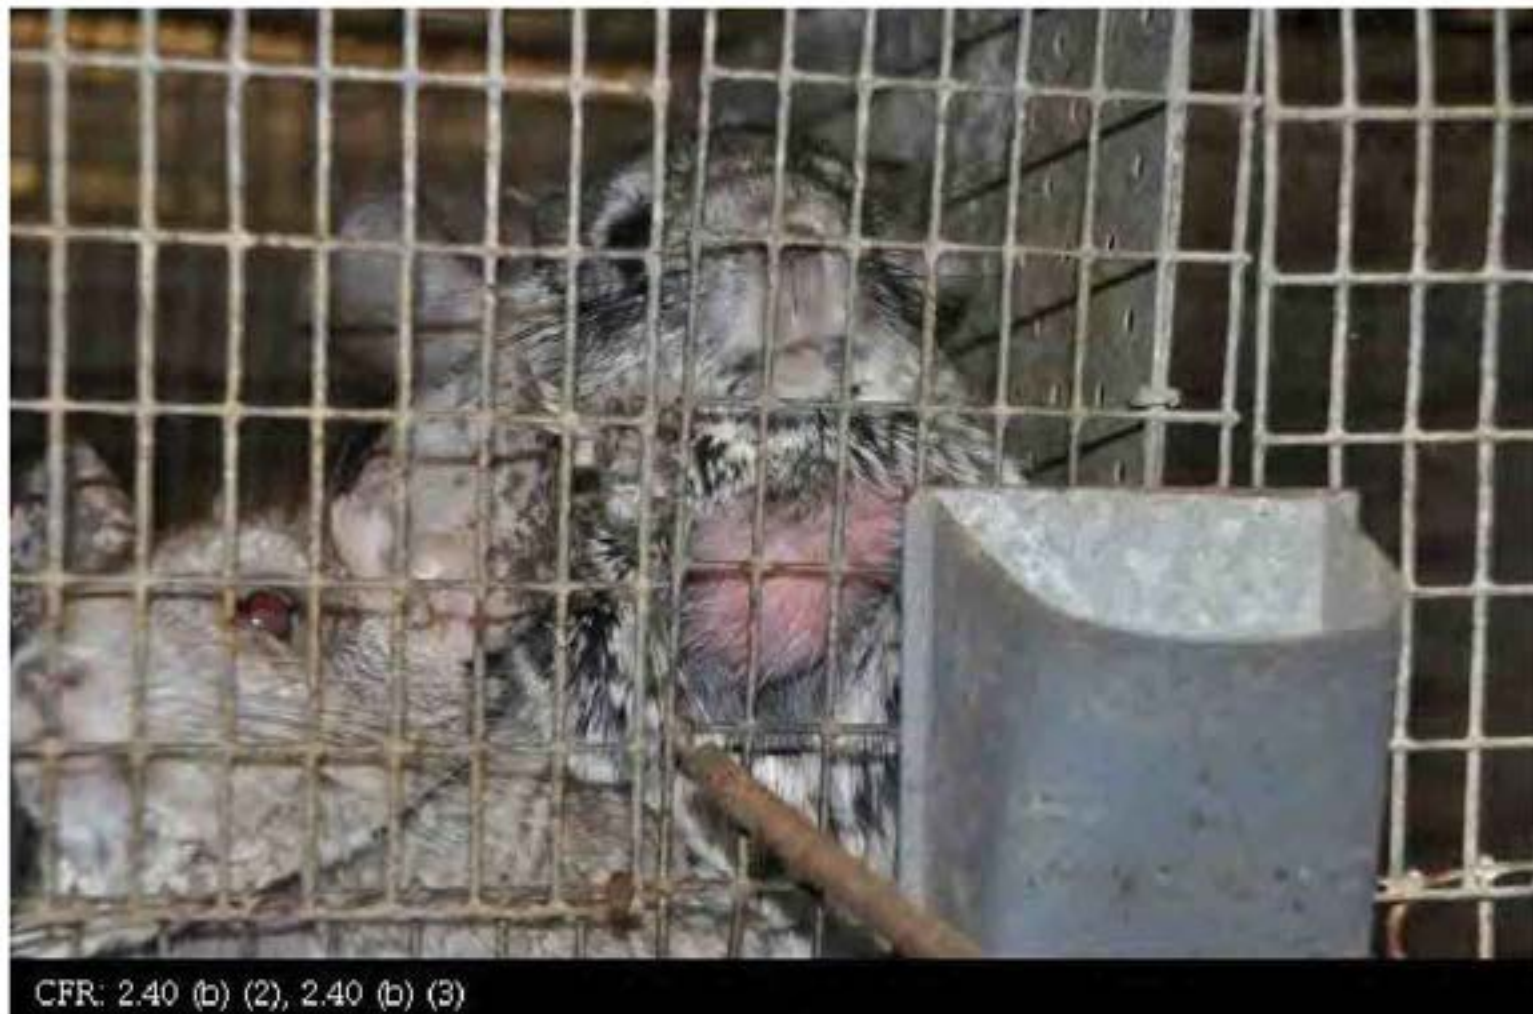
CFR: 2.40 (b) (2), 2.40 (b) (3)

| Description: | Male with eartag 147; large swelling under its chin with reddened skin and hair loss. | | |

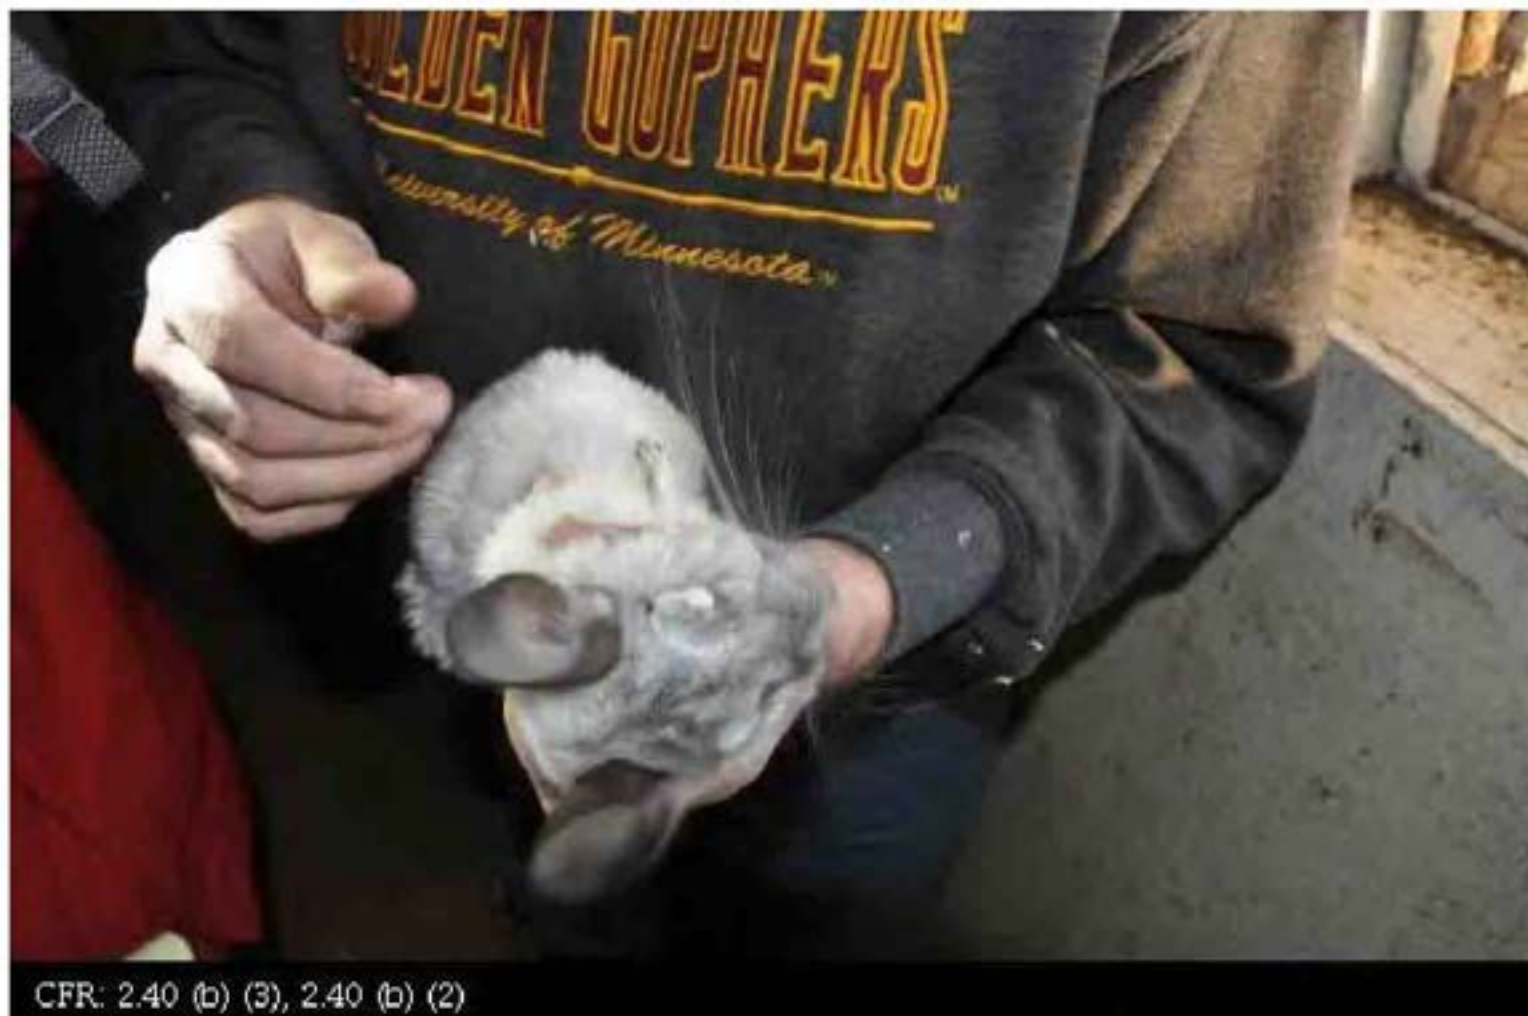
CFR: 2.40 (b) (3), 2.40 (b) (2)

| Description: | Beige male (no ID; cage card AM-F-8; housed on south wall stacked cages). Its left eyelids swollen and pale creamy discharge from the eye. | | |
