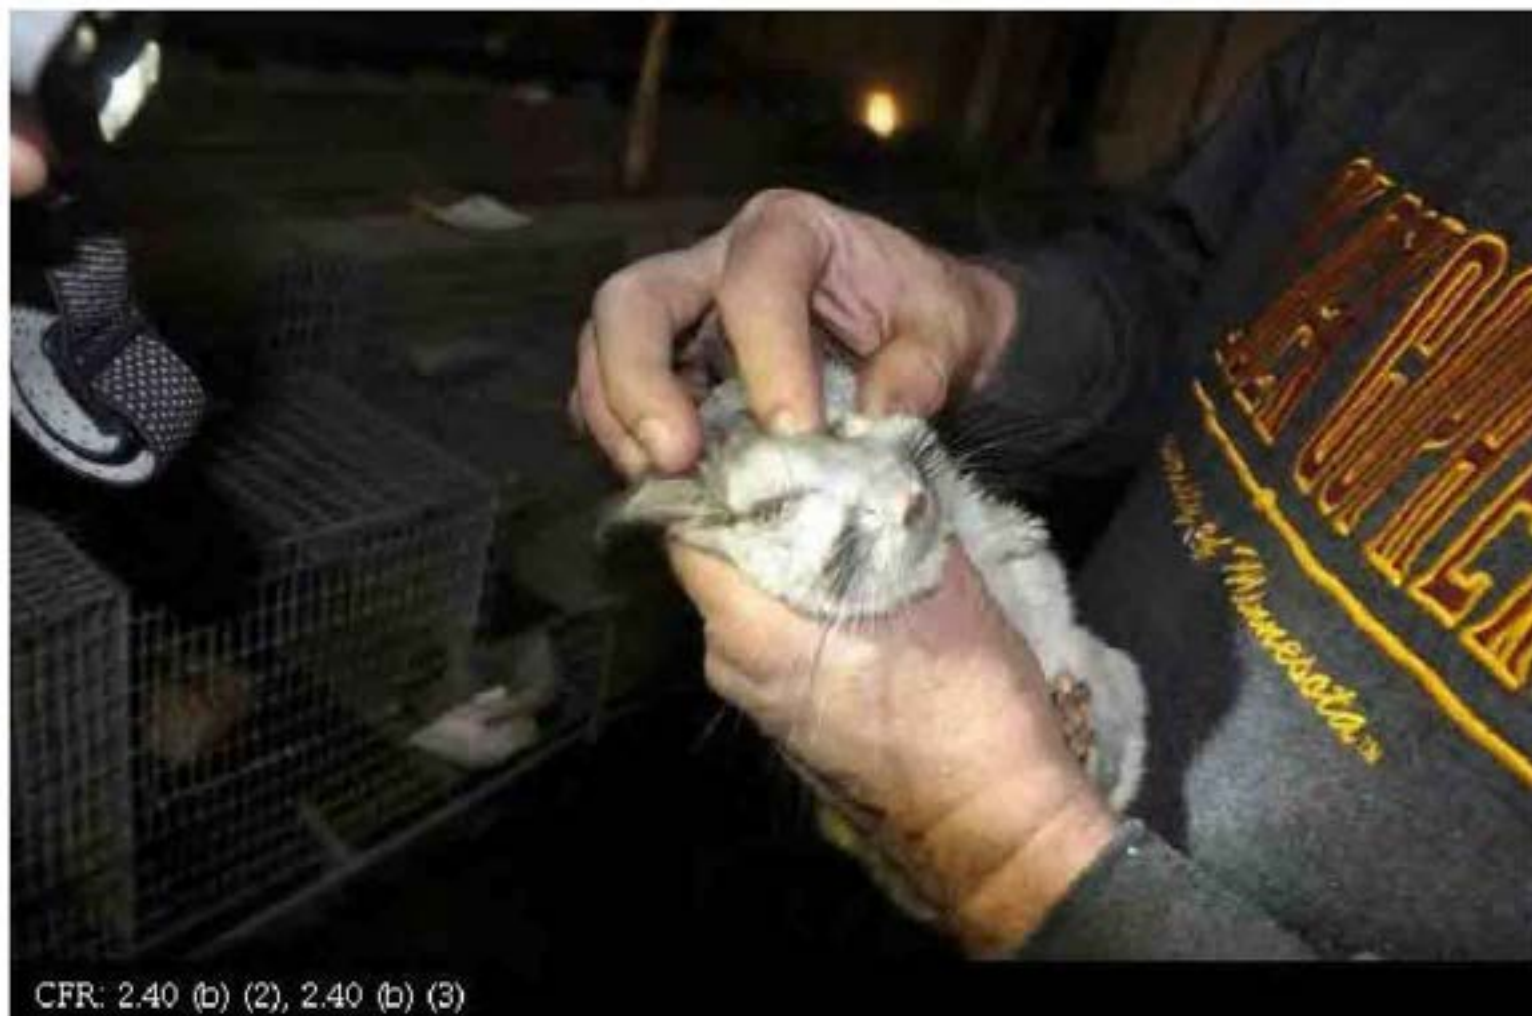
CFR: 2.40 (b) (2), 2.40 (b) (3)

| Description: | Beige male (no ID; cage card AM-F-8; housed on south wall stacked cages). Its right eye crusted shut. | | |

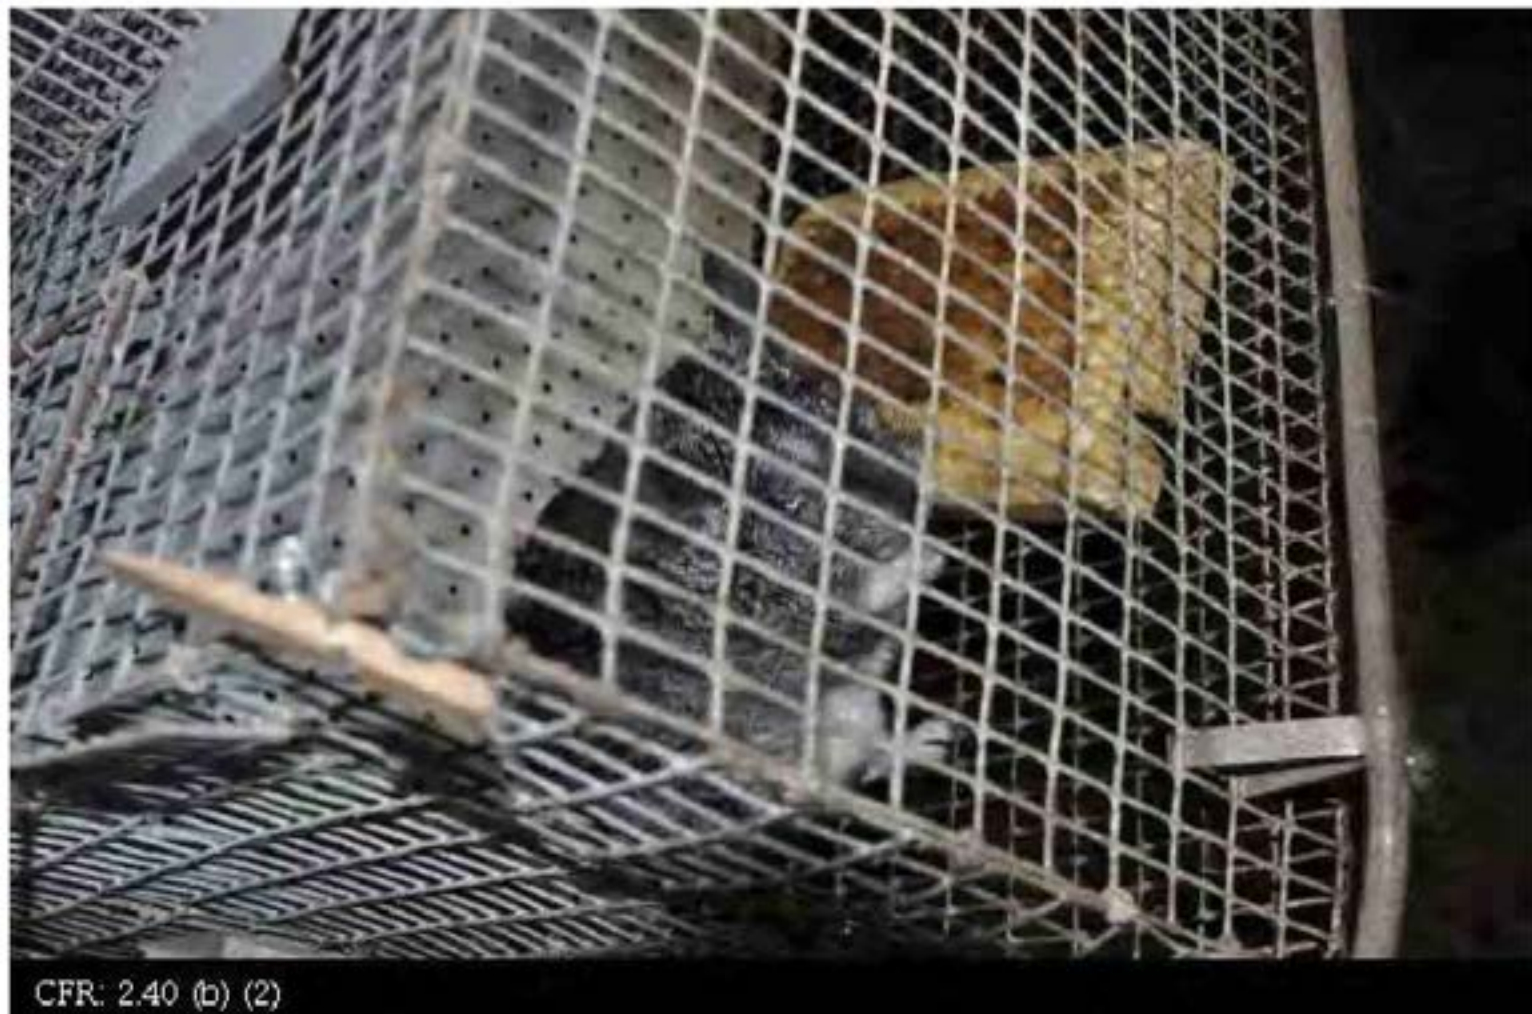
| Description: | Male with eartag "VVCR 179". Its right eyelids are swollen and crusted shut. Licensee had cage marked and said he was watching this one, but not giving medicine. | | |

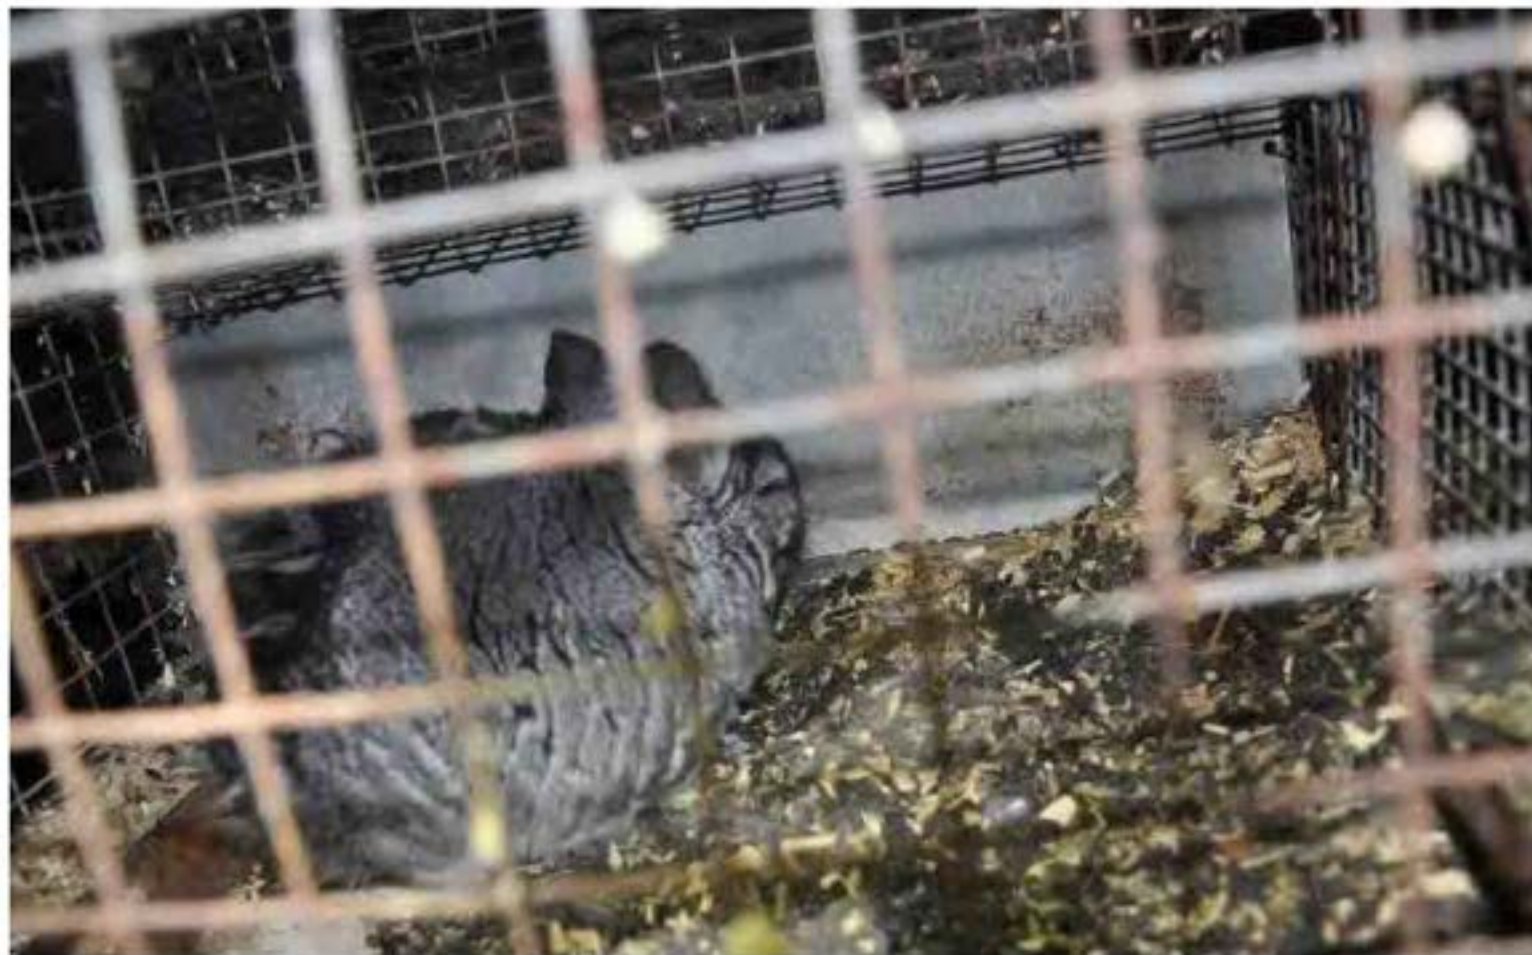
CFR: 2.40 (b) (2), 3.131 (a)

| Description: | Chinchilla in backroom; three (no id's) had unresolved eye problems. Note right eye is difficult to visualize; Representative of other 2 in backroom with un-resolved eye problems. Note excessive feces | | |

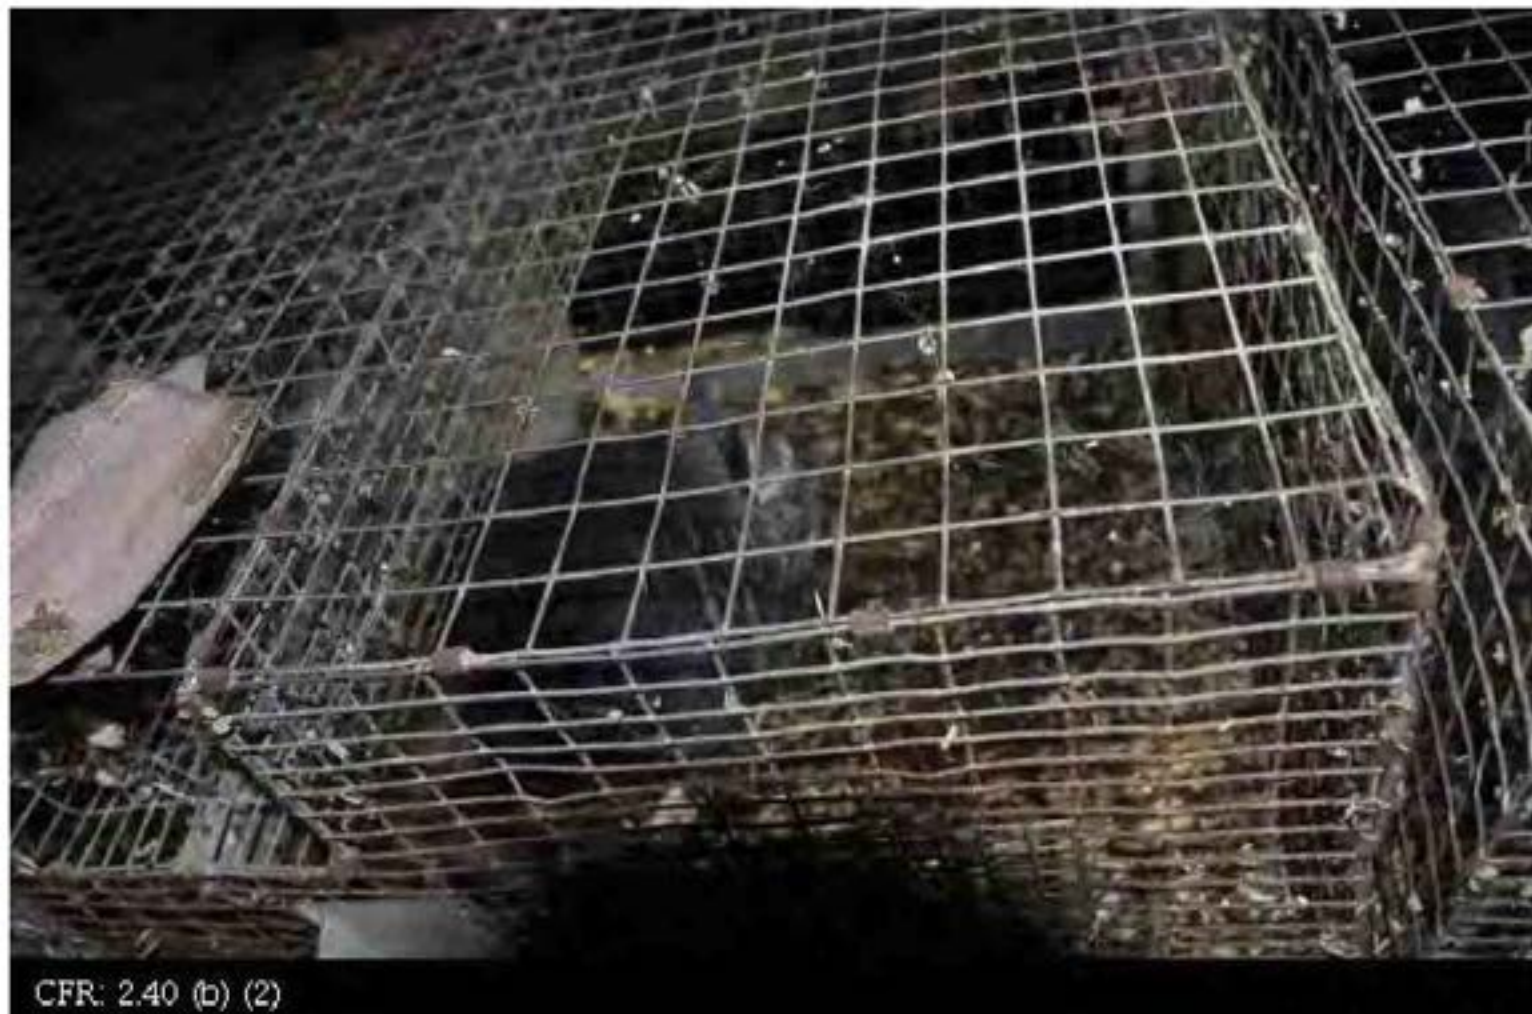
CFR: 2.40 (b) (2)

| Description: | Chinchilla in backroom; three (no id's) had unresolved eye problems; right eye was not well visualized as in normal chinchillas. | | |

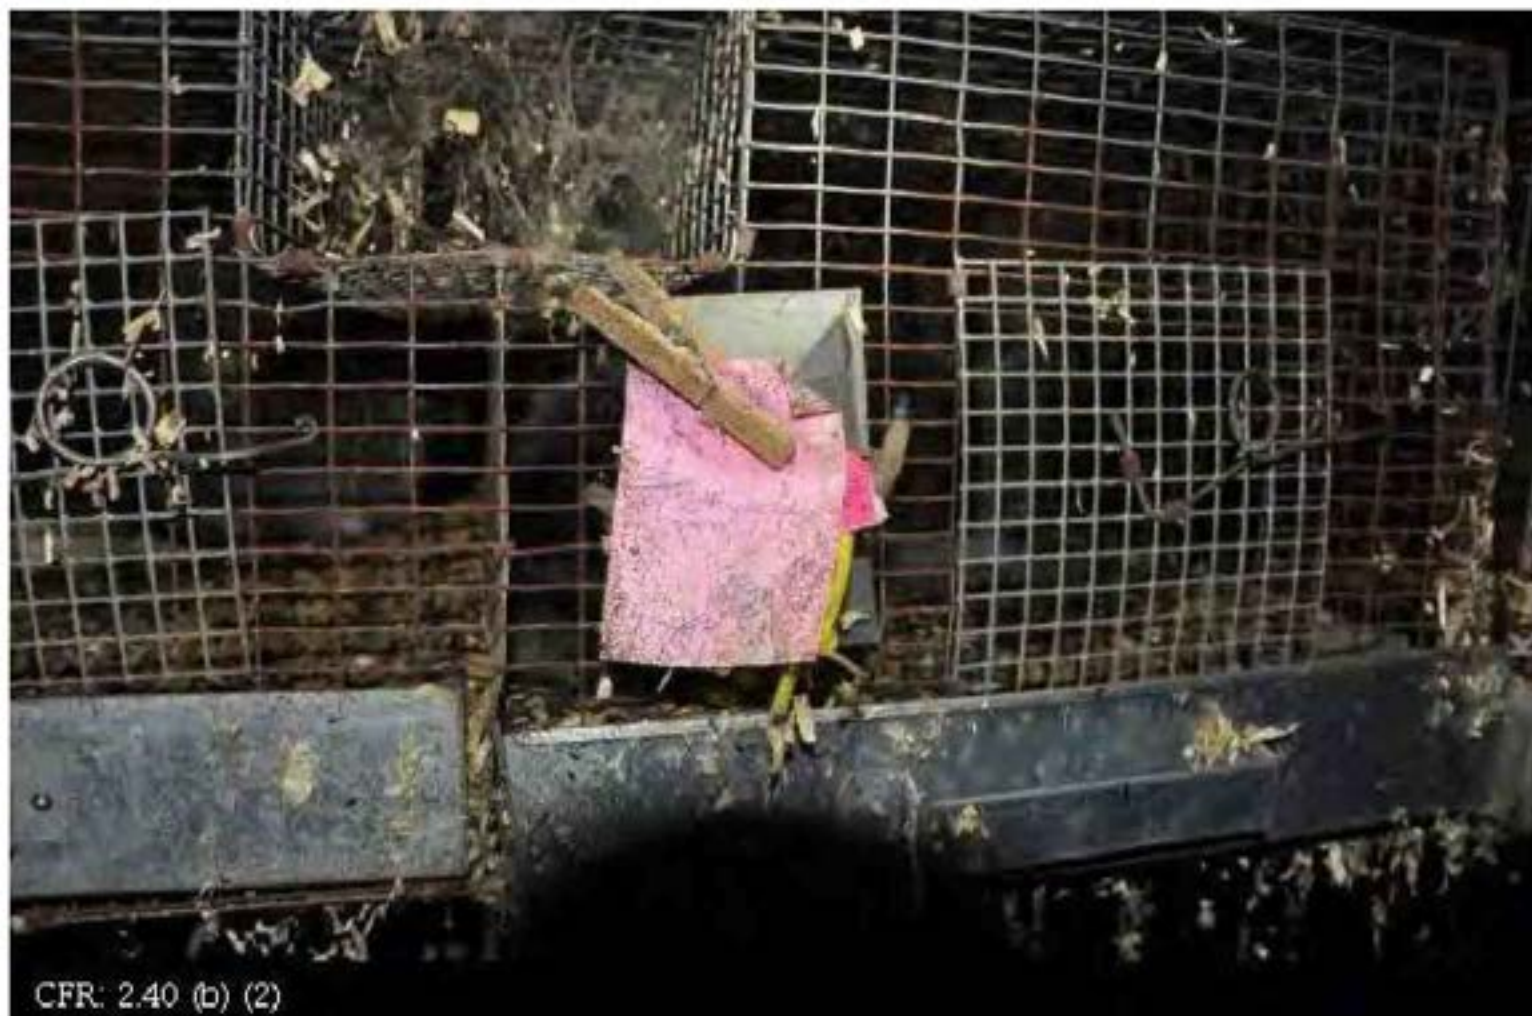
| Description: | Chinchilla in backroom; three (no id's) had unresolved eye problems. Treatment card on cage upper left has 7/3 for date and lower right has 9/4. | | |

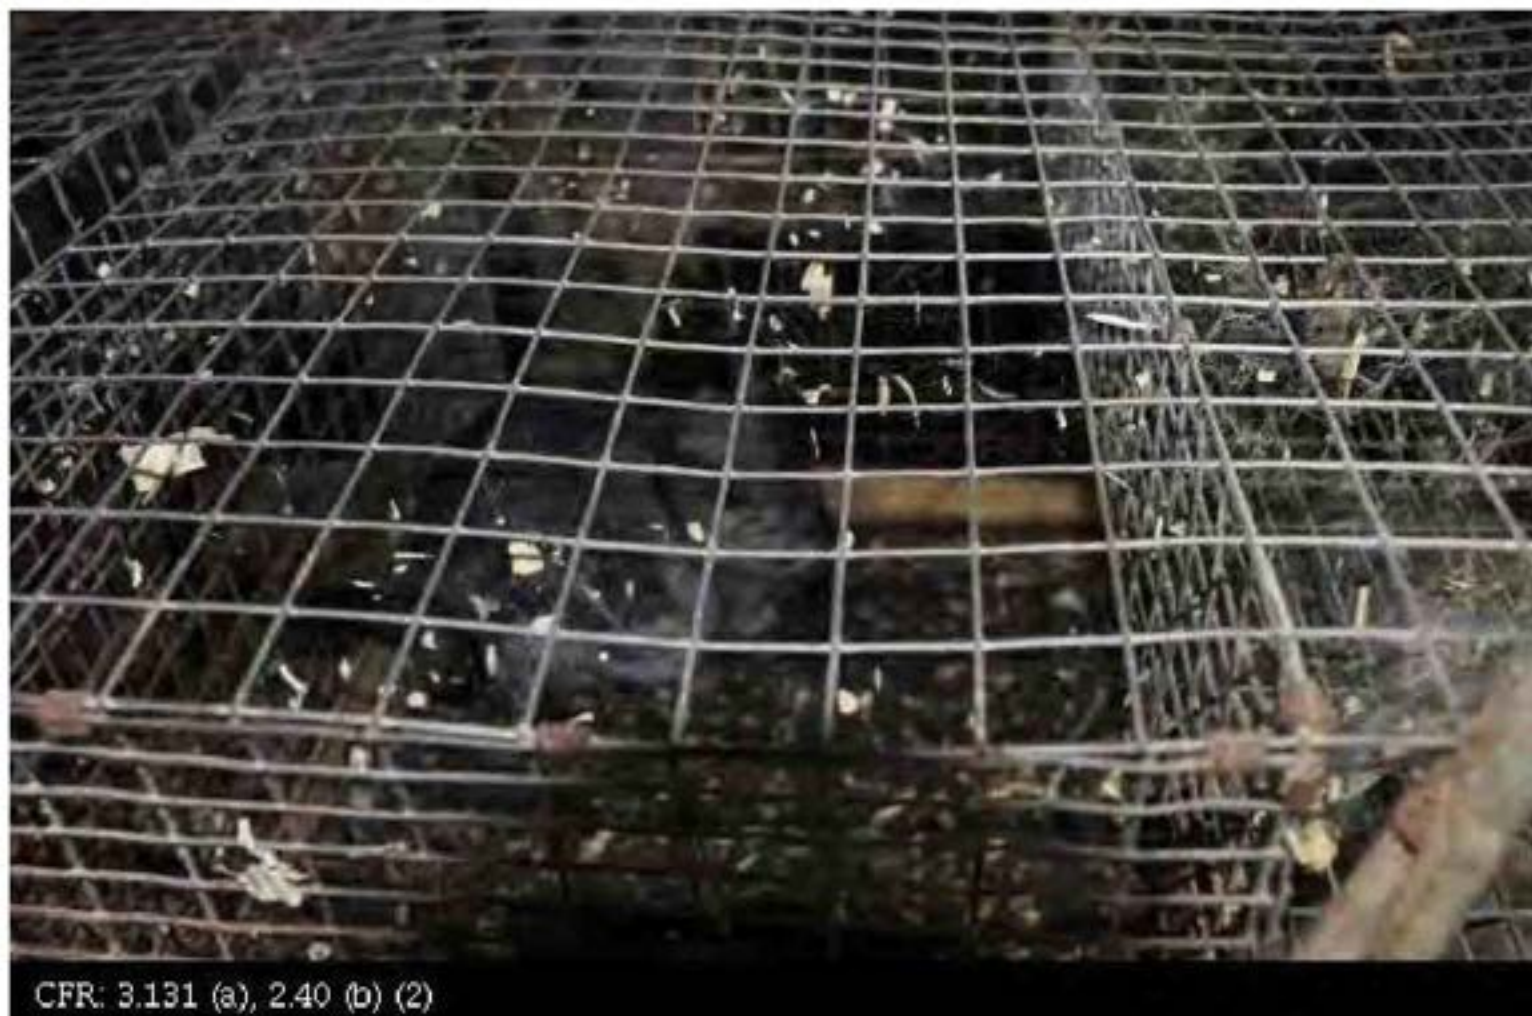
CFR: 3.131 (a), 2.40 (b) (2)

| Description: | Chinchillas in backroom; three (no id's) had unresolved eye problems. Note excessive feces in enclosure. | | |

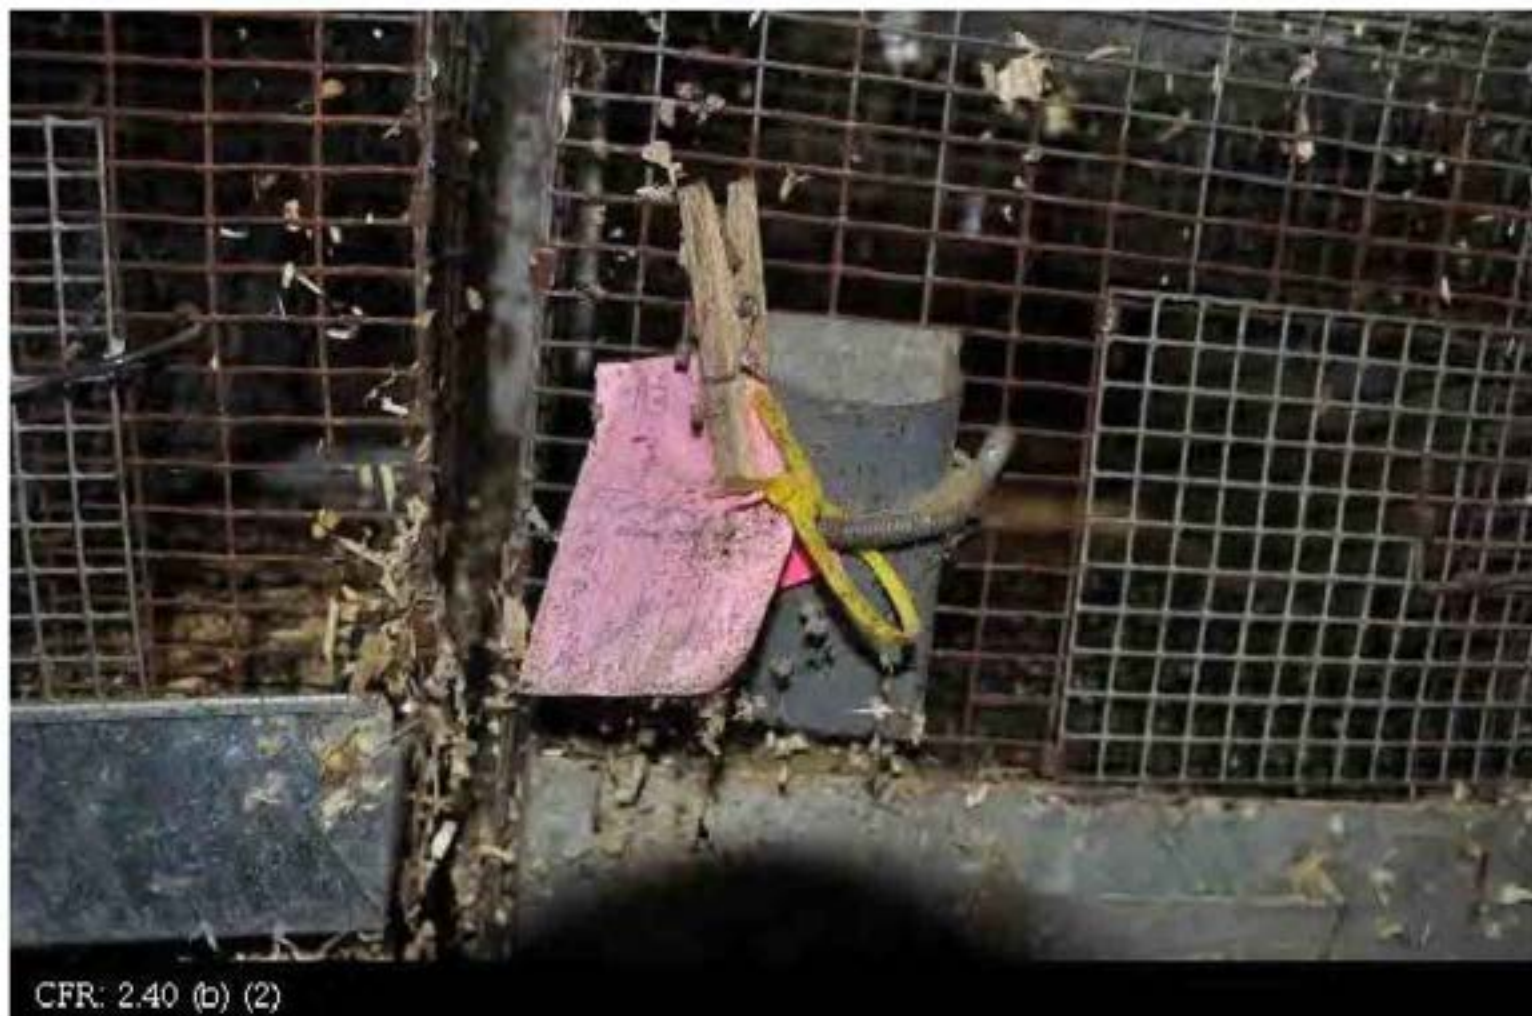
| Description: | Chinchillas in backroom; three (no id's) had unresolved eye problems. Treatment card on cage upper left has 7/3 for date and lower right has 9/7. | | |

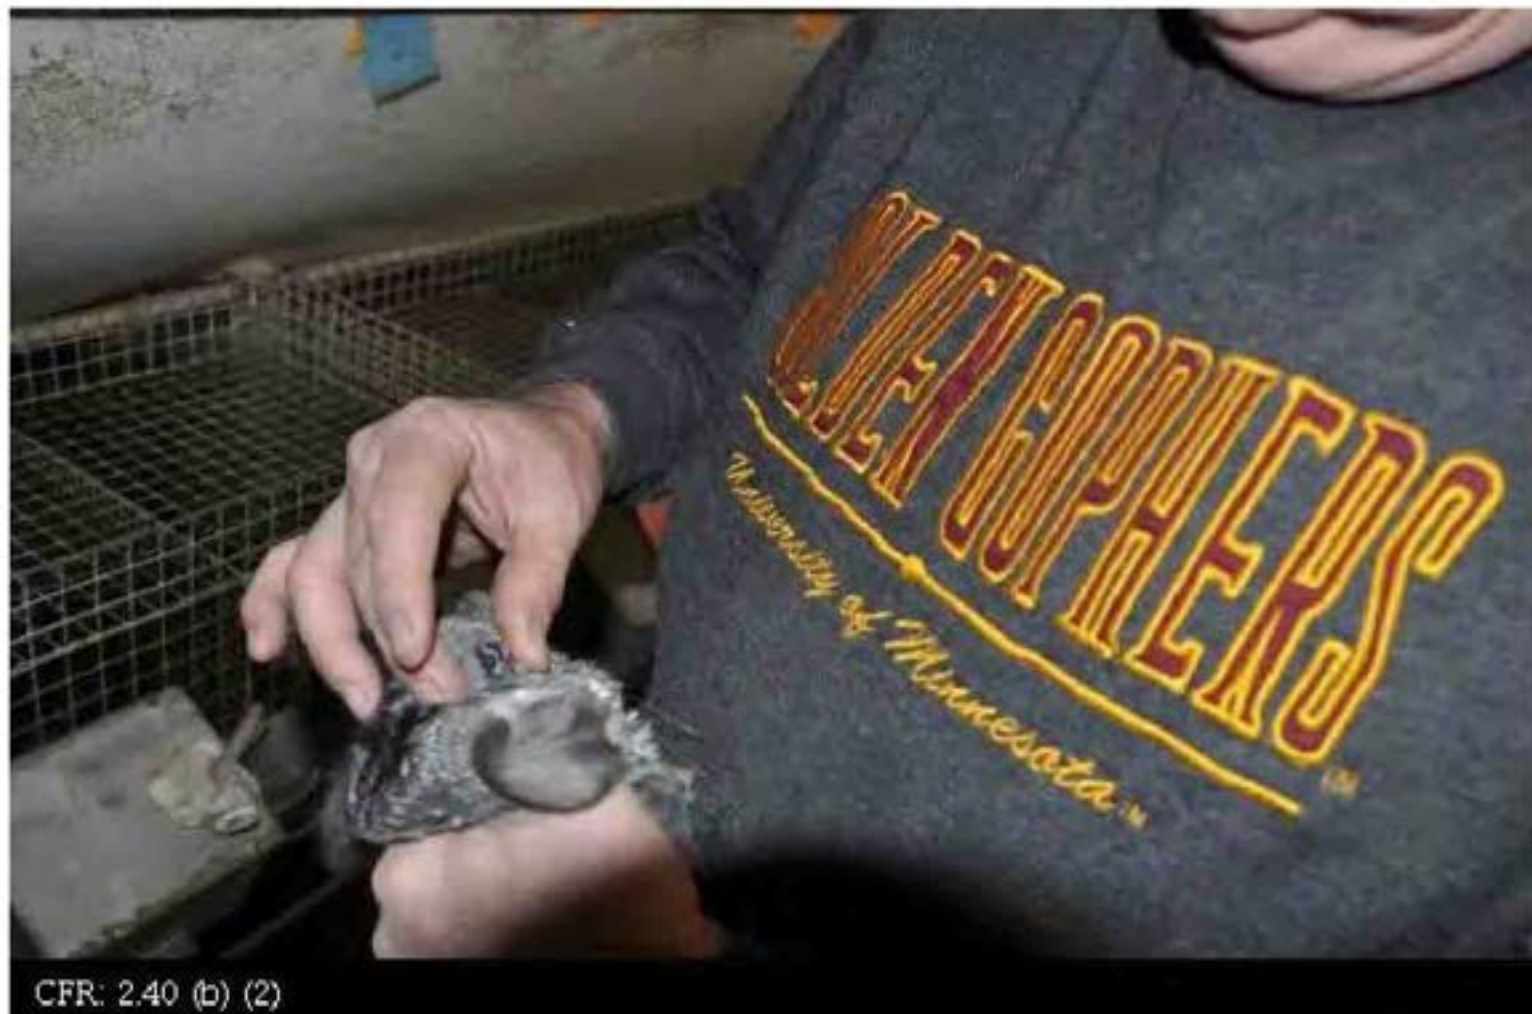
CFR: 2.40 (b) (2)

| Description: | Female with eartag "337". Right eyelids swollen with crusty material and creamy pale discharge from eye. Licensee had cage marked and said he was watching this one, but not giving medicine. | | |

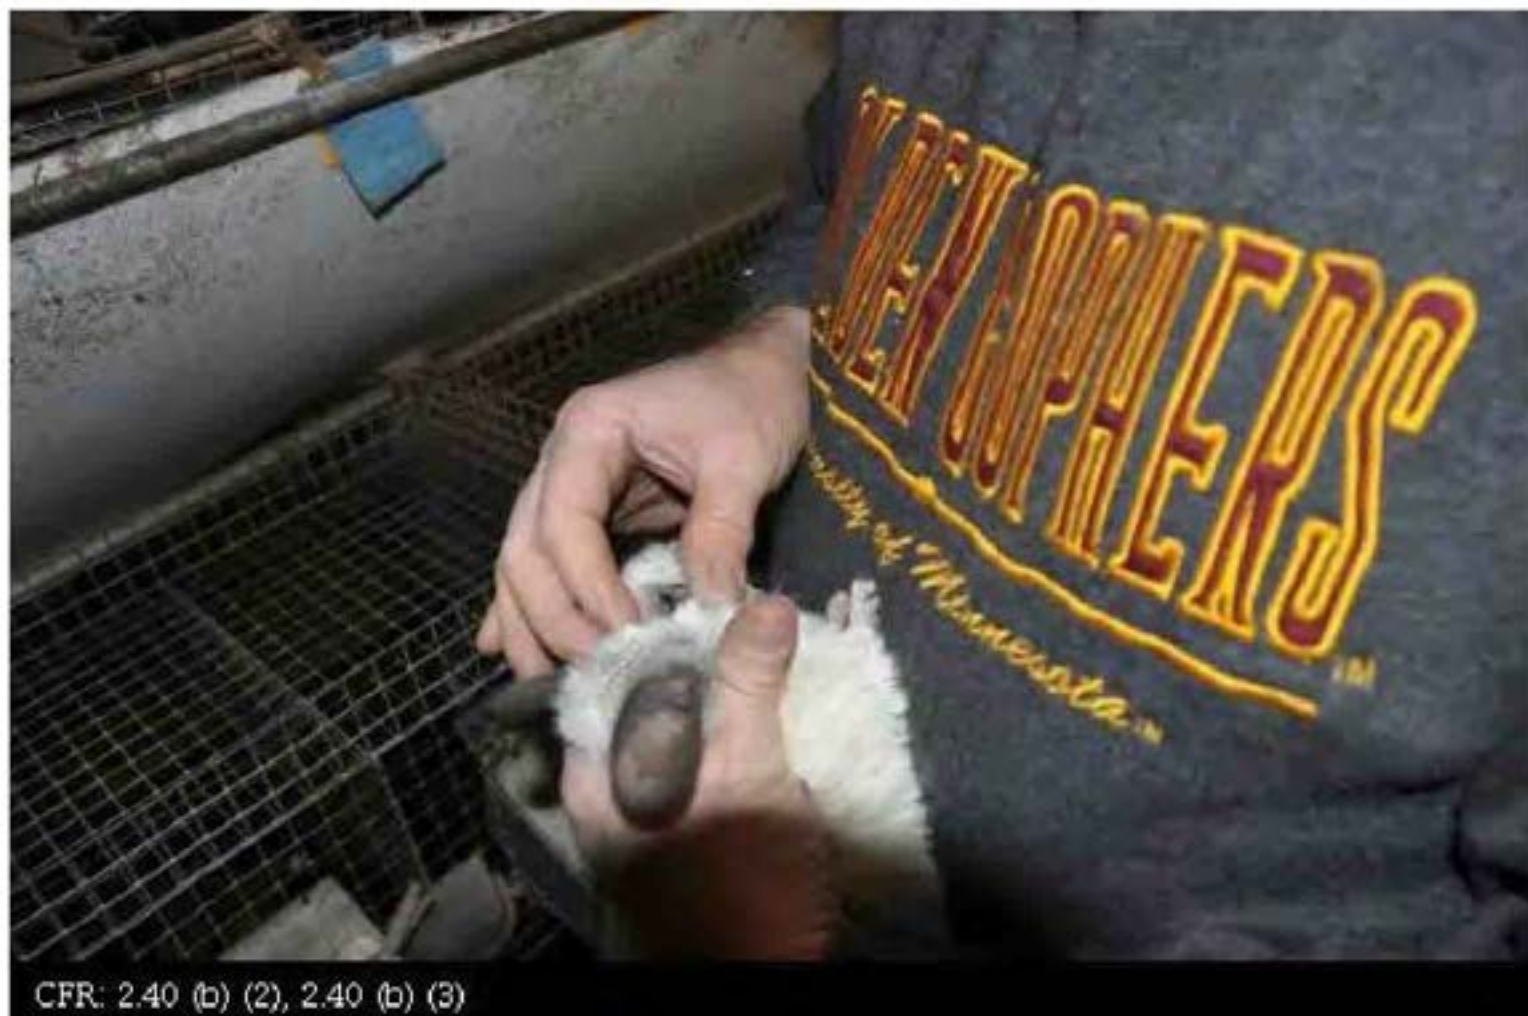
| Description: | Male with cage card R242; its right eyelids were swollen and had a pale creamy discharge. | | |

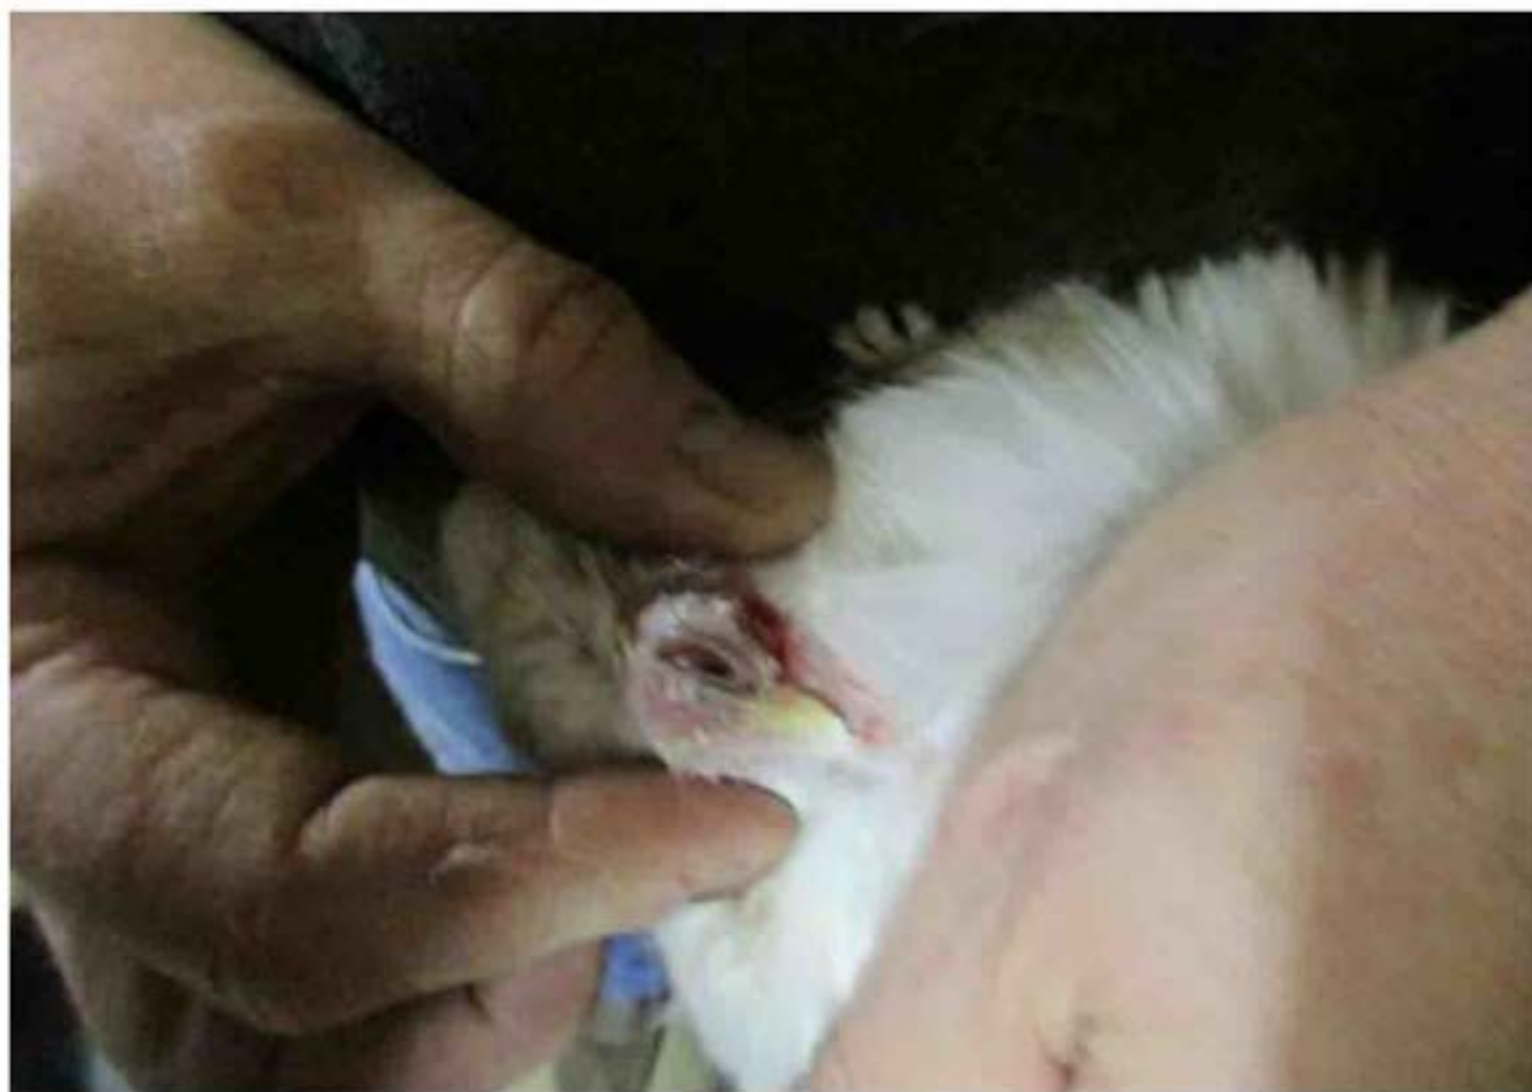
CFR: 2.40 (b) (2), 2.40 (b) (3)

| Description: | Male (no id; '3-5' on cage card); its right eyelids crusted, swollen with pale creamy discharge in eye, its right lower eyelid also bled after licensee touched it. | | |

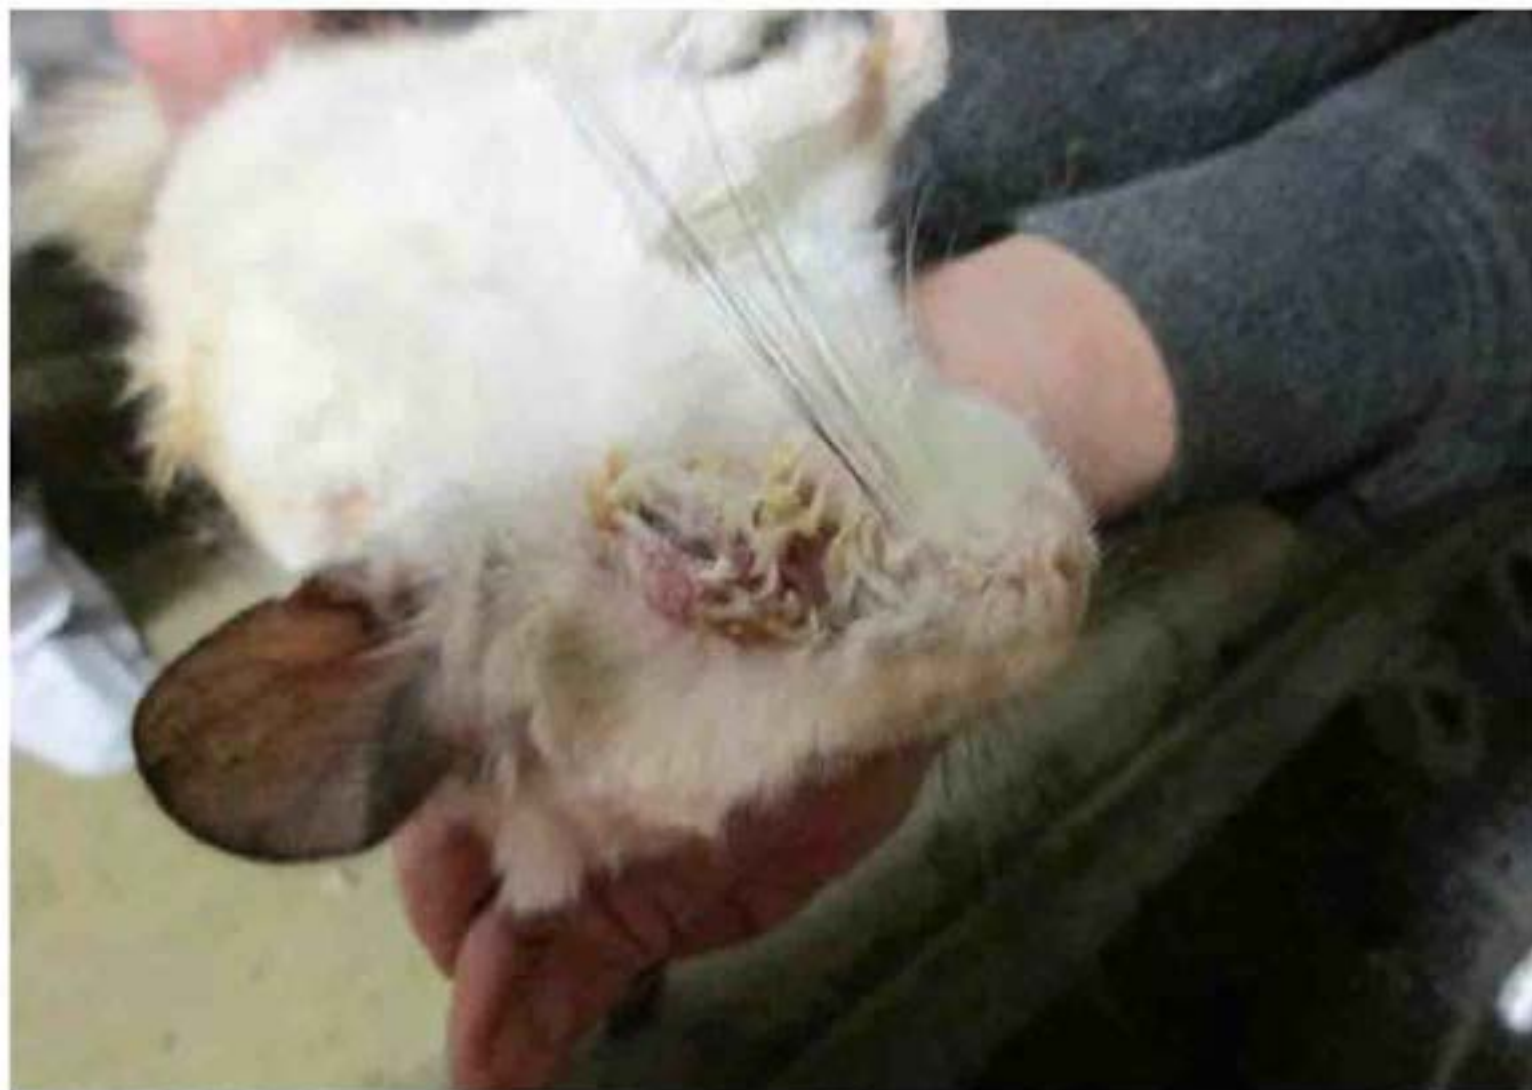
CFR: 2.40 (b) (2), 2.40 (b) (3)

| Description: | Male (no id; '3-5' on cage card); its left eyelids were crusted, swollen, and had a creamy pale discharge from the eye. | | |

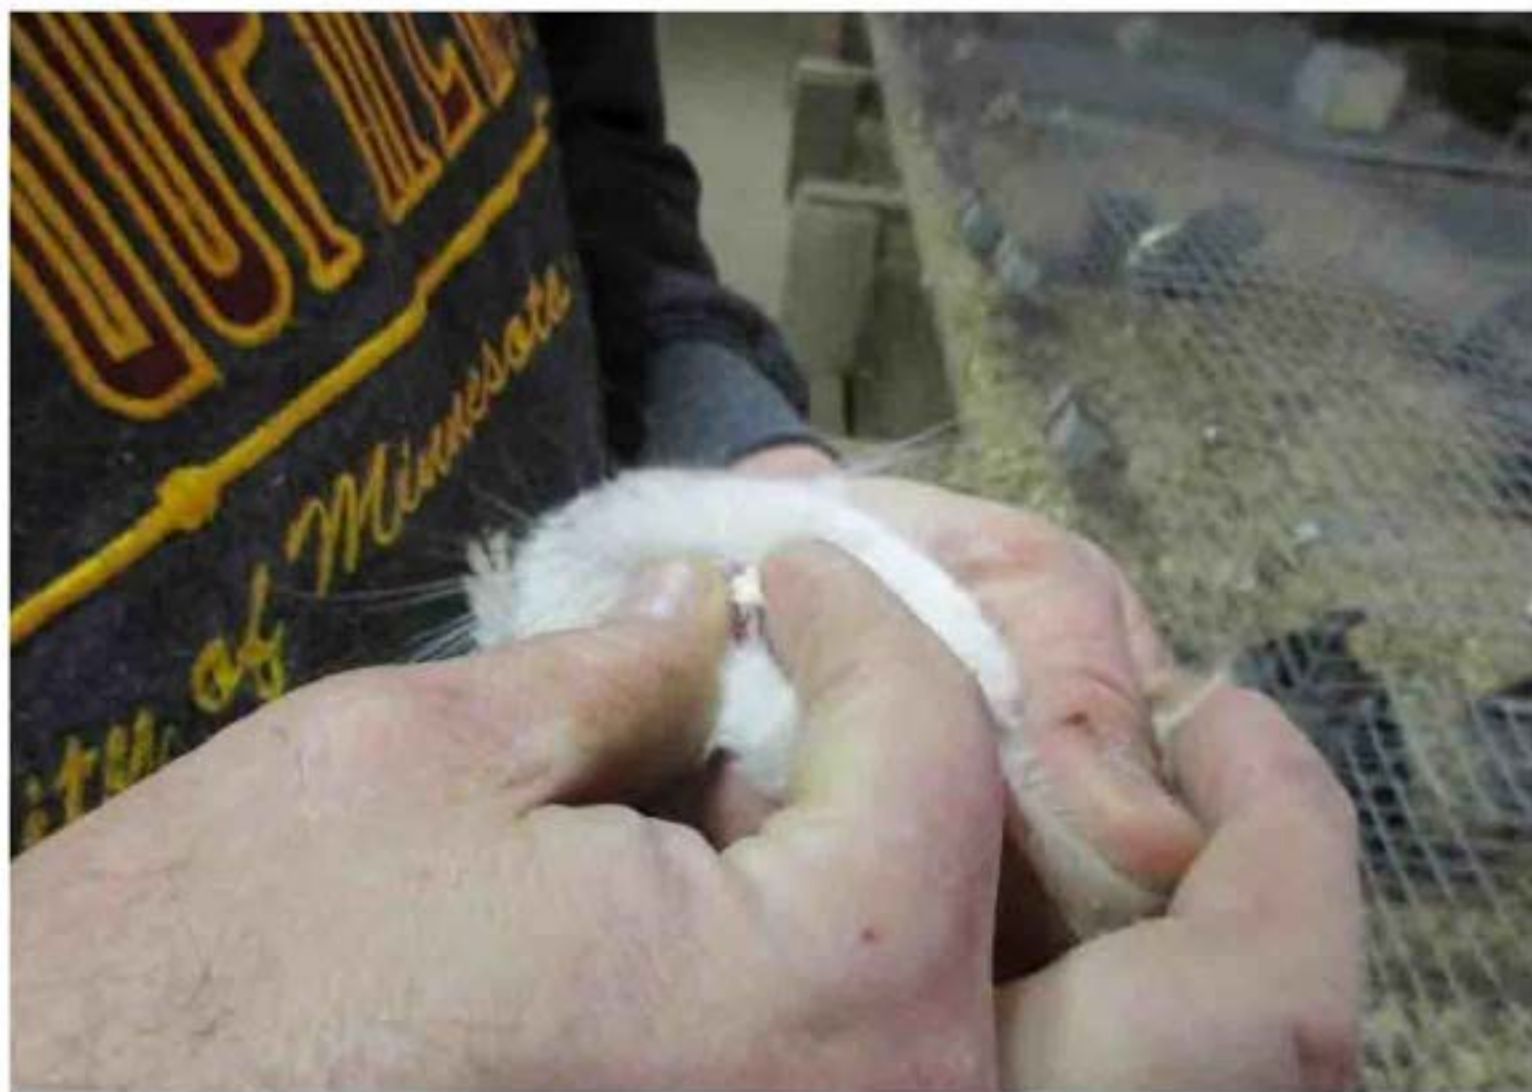
CFR: 2.40 (b) (3), 2.40 (b) (2)

| Description: | Female with eartag 'DJM 196'; swollen left eyelids and a thick pale creamy discharge that came out from underneath them as licensee handled the eyelids. | | |

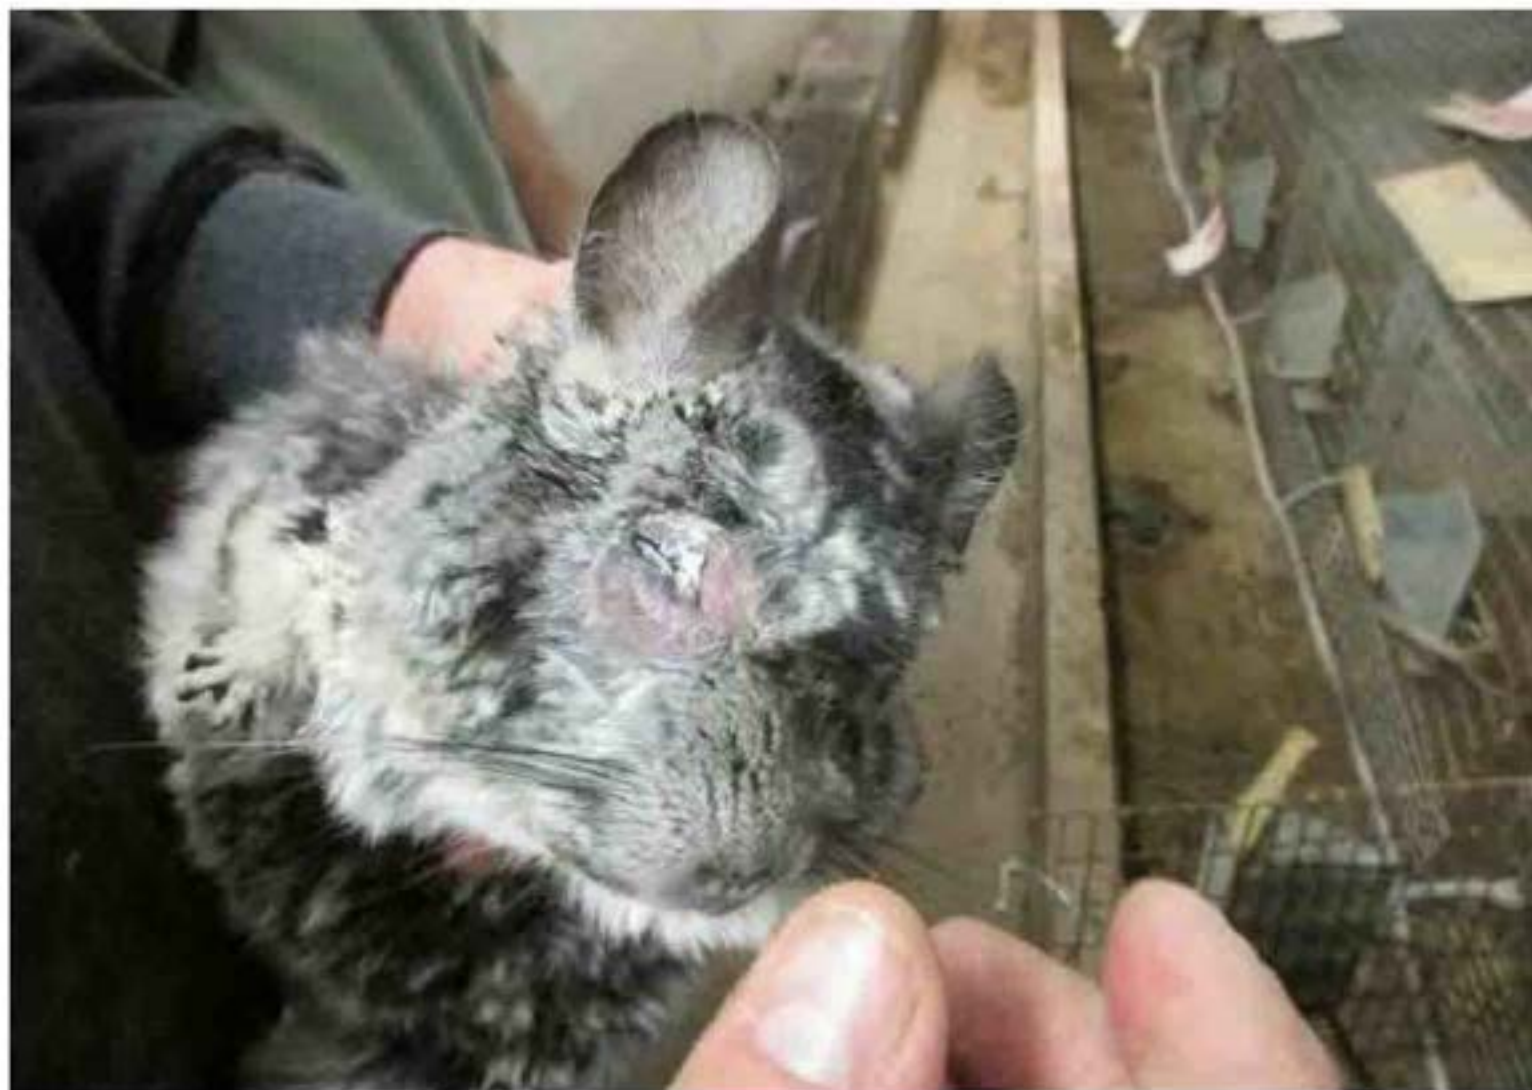
CFR: 2.40 (b) (2), 2.40 (b) (3)

| Description: | Female with eartag "505"; its right eyelids sealed shut with crusty material with hair loss, reddened skin, and a pale creamy discharge from eye. | | |

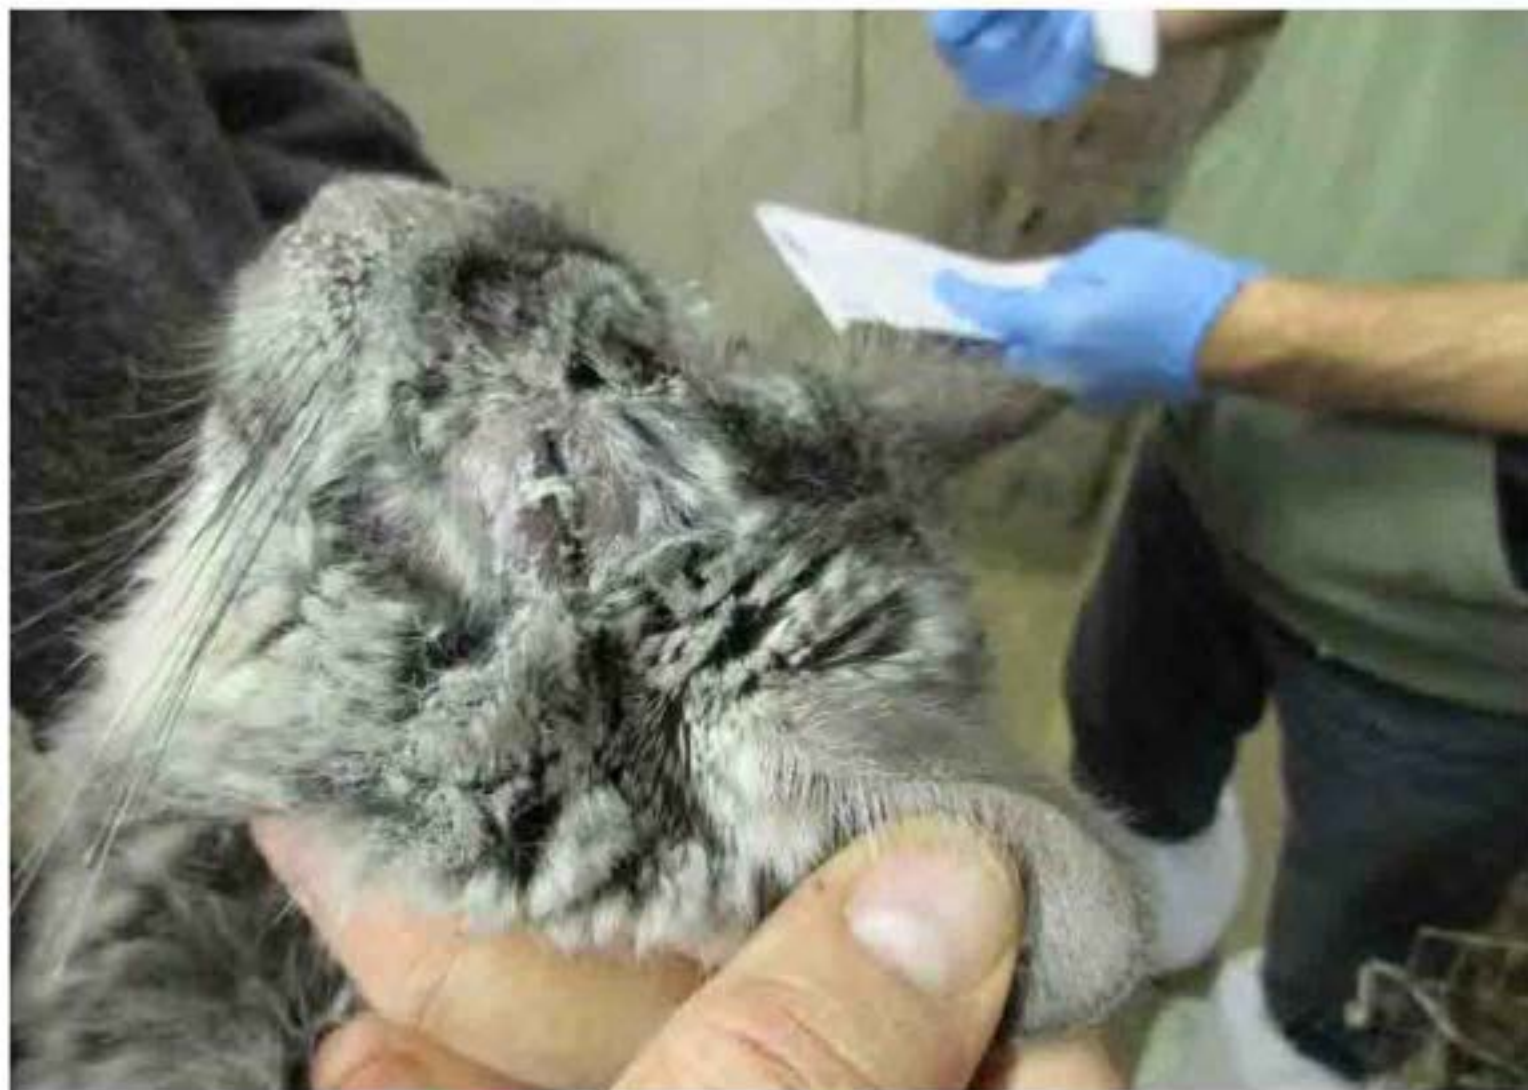
CFR: 2.40 (b) (2), 2.40 (b) (3)

| Description: | Female with eartag "505" its left eyelids sealed shut with crusty material with hair loss, reddened skin, and a pale creamy discharge from eye. | | |
