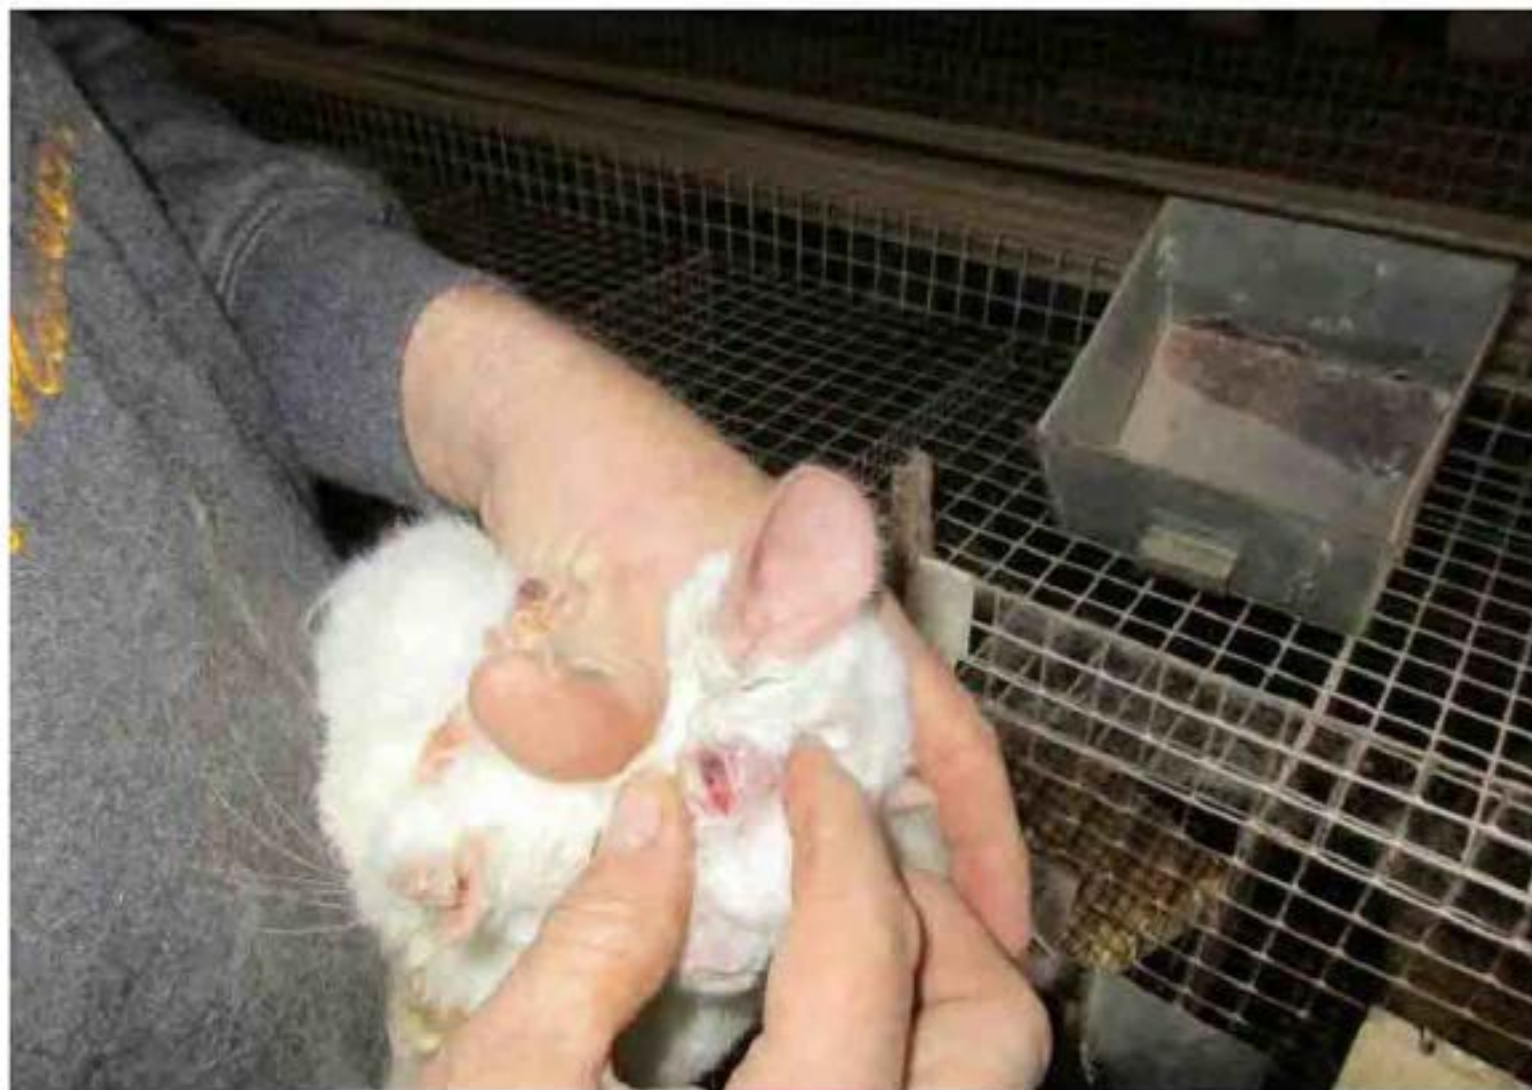
CFR: 2.40 (b) (3), 2.40 (b) (2)

| Description: | Male (no id; cage card "4-8"); its right eye was crusted shut; eyelids swollen with hair loss and surrounding tissues under eyelids bright red. | | |

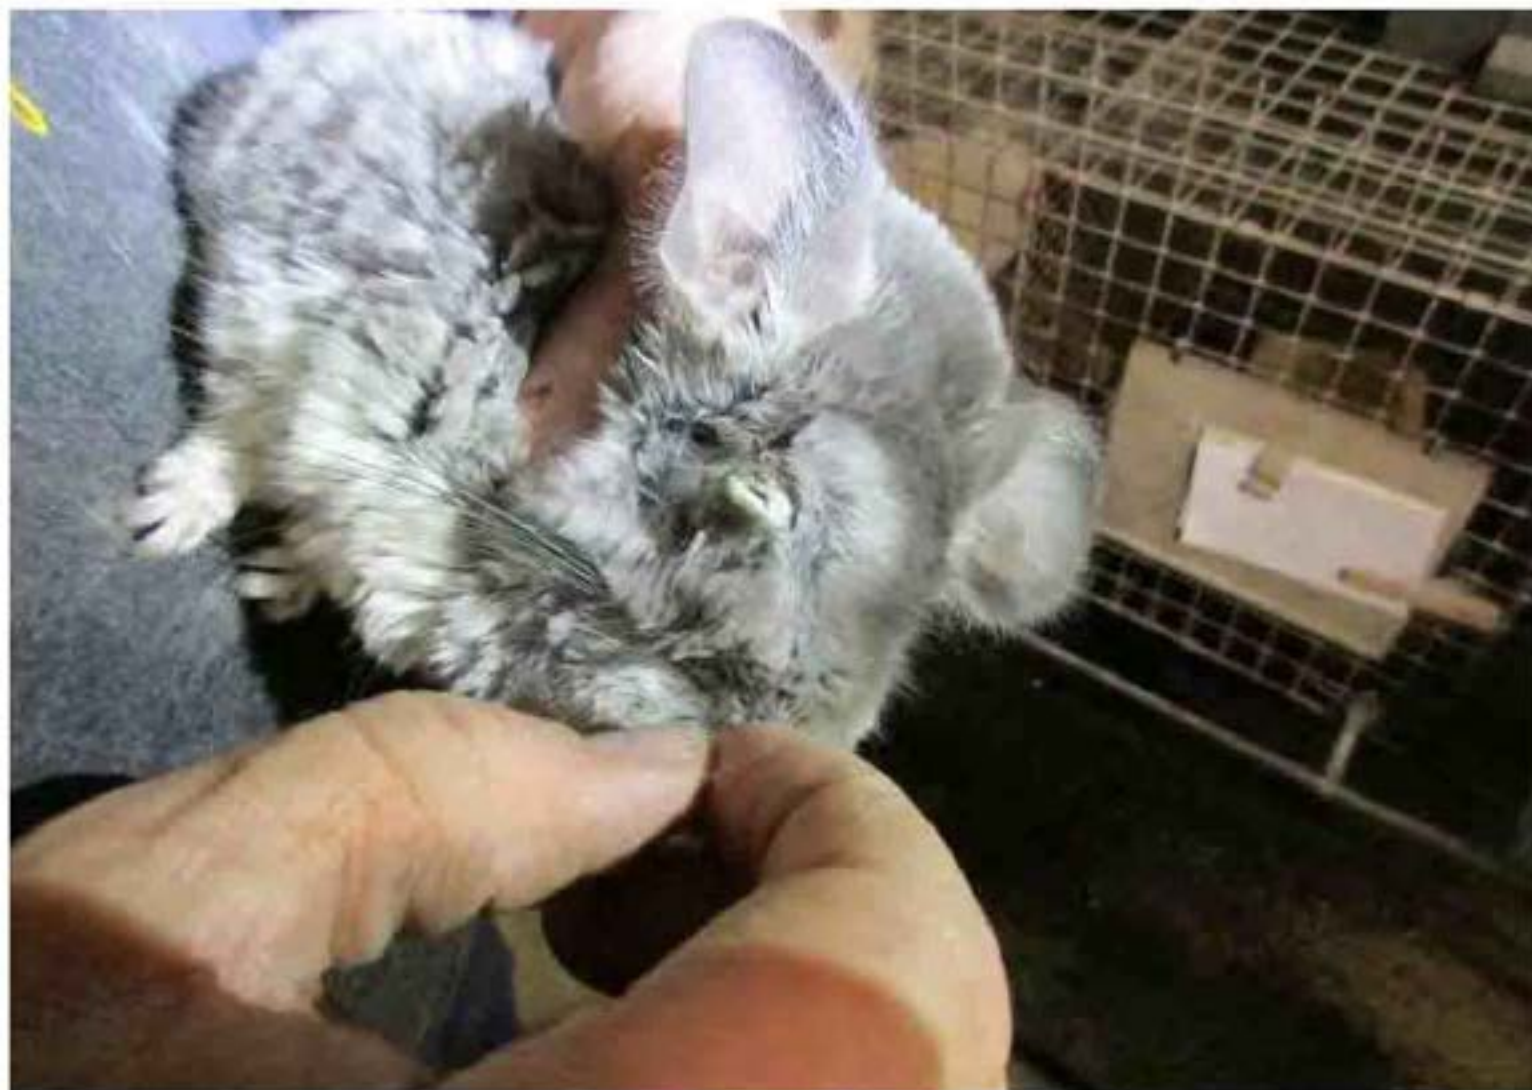
CFR: 2.40 (b) (2), 2.40 (b) (3)

| Description: | Male (no id; cage card "9-13-11"); right eye was sealed shut with crusted material and had some pale creamy discharge. | | |

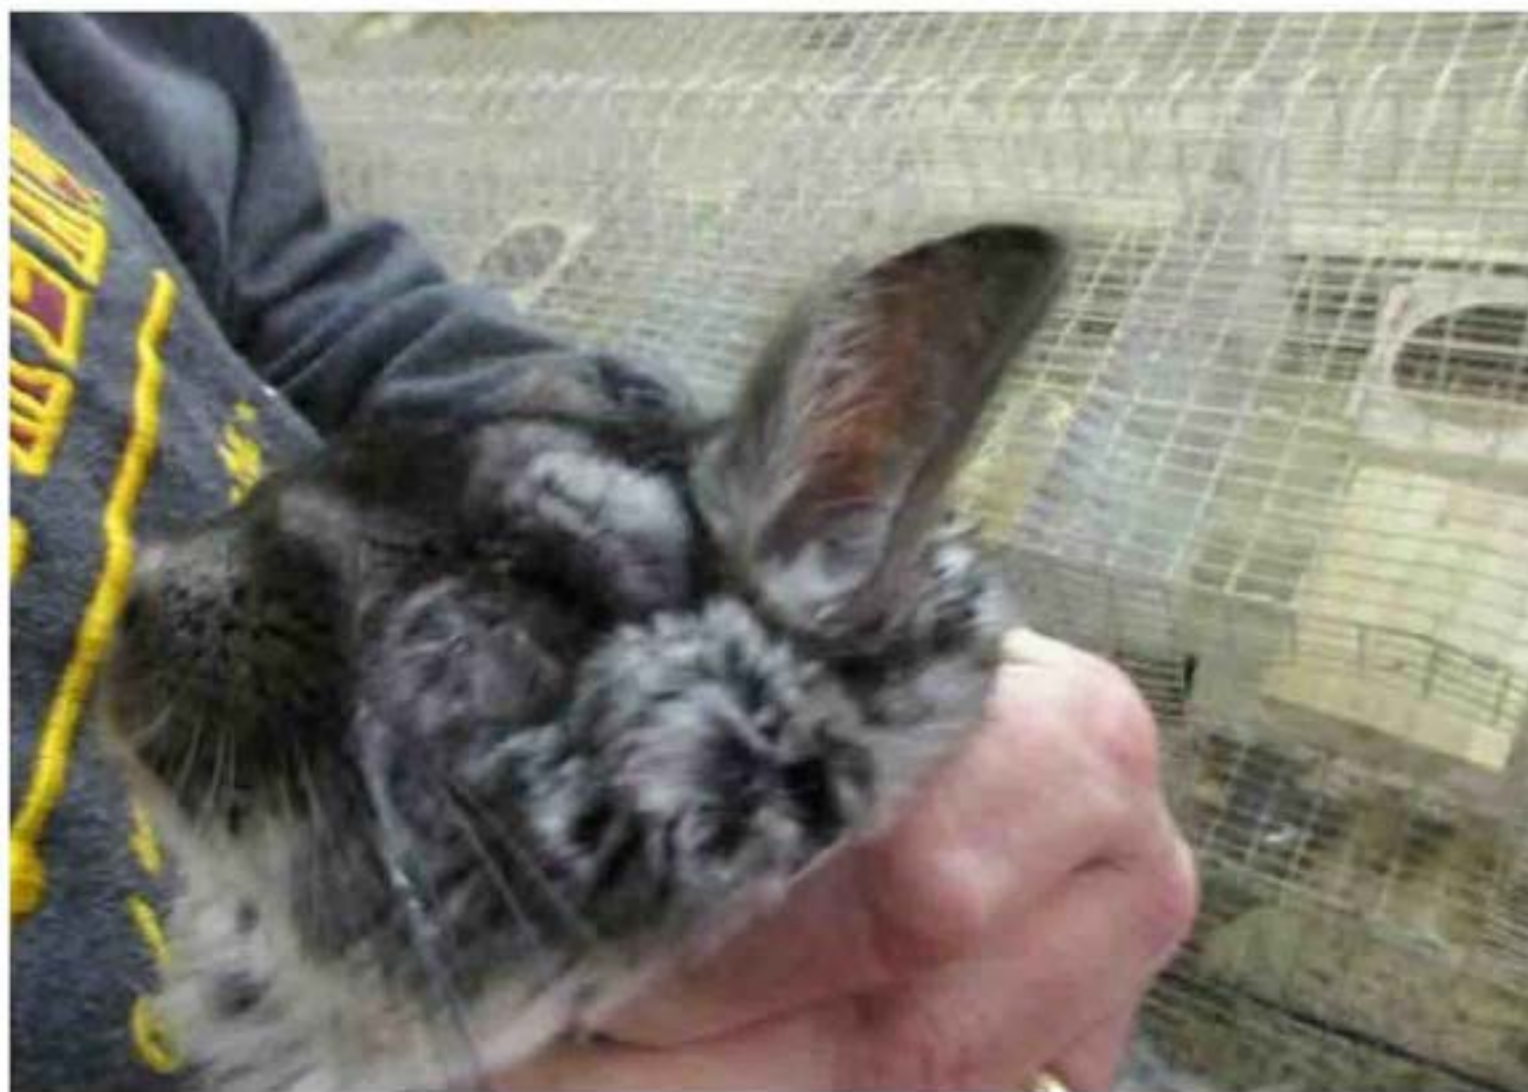
CFR: 2.40 (b) (2)

| Description: | BDX-531's left eye with some crusting and partly sealed shut. | | |

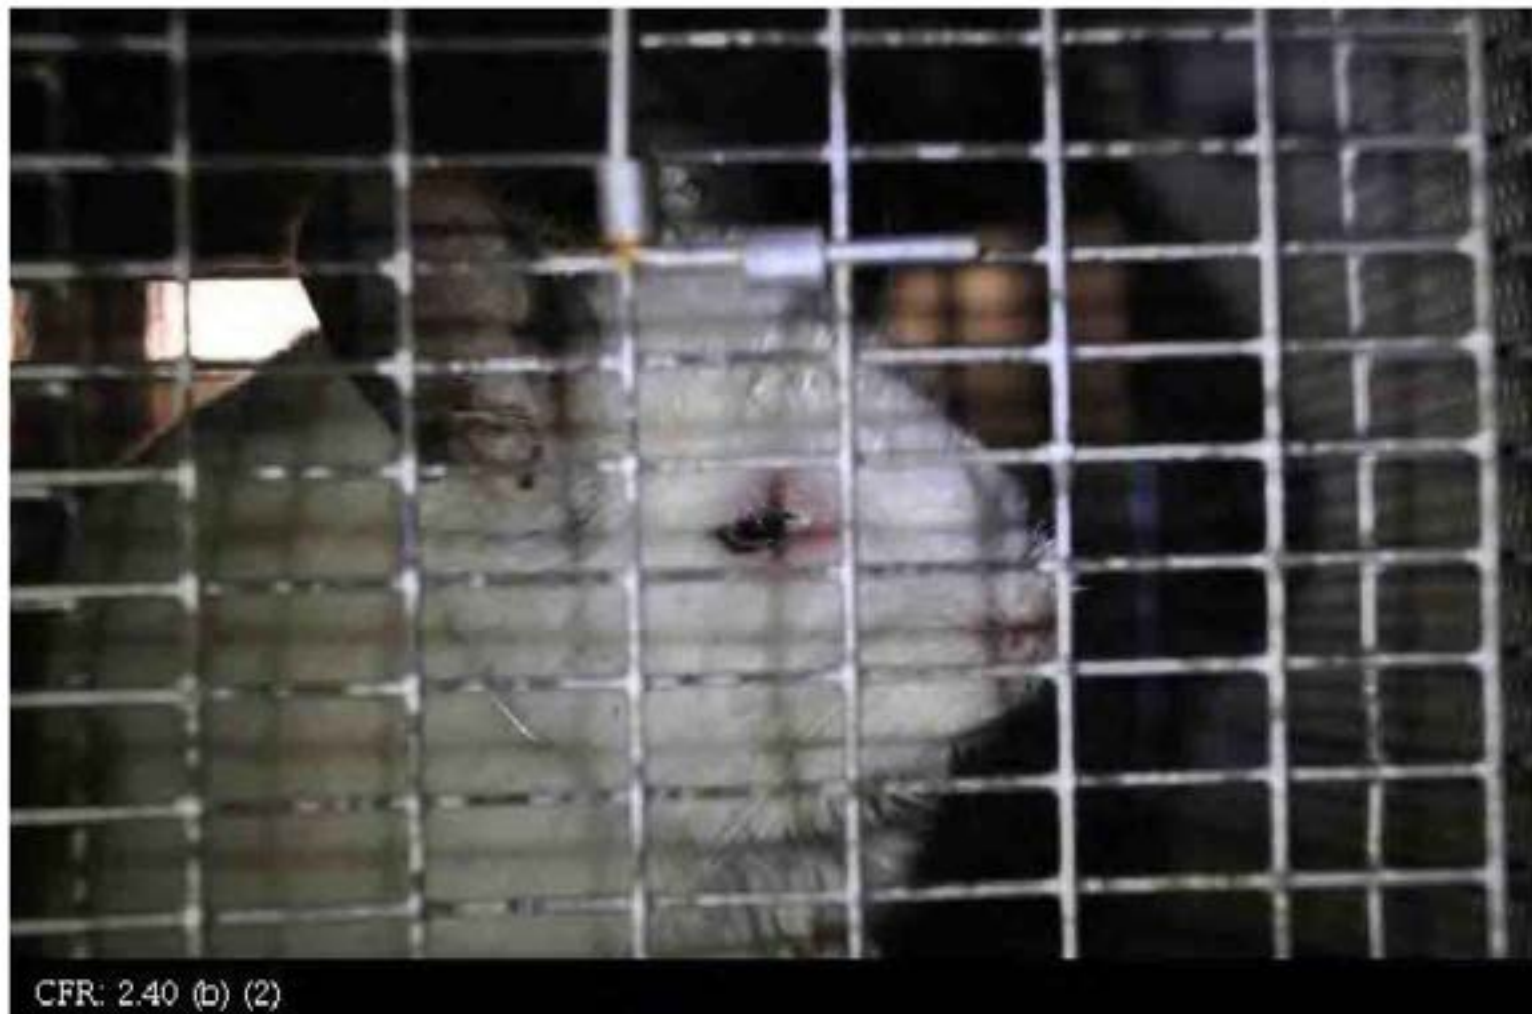
CFR: 2.40 (b) (2)

| Description: | White colored with cage card 2113; had a small amount of pale creamy discharge in right eye. | | |

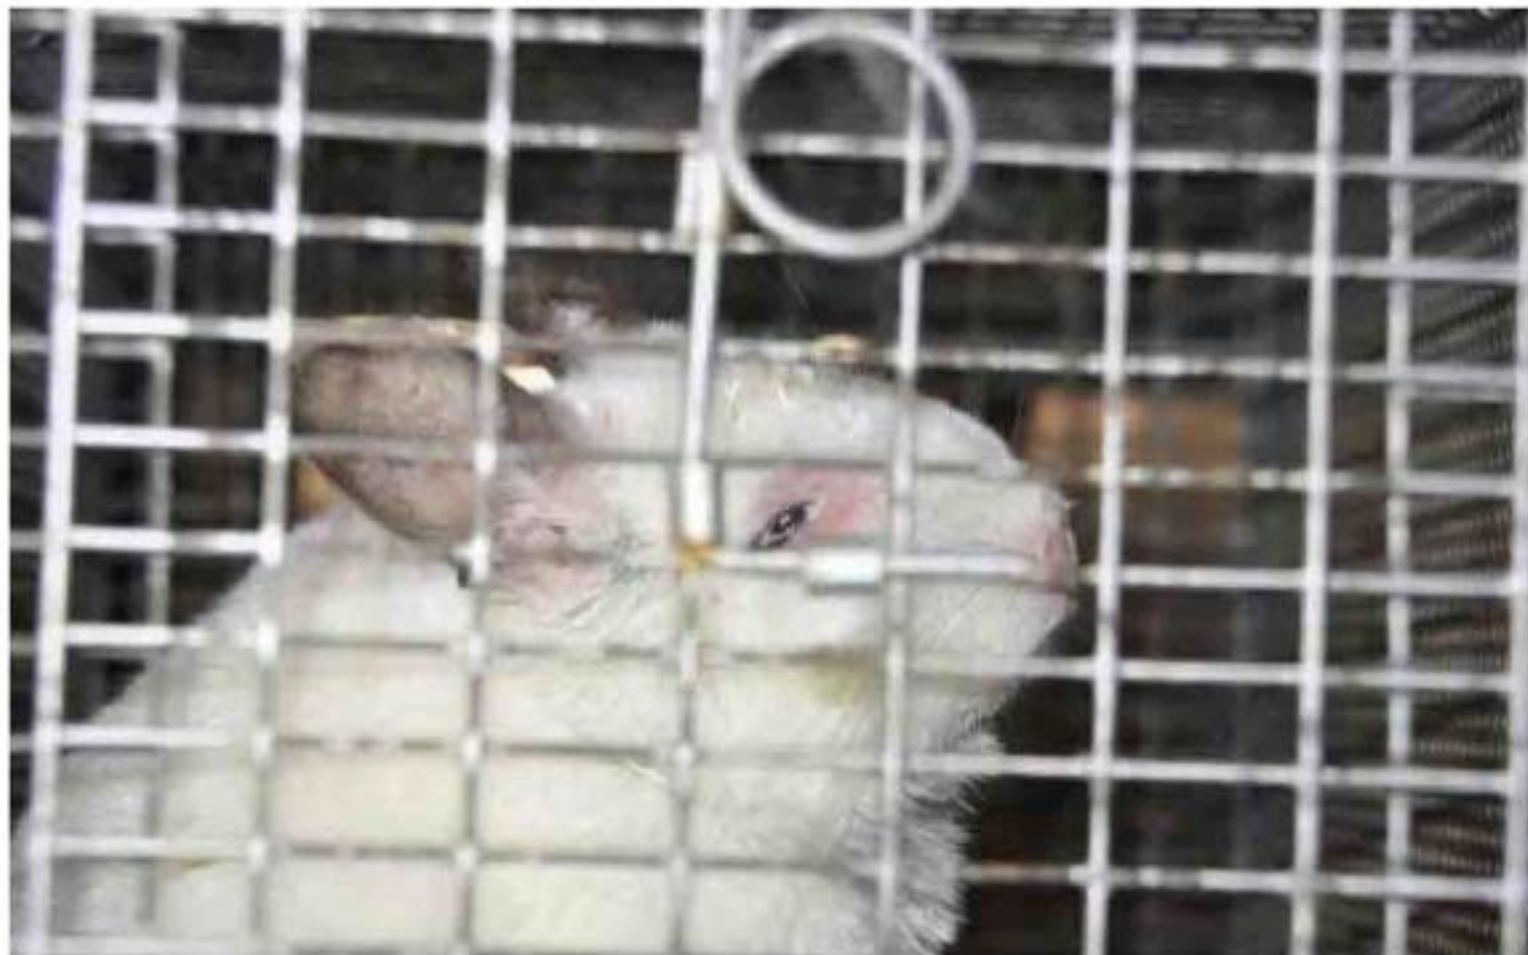
CFR: 2.40 (b) (2)

| Description: | White colored with cage card 2113; had a small amount of pale creamy discharge in right eye. | | |

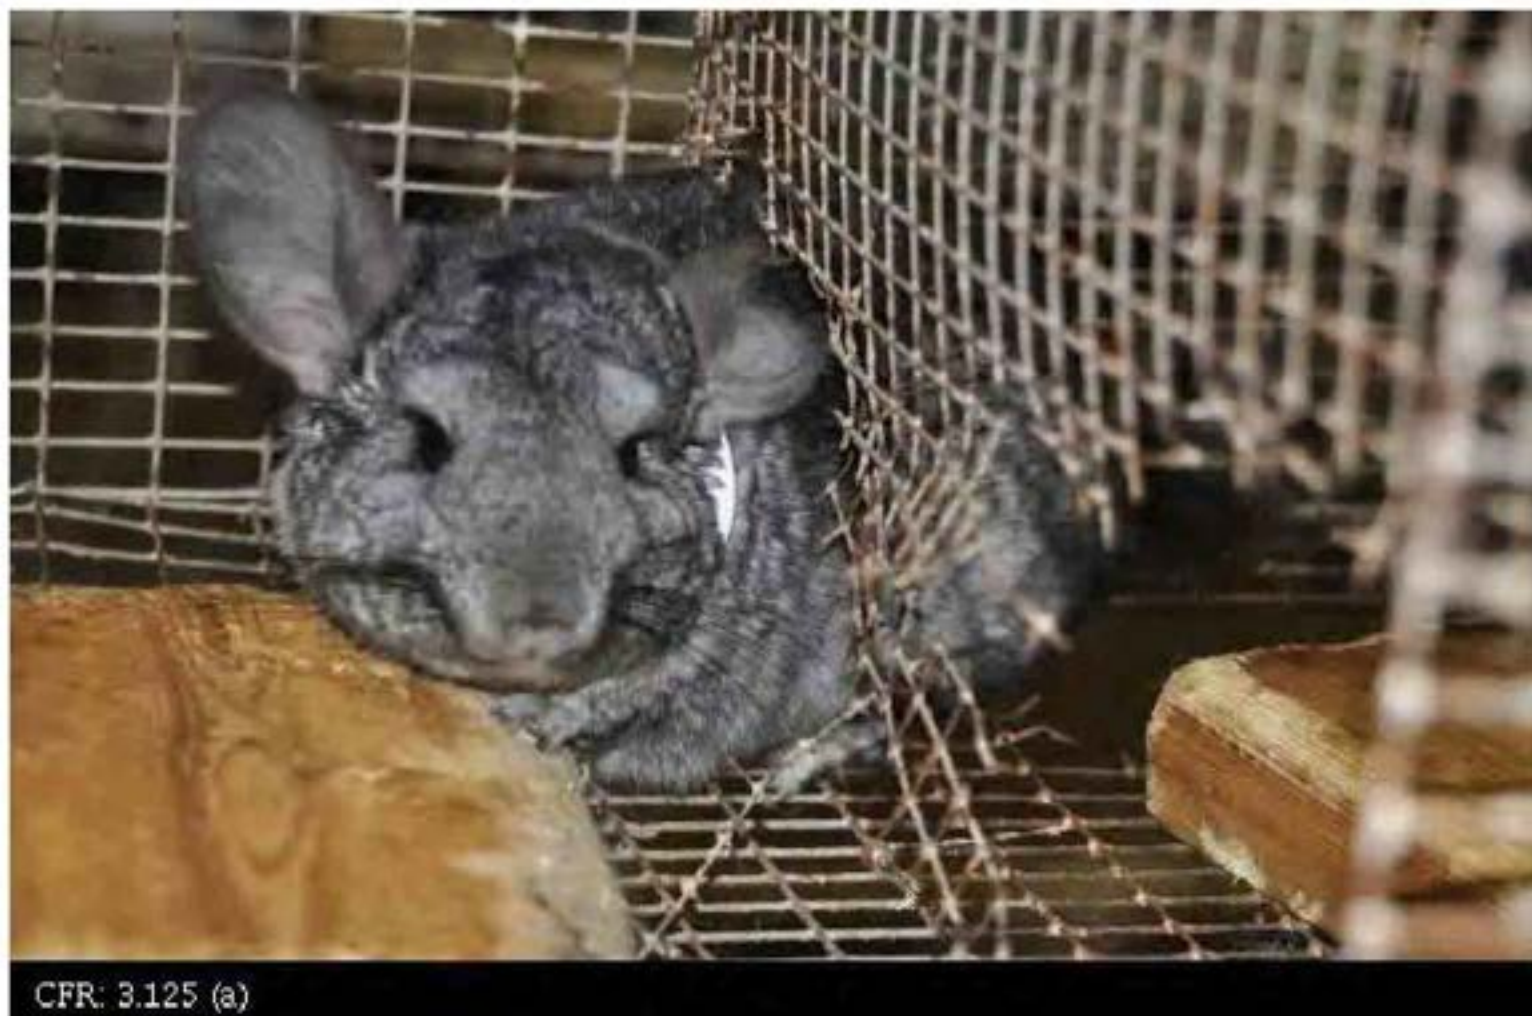
| Description: | Wire points and holes in enclosure; note behind the chinchilla behind the wood block on the right there is a large hole with points in the enclosure floor. | | |

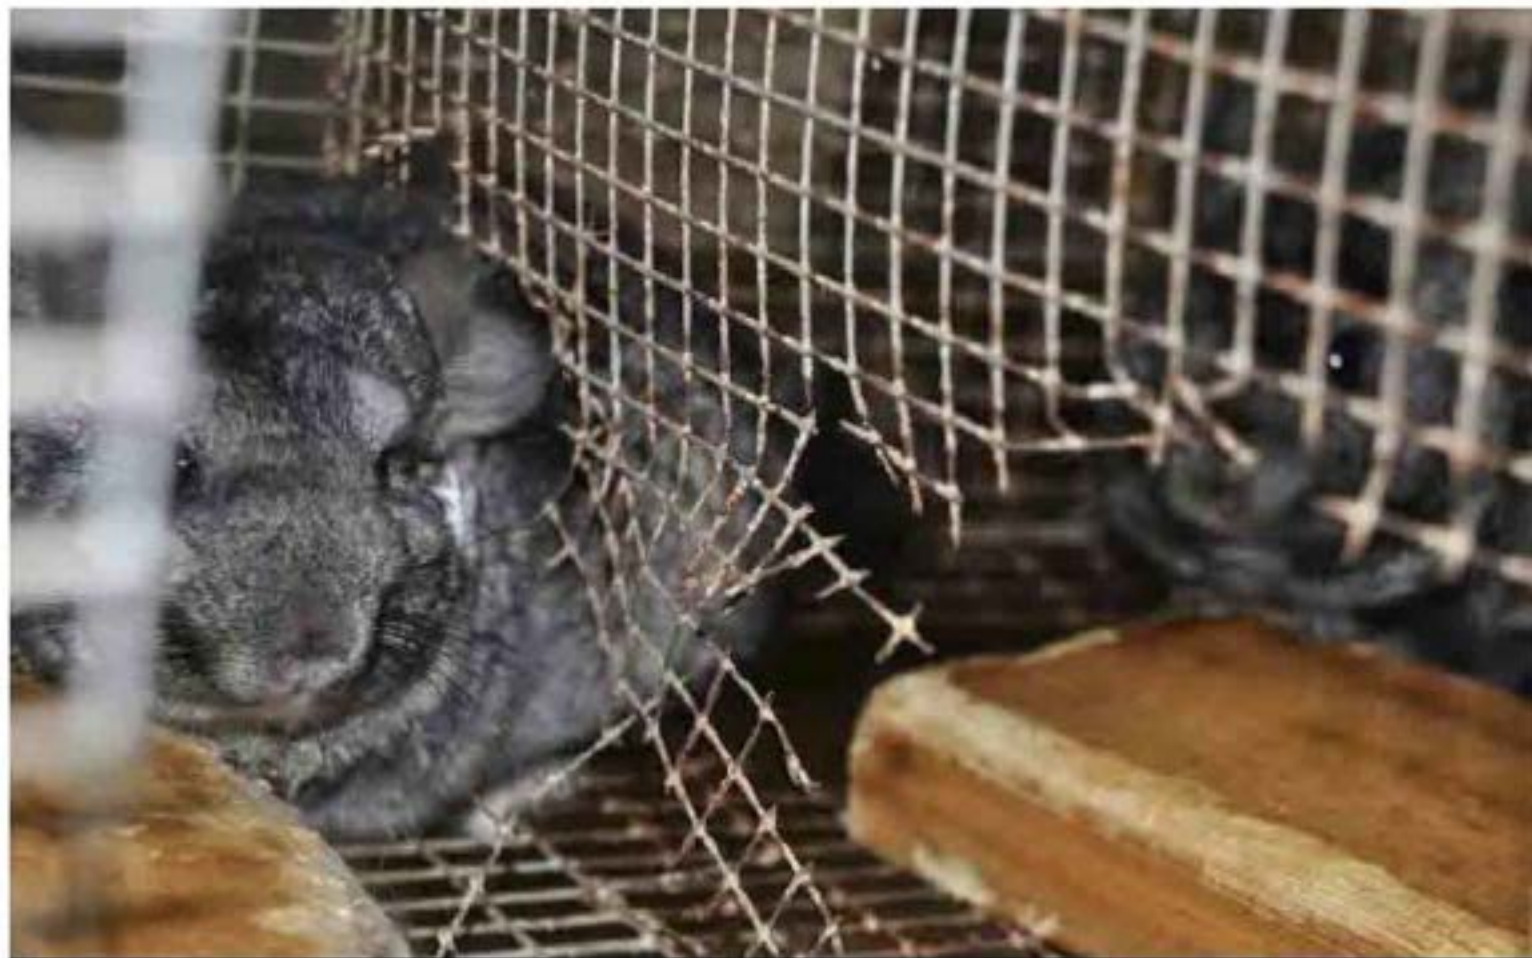
CFR: 3.125 (a)

| Description: | Close up of wire points in enclosure. | | |

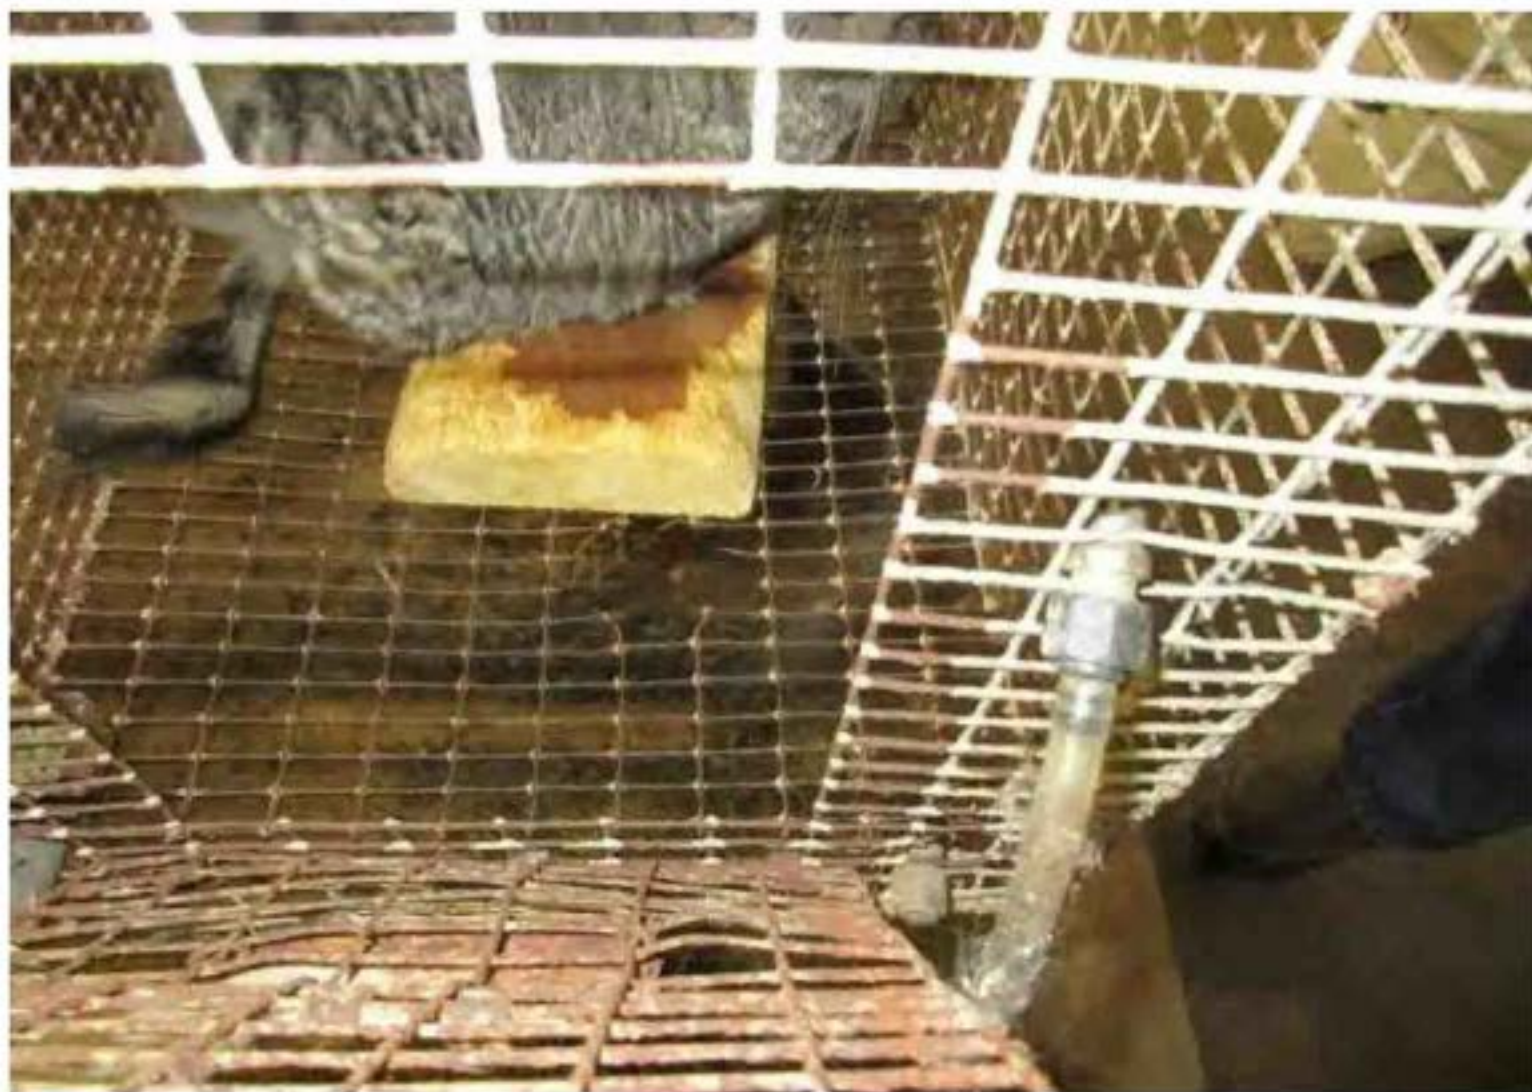
CFR: 3.125 (a)

| Description: | Another enclosure with hole and wire points in flooring that was housing chinchilla with cage card BD-Z-46. | | |

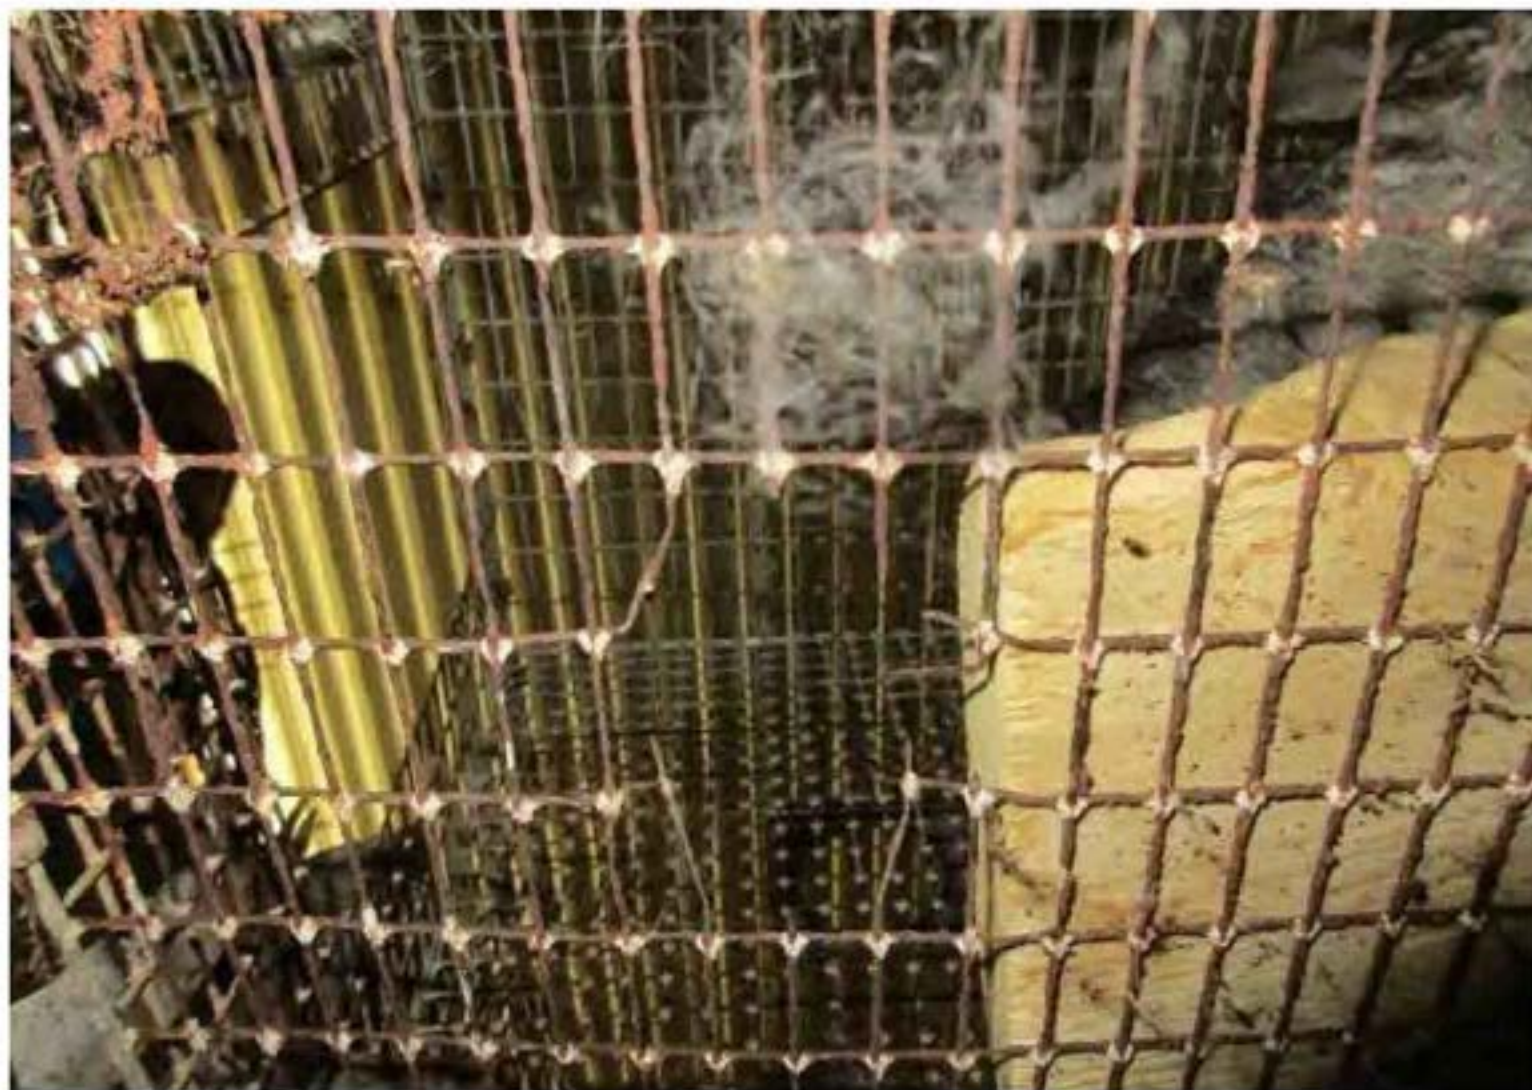
CFR: 3.125 (a)

| Description: | View of hole in flooring with wire points from underneath enclosure that was housing chinchilla with cage card "BD-Z-46". | | |

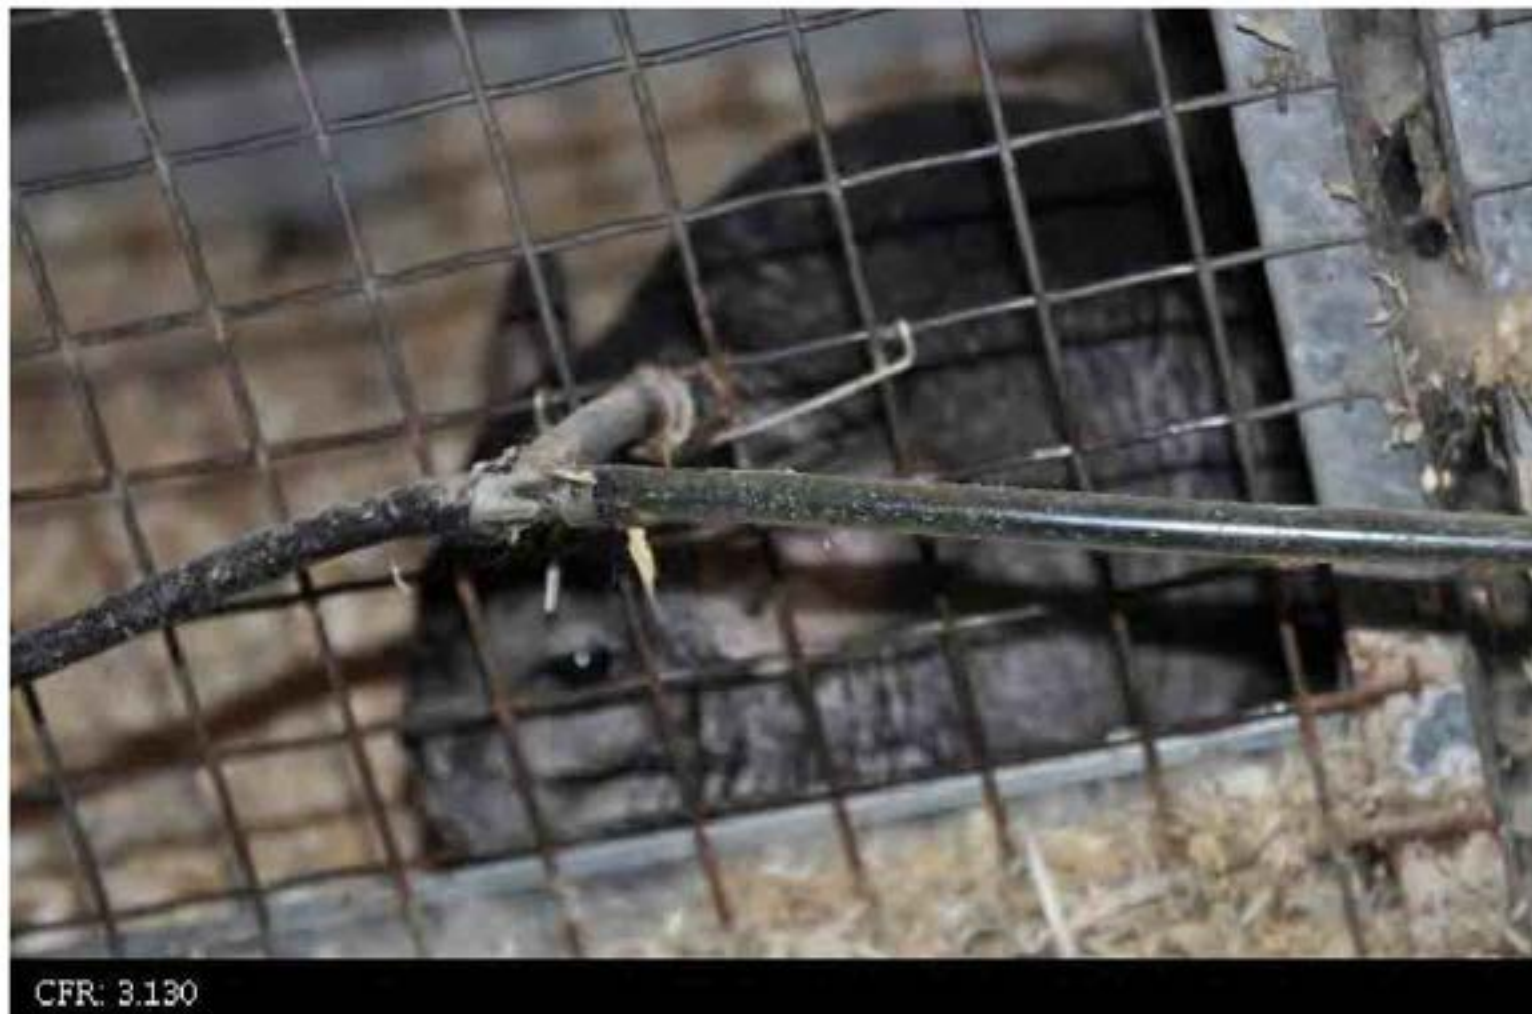
| Description: | Watering line on right of drinking nozzle is clear and has a greenish appearance on the inside. Line on left of nozzle is a different black material. | | |

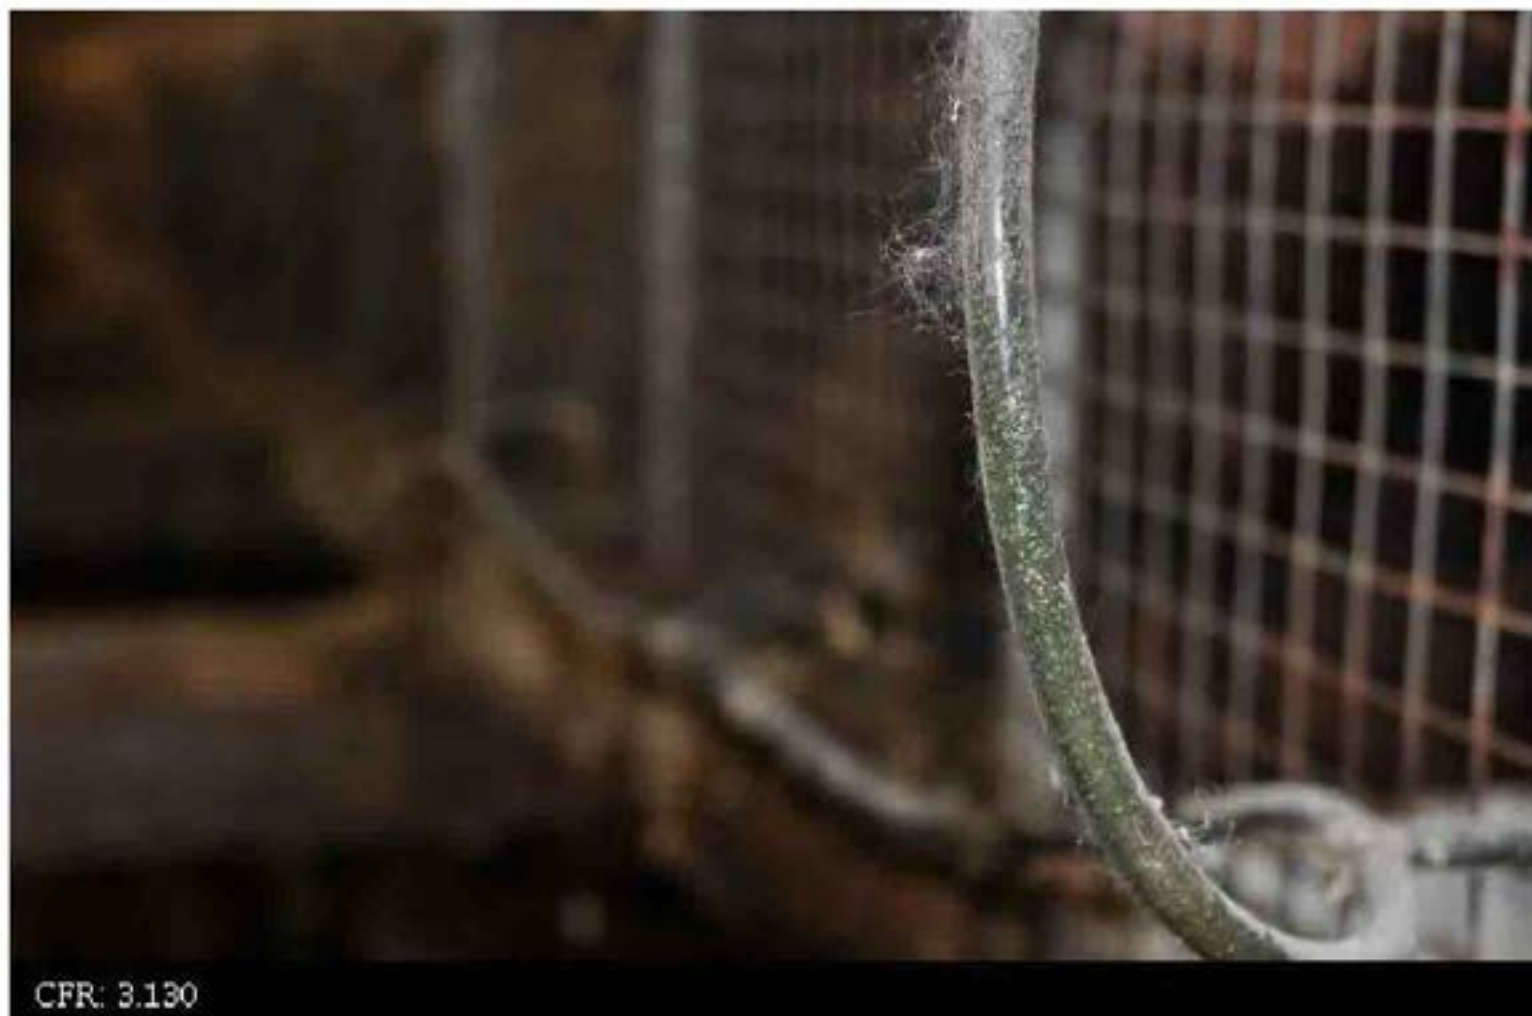
| Description: | Clear water line with greenish appearance. | | |

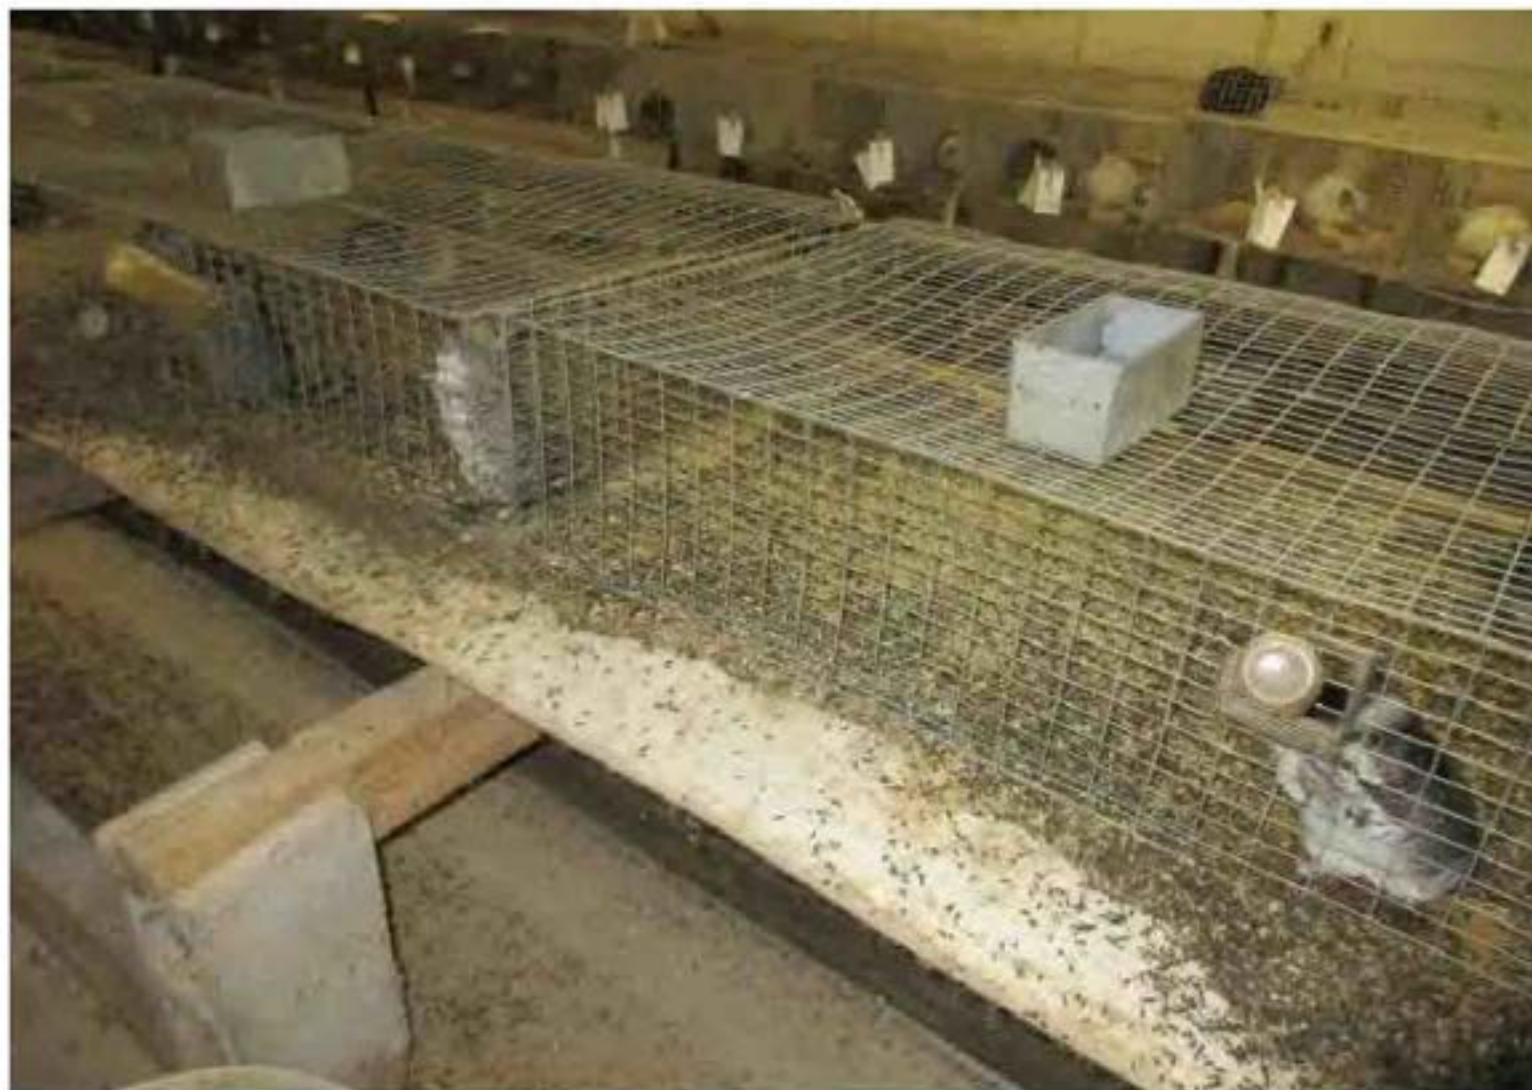
| Description: | Two enclosures in back part of first room with excessive feces. Licensee stated they hadn't been cleaned in four weeks. Representative of enclosures housing about 38 animals in front room. | | |

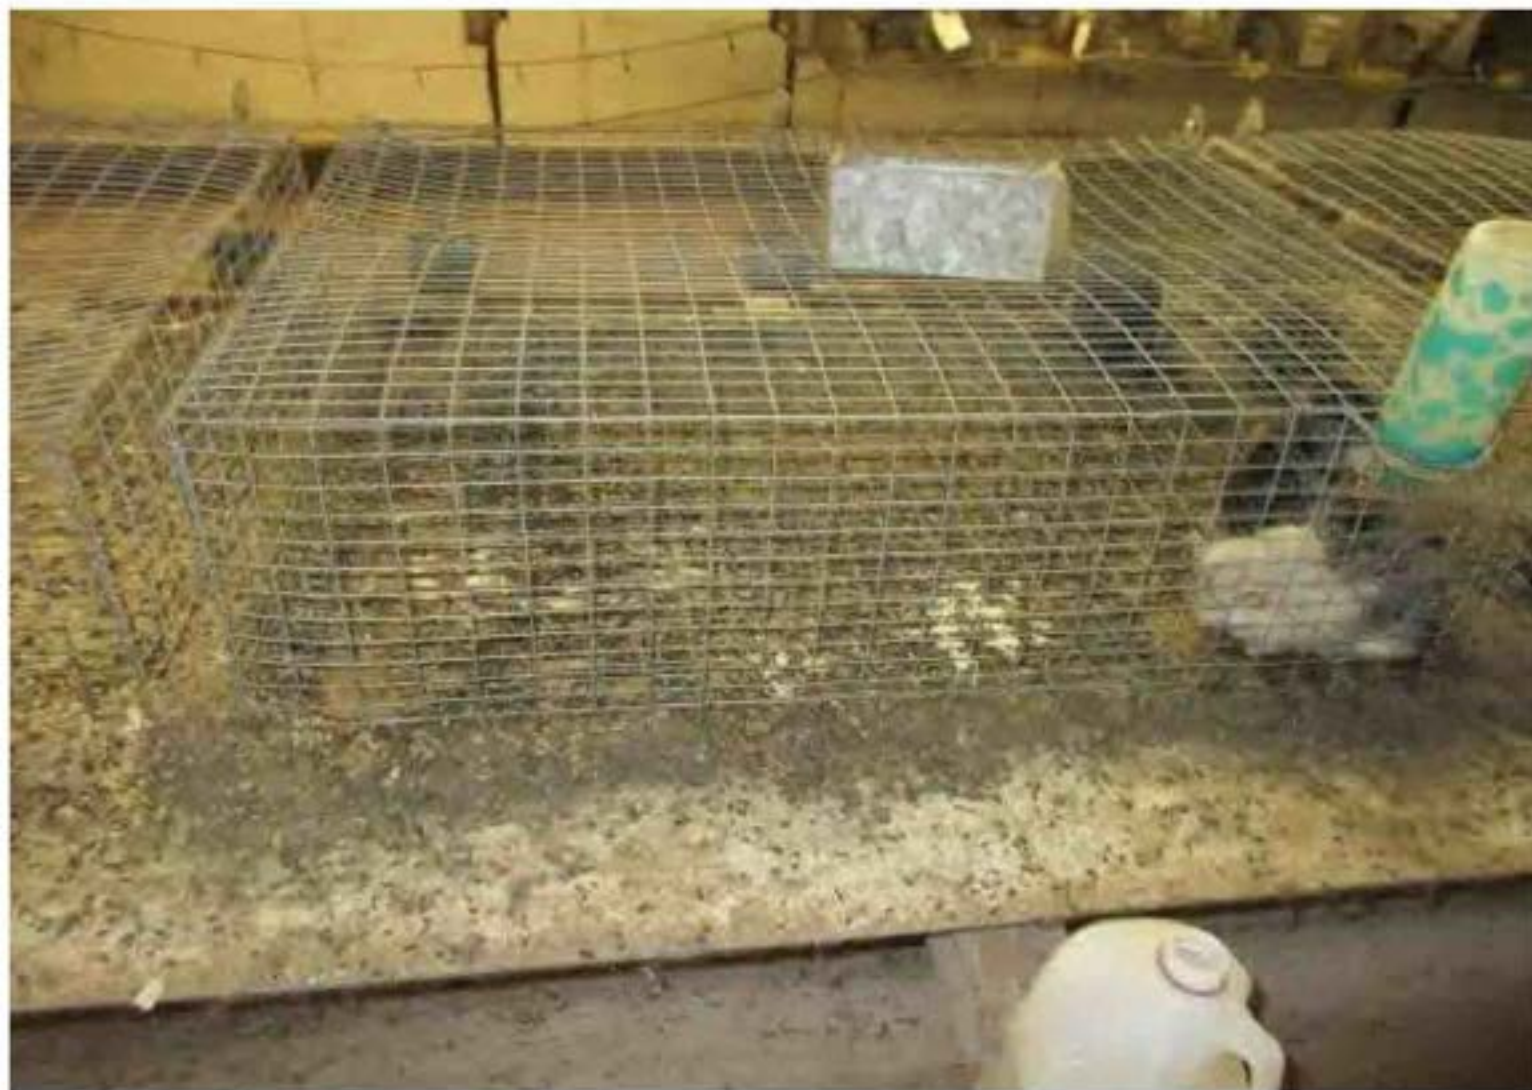
| Description: | Enclosure in back part of first room with excessive feces. Licensee stated it hadn't been cleaned in four weeks. Representative of enclosures housing about 38 animals in front room. | | |

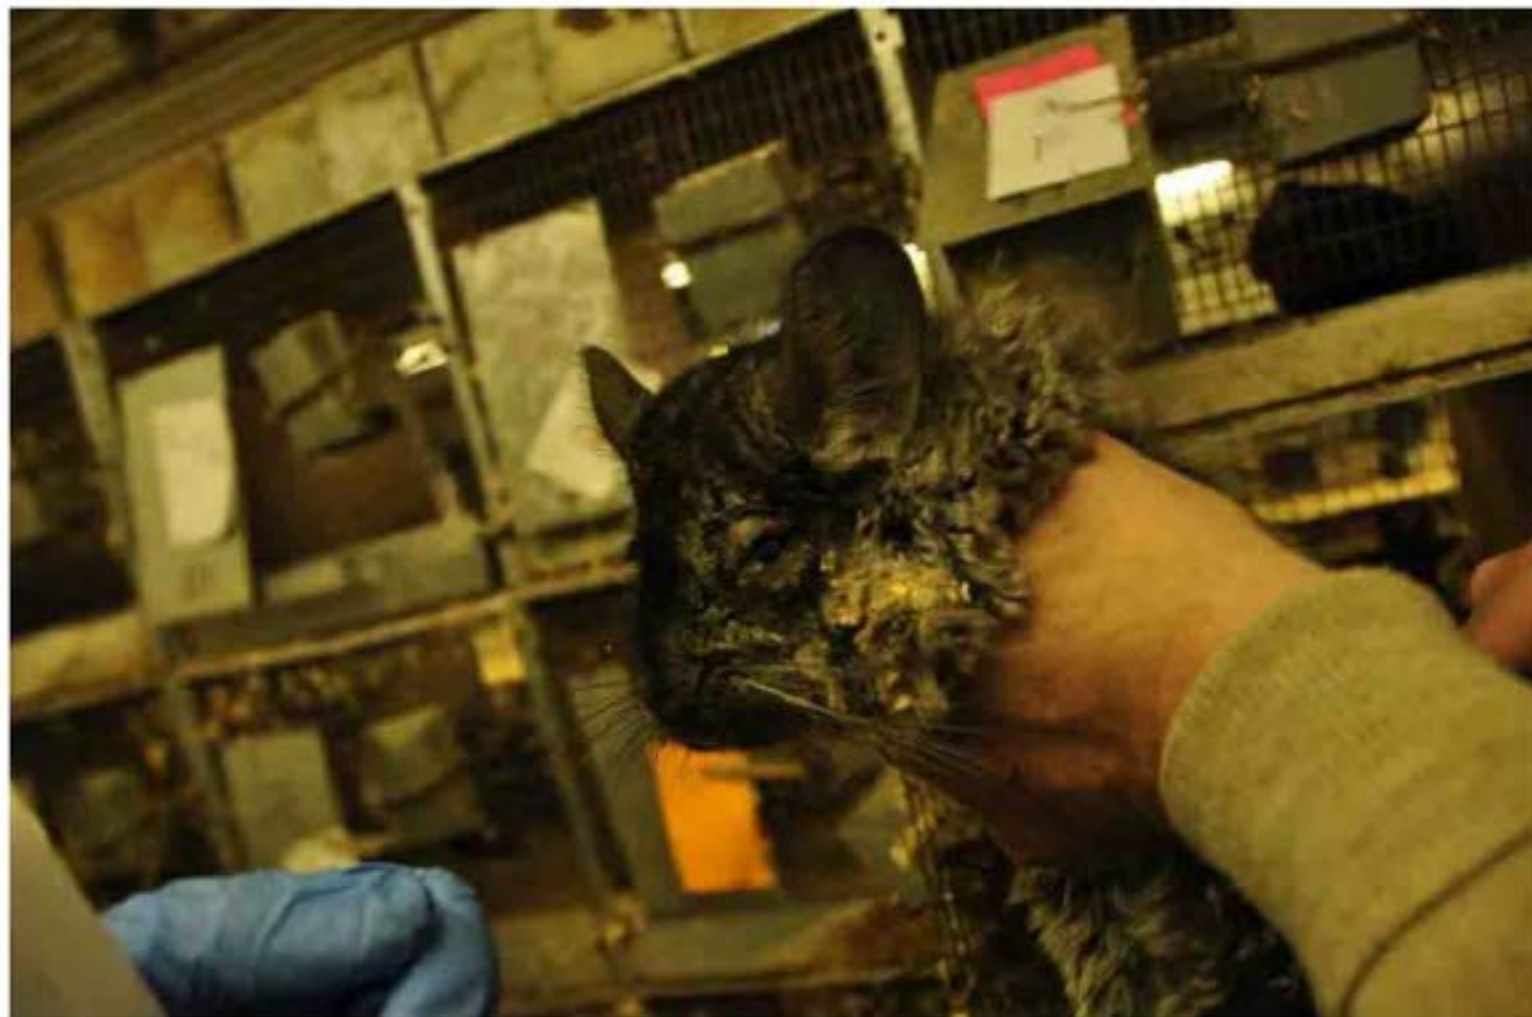
| Description: | Left eye black and silver female Chinchilla (eartag DJM 145). Per records, cage marker; and licensee, animal is receiving veterinary-prescribed treatment. | | |
