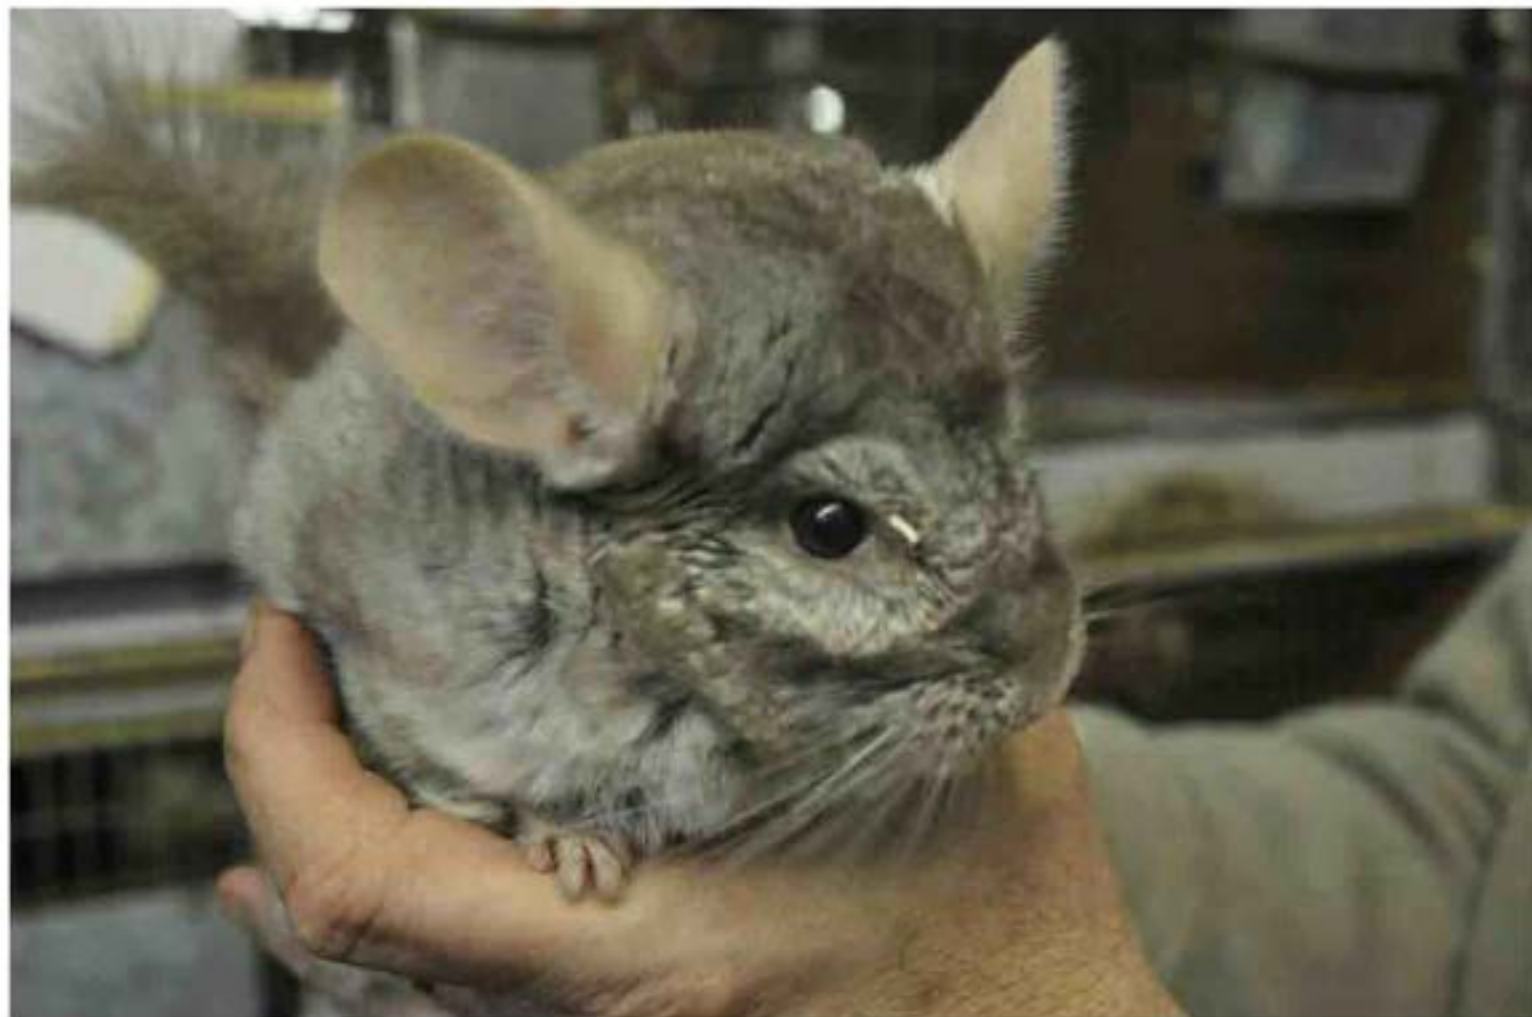
| Description: | Chinchilla (no id, pen 166); Per records, cage marker; and licensee, animal is receiving veterinary-prescribed treatment. | | |

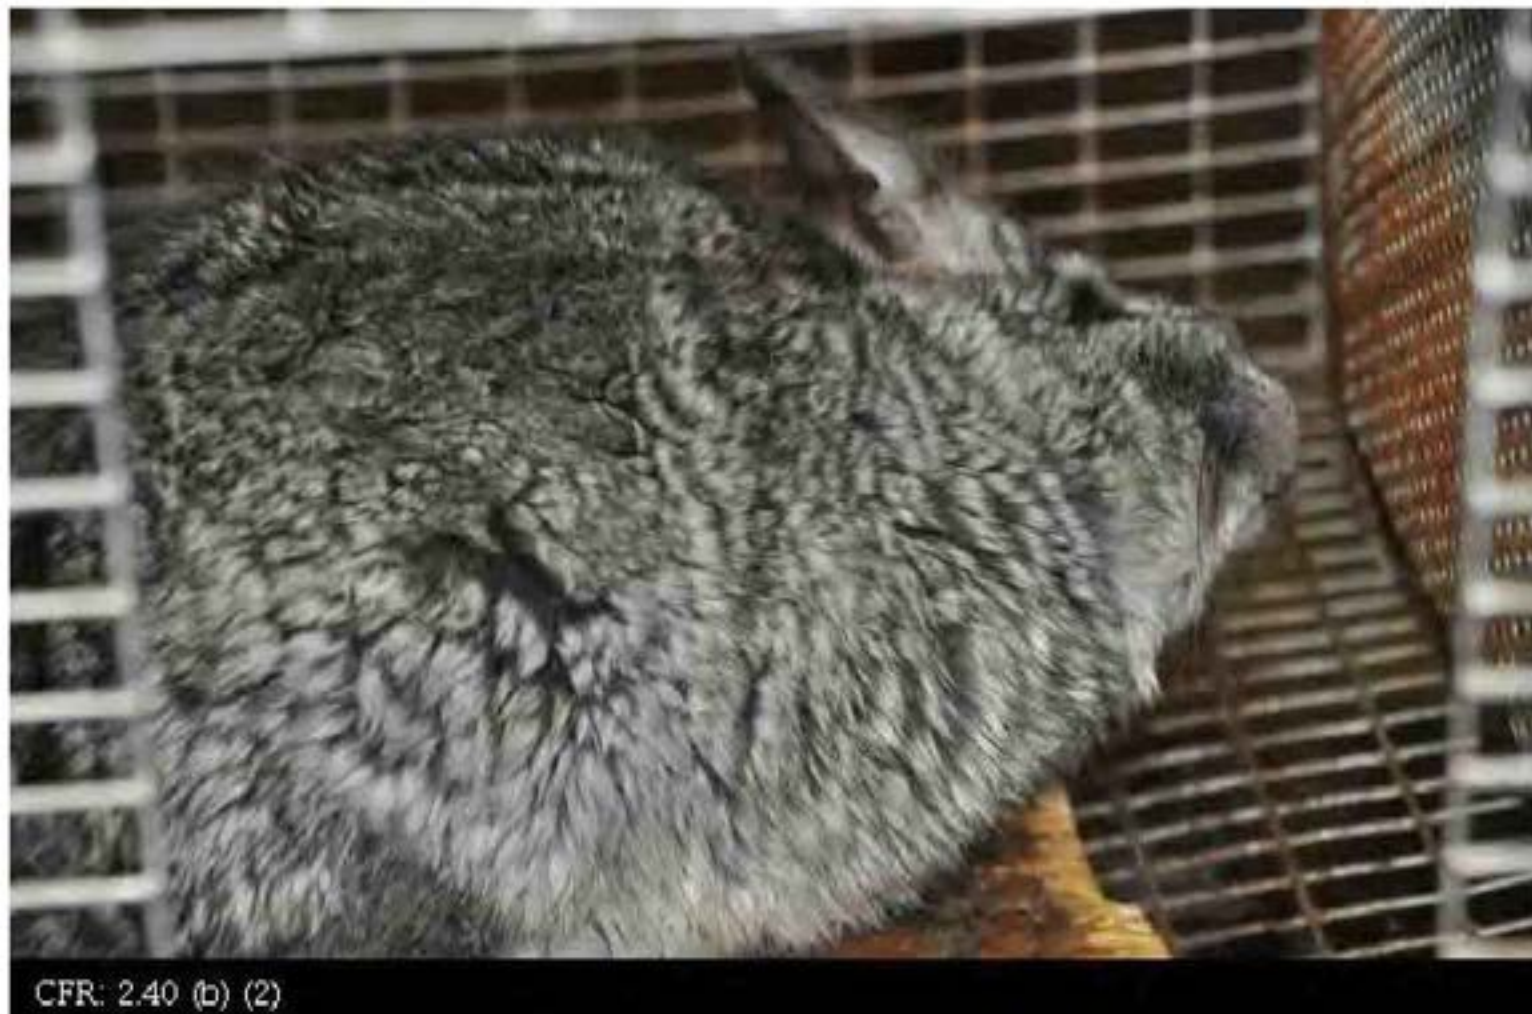
| Description: | Silver grey female (no ID, housed in front room, north side, cages facing the wall); head tilted to the left. | | |

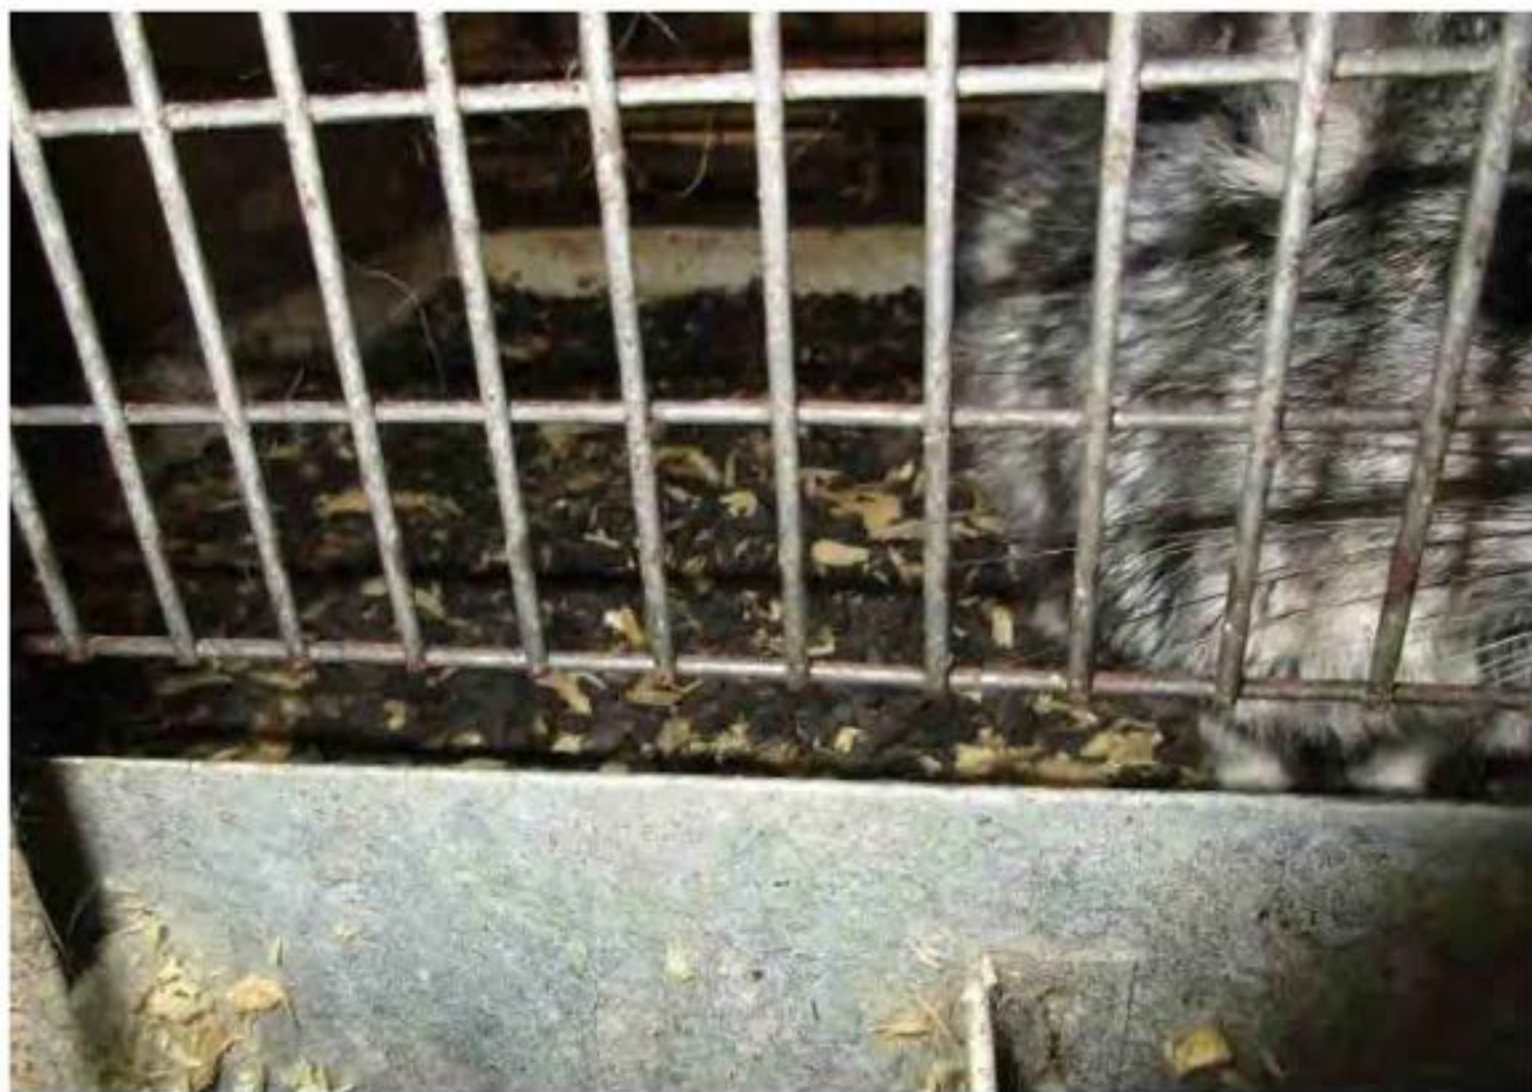
| Description: | Enclosure in front room, south side; representative of enclosures with excessive feces and soiled material. | | |

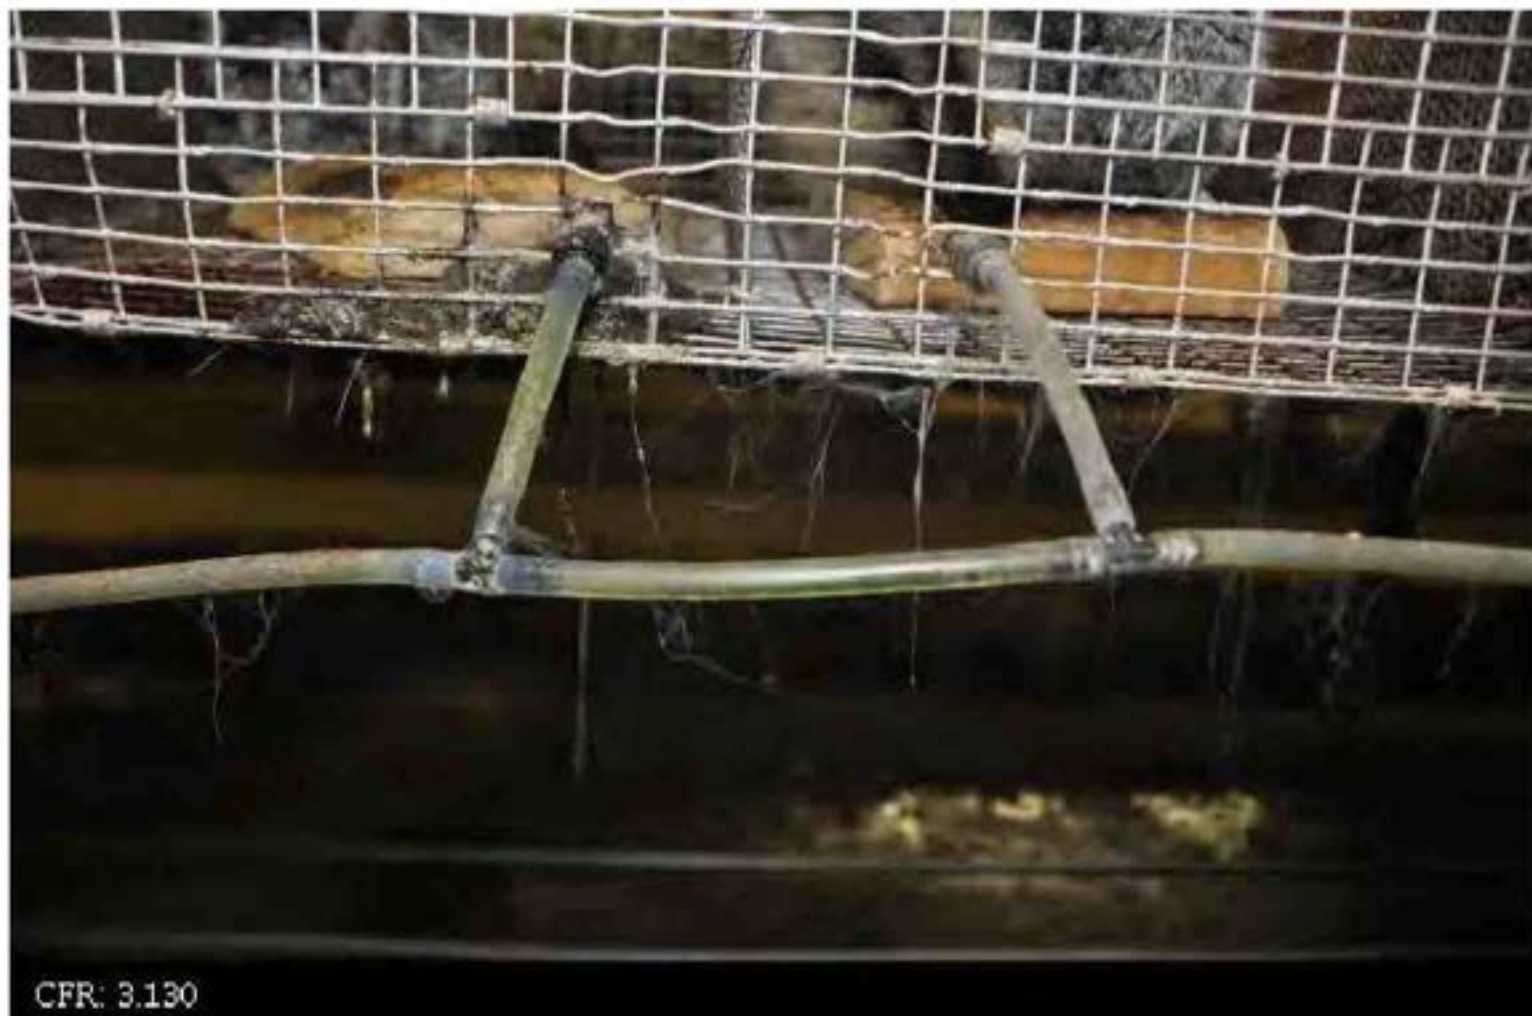
| Description: | Water line facing north wall with greenish build-up inside. | | |

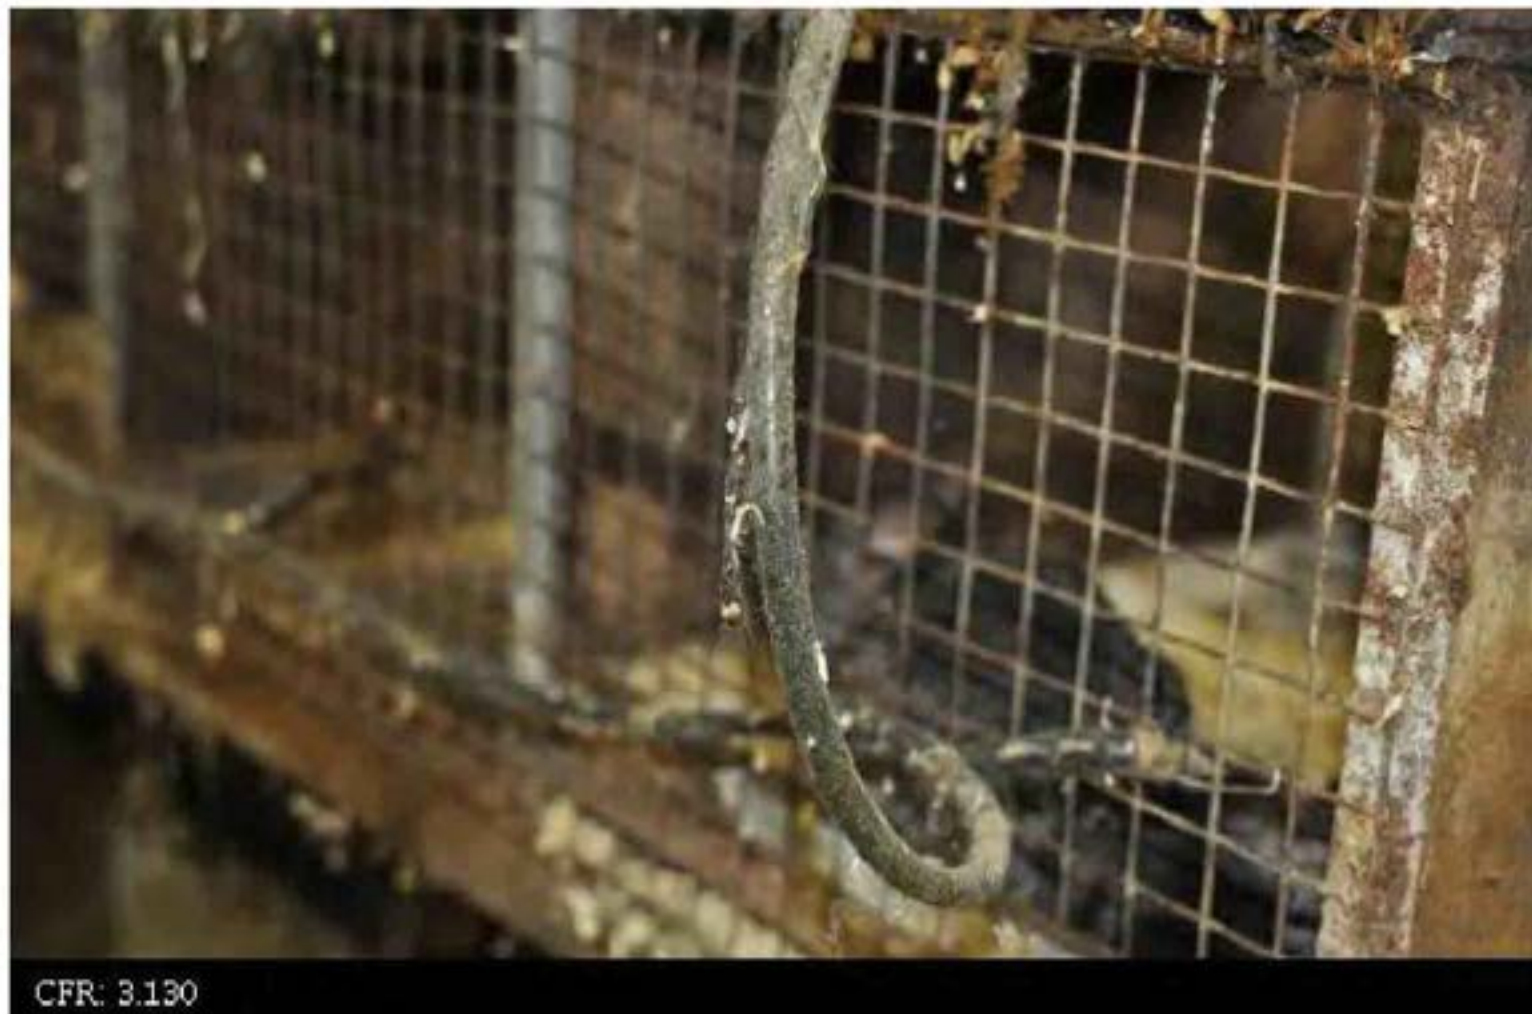
| Description: | Water line; front room, stacked cages on south wall. | | |

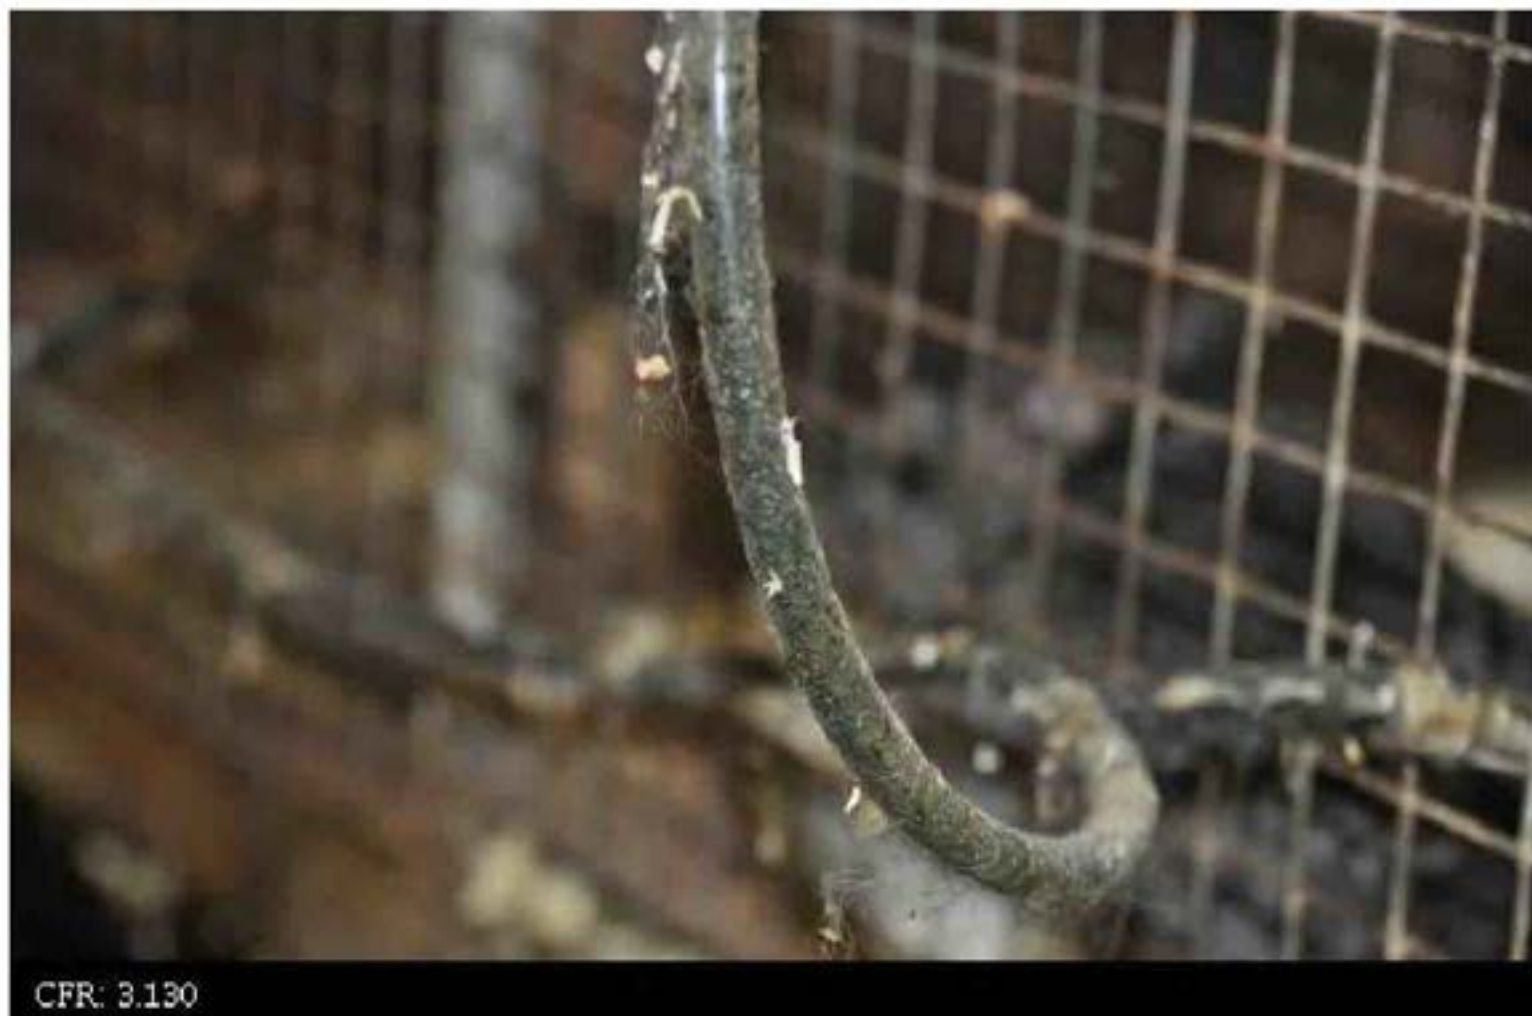
| Description: | Water line; front room, stacked cages on south wall. | | |

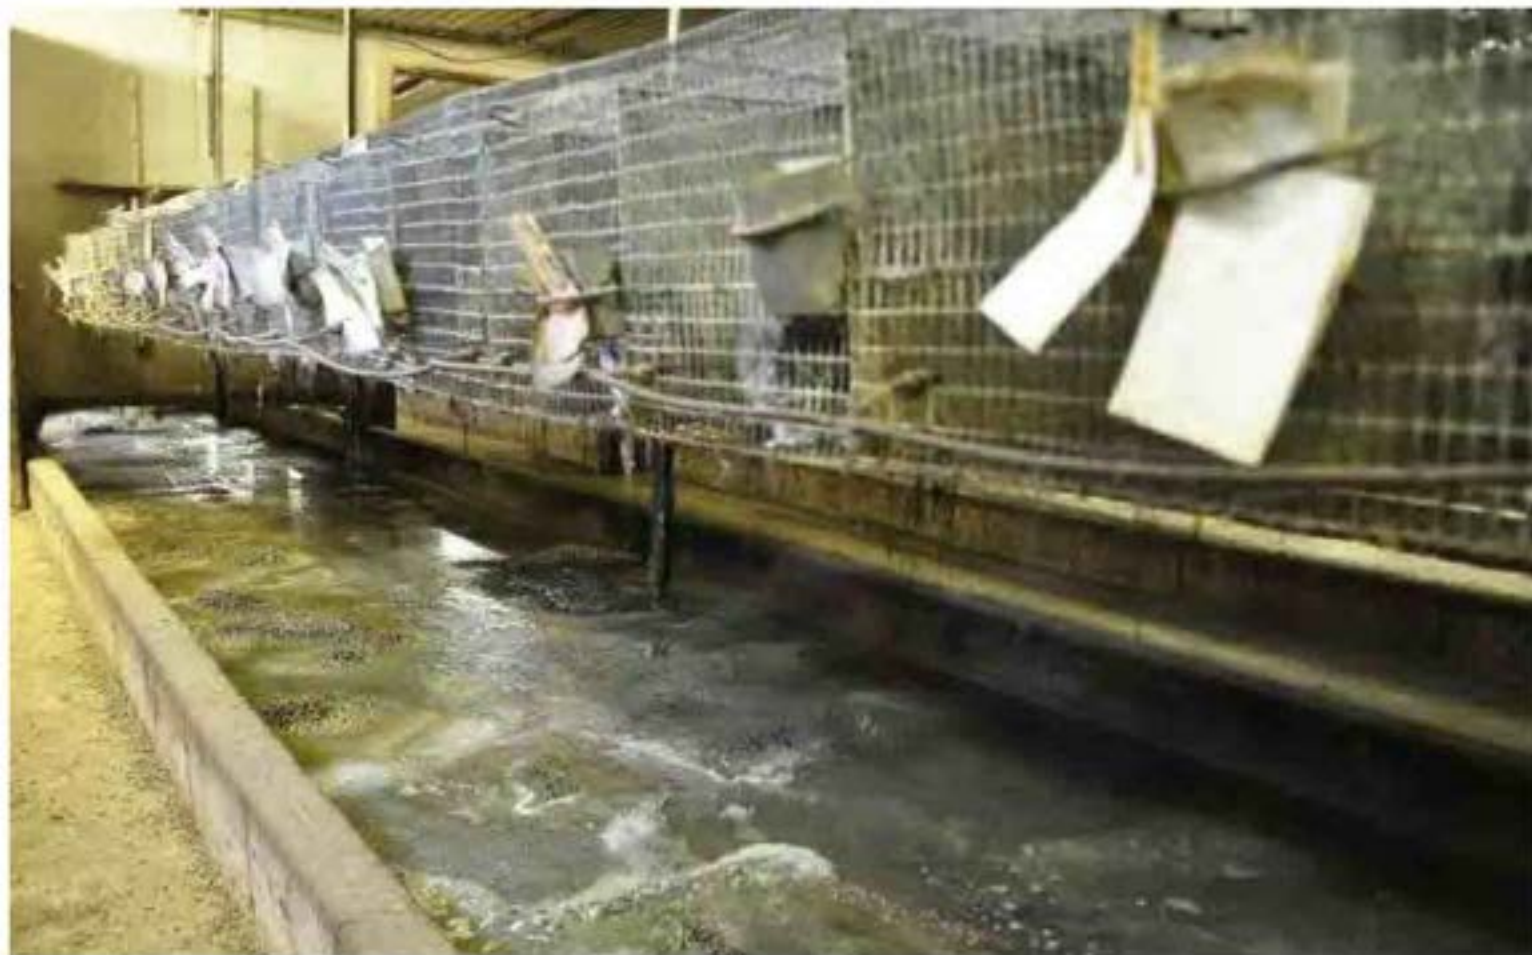
| Description: | Build up of soiled material in south gutter of facility; picture taken in middle room looking northwest. | | |

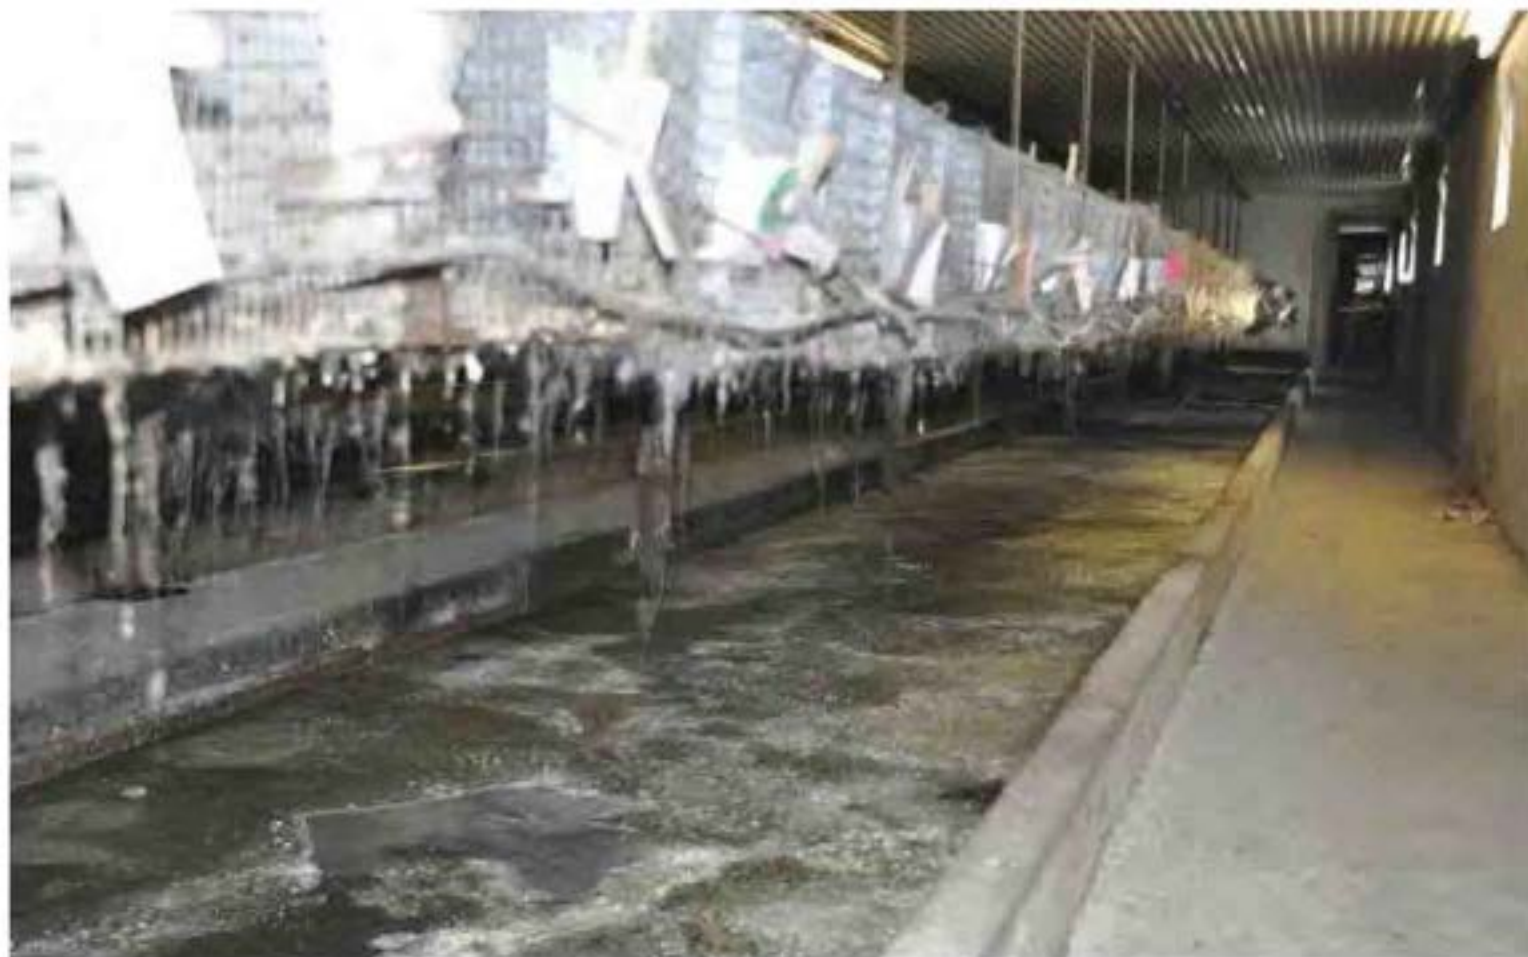
| Description: | Build up of soiled material in south gutter of facility; picture taken in middle room looking east. | | |

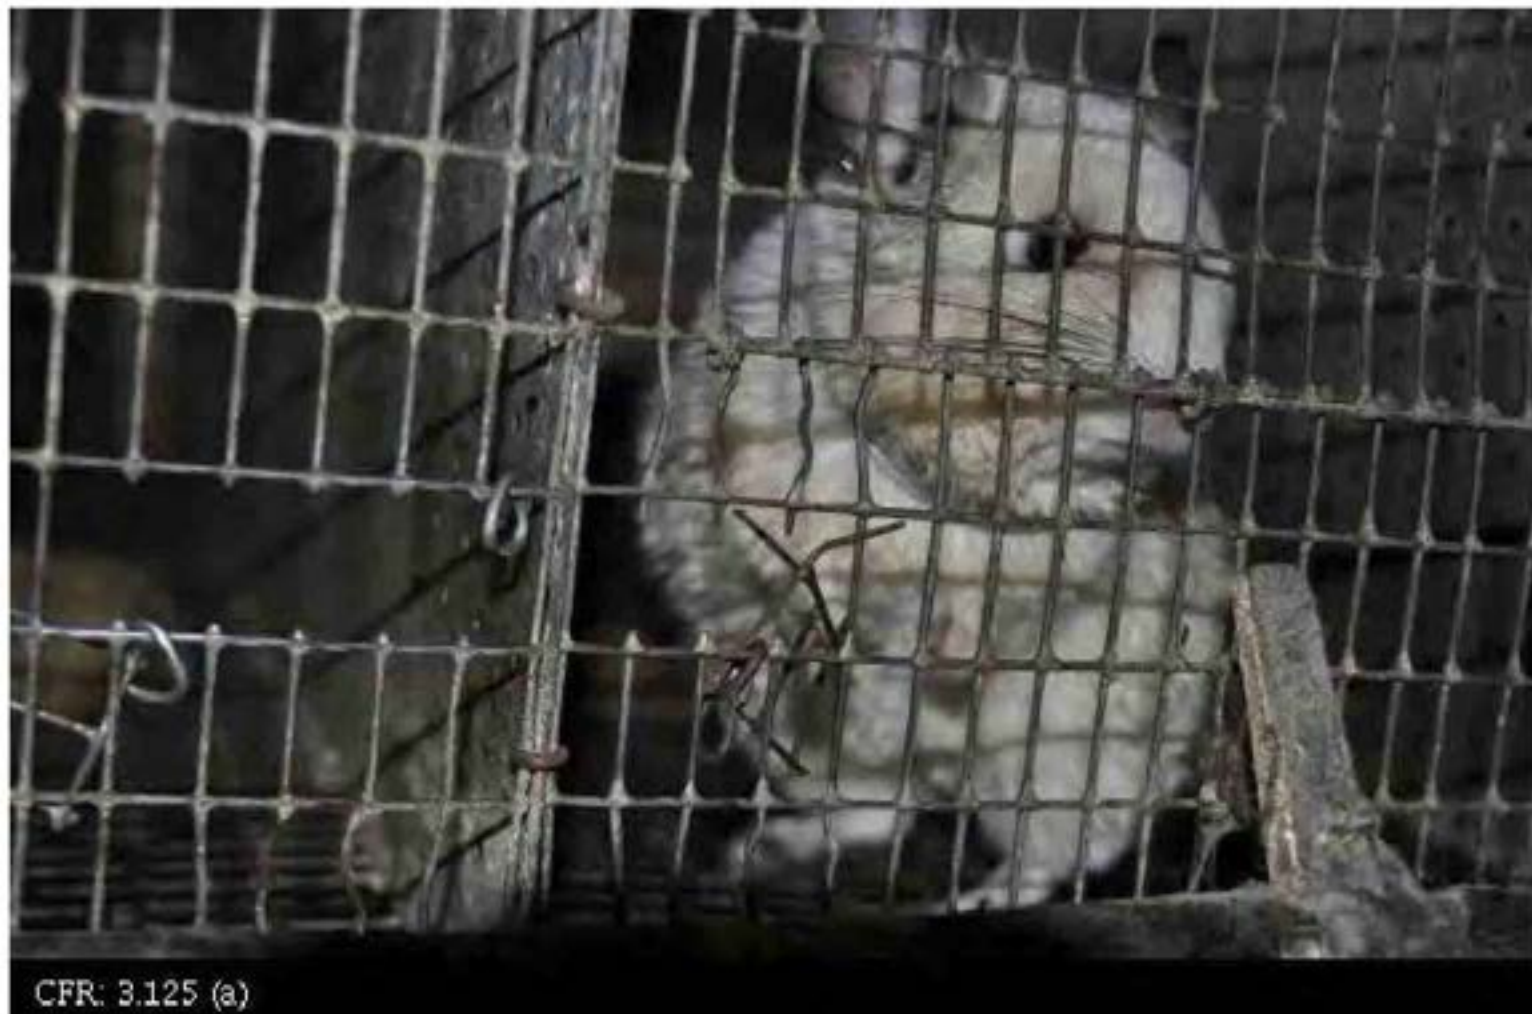
| Description: | Piece of broken panel with sharp wire points; similar piece is present in enclosure to left white chinchilla and noted in bottom left of photo. | | |
