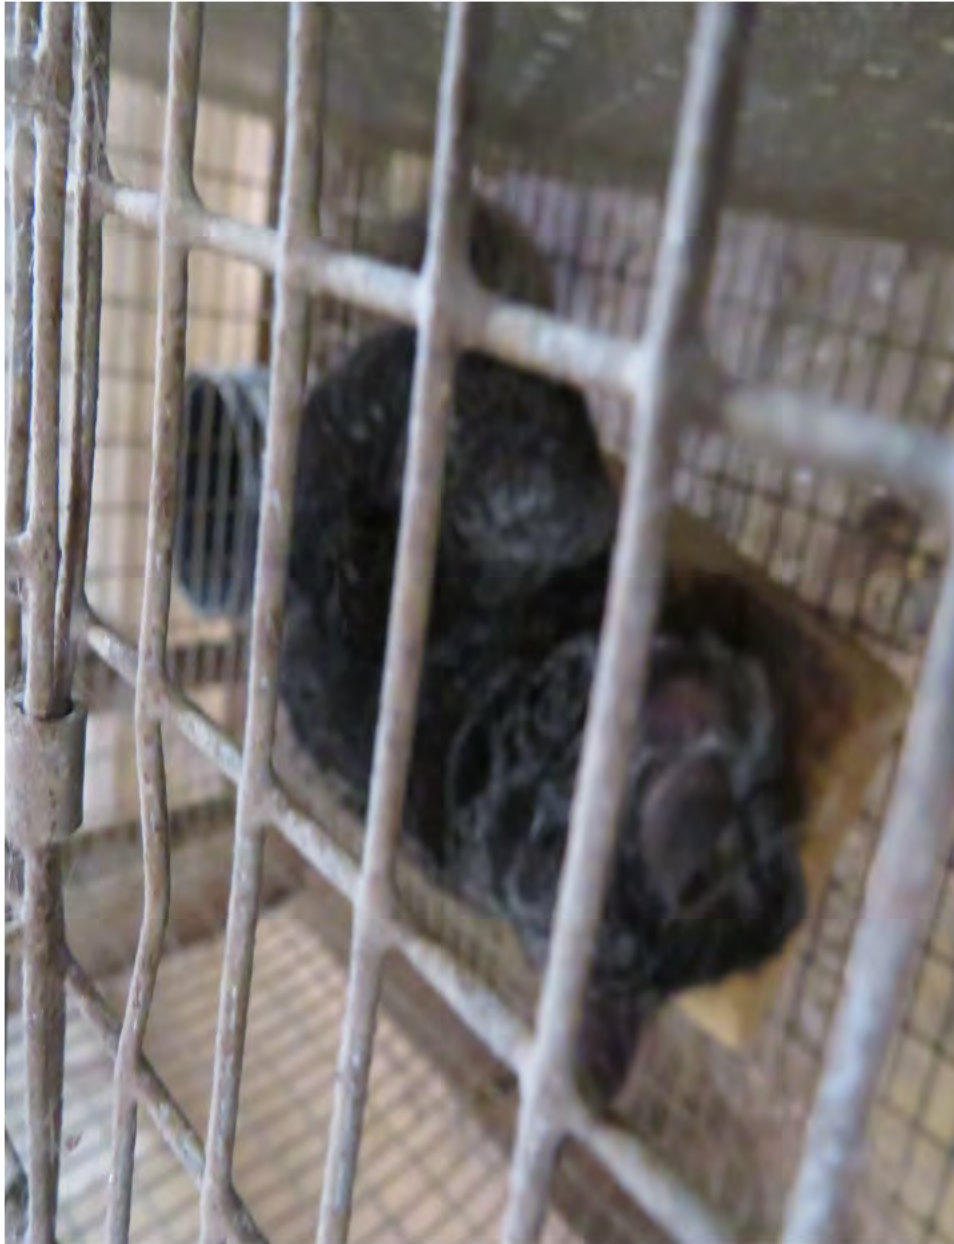
Female grey chinchilla with a swollen area under her left side of her jaw. Facility assigned her treatment tag #65 after we pointed the problem out. Picture is taken looking at chinchilla from above.
