EXHIBIT B –  
Declaration of  
Amy Katherine Taylor

**DECLARATION OF AMY KATHERINE TAYLOR**

3. I was the lead building and enclosure assessor who assisted the United States in the execution of the federal criminal search warrant from May 18, 2022 to May 22, 2022 at Envigo RMS's Cumberland, Virginia facility. As the lead building and enclosure assessor, I led a team of law enforcement and animal control officers that conducted evaluations of the

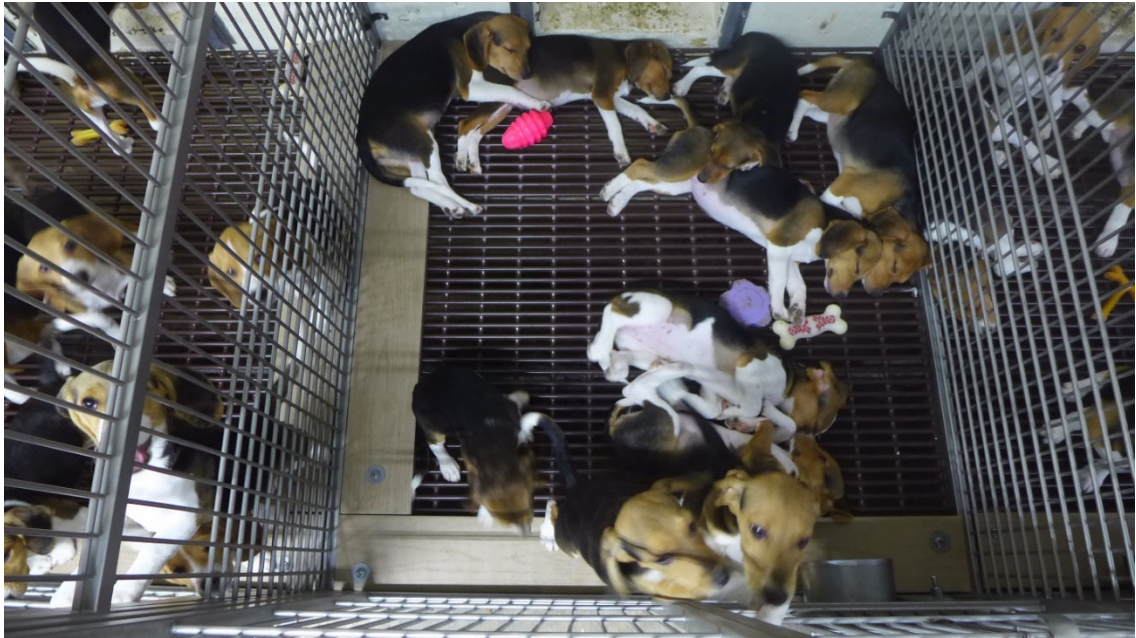
4. I observed that there were enclosures with numerous animals in them, and that there were enclosures that contained nine or more dogs. *See photo below.*

For example, enclosures 9A102, 9A103, 9A105, 9A106, and 9A107 all had 10 dogs in them, and enclosures 9A124, 10A16, 10A23, 10A24, and 10A25 had 9 dogs in them. In many enclosures, I observed that one beagle would be hunched in the corner in a manner that indicated it was overwhelmed.
